CEN23LA217

## INVESTIGATION PHOTOGRAPHS

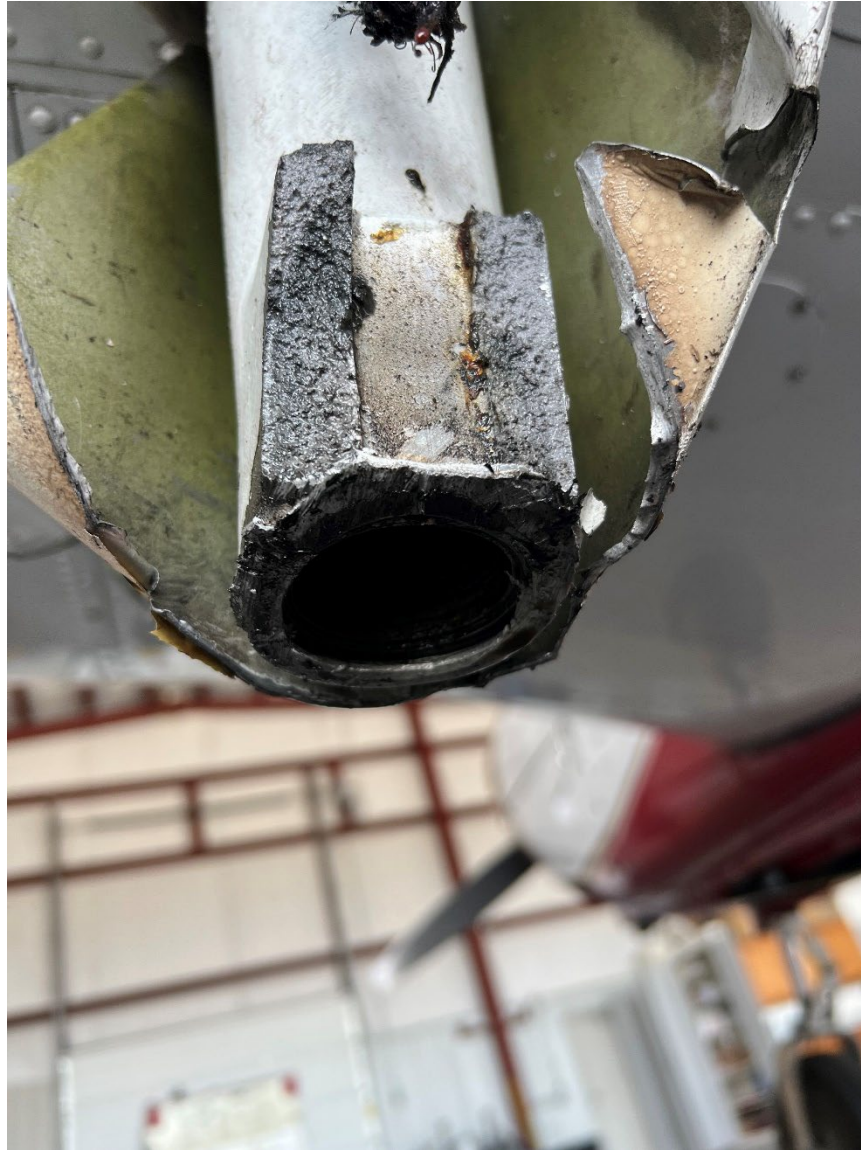
**Photograph 1 - Fractured left main landing gear strut housing clevis (Courtesy of the Federal Aviation Administration)**

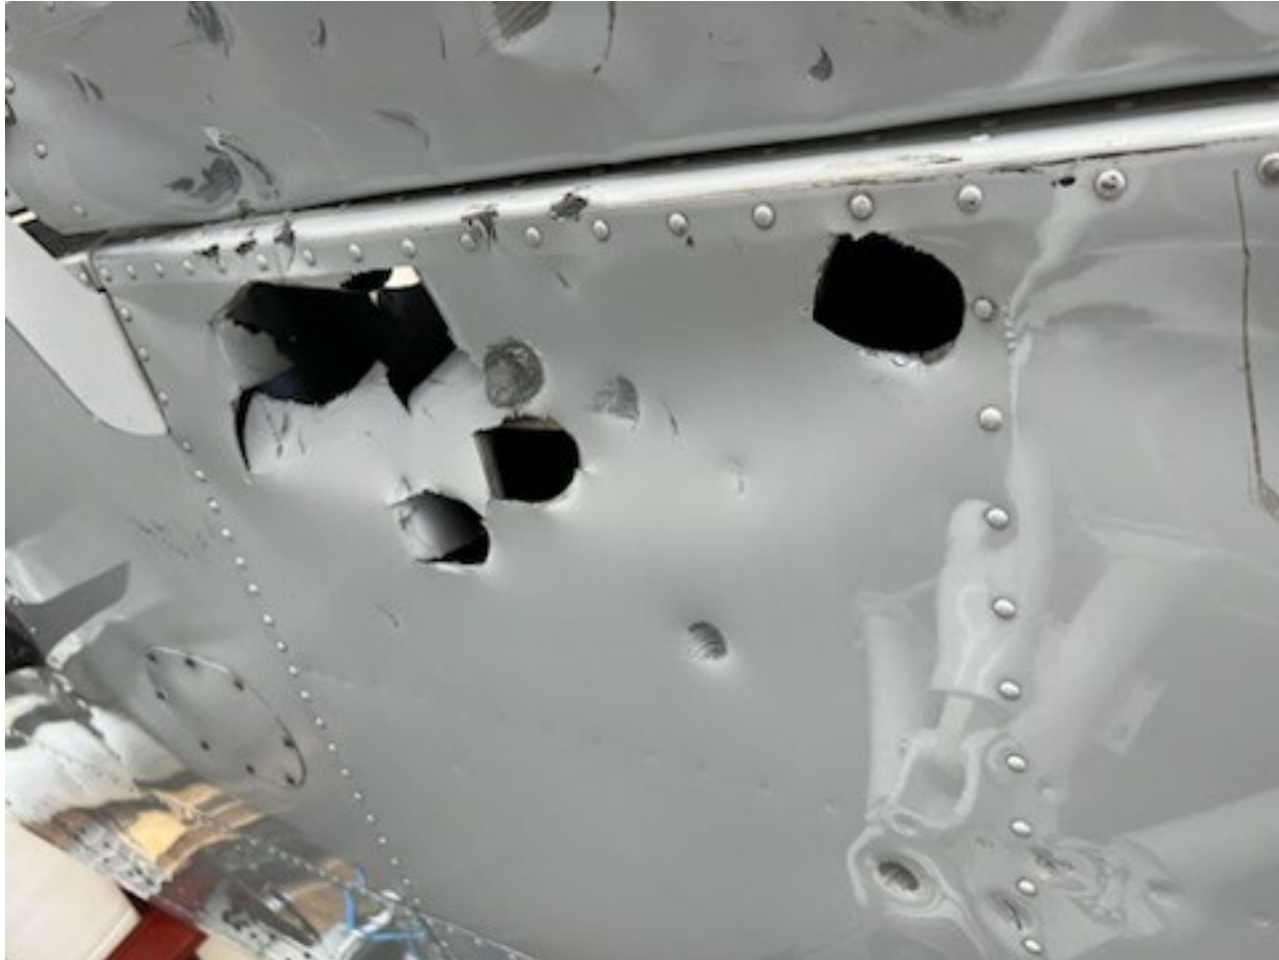
**Photograph 2 - Damaged left wing (Courtesy of Federal Aviation Administration)**
