# National Transportation Safety Board

CEN23LA223

## **EXAMINATION SUMMARY**

Location: Lake Village, Arkansas  
Date: June 3, 2023  
Time: 1158 CDT  
Airplane: Air Tractor AT-502B, N509HB

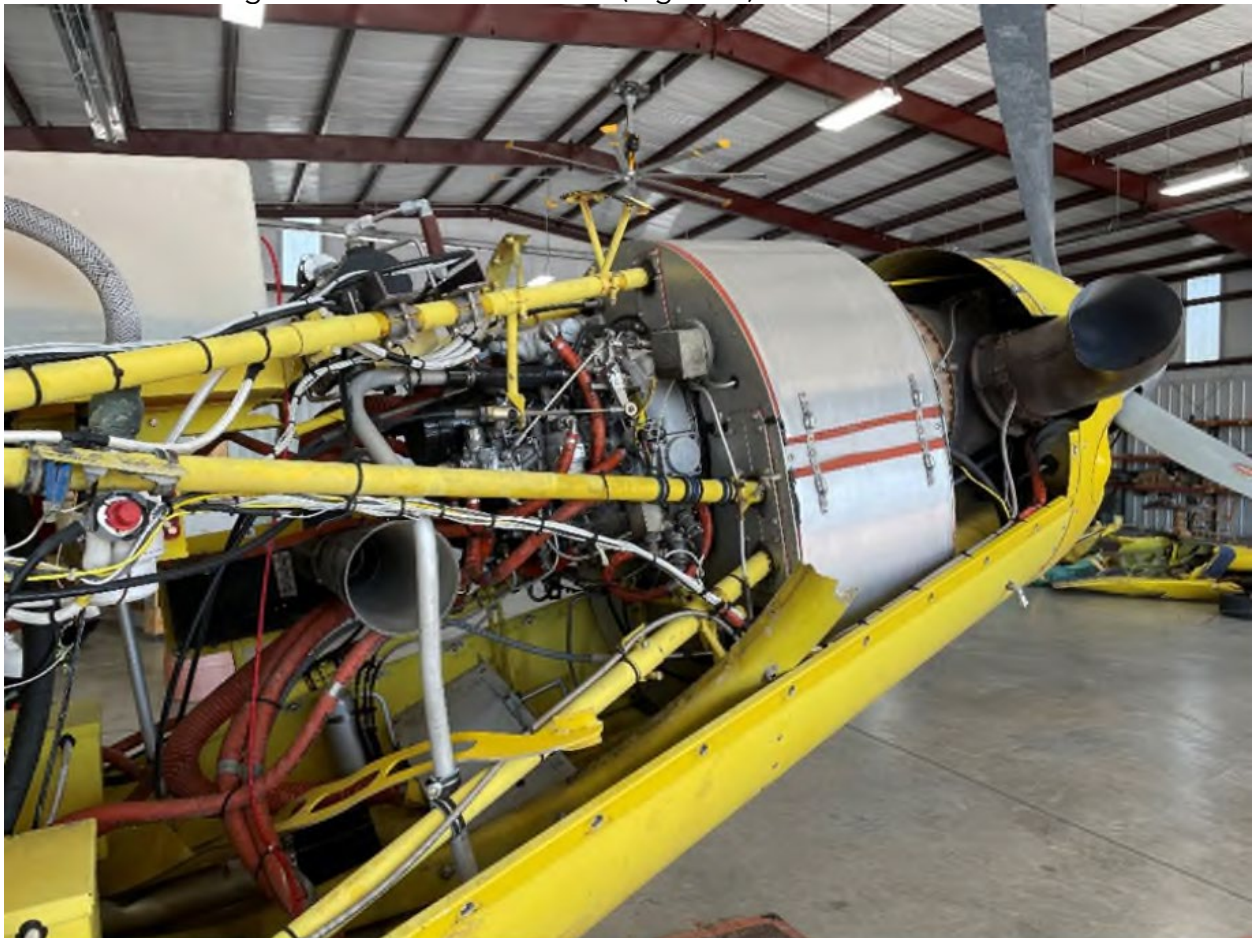
Figure 1 - Engine as presented

The engine was still within the air frame (Figure 1). The propeller was still attached to the engine and showed some damage to the propeller tips (Figure 2). The data plate confirmed the engine S/N was PCE-PH0492 (Figure 3).

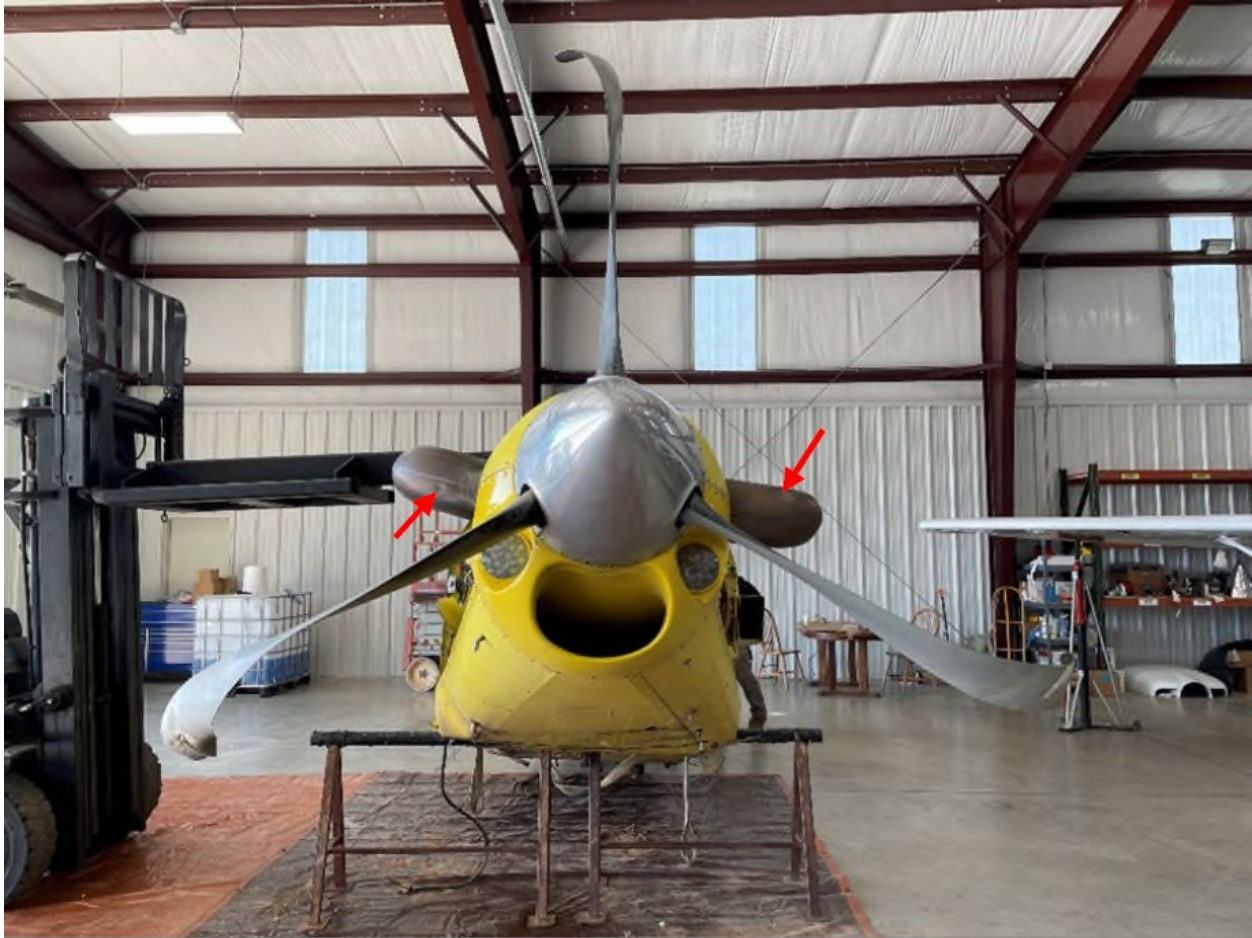
Figure 2 - Propeller and exhaust stacks

**Exhaust Duct:** The exhaust duct exhibited some deformation to the top and bottom surface regions (circled, Figures 5 and 6). The exhaust stack showed occasional dents on the front surfaces that did not appear recent in coloration (red arrows, Figure 2).

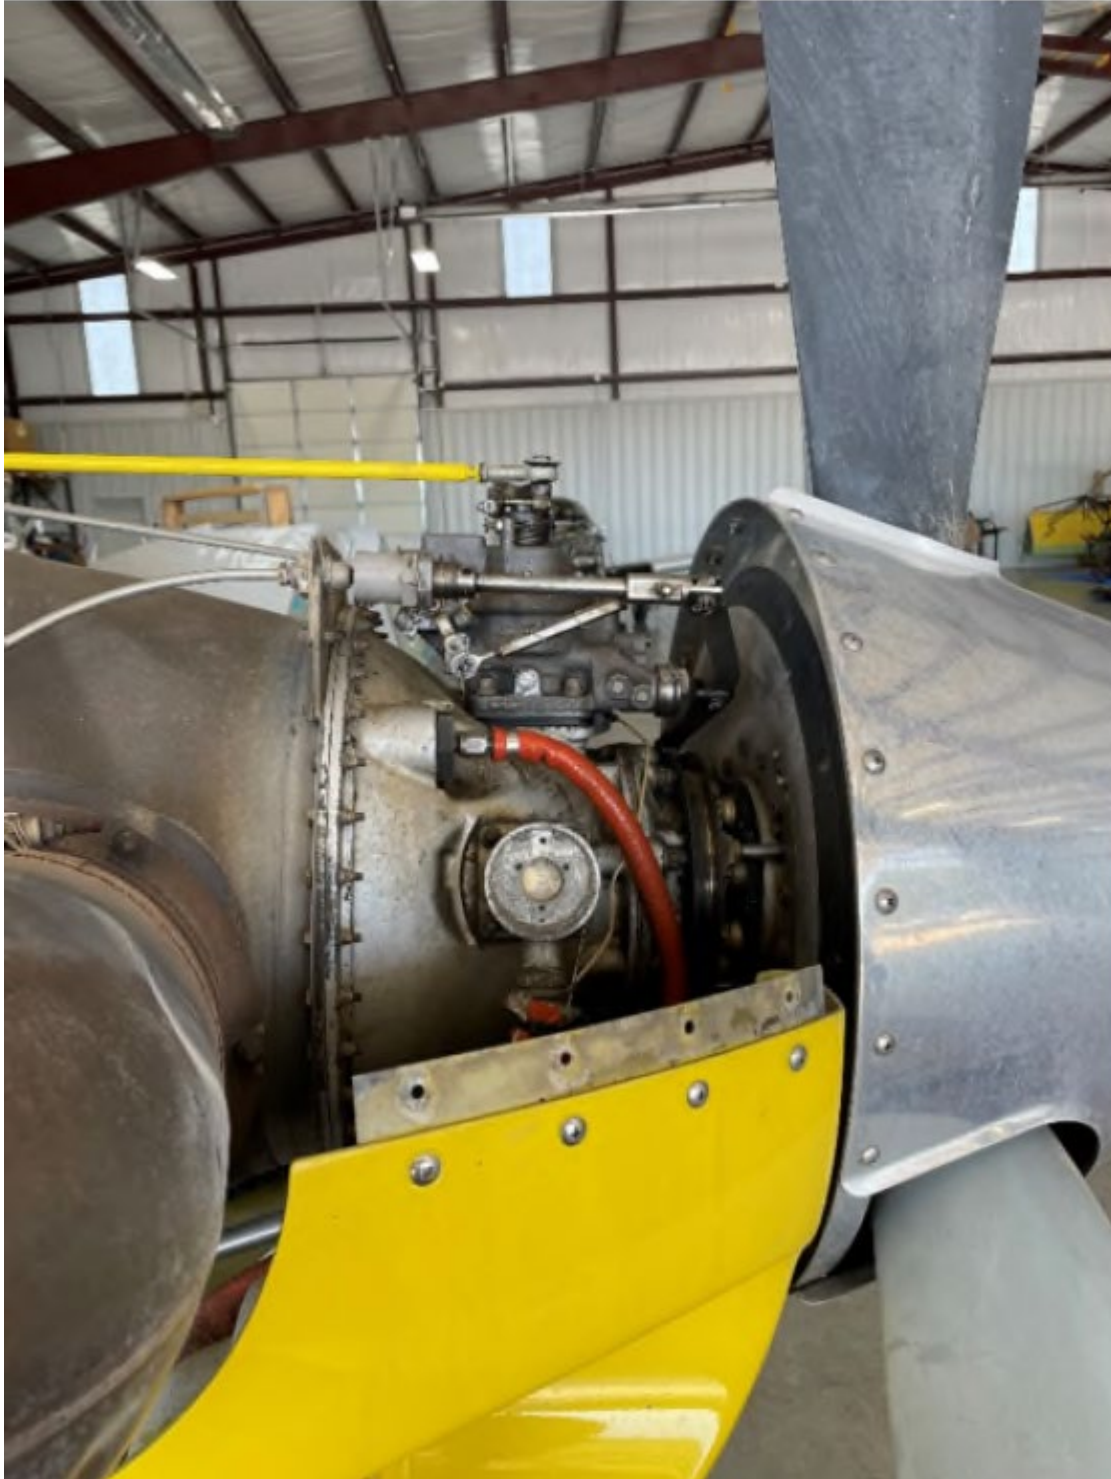
Figure 4 - Reduction Gear Box

**Reduction Gearbox (RGB):** The RGB could not be rotated, however no external damages were observed (Figure 4).

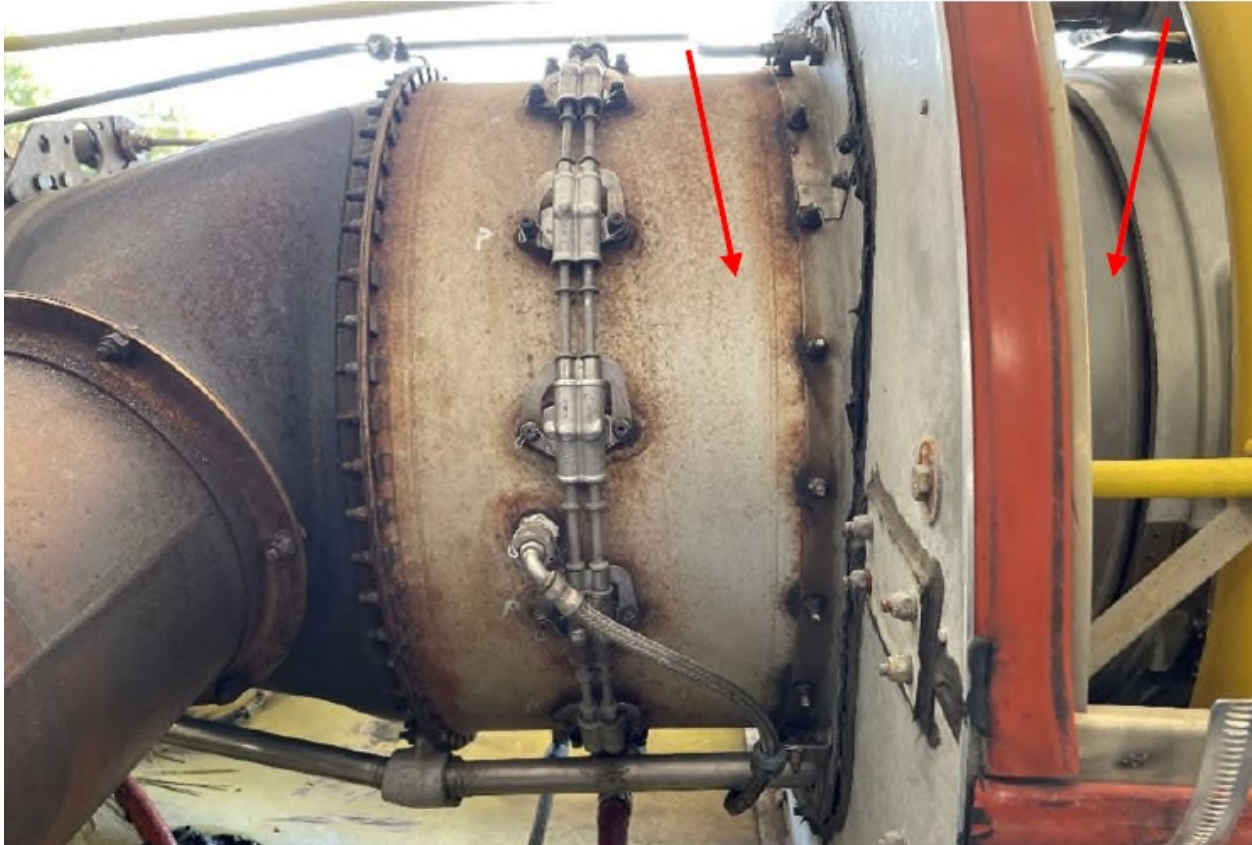
Figure 7 - GGC

**Gas Generator Case (GGC):** The GGC case showed no damages (red arrows, Figures 5 and 7).

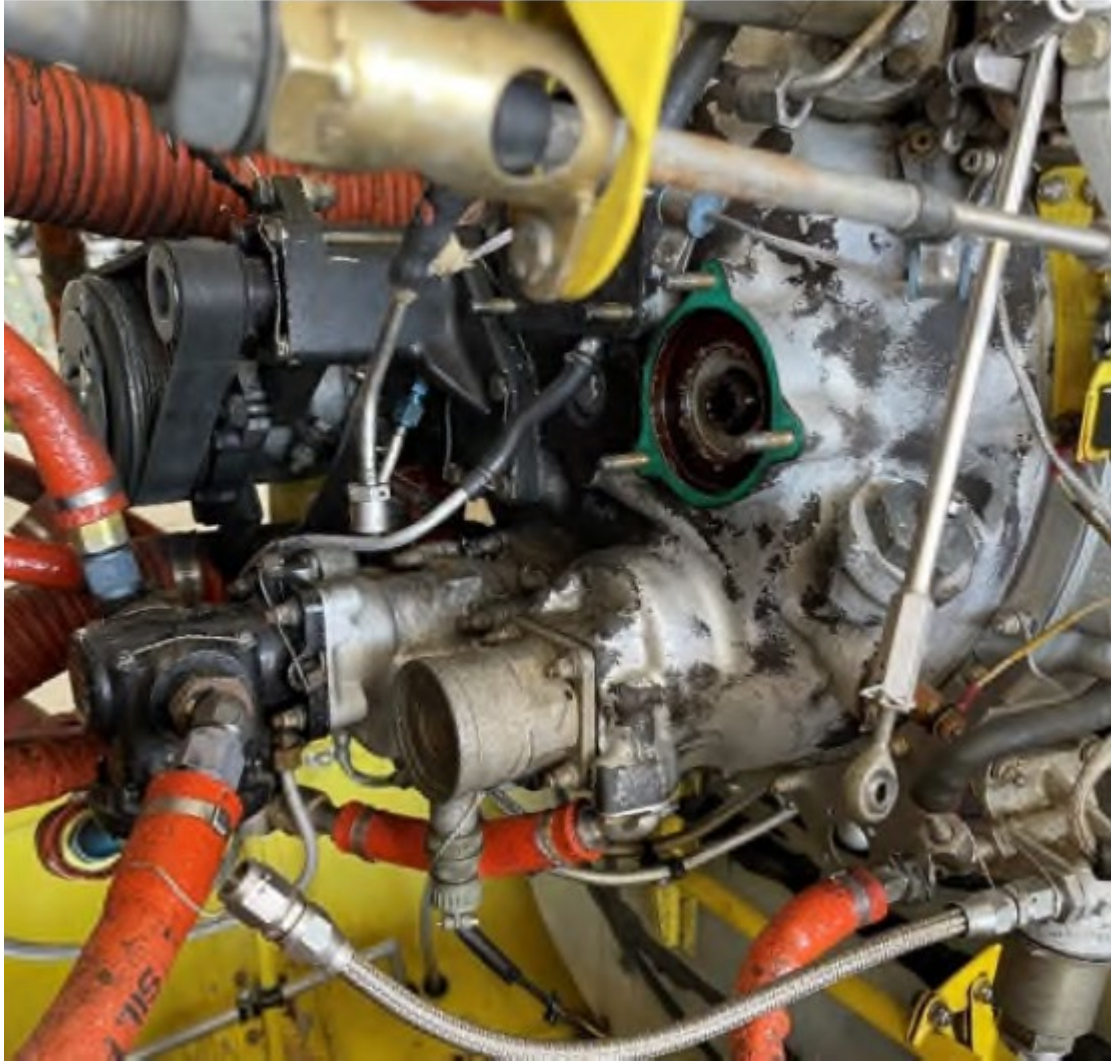
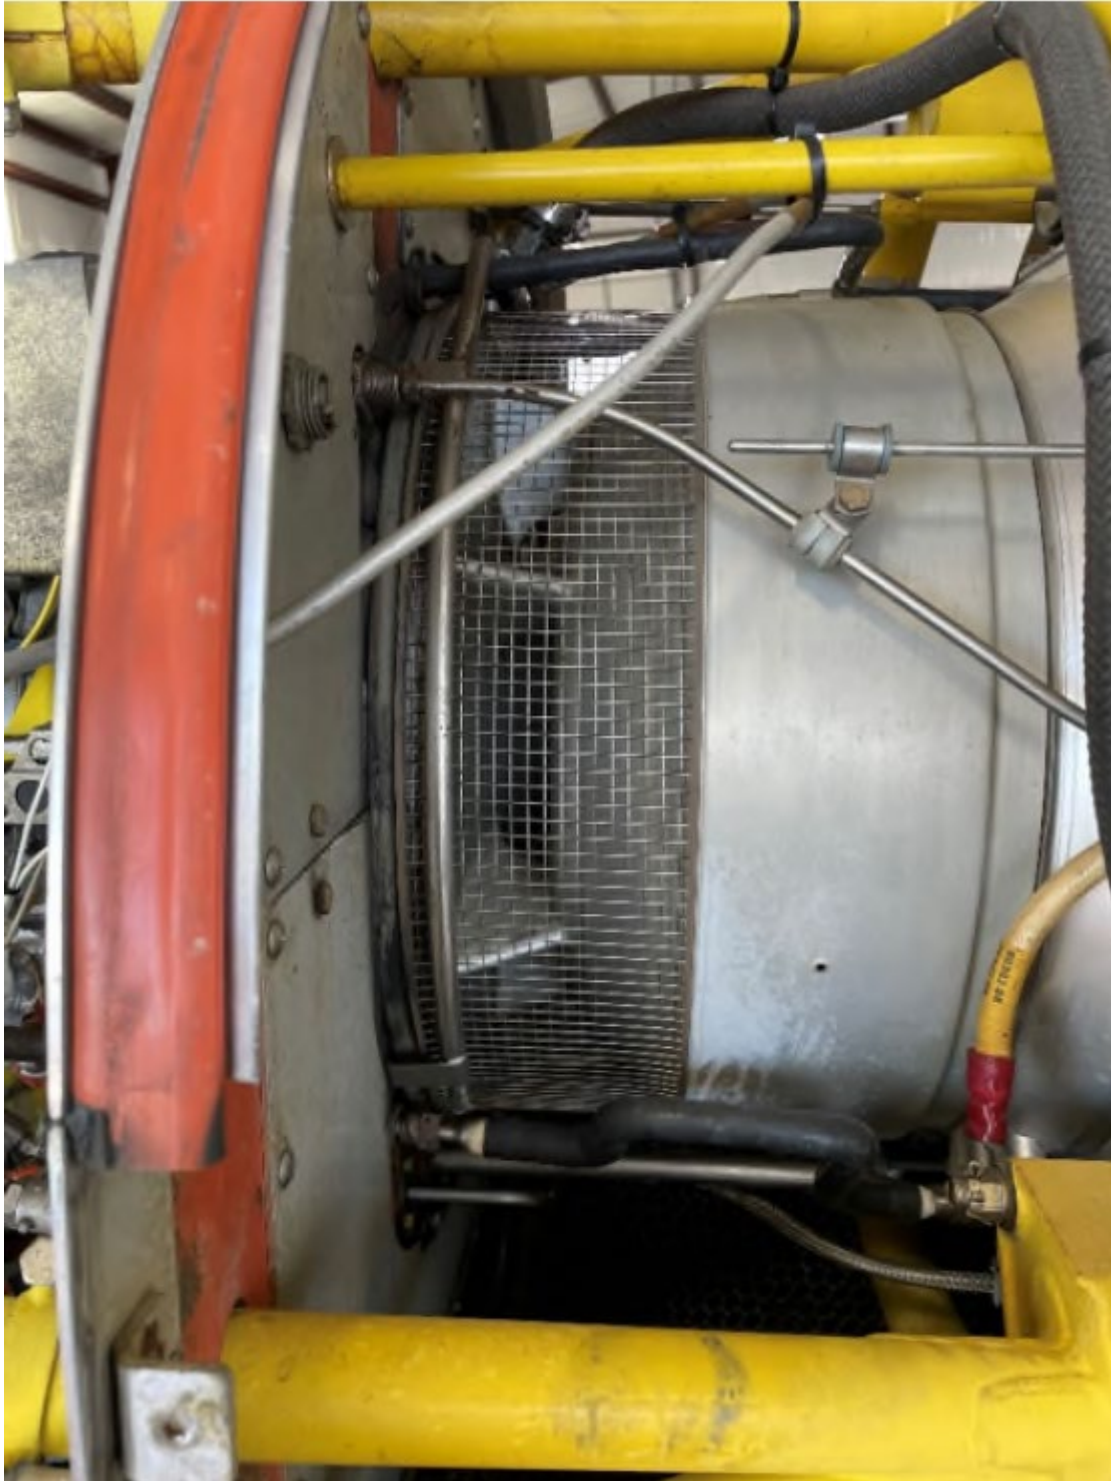
**Accessory Gearbox (AGB) and Inlet Case:** The AGB and inlet case showed no damages (Figures 8 and 9 respectively).

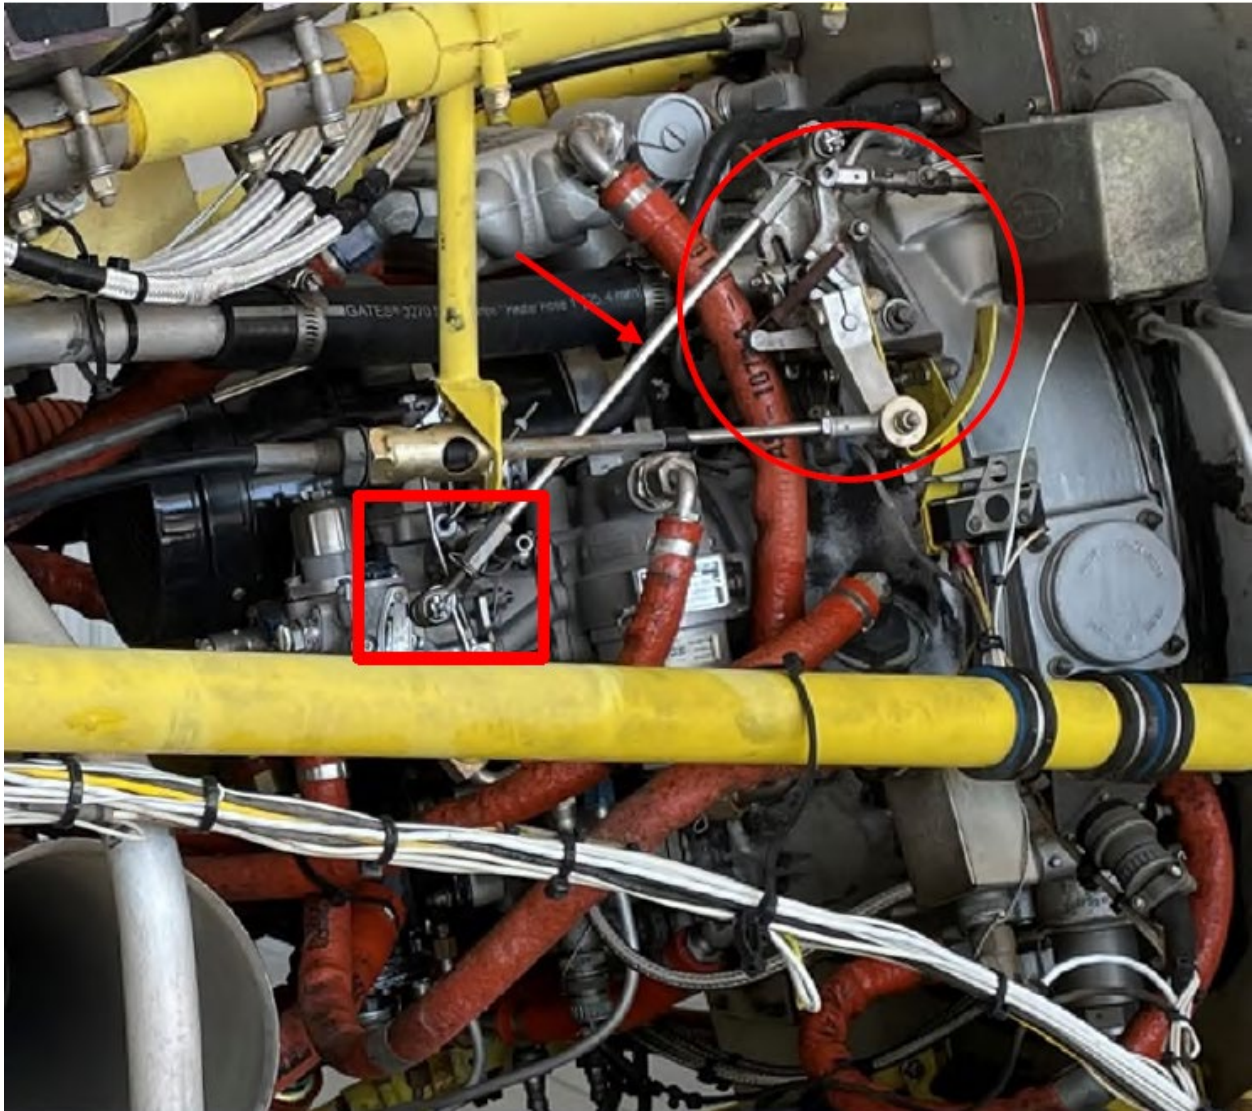
Figure 10 - CAM Box, Fuel Control Unit (FCU) Connecting Rod, and FCU Arm.

The CAM box (red circle), fuel control unit (FCU) connecting rod (red arrow) and FCU Arm (red square) were undamaged (Figure 10). The reversing cable (dashed red arrow), interconnect rod (red arrow), propeller governor (CSU) reset arm (white

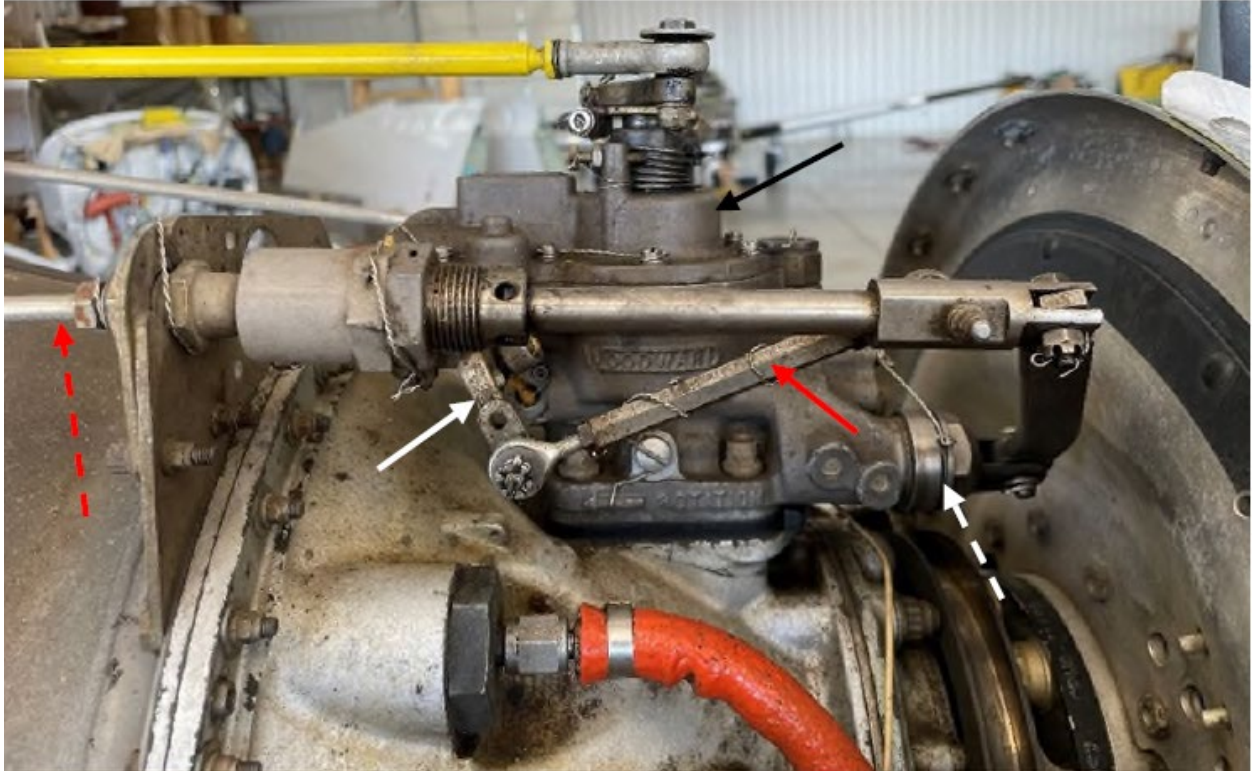
Figure 11 - Reversing Cable, Interconnect Rod, Propeller Governor (CSU) Reset Arm, Beta Valve and CSU

arrow) and Beta Valve (dashed white arrow) showed no damages (Figure 11). The beta valve movement was verified with no abnormality in its movement observed. The beta lever (red arrow) and reversing lever guide (white arrow) were found displaced but still underneath the reversing lever guide pin (dashed red arrow), which was mechanically bent (Figure 12). Moving the power lever angle (PLA), which was found at the flight idle position, showed continuity and ease of movement throughout the PLA range with the CAM box, FCU and reversing linkage.

**Propeller Governor (CSU):** The CSU (black arrow, Figure 11), which showed no distress was removed. The CSU rest lever and propeller control lever could be moved by hand. The CSU drive shaft could be rotated freely by hand. The gasket screen showed no presence of any debris. The CSU and sent by the NTSB to Woodward for further analysis.

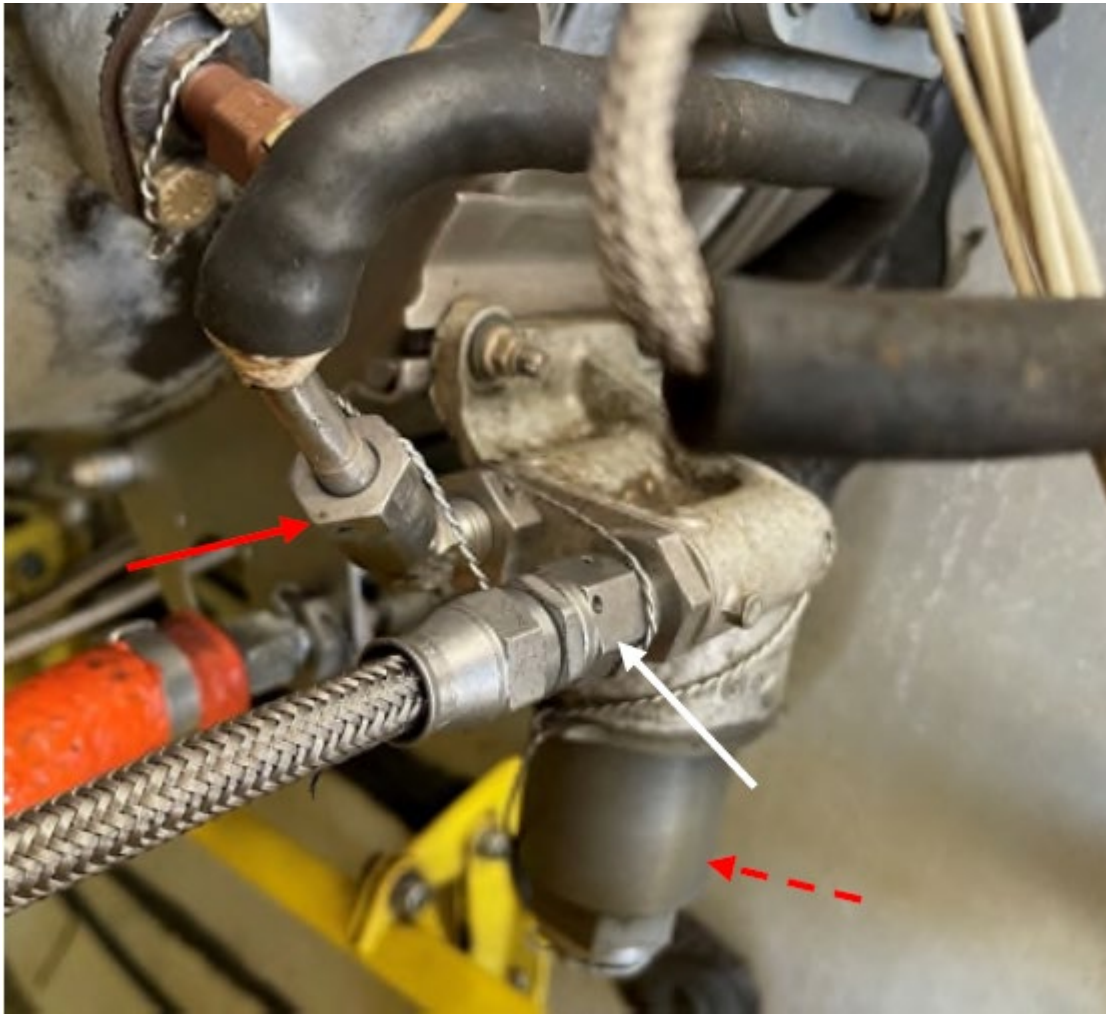
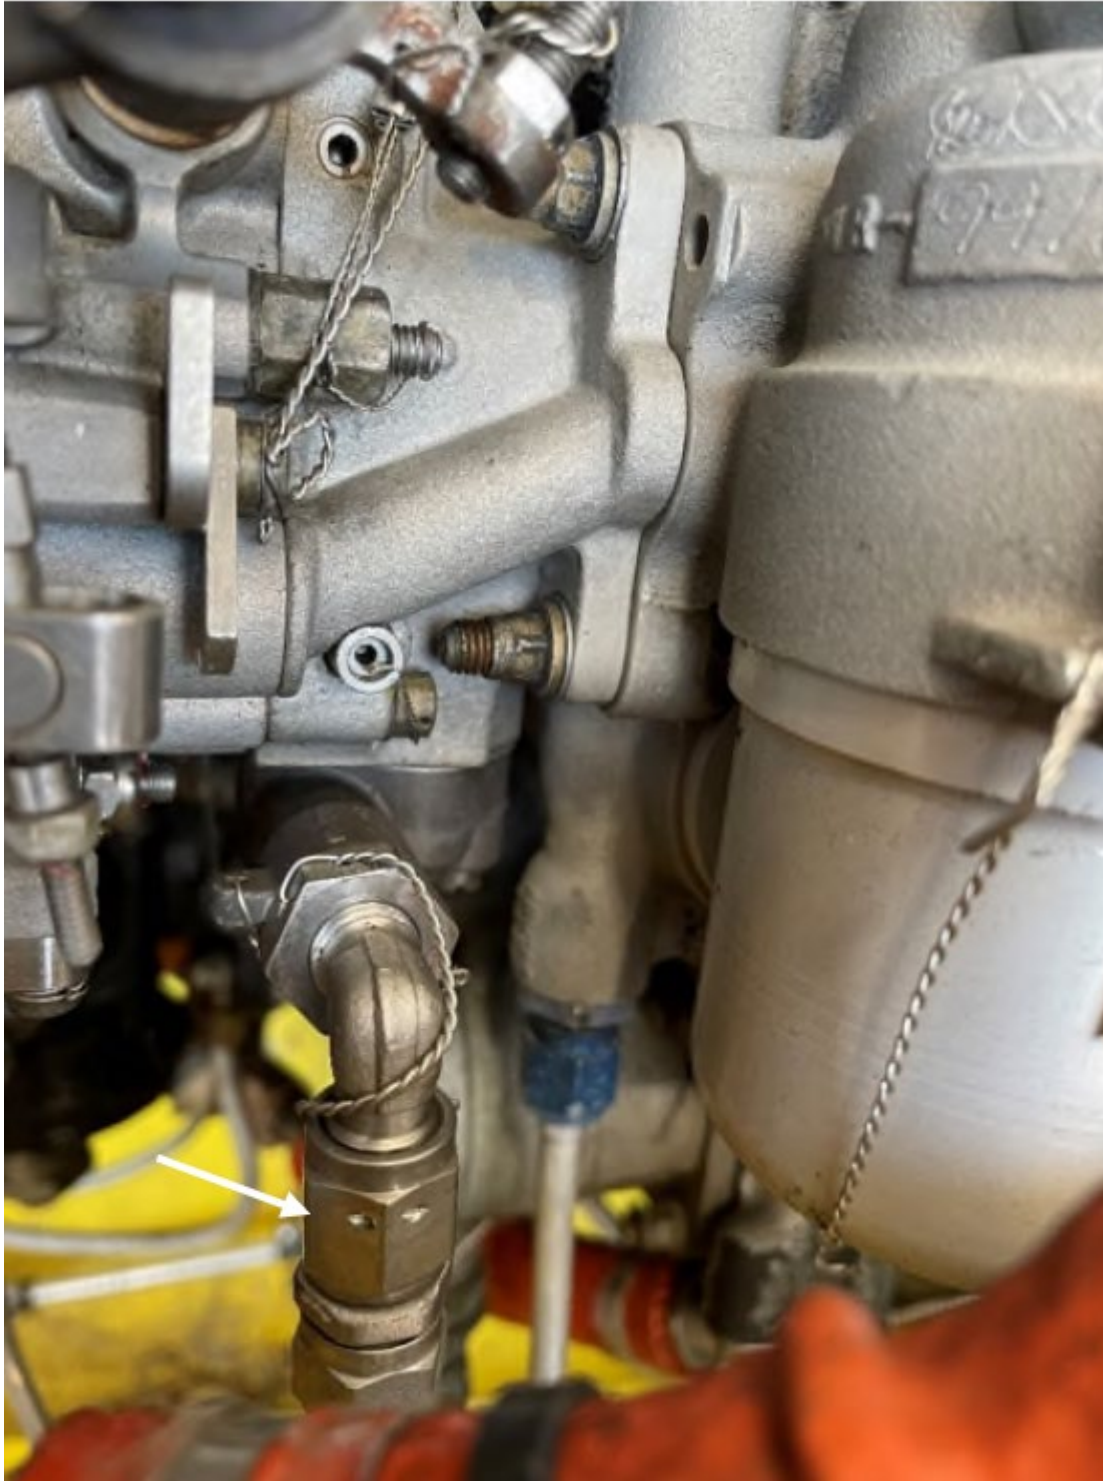
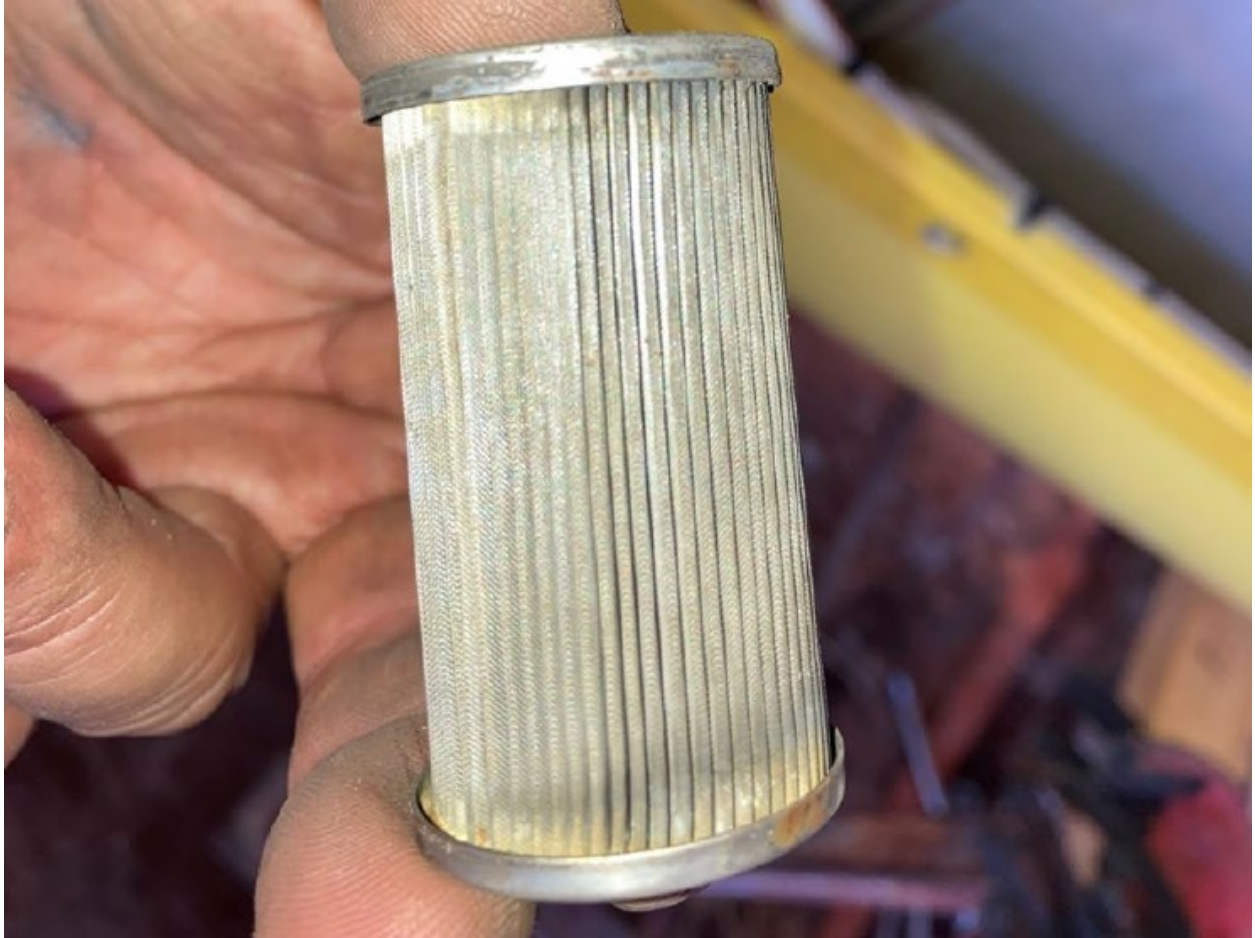
**Compressor Discharge Air (P3) and P3 Filter:** The P3 lines and fittings from the GGC (red arrow) to the P3 filter (dashed red arrow) and to the FCU (white arrow) were

found tight and secured (Figures 13 and 14). The P3 filter and bowl, which was tight and secured, were clean and dry (Figure 15).

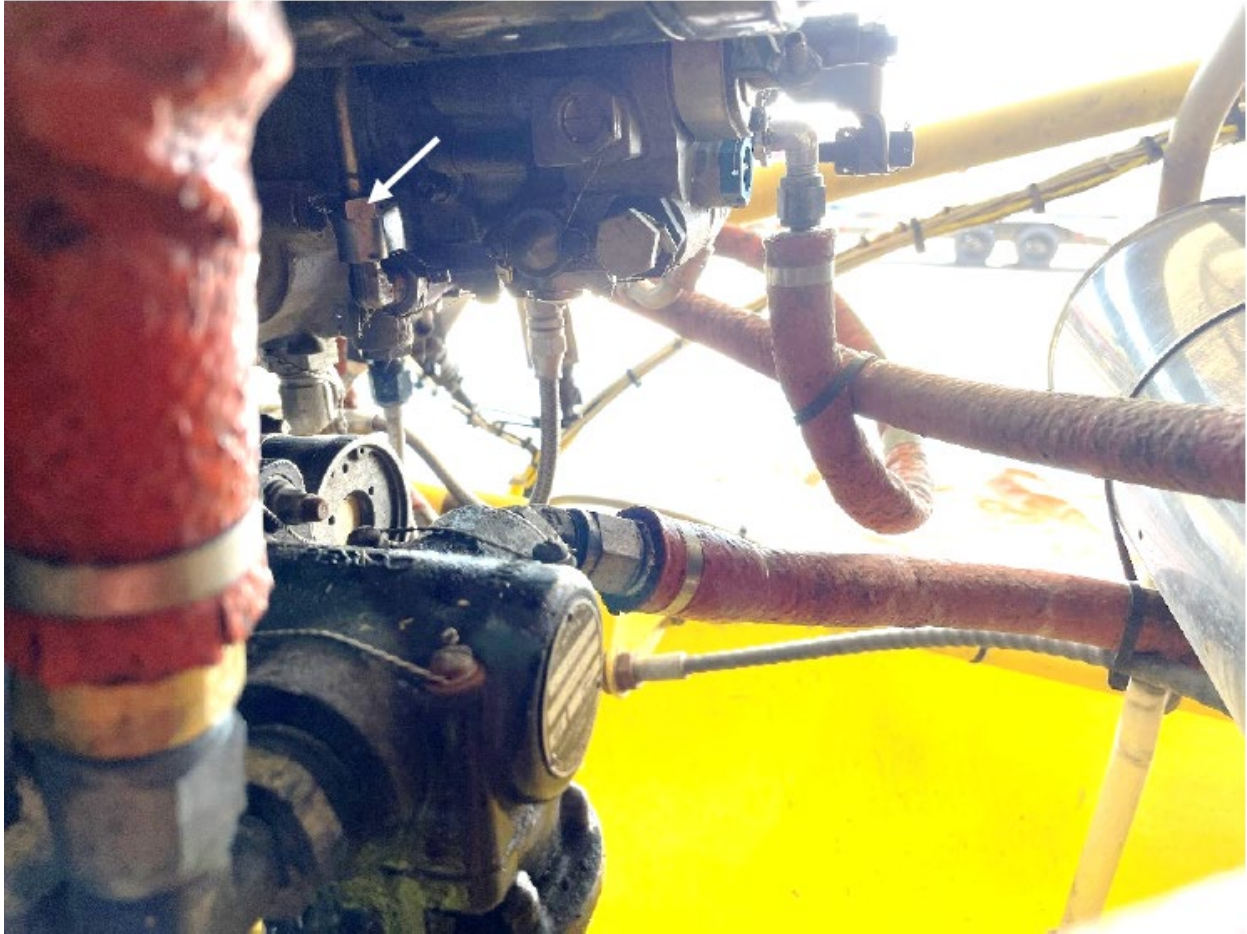
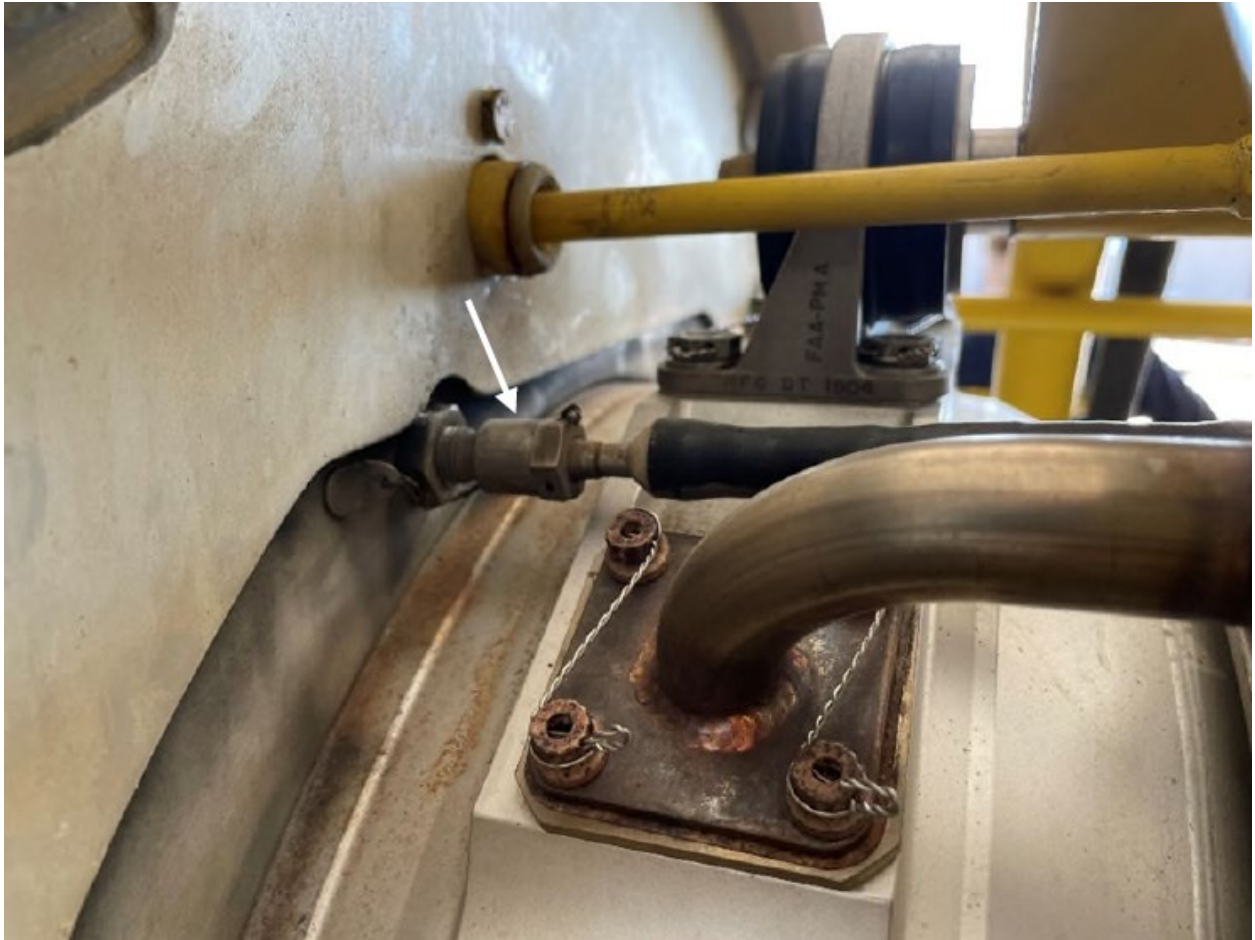
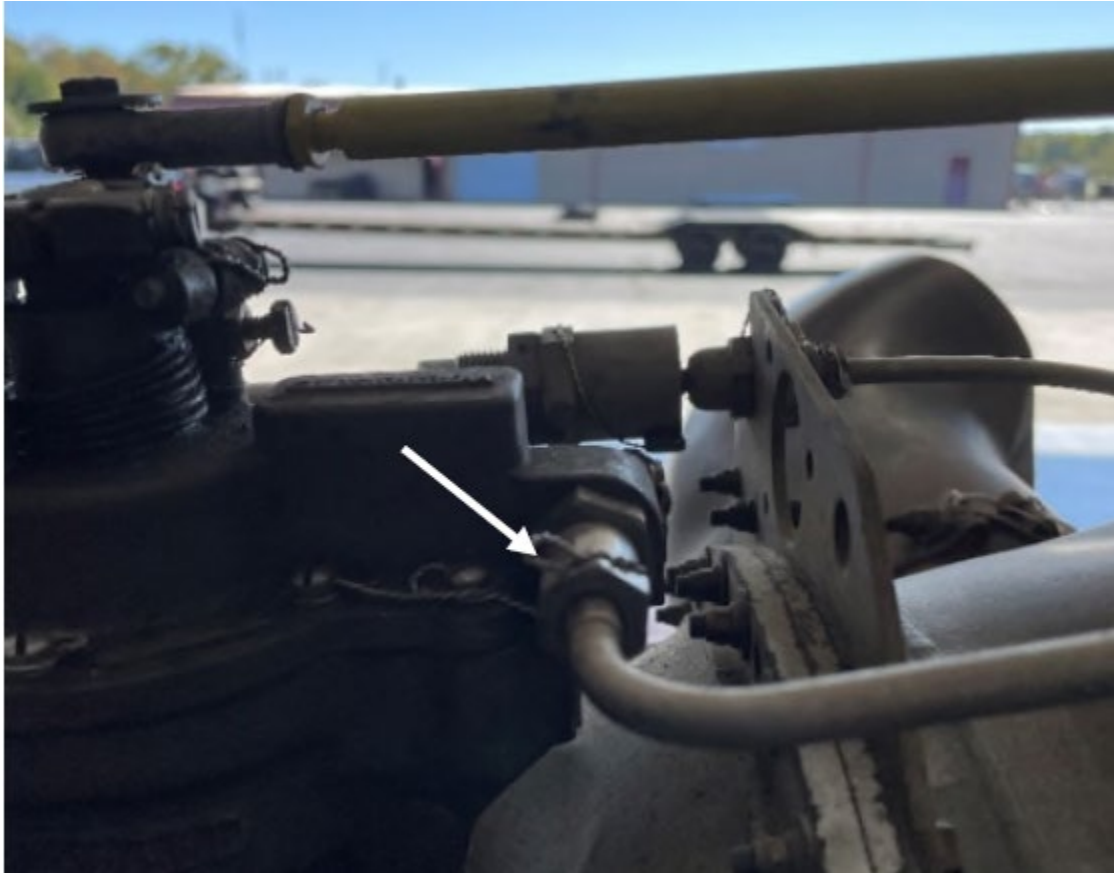
**Power Turbine Control (Py):** The Py line fittings from the FCU, through the front firewall to the CSU were found tight and secured (white arrow, Figures 17 to 19).

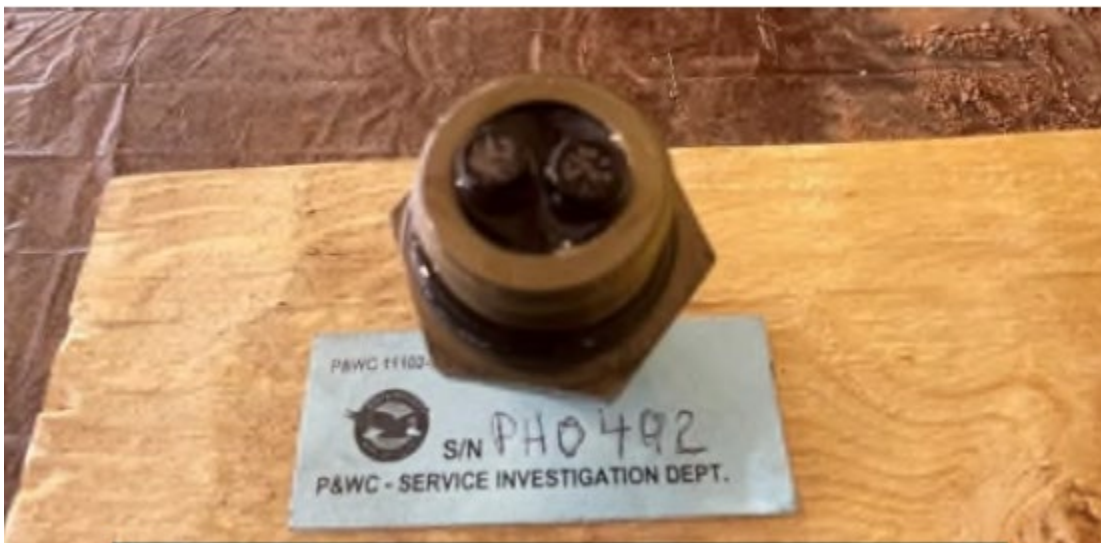
Figure 20 - Magnetic Chip Detector

**Chip Detector:** The RGB magnetic chip detector poles showed only "Fuzz" (Figure 20).

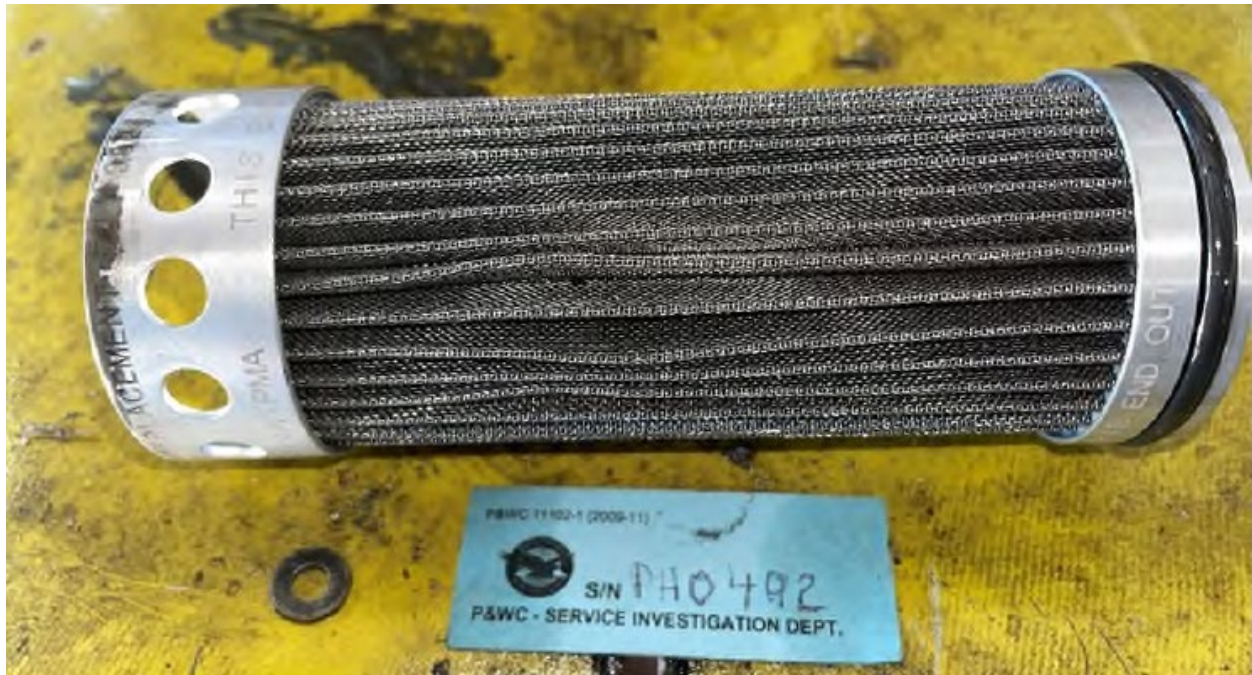
Figure 21 - Oil Filter

**Oil Filter:** The main oil filter was clean and showed no debris contamination (Figure 21).

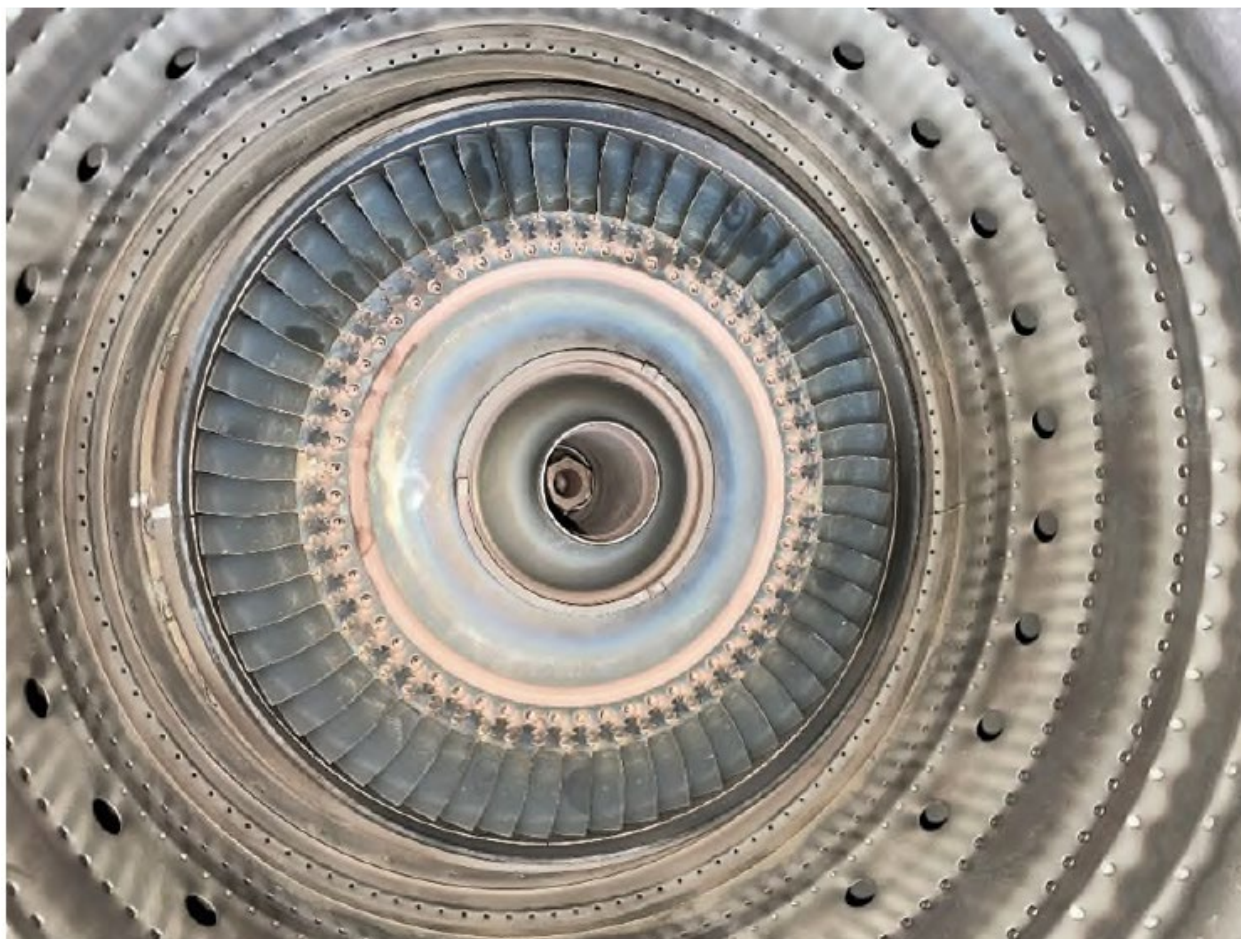
Figure 22 - CT disc and blades

The engine was split at the "C" flange. The CT disc and CT blades showed no evidence of distress. No evidence of CT blade tip rubbing with the CT shroud segments was observed (Figure 22). The CT was freely rotated by hand and showed continuity with the AGB. The CT disc retaining nut was secure. The CT stator was not accessed for the purpose of this investigation.

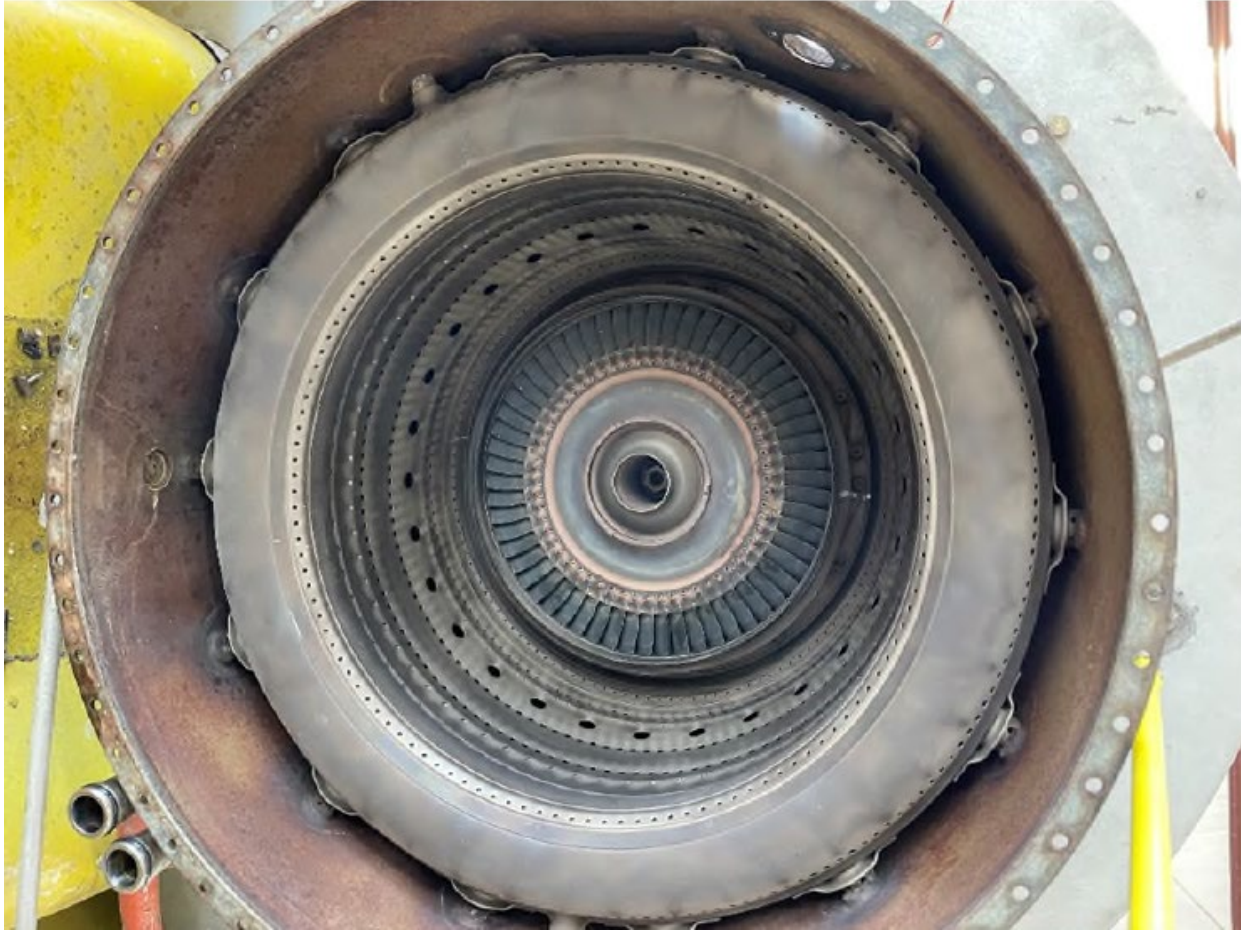
Figure 23 - Combustion Chamber

The combustion chamber other than operational wear showed no evidence of distress and was not accessed further for the purpose of this investigation (Figure 23).
