# National Transportation Safety Board

CEN23LA223

## **EXAMINATION SUMMARY**

Location: Lake Village, Arkansas  
Date: June 3, 2023  
Time: 1158 CDT  
Airplane: Air Tractor AT-502B, N509HB

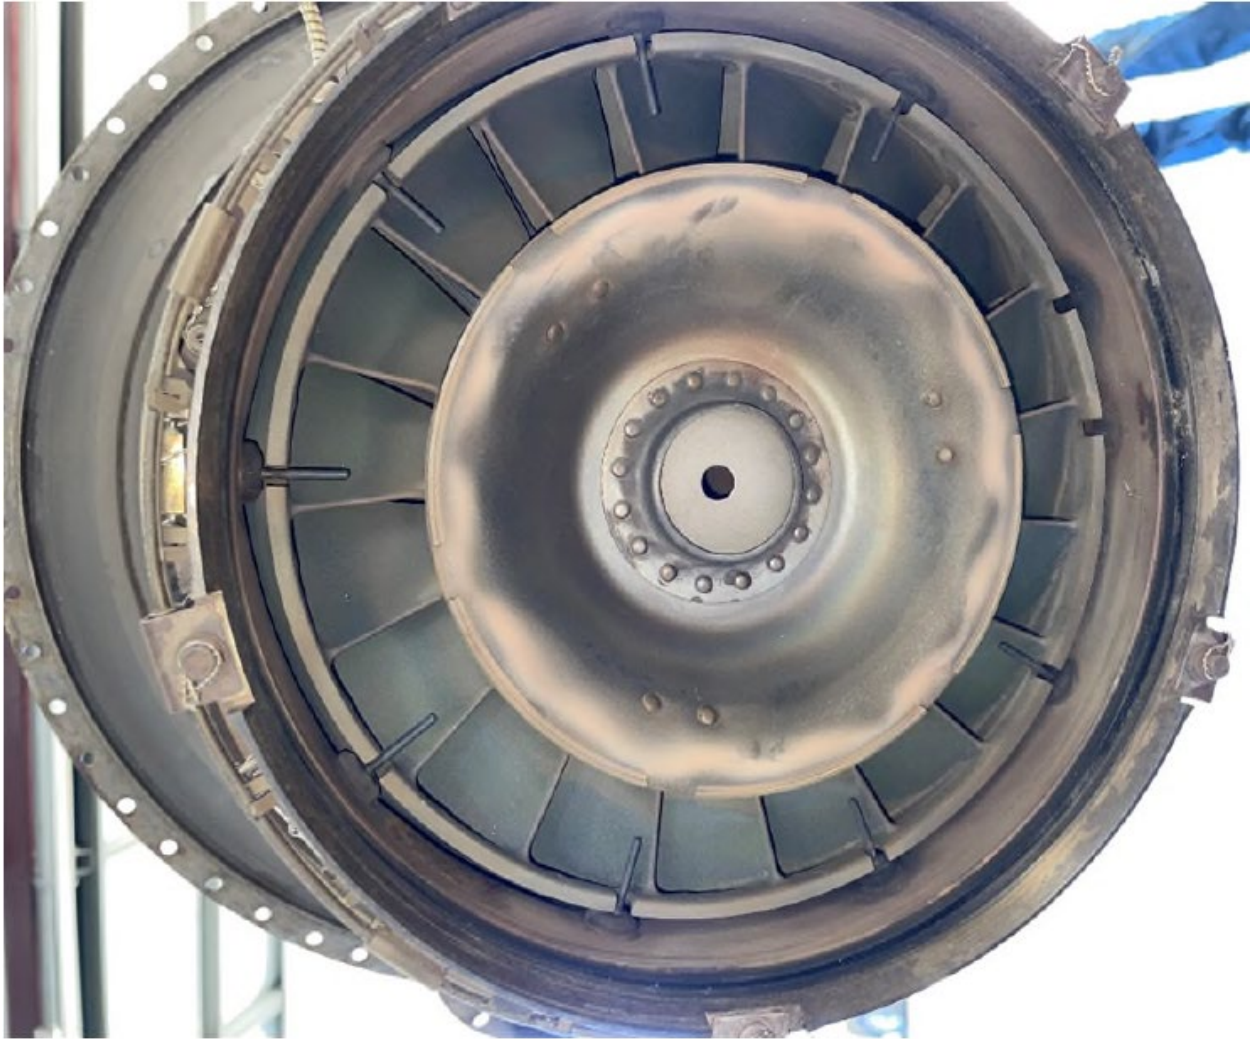
Figure 24 - PT Vane Ring, ITT Probes and Busbar

The PT could not be rotated by hand. The upstream side of the PT vane ring showed no damages (Figure 24). The inter turbine temperature (ITT) Probes, Busbar, and Harness showed no damages. The PT vane ring was removed, after which the PT could be rotated by hand and showed continuity with the propeller shaft. The downstream side of the PT vane ring shroud lip showed circumferential contact with the PT Blades over an arc of approximately 180° (red arrow Figure 25). The PT blades showed no distress (Figure 26). The PT blades shroud tips showed no significant rubbing, however the shroud tips upstream face showed circumferential rubbing wear from contact with the PT vane ring outer shroud lip (red arrow Figure 27). The PT stator housing, PT shaft, PT shaft housing and Nos. 3 & 4 bearings were not accessed for the purpose of this investigation.

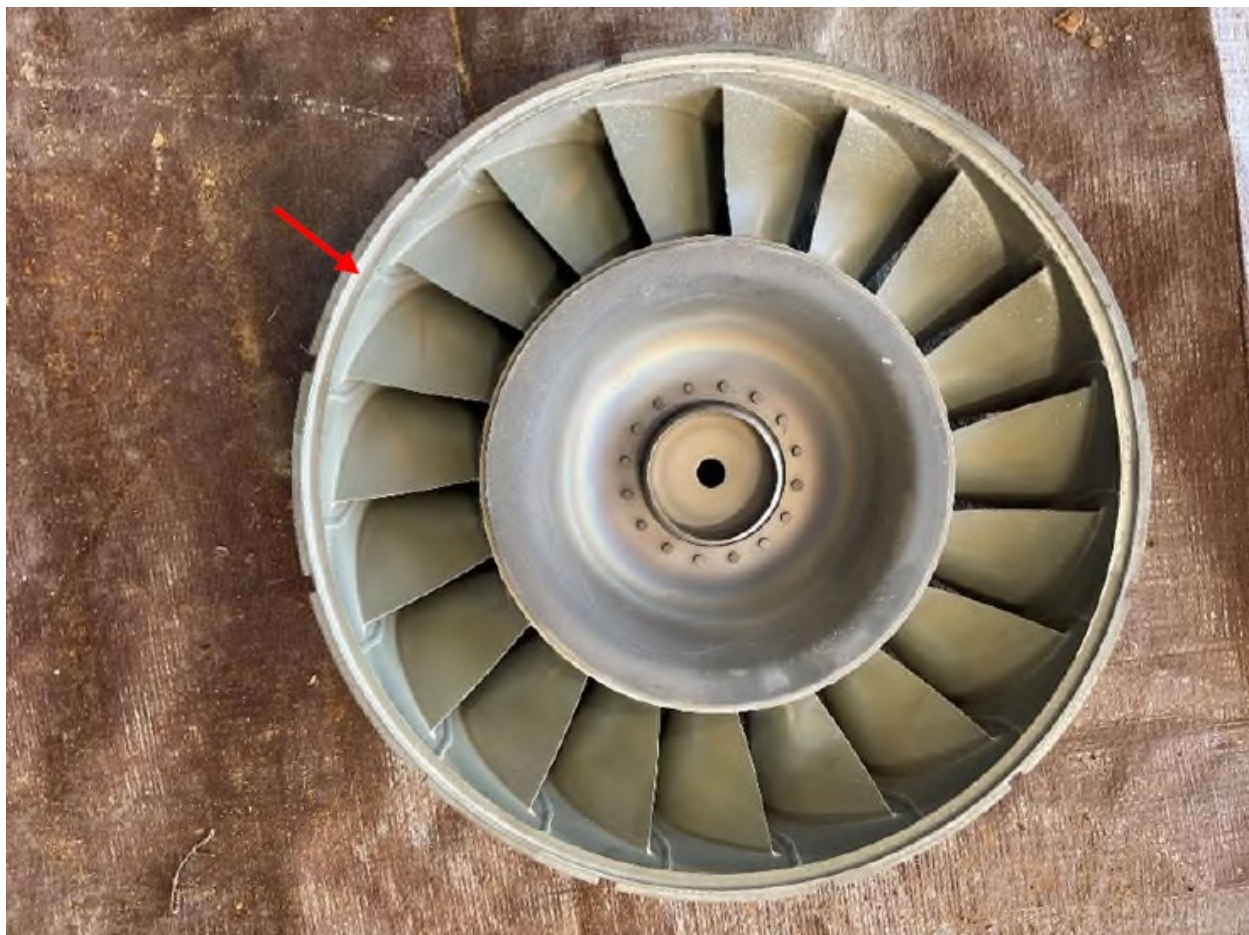
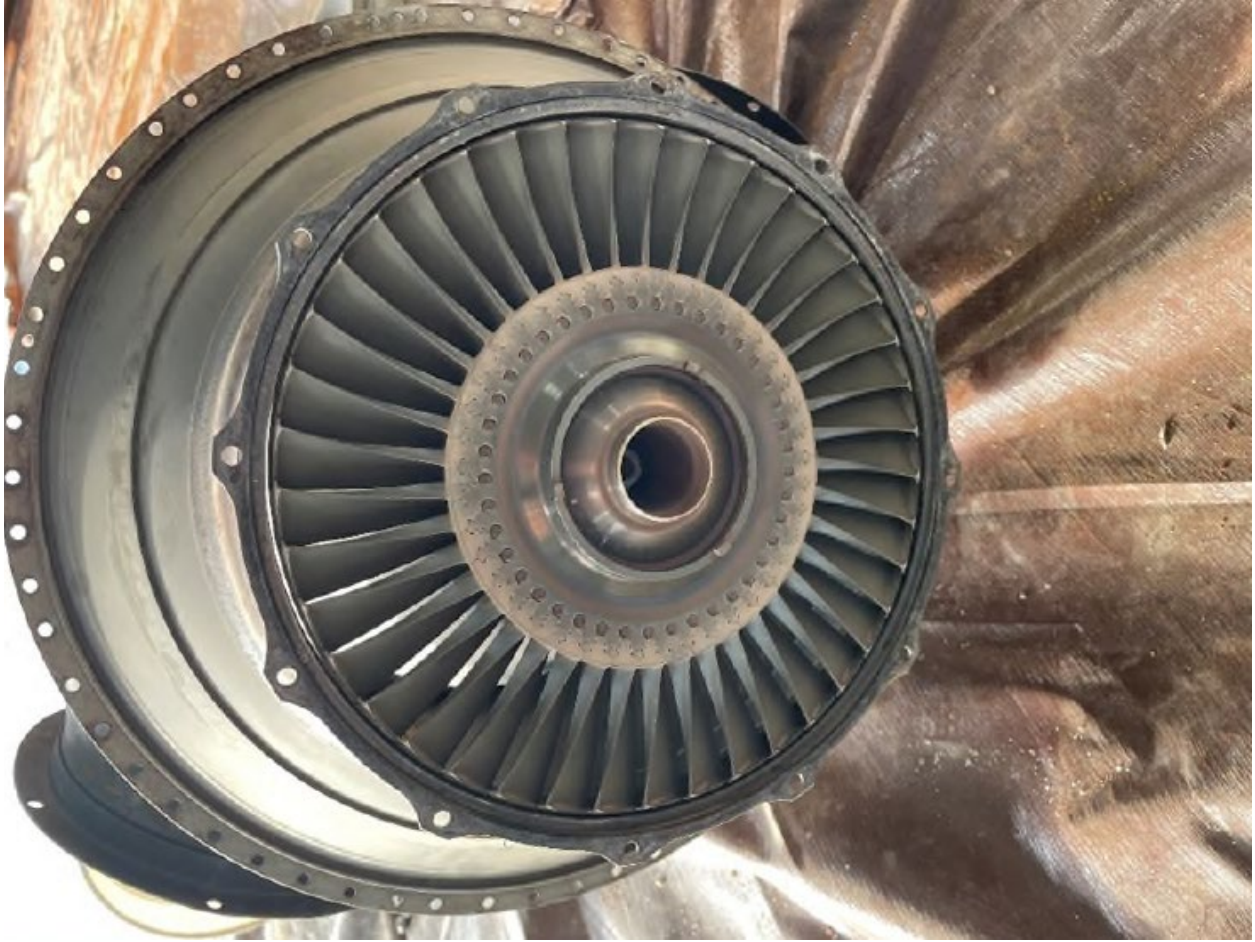
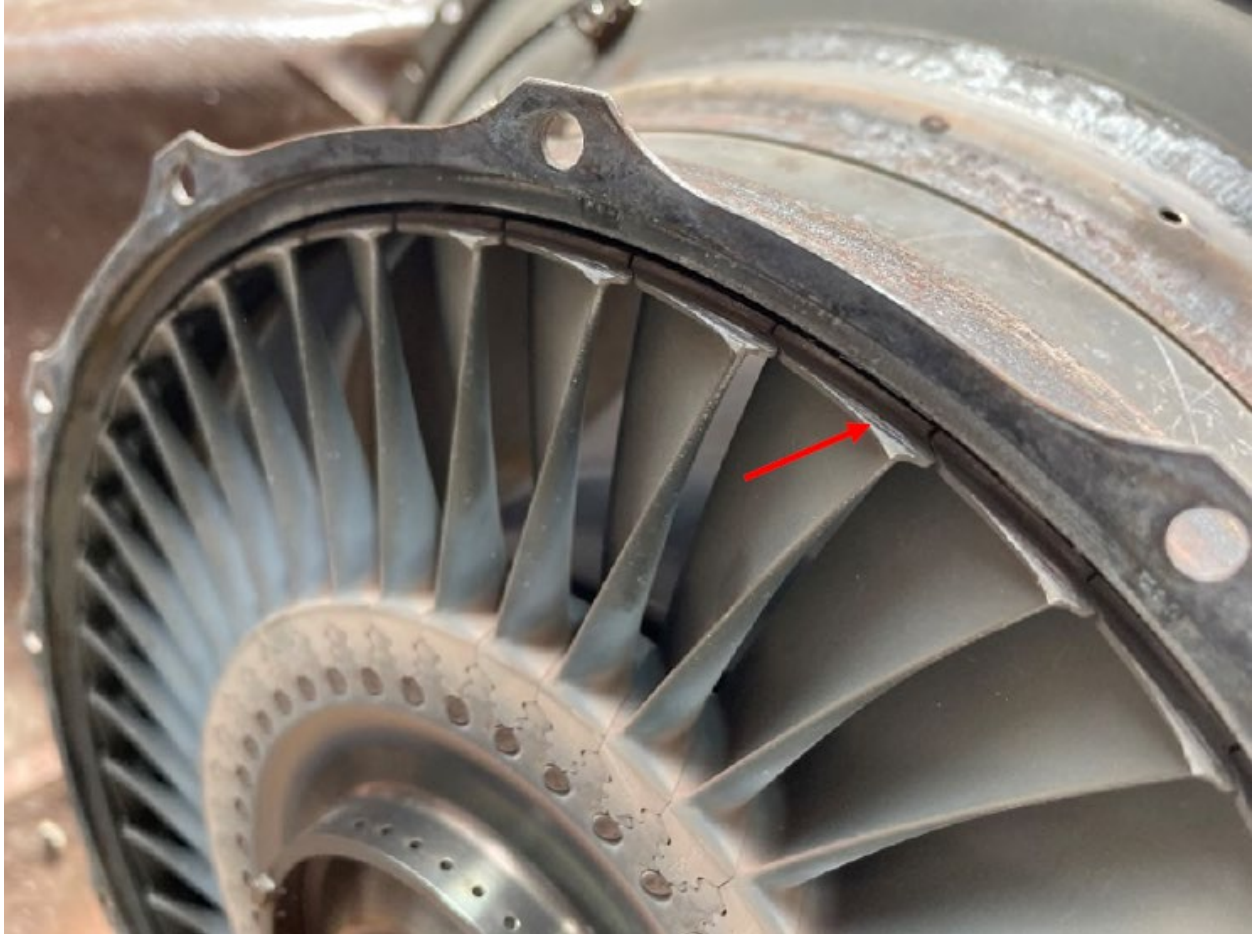
The engine displayed contact signatures to its power turbine blades and vane ring characteristic of the engine developing some degree of power at the time of impact. There were no indications of any pre-impact mechanical anomalies to any of the engine components that would have precluded normal engine operation.

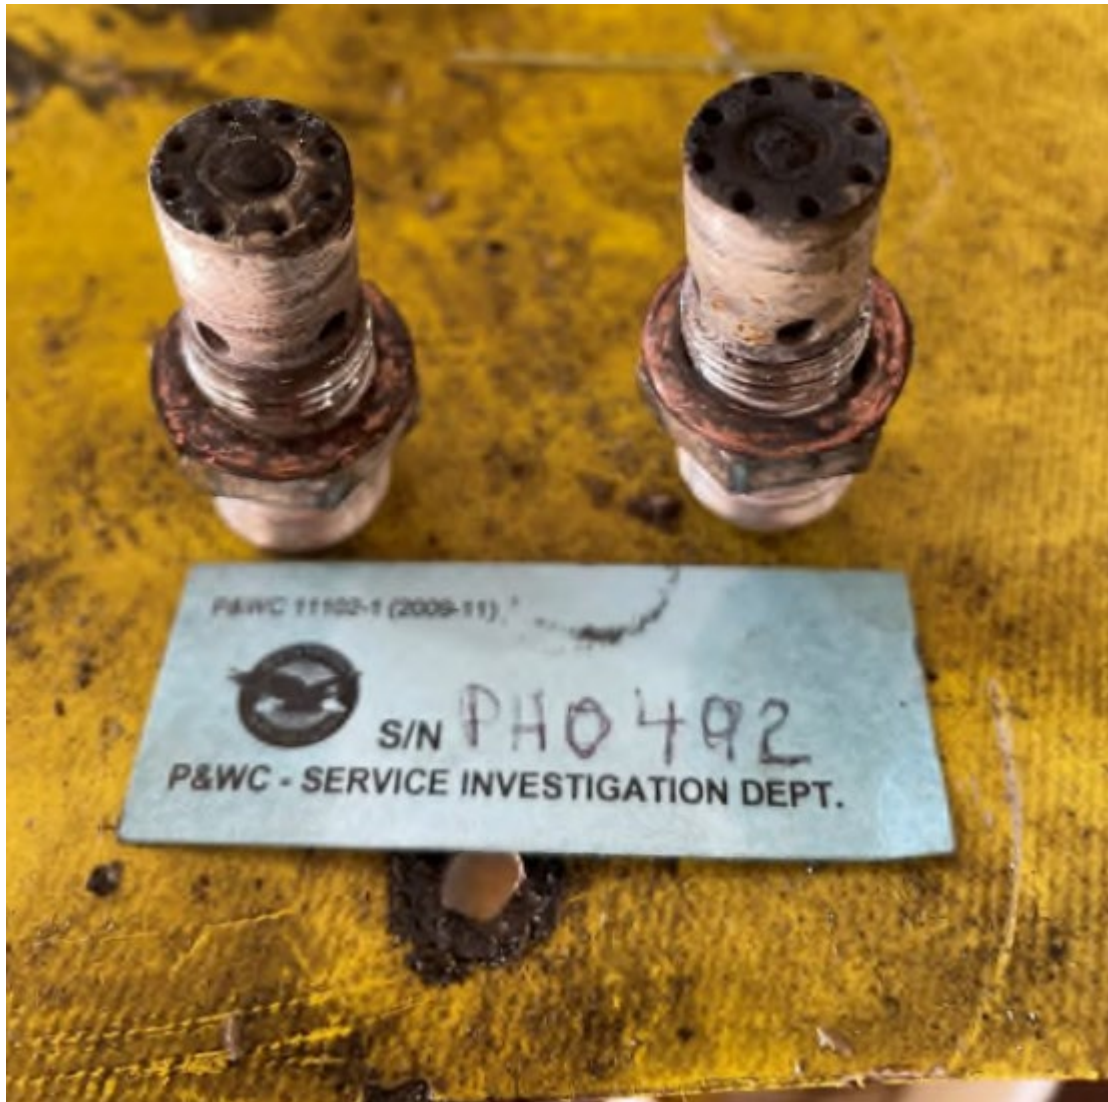
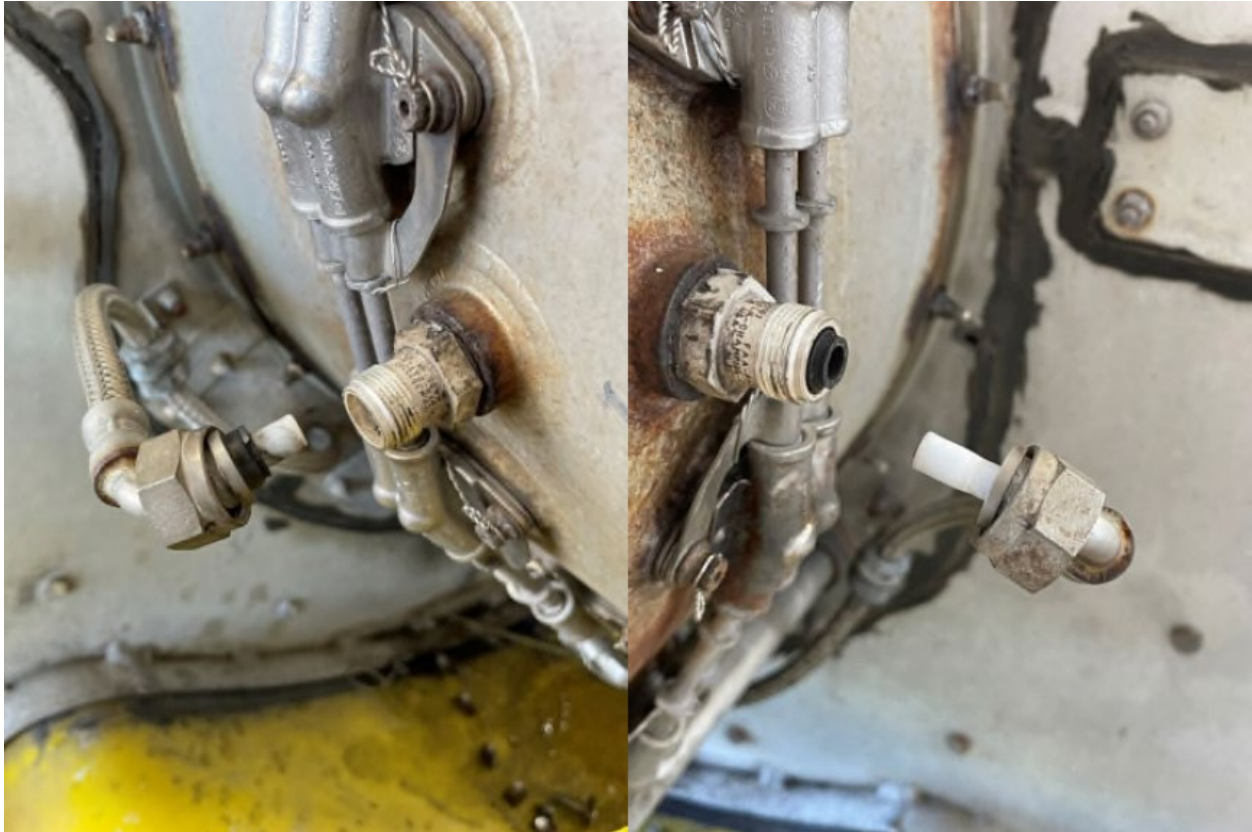
Ignition Plugs, Leads and Exciter: The ignition plugs and leads showed operational wear (Figures 28 and 29 respectively). The exciter showed no damages.

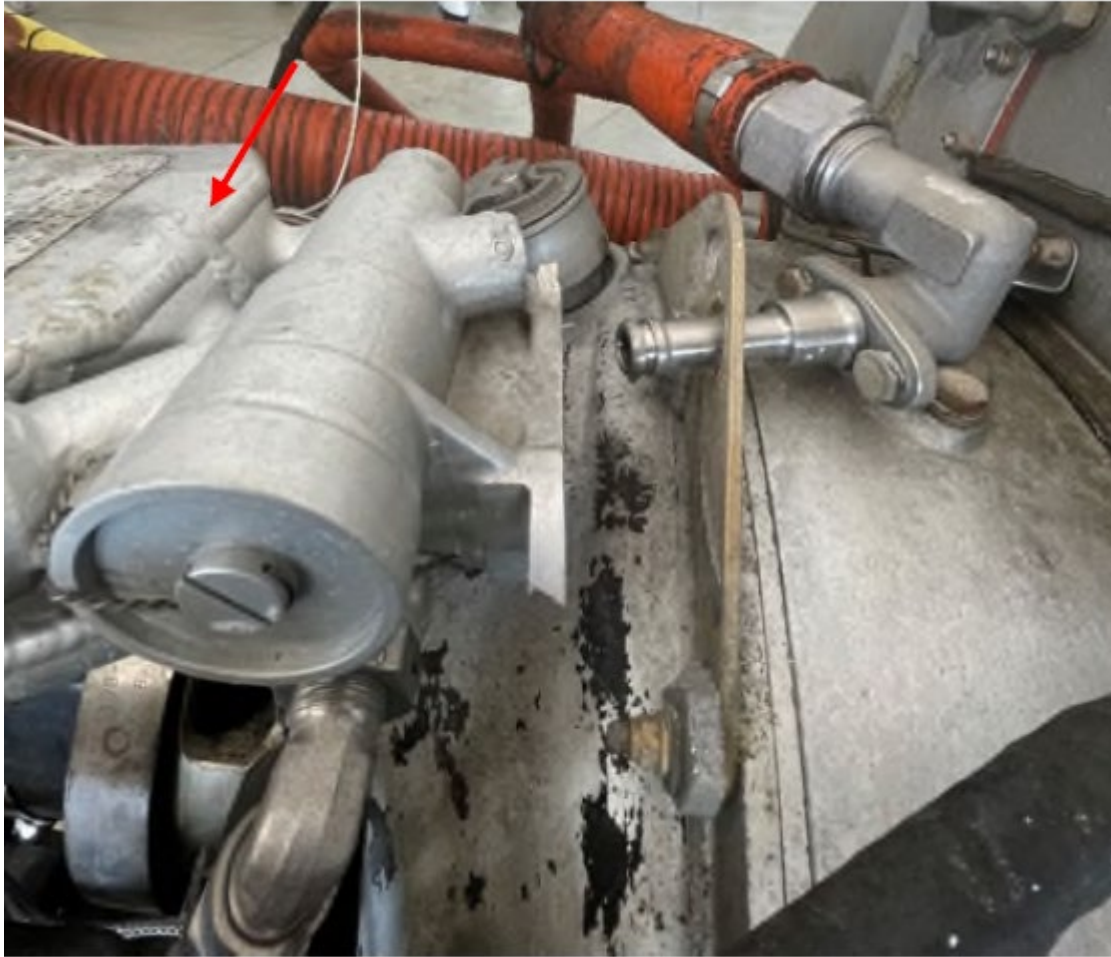
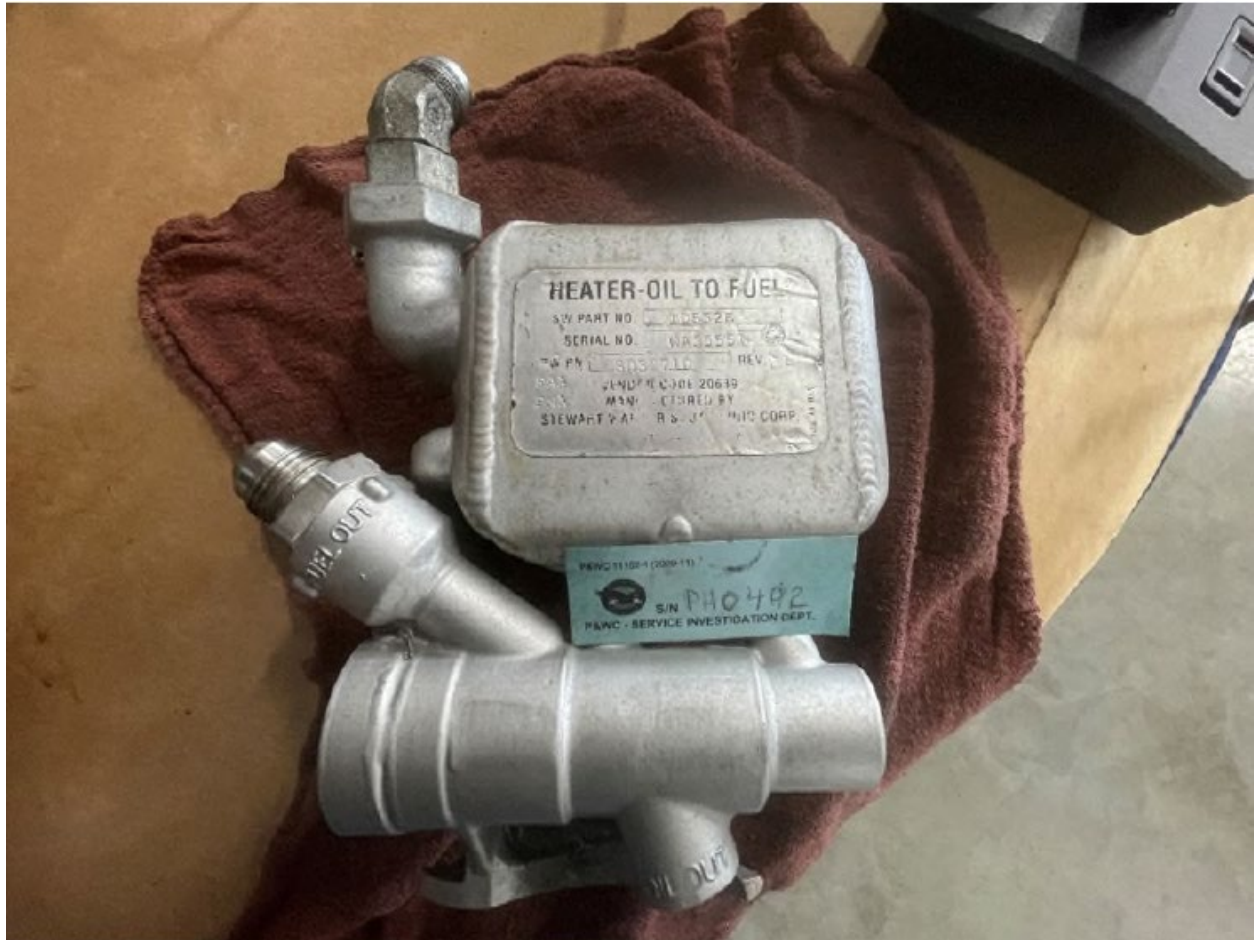
**Fuel Oil Heat Exchanger (FOHE):** The FOHE was found fractured from its mounting on the AGB rear housing (red arrow, Figure 30). The FOHE was removed and sent by the NTSB to PWC for further analysis (Figure 31).

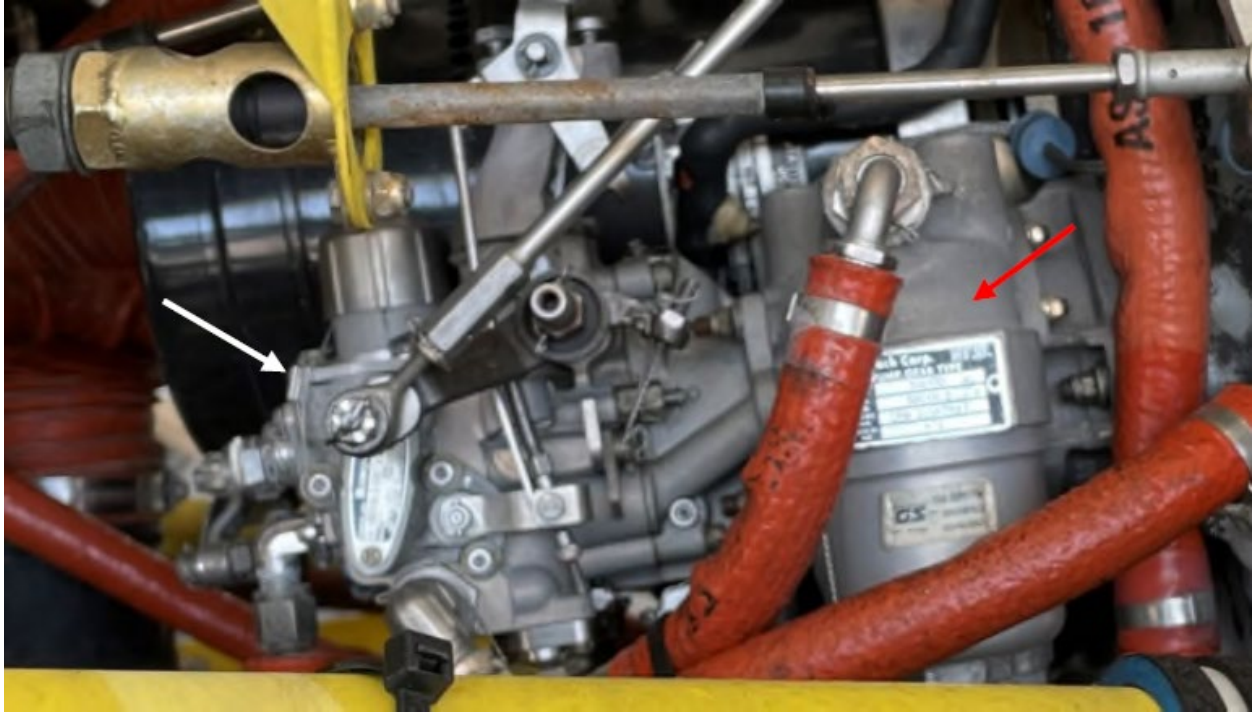
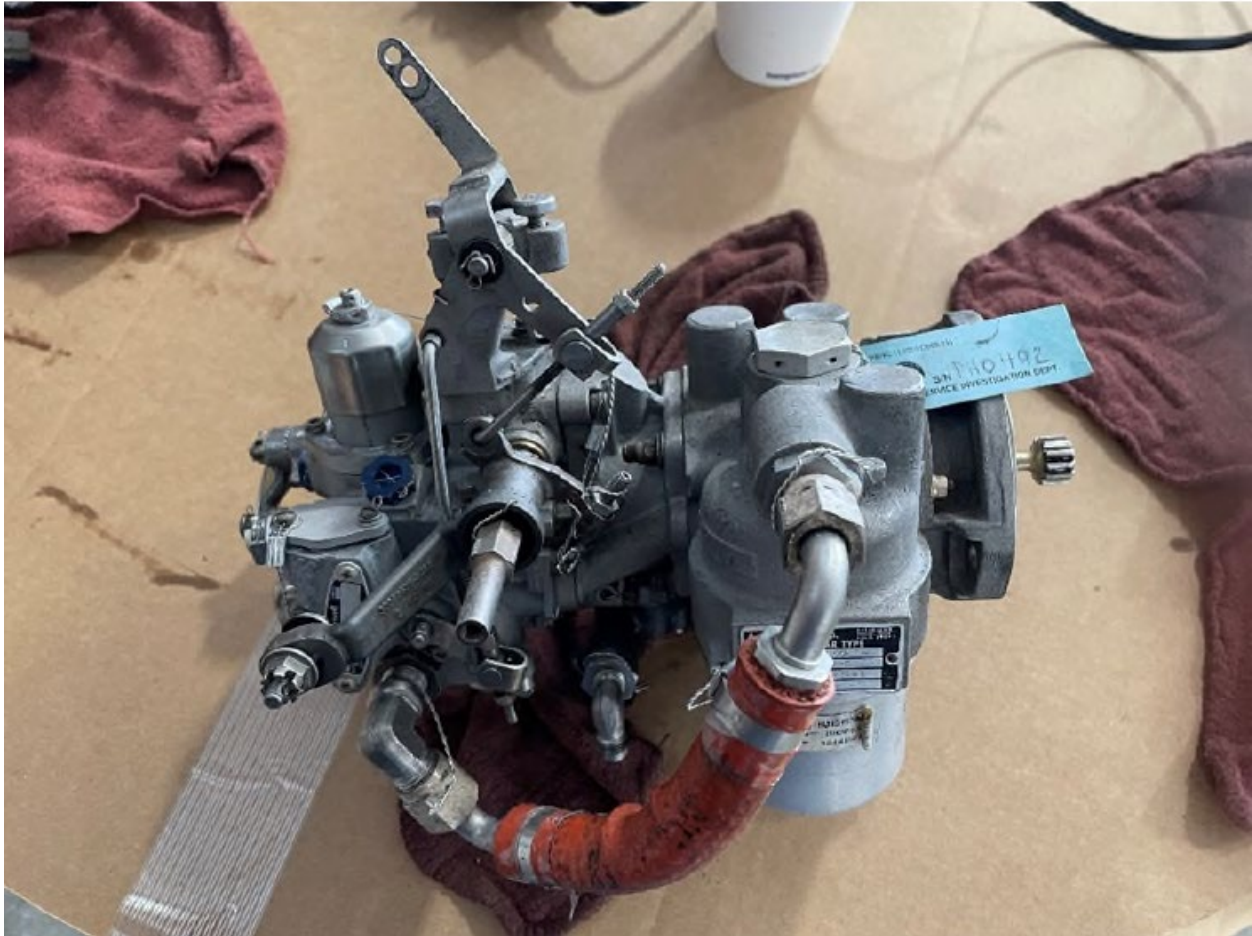
**Fuel Pump:** The fuel pump (red arrow, Figure 32) showed no damages and was removed with the FCU attached. The fuel pump with the FCU was sent to P&WC Accessories Investigation for further analysis (Figure 33).

**Control Unit (FCU):** The FCU (white arrow, Figure 32) showed no damages and was removed attached to the fuel pump. The fuel pump with the FCU was sent to P&WC Accessories Investigation for further analysis (Figure 33).

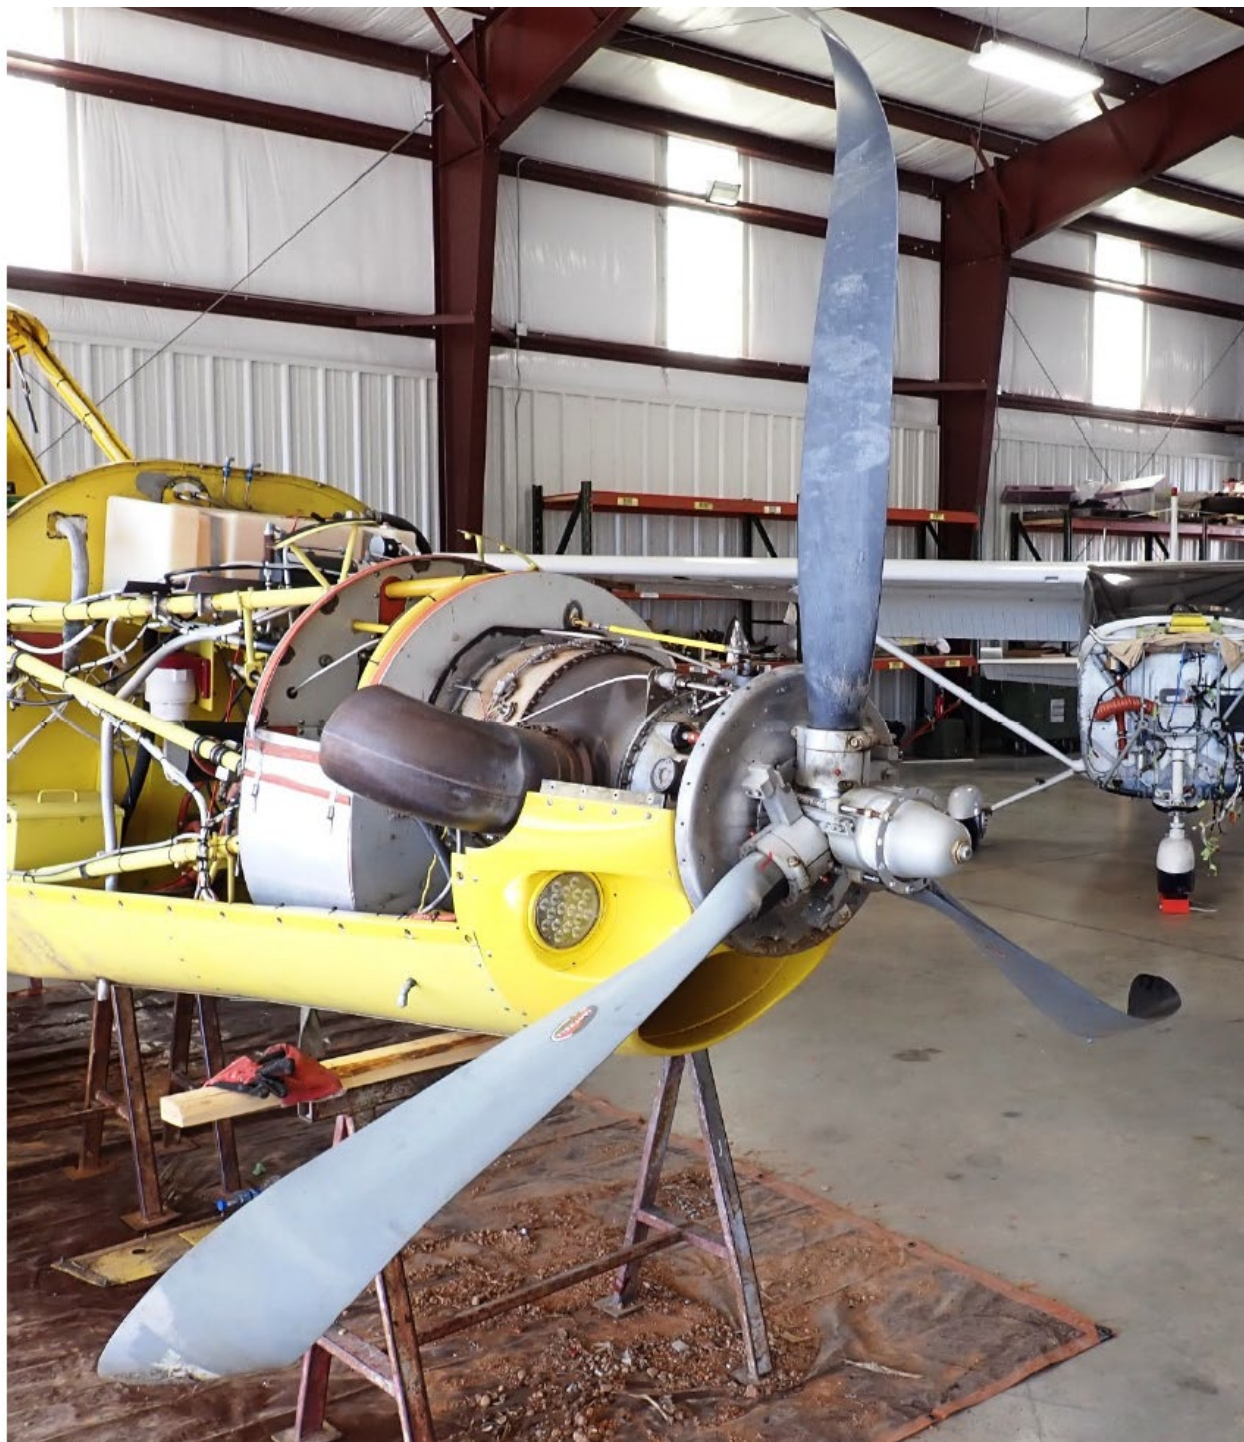
Figure 34 -Propeller as-presented

The propeller was presented for examination (Figure 34). The propeller remained mounted to the engine prop shaft flange with all eight bolts secure and lock-wired. The spinner dome was undamaged.

All three blades presented in the feathered position with no indication of slipping in the clamps. There was no evidence of an external oil leak. All three link arms remained attached at the piston link pin and clamp link screw. The beta system was exercised with a beta puller; it actuated smoothly and returned to the home position

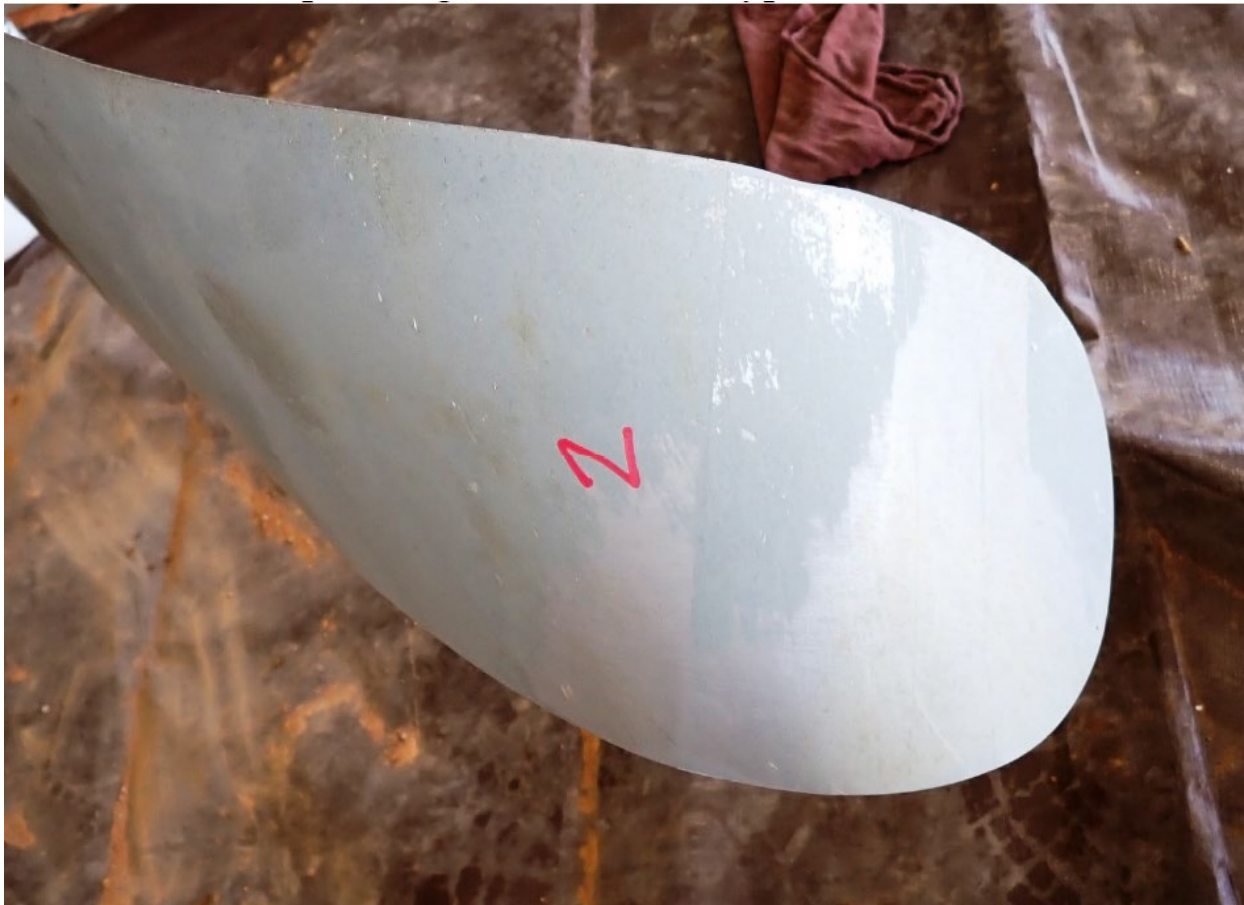
All three blades were bent aft, bent opposite rotation and twisted towards low pitch in the tip region (outboard 16-18" of the blade). All three blades exhibited varying degrees of leading edge gouging and bending. Chordwise/rotational scoring and abrasion was isolated to the camber side of the blade (Figure 35).

Figure 35: Tip damage on Blade #2, typical on all three blades

There were no visible discrepancies noted that would prevent or degrade normal propeller operation prior to impact. All visible damage was consistent with high impact forces while rotating at low power and low blade angle (not feathered).

1. Chordwise/rotational scoring isolated to the camber side.
2. Aft bends, bending opposite rotation, twisting towards low pitch isolated to the tip region.
