# National Transportation Safety Board

CEN23LA232

## **MATERIALS LABORATORY**

Factual Report 24-022

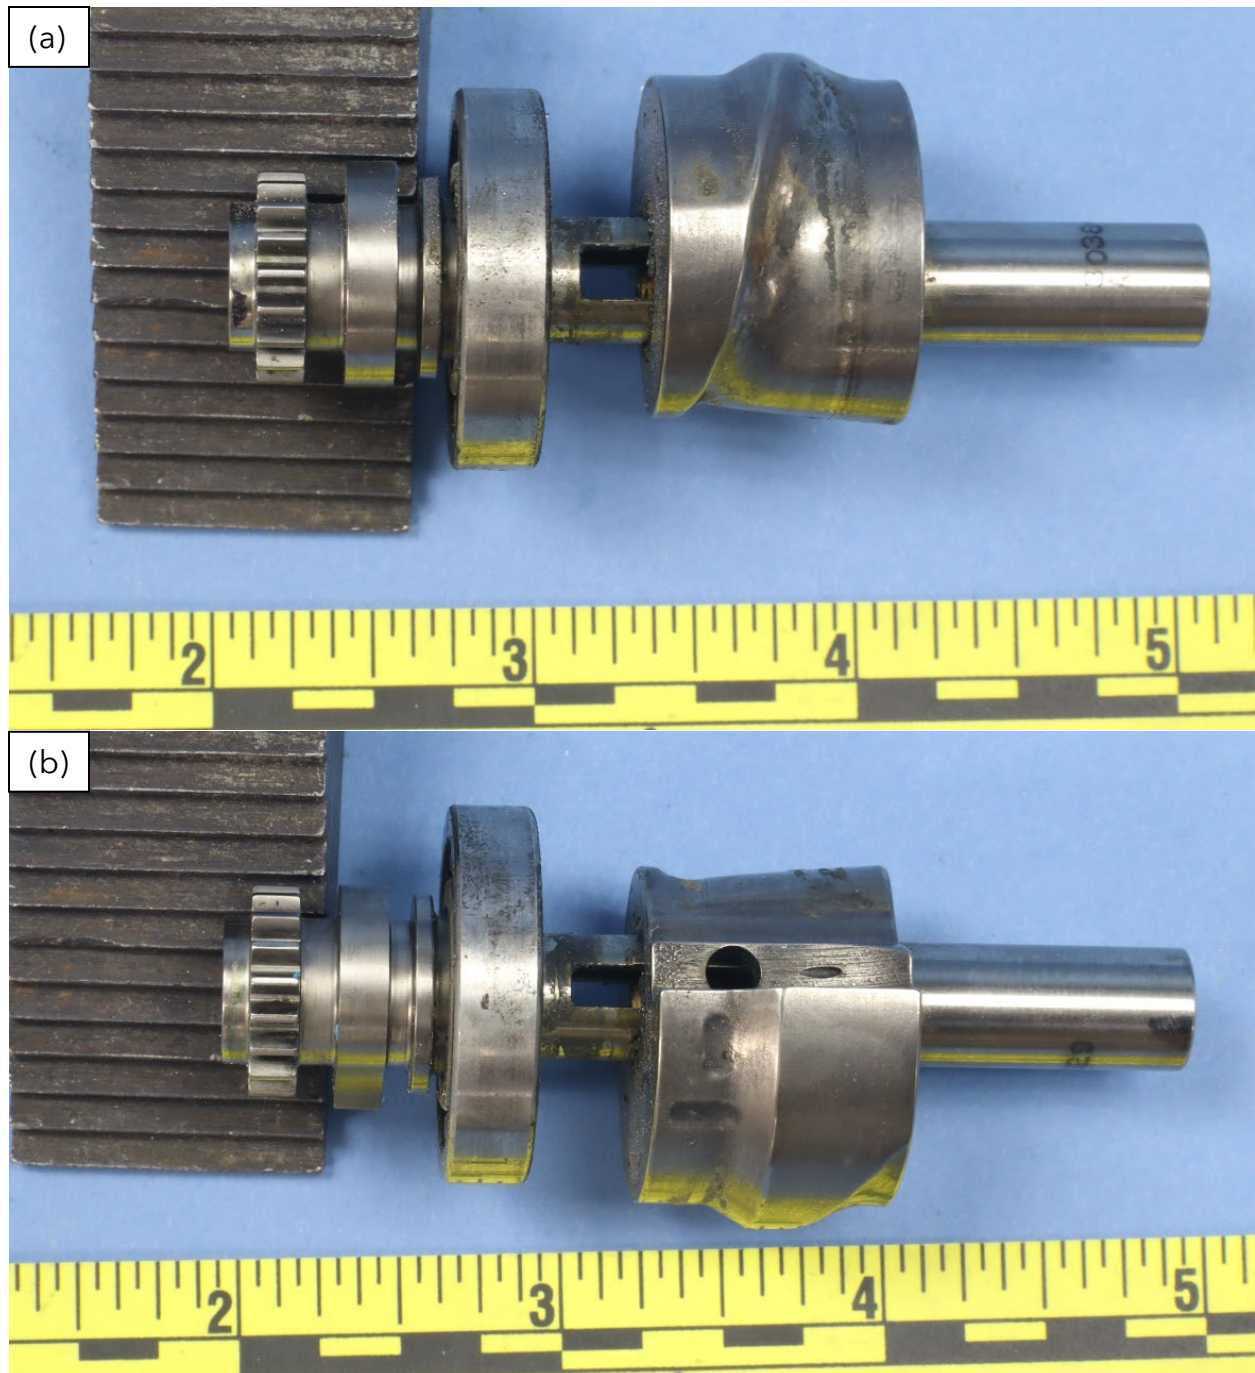
The amount of the slot present towards the left side of Figure 5 was 0.22 inches. Different views of each face of the slot that faced the bearing and gear side of the shaft are shown in Figure 6 through Figure 9. Figure 10 shows an angled view of the slot visible from the opposite face of the camgear, which faced the straight shaft end. The amount of the slot present on this side was 0.03 inches longitudinally. The slot shown in Figure 7 was named Slot 1, and the slot in Figure 6 was named Slot 2 for the purposes of this examination.

**Figure 5.** Isolated view of the camshaft assembly with the bearing on its seat, rotated 180° of the camgear.

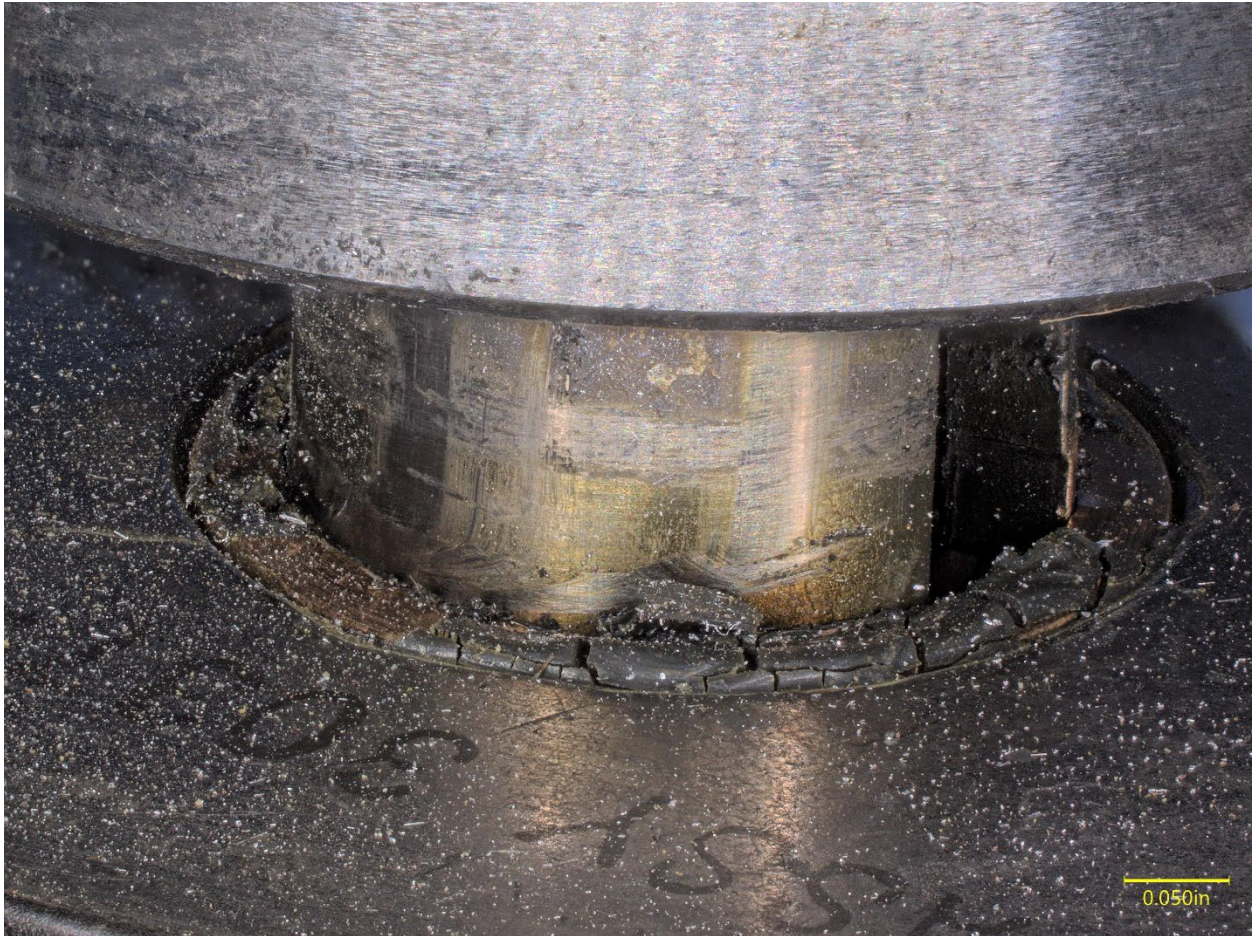
**Figure 6.** Angled view of the shaft and camgear face from the pinion side of the shaft, showing slot 2.

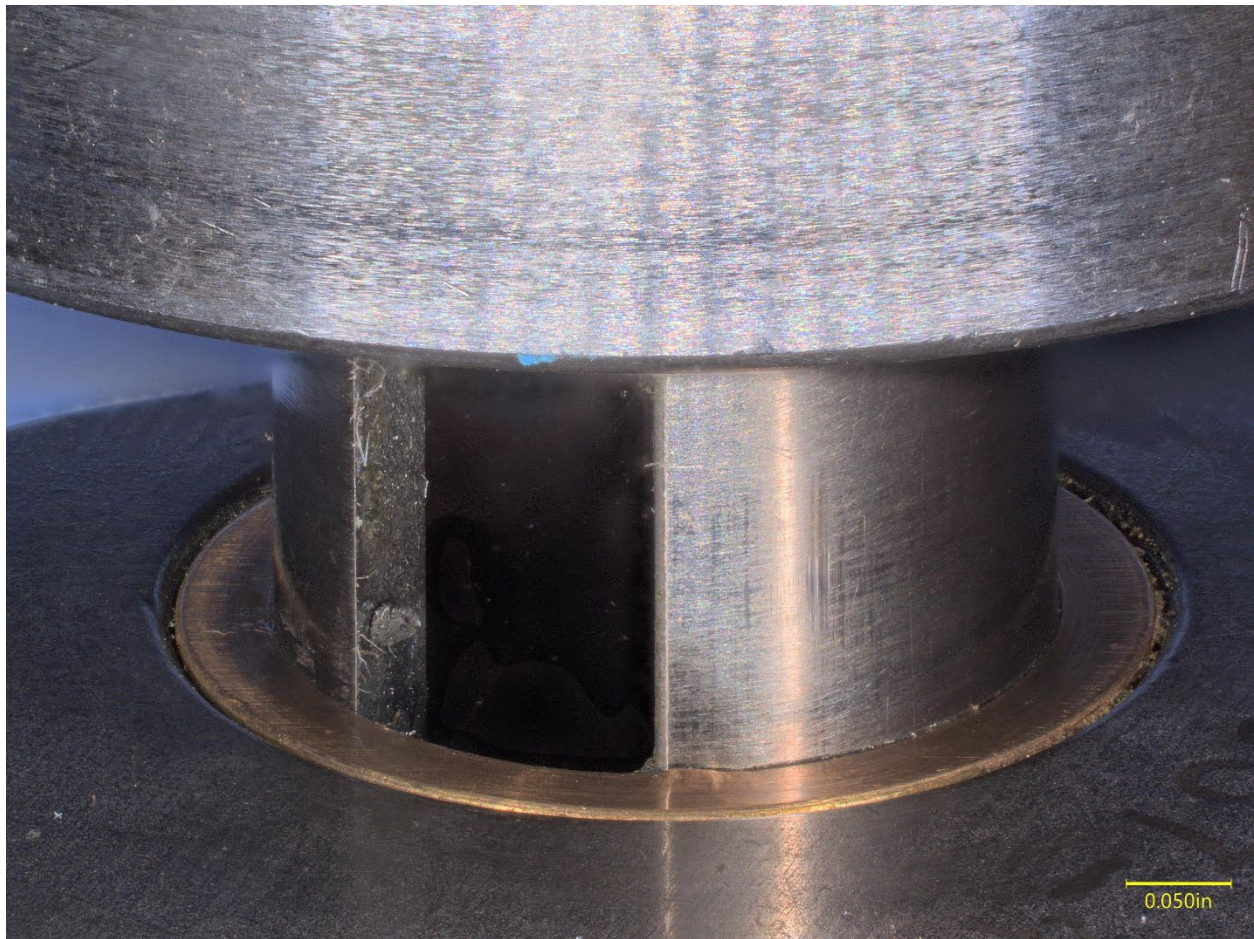
After removing the excess surface compounds, the camshaft assembly was cleaned in an ultrasonic bath with acetone. Figure 11 shows the slot visible from the shaft side, whereas Figure 12 through Figure 14 show areas of the slot on the pinion and bearing side of the camshaft. Of note was the condition of the bushing on the interior surface of the camgear—at two slot edge corners in contact with the inner bushing surface. Figure 12 and Figure 13 show the bushing deformation longitudinally against the shaft (upward in the figures) on slot 1.

**Figure 12.** Angled view of the shaft and camgear face from the pinion side of the shaft after cleaning, showing slot 1.

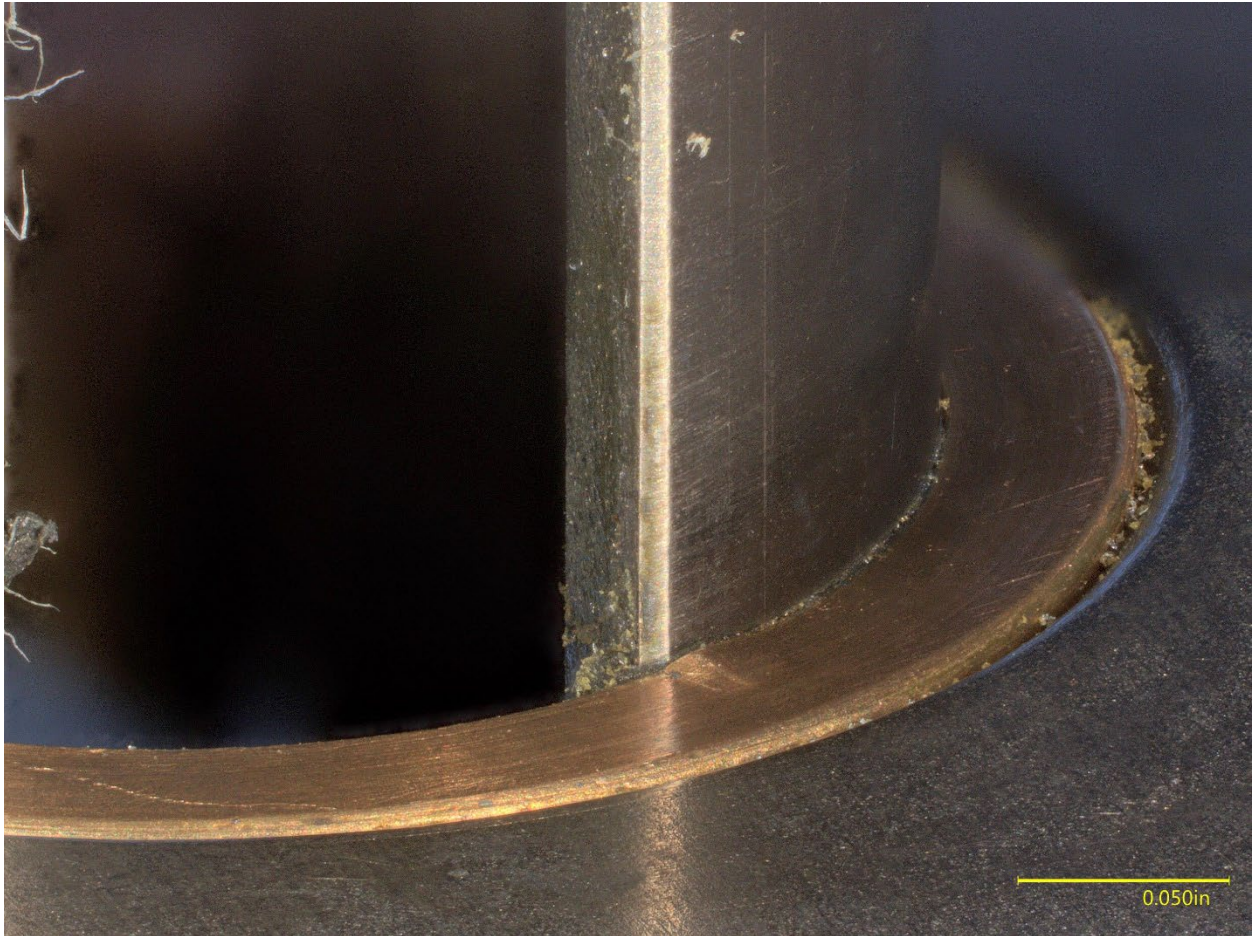
**Figure 13.** Closer view of the corner of slot 1 against the bushing, showing deformation.

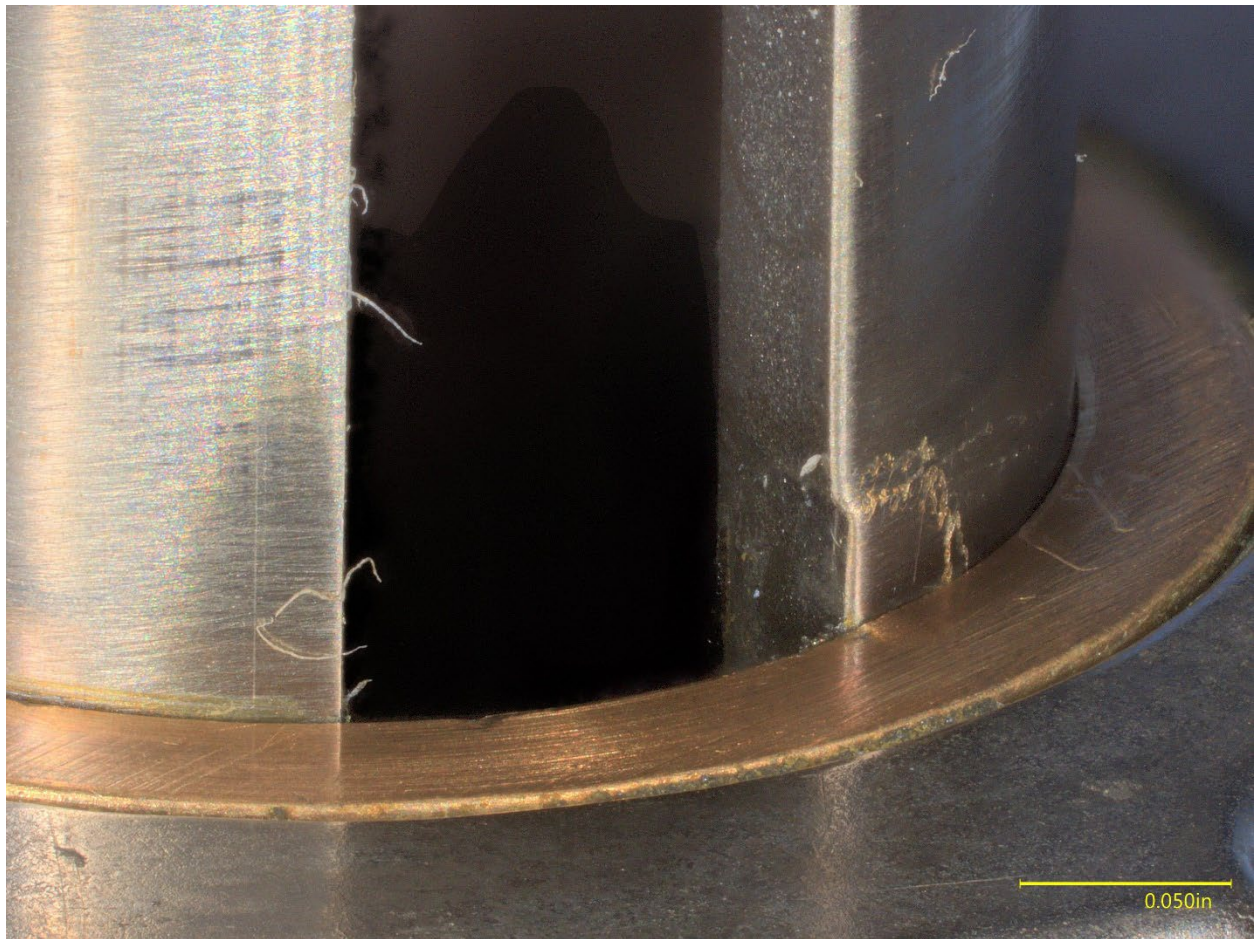
A similar but less pronounced deformation was also visible on the bushing inner surface in contact with the clockwise edge corner of slot 2, shown in Figure 14. Two concentric damage marks were present near this contact and deformation.

**Figure 14.** Closer view of the corner of slot 2 against the bushing, showing bushing deformation and cracking in the shaft surface.

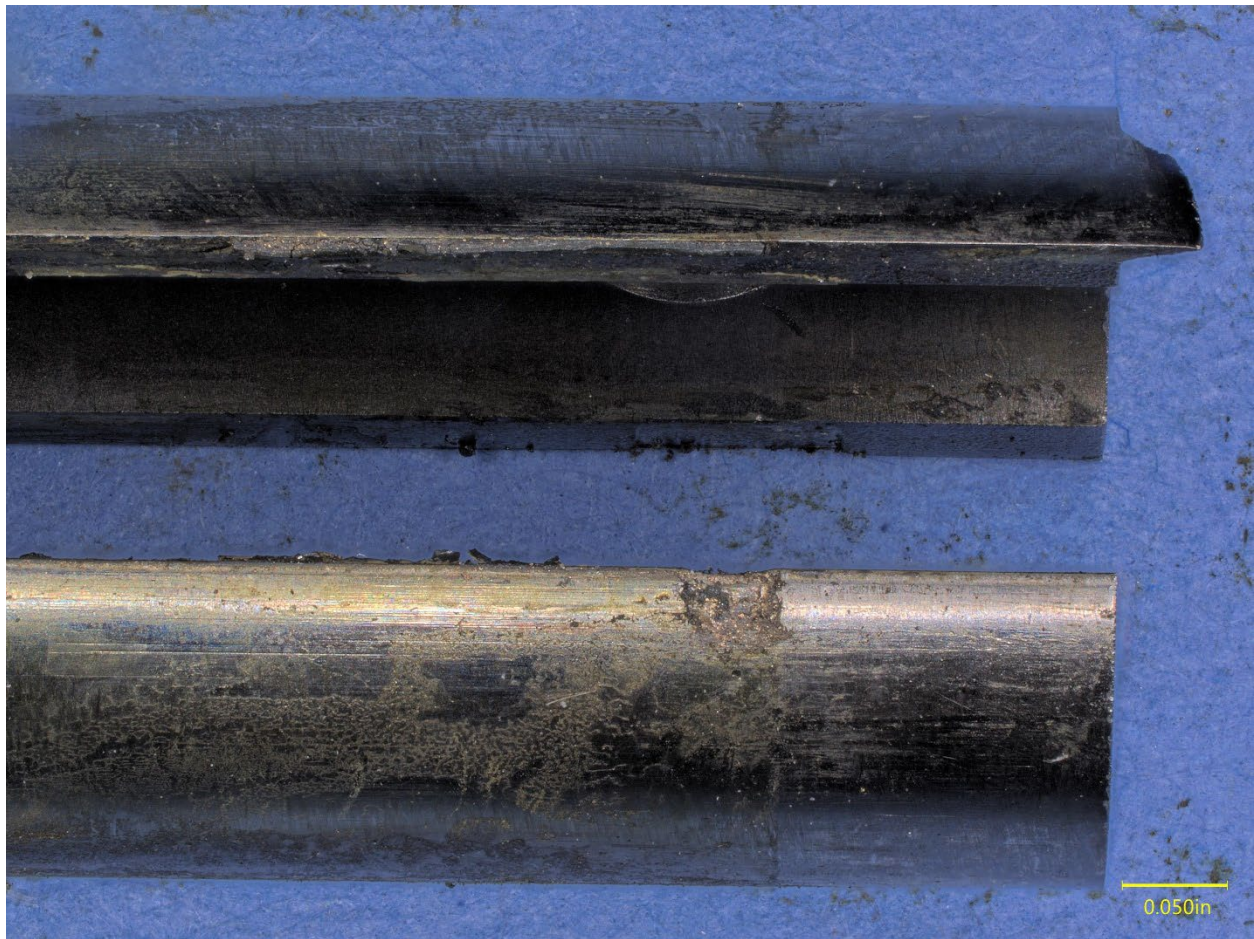
The two areas of damage at the corners of the slot adjacent to the inner bushing surfaces were found to align, as illustrated in Figure 20 and Figure 21. The grease line in these figures indicated the seized camgear's position before separation. Figure 22 and Figure 23 show closer views of the concentric damage patterns on the corner of the slot 2 edge, previously shown in Figure 14.

**Figure 20.** Angled view of the damage marks to the slot corners, viewed from slot 1.

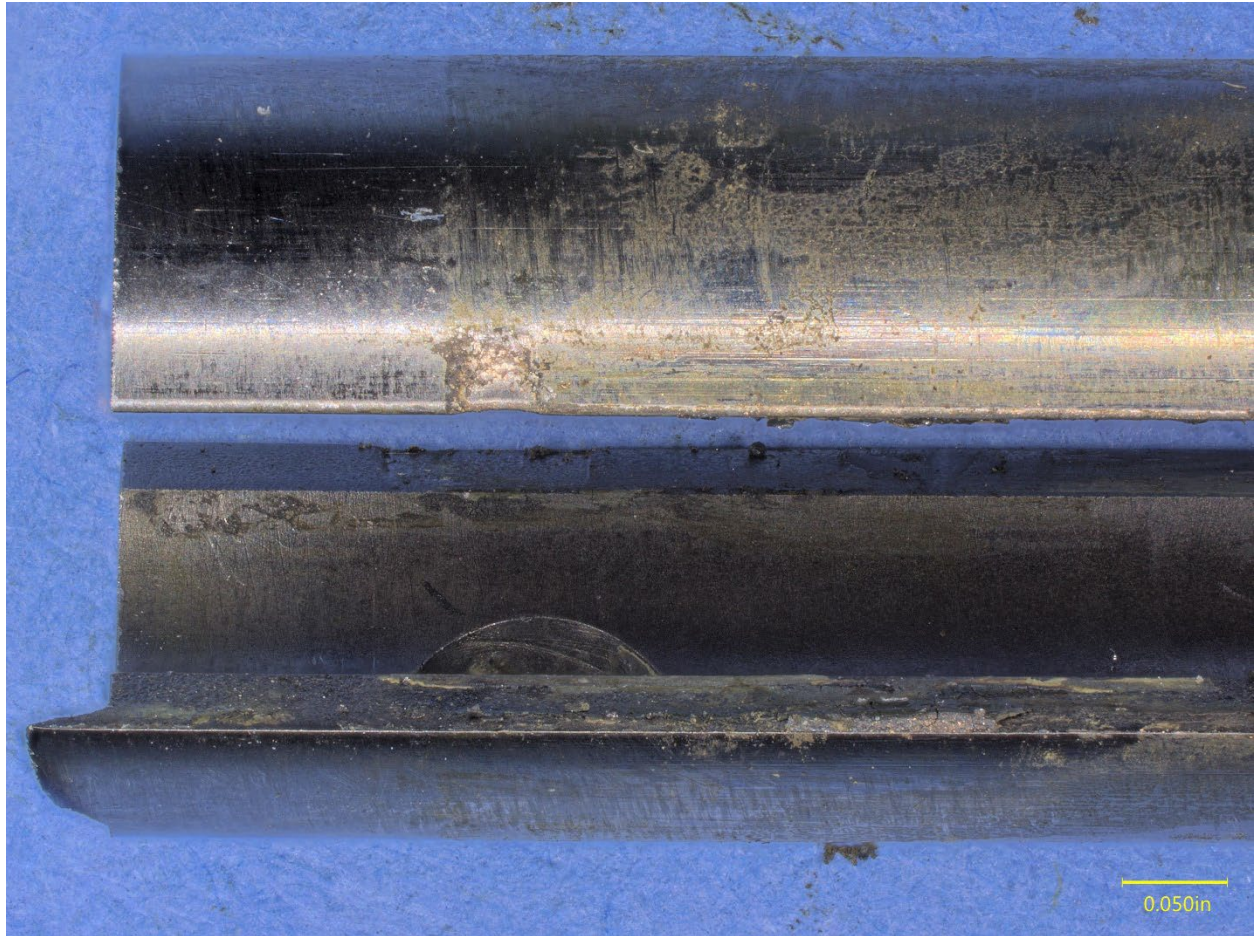
**Figure 21.** Angled view of the slot corner damaged areas, viewed from slot 2.

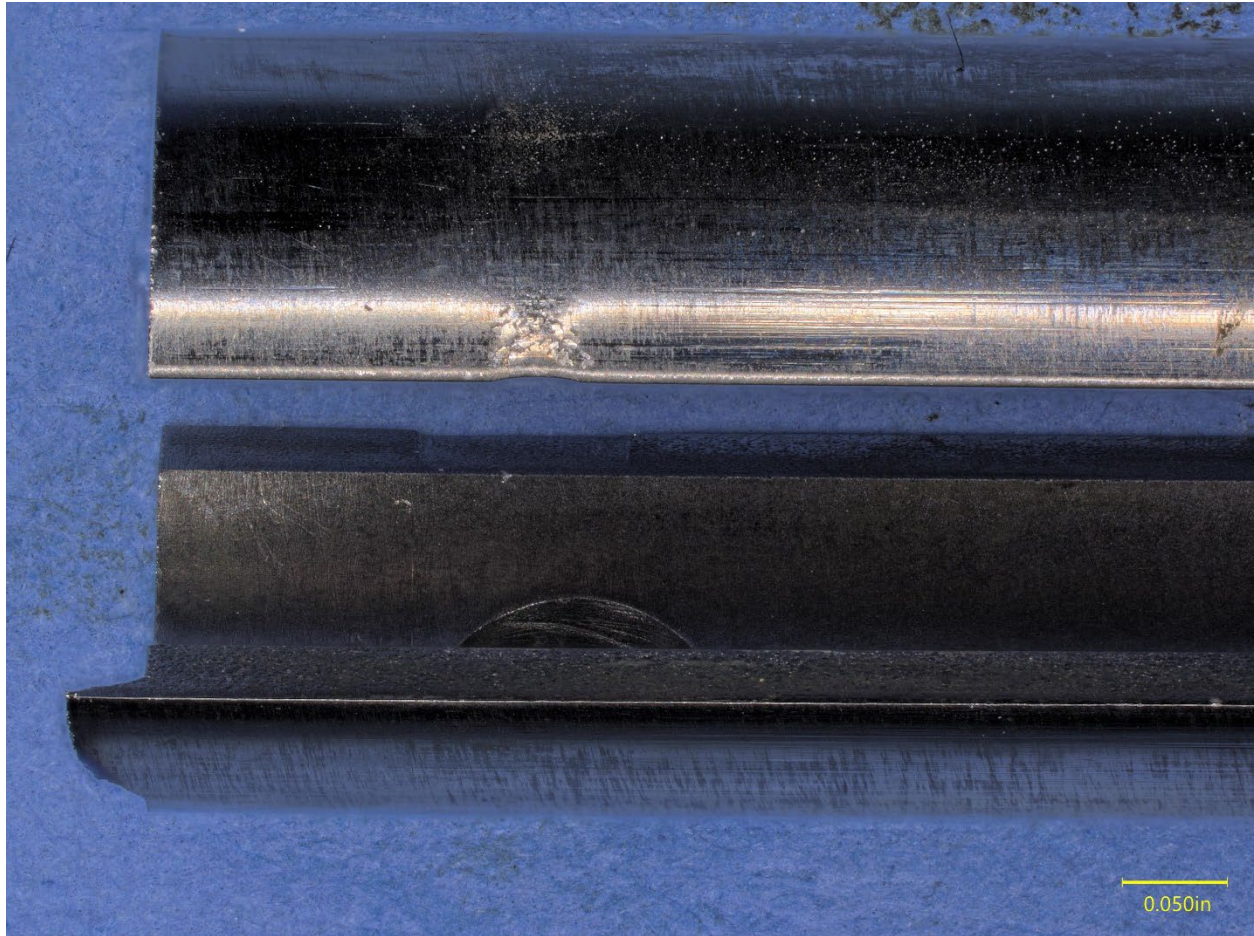
The grease remnants were collected to better examine the damaged areas of the slots on the shaft, and the shaft was cleaned in an ultrasonic bath of acetone. Figure 24 and Figure 25 show the damaged areas of the slot corners, positioned to show their alignments with each other and the pinhole. Figure 24 shows the circular damaged area of slot 1, and Figure 25 shows the concentric damage pattern of slot 2.

**Figure 24.** View of the damaged areas of the slot corners after cleaning and grease removal, viewed from slot 1.

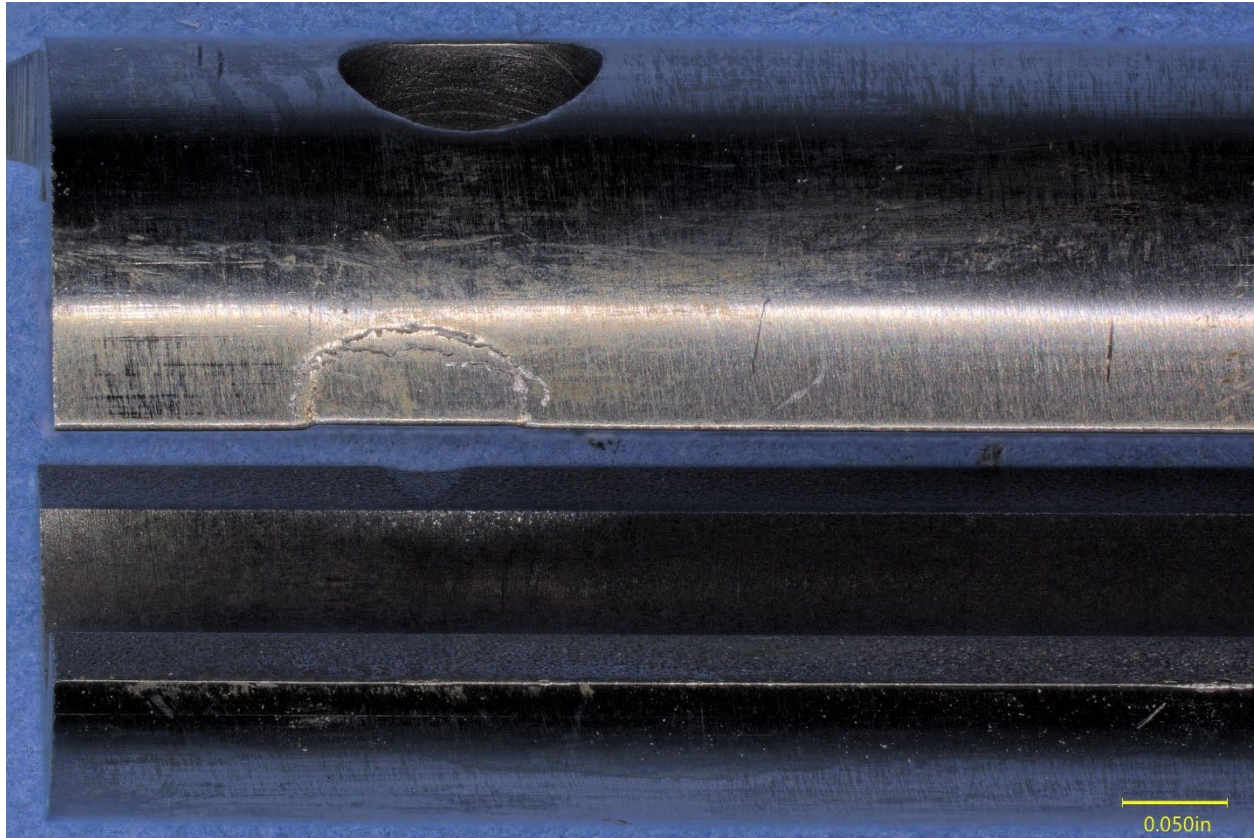
**Figure 25.** View of the damaged areas of the slot corners after cleaning and grease removal, viewed from slot 2.

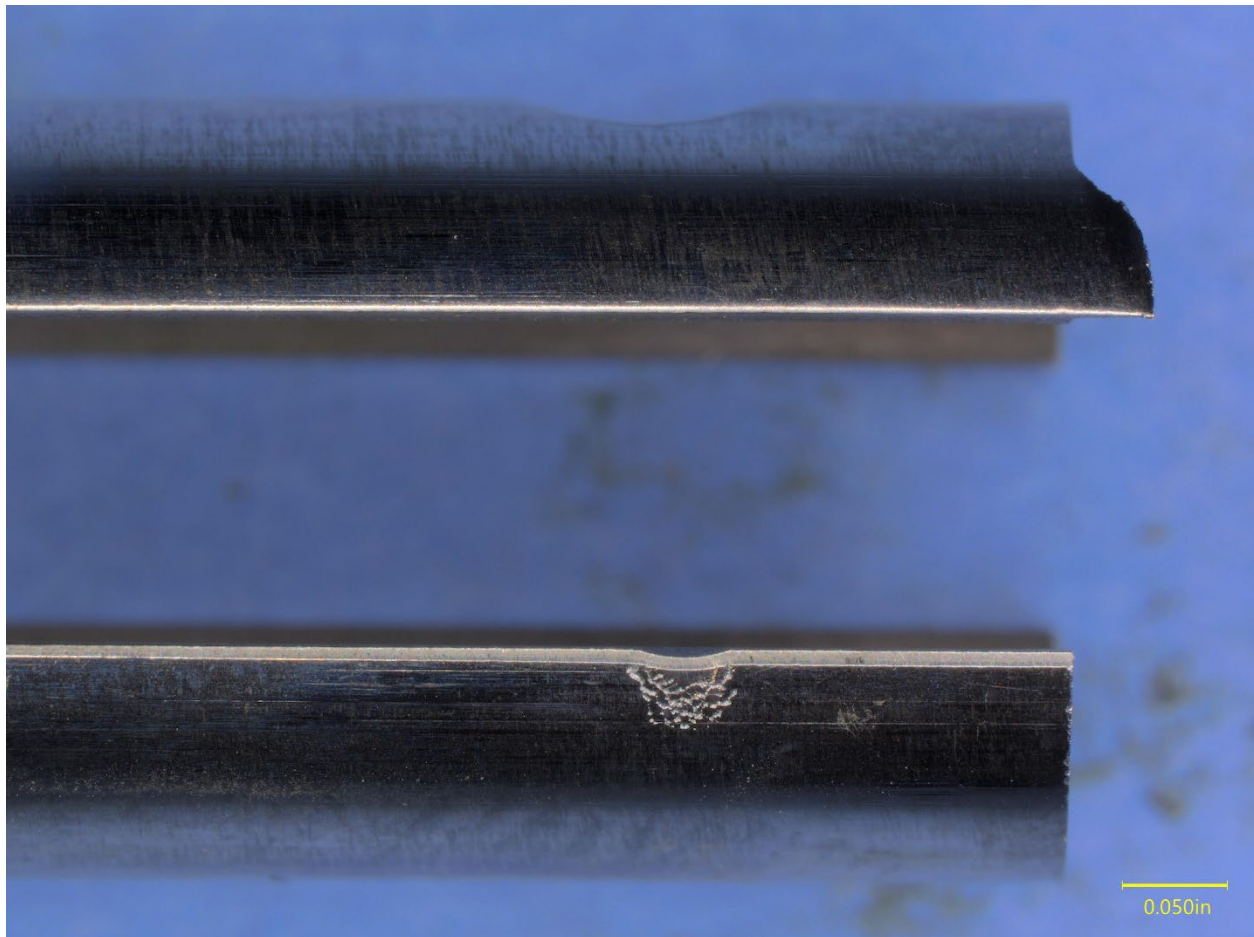
Figure 26 and Figure 27 show direct views of the damaged area on the corner of slot 1 of the shaft. As illustrated in these figures, the damage pattern manifested as convex ovoid areas, exhibiting radiating cracking from an area consistent with inward deformation or indentation of the slot face. The degree of deformation is illustrated in Figure 27.

**Figure 26.** View of the damage to slot 1, after cleaning and removal of grease.

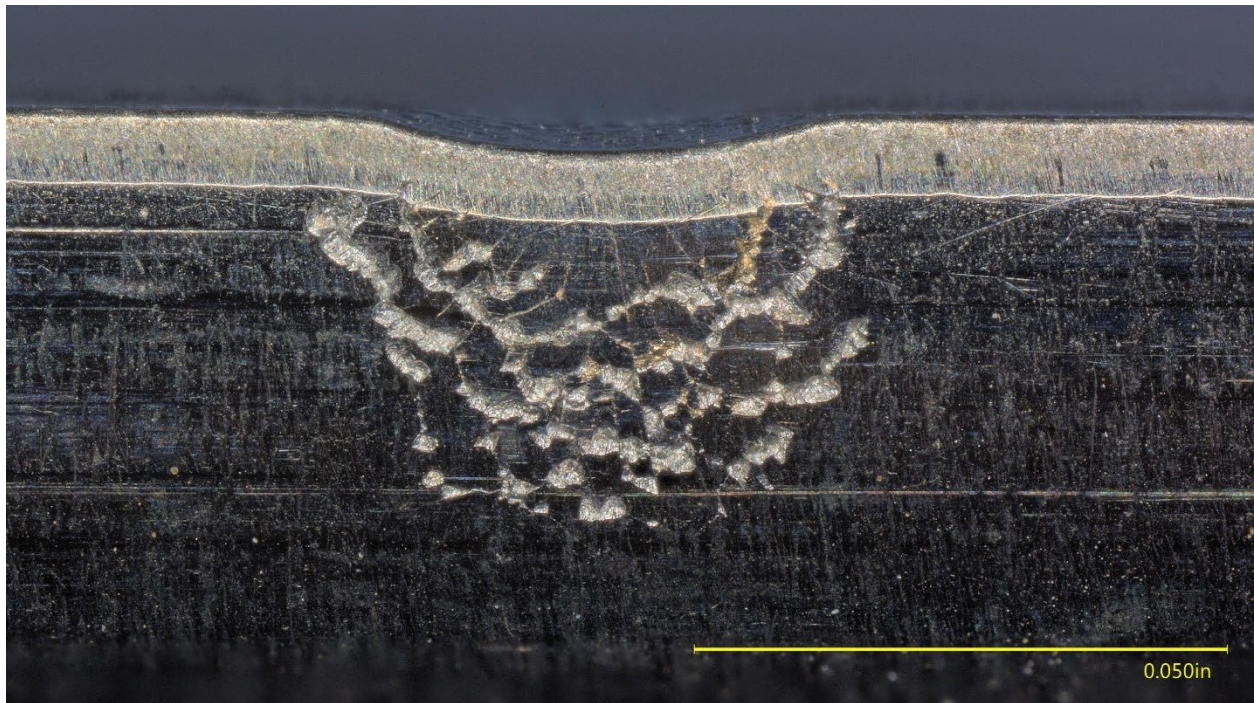
**Figure 27.** Closer view of the slot 1 damaged area in Figure 26.

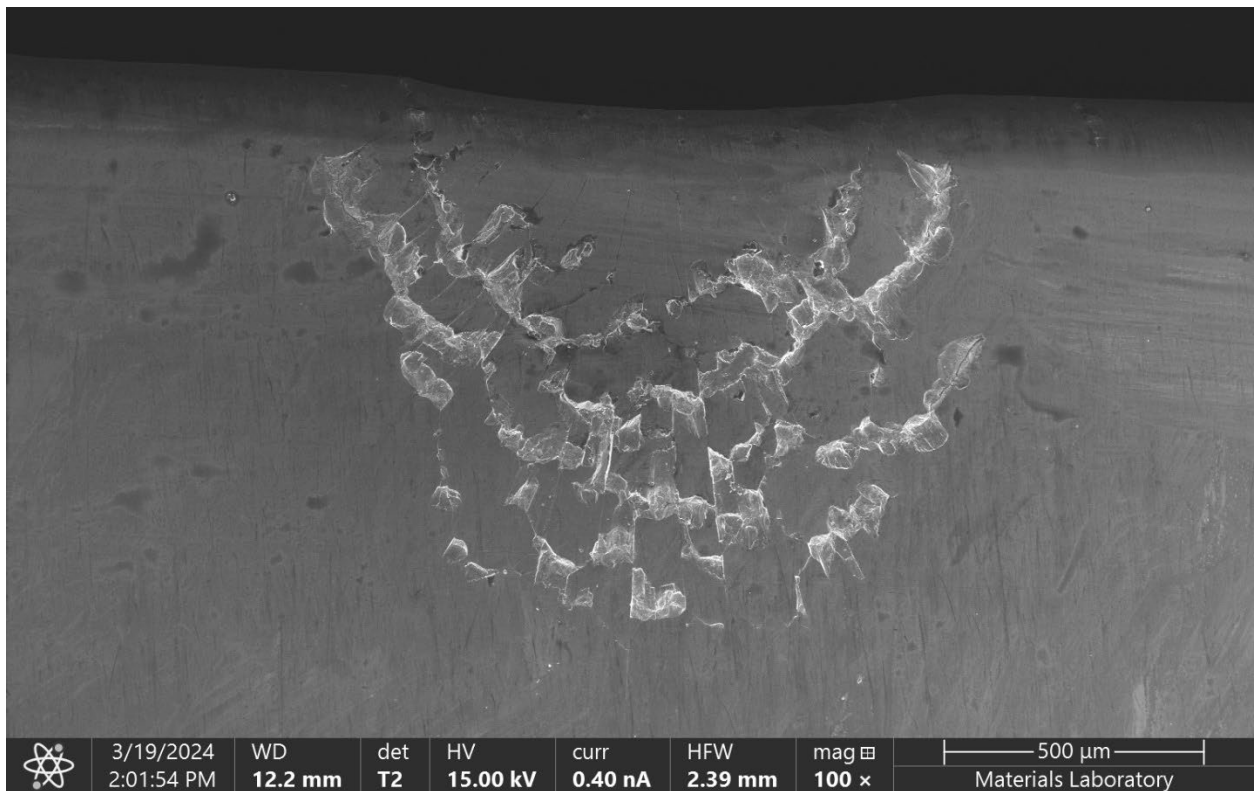
The shaft was examined using a field-emission scanning electron microscope (SEM), which confirmed the radiating cracking pattern shown in Figure 28 and Figure 29. A closer view of the cracking found the concurrent areas of localized fractured and spalled material (see Figure 30).

**Figure 28.** Secondary electron (SE) micrograph of the damaged area of slot 1.

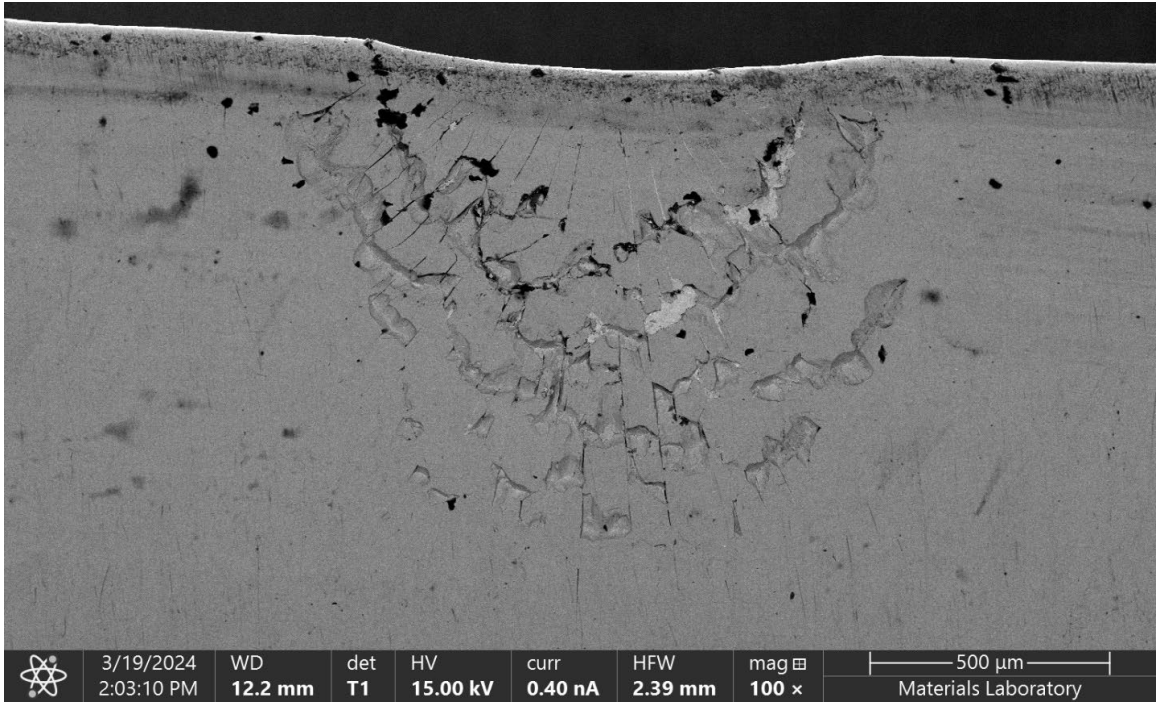
**Figure 29.** Backscattered electron (BE) micrograph of the damaged area of slot 1.

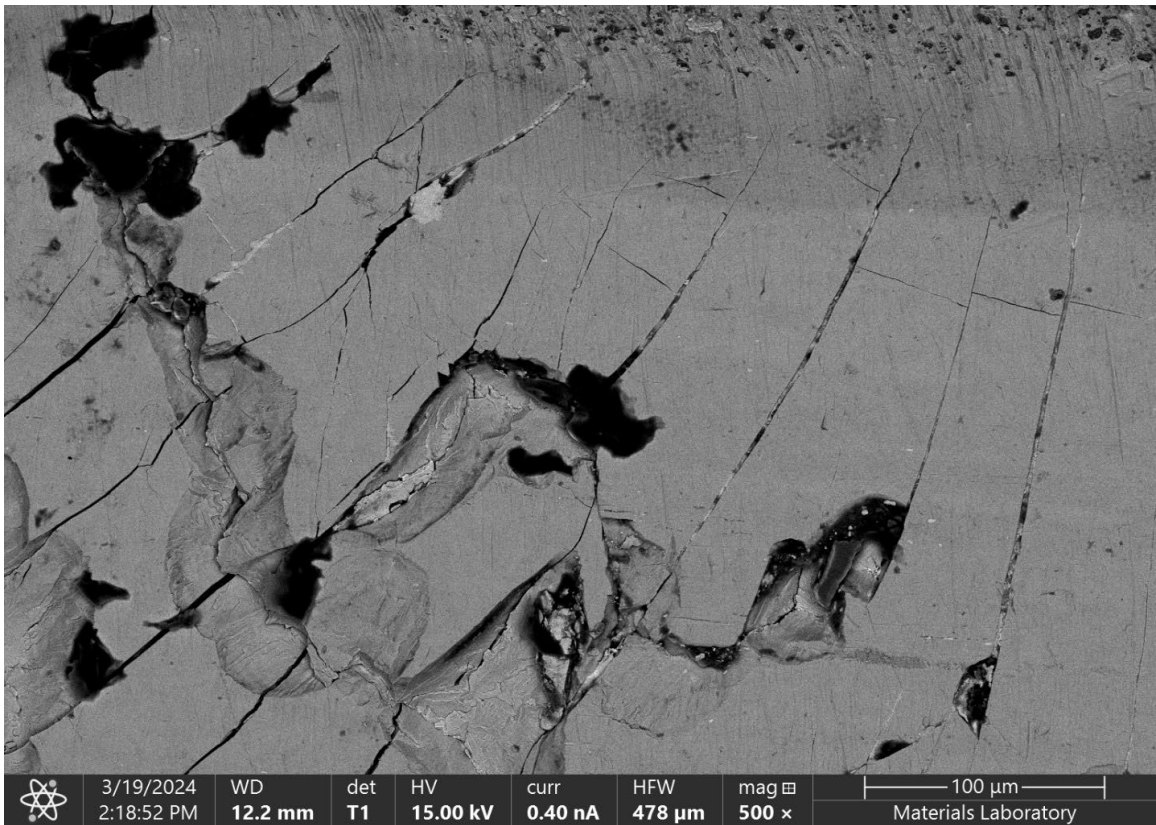
**Figure 30.** BE micrograph of cracked and spalled areas of the slot 1 damaged area containing no or lower-Z material (dark).

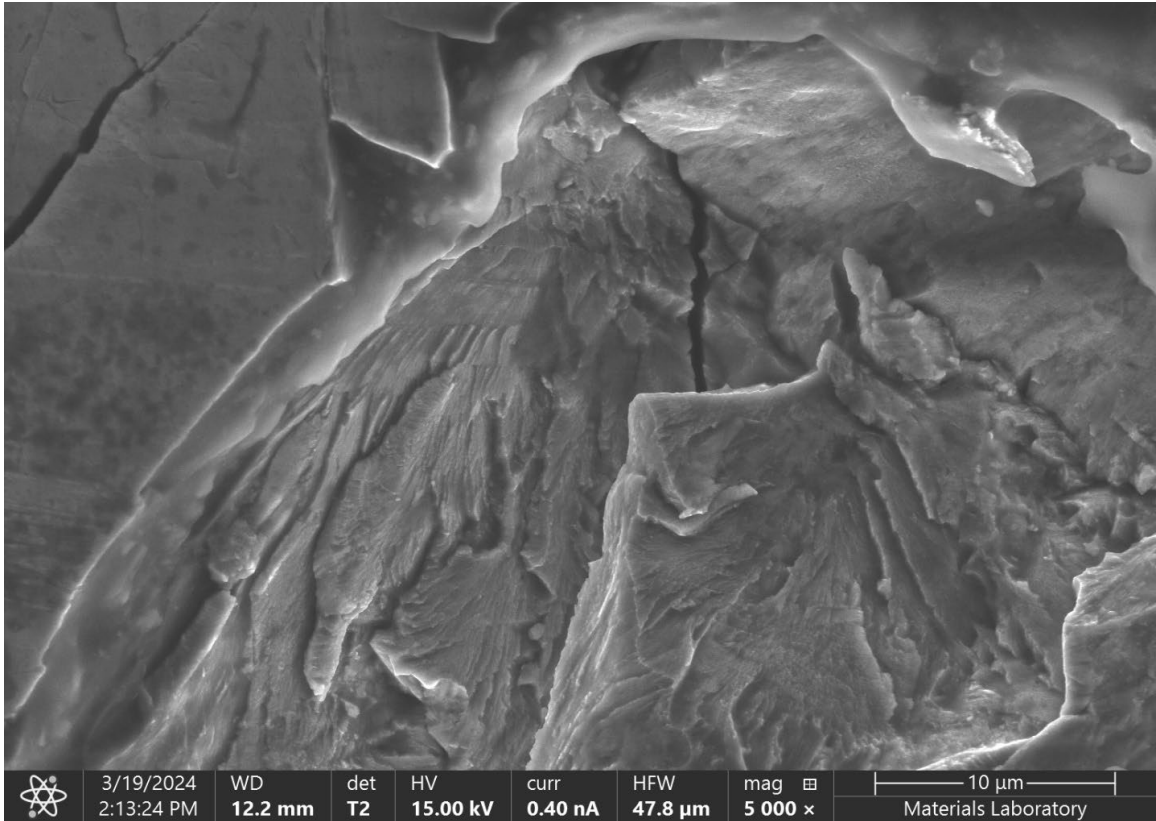
As shown in Figure 31 and Figure 32, these areas of spalled material exhibited forks and tongues consistent with cleavage fracture. This type of fracture on this material was consistent with the higher hardness and lower ductility properties typical of a nitride (surface-hardened material). As found from examination using energy-dispersive x-ray spectroscopy (EDS), the spalled areas exhibited a composition consistent with 17-4 precipitation-hardened stainless steel and nitrogen contents typical of nitriding processes.

**Figure 31.** SE micrograph of a closer area of spalled surface material in Figure 30, exhibiting cleavage features.

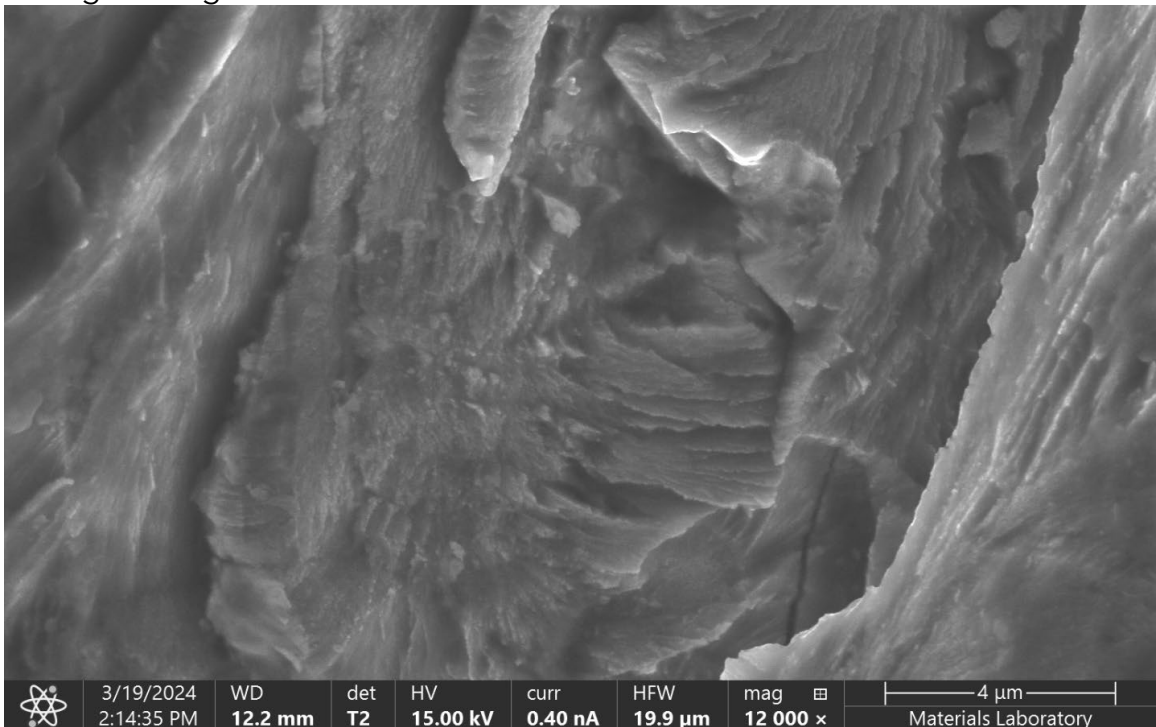
**Figure 32.** SE micrograph of a closer view of the tongues and river patterns in the cleavage fracture in Figure 31.

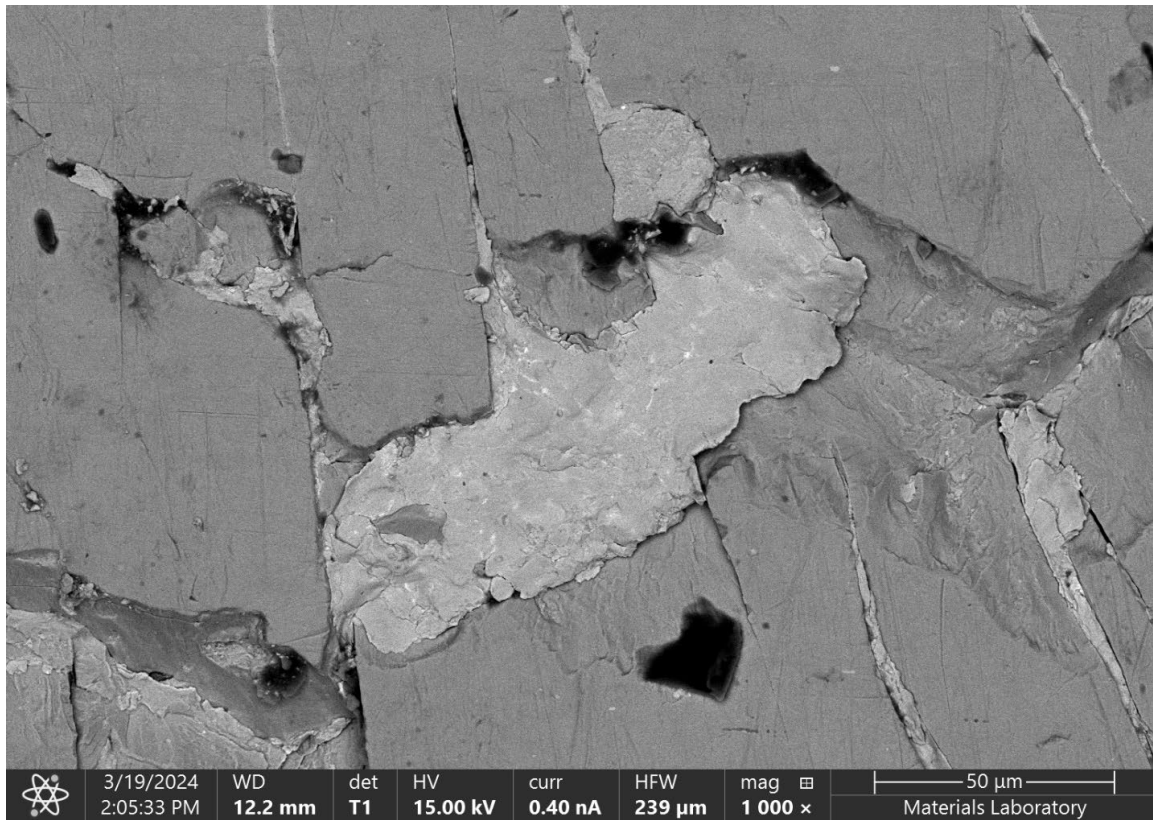
As shown in Figure 33, some of the spalled areas in the cracking contained material with a higher atomic number (Z).<sup>1</sup> Rather than sharp, faceted cleavage features, this material was mottled and smoother in surface features, consistent with dissimilar material. Portions of the spalled surface also contained lower-Z material, indicated by the darker regions in Figure 30.

**Figure 33.** BE micrograph of a closer view of the damage and cracks in Figure 29, showing higher-Z material in the spalled areas.

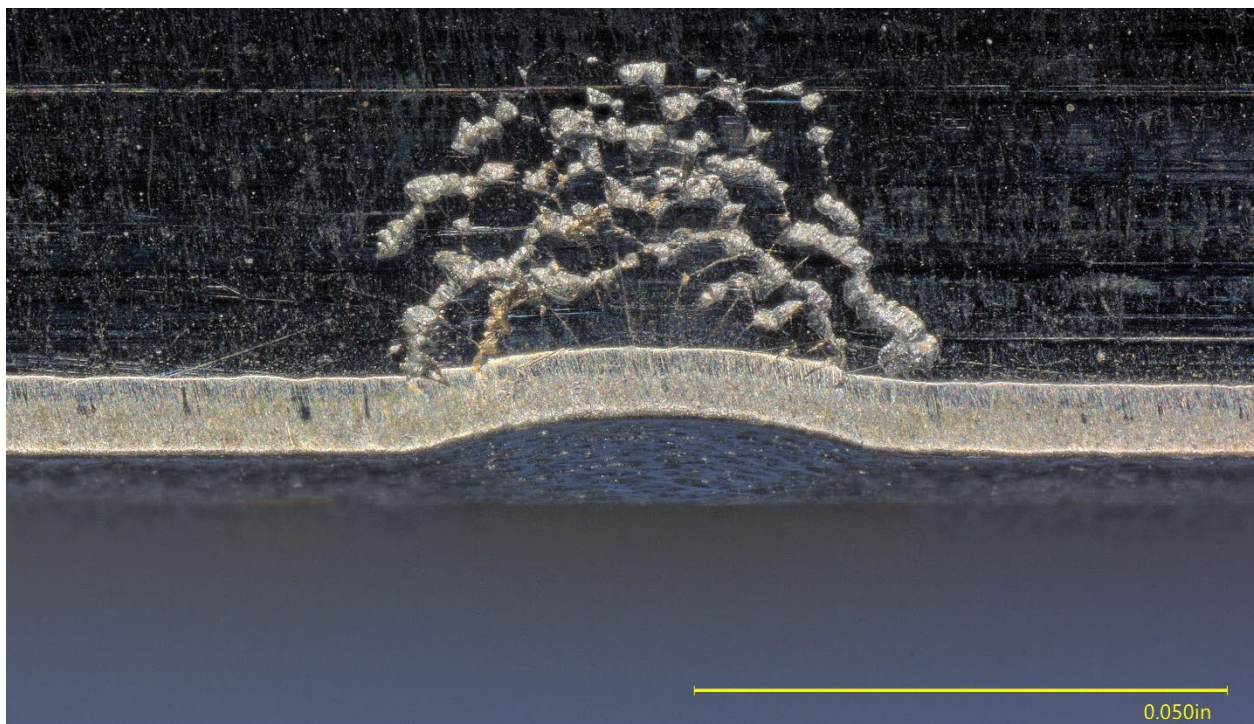
A reverse view of the slot 1 damaged area revealed a circular indentation pattern on the slot face. The diameter of a circle fitted to this indent was approximately 0.14 inches. Figure 34 and Figure 35 show the extent of this deformation, with Figure 36 highlighting the localized cracking along the corners of the region. Like the cracking on the surface, the cracks at the indented area radiated outward from a central location (Figure 37).

**Figure 34.** Reverse view of the damaged region of the slot 1 corner, showing inward indentation at the slot face below the corner.

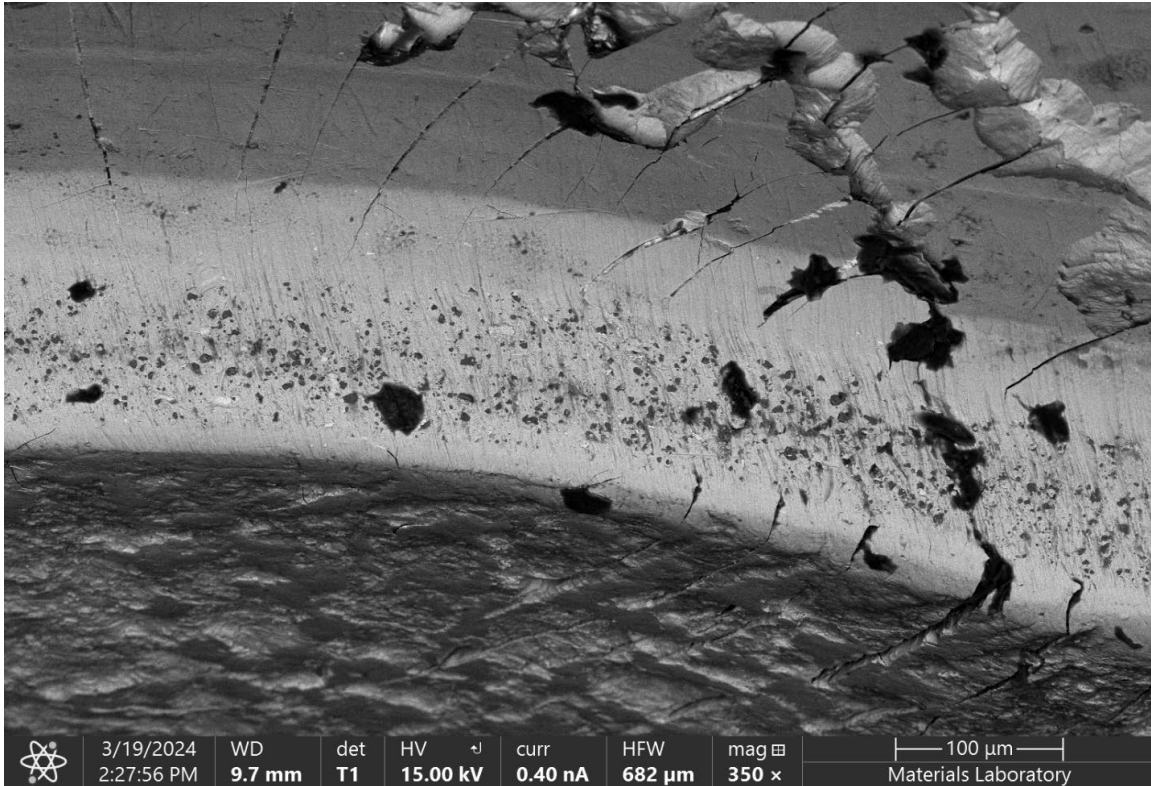
**Figure 37.** BE micrograph of a closer view of the slot 1 corner, showing surface cracking emanating from the indentation in a radial pattern.

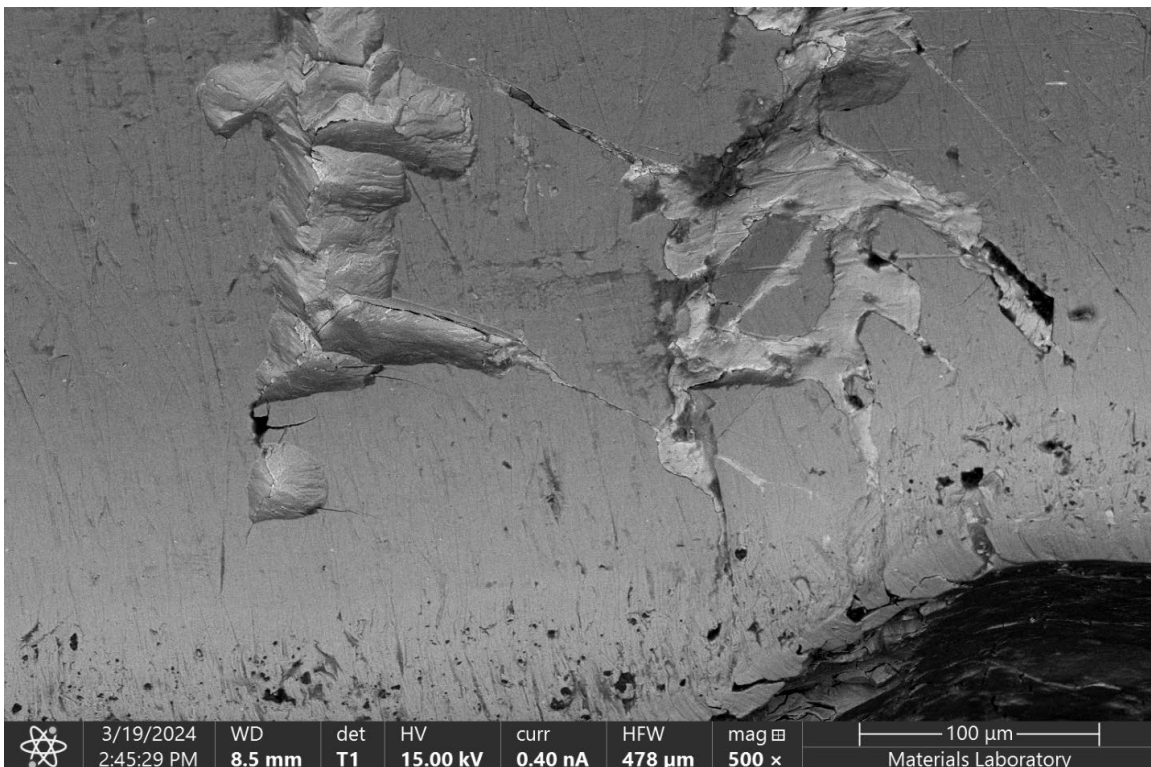
As illustrated in Figure 38, some of this cracking developed into localized surface material spalling (left in the figure). In some instances, the spalled regions were backfilled with dissimilar material. While the surface and fractured areas of the shaft exhibited compositions consistent with a ferrous material (exemplified by the spectrum in Figure 39), the higher-Z dissimilar material was consistent with a copper alloy (Figure 40).

**Figure 38.** BE micrograph of spalled surface material along the cracks in Figure 38, with the left area absent of and the right area filled with higher-Z material.
