# National Transportation Safety Board

CEN23LA232

## **MATERIALS LABORATORY**

Factual Report 24-022

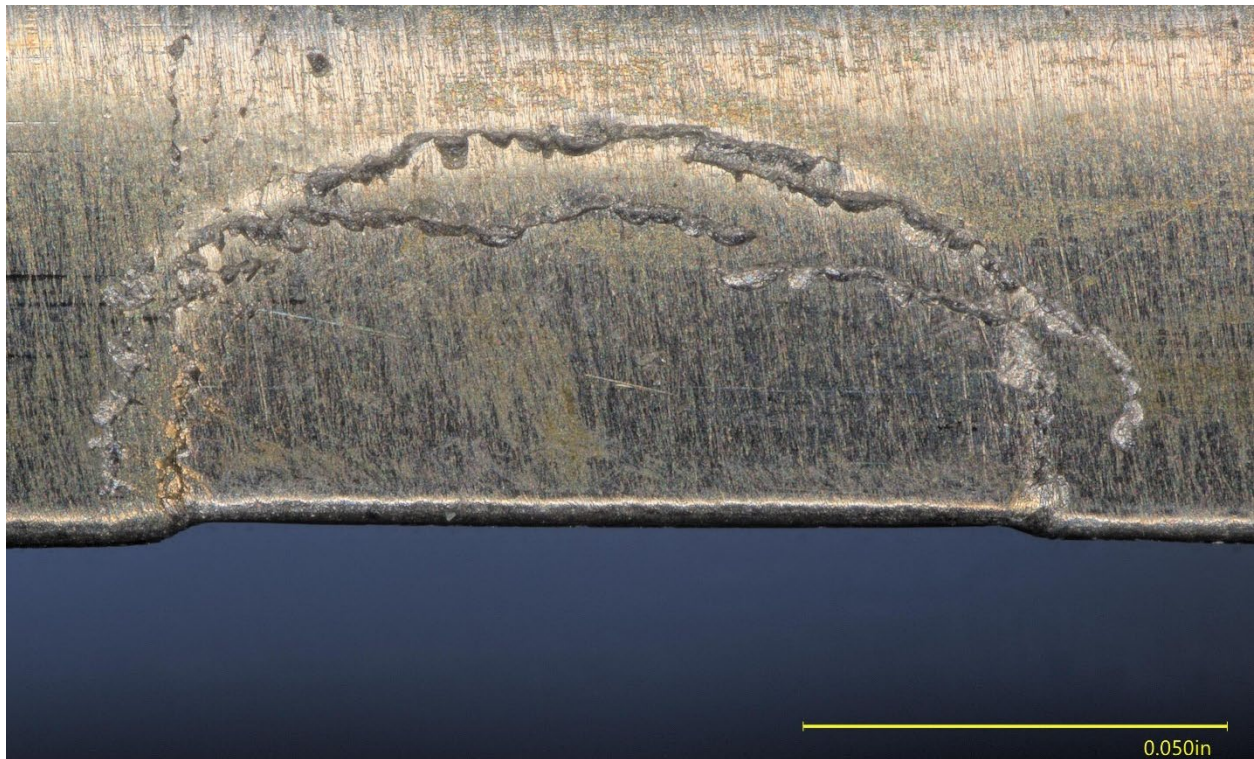
Figure 41 and Figure 42 show closer views of the damaged area on the corner of slot 2 on the shaft. Like slot 1, this damaged area was next to an indentation at the slot face surface. Unlike slot 1, the impression pattern into the shaft was angled and flat rather than rounded (see Figure 43 and Figure 44). The interior distance between the angled indentation was 0.094 inches, and the exterior was 0.103 inches.

**Figure 41.** View of the damaged area in the corner of slot 2, after full cleaning.

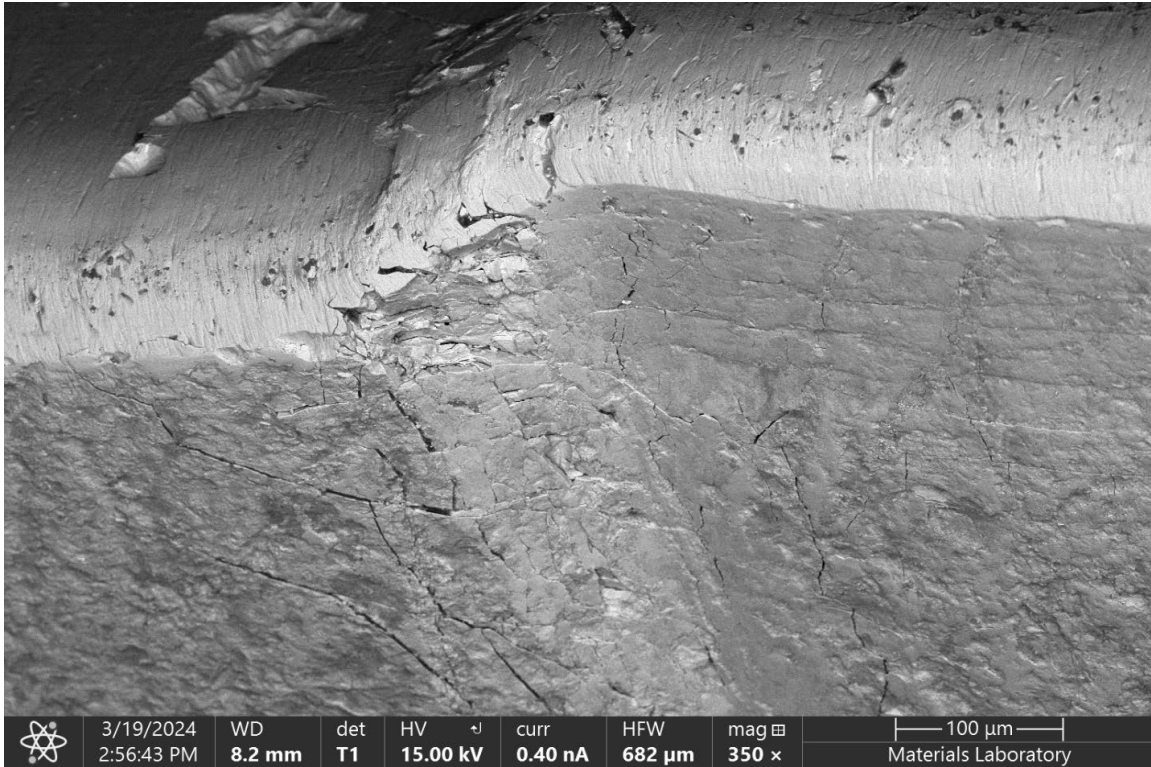
Multiple cracks were present at the corners of the impression (Figure 45). Where they intersected, the cracks had developed into fractured and spalled material, as shown in Figure 46 through Figure 48. Like the spalled regions on the exterior surface, these chipped areas at the slot 2 indentation corners exhibited features consistent with cleavage fracture.

**Figure 45.** BE micrograph of a closer view of the left angled corner depression in Figure 44, showing parallel horizontal and cross-cracking in the area.

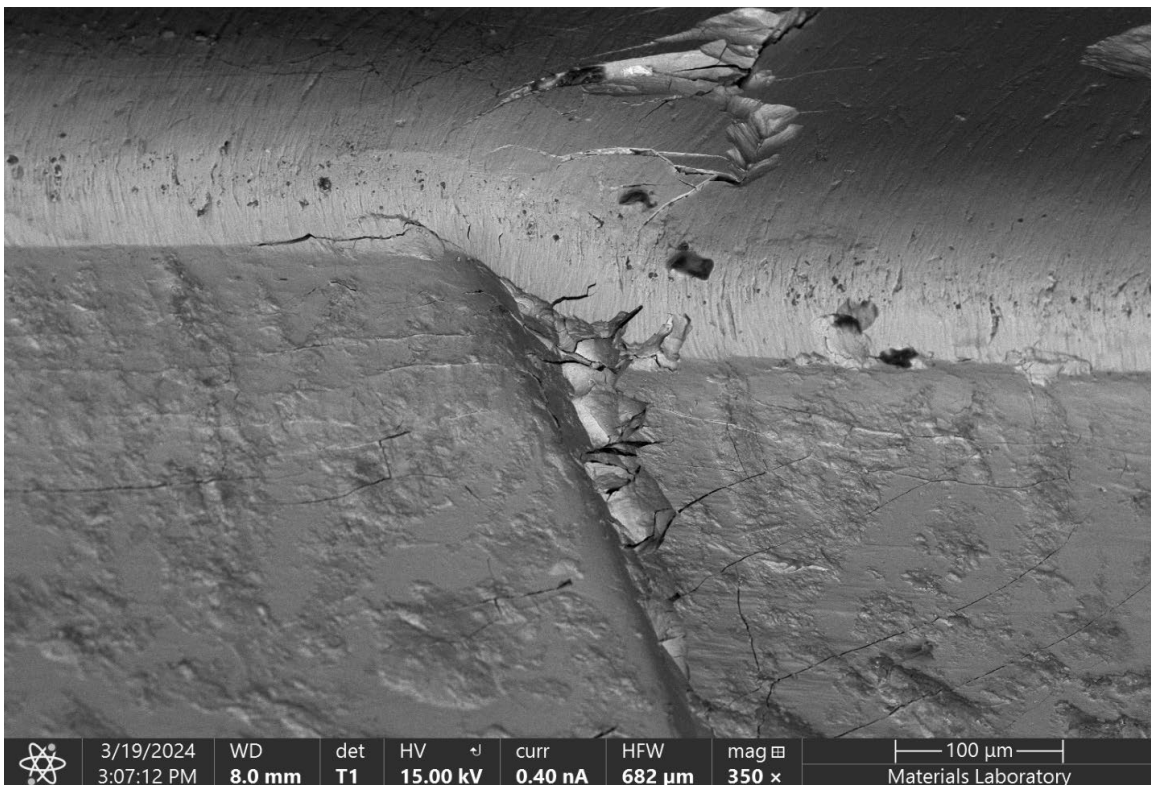
**Figure 46.** BE micrograph of a corner of the depression on the sides of the slot 1 damage, showing chipping and spalling, with cracking emanating outward.

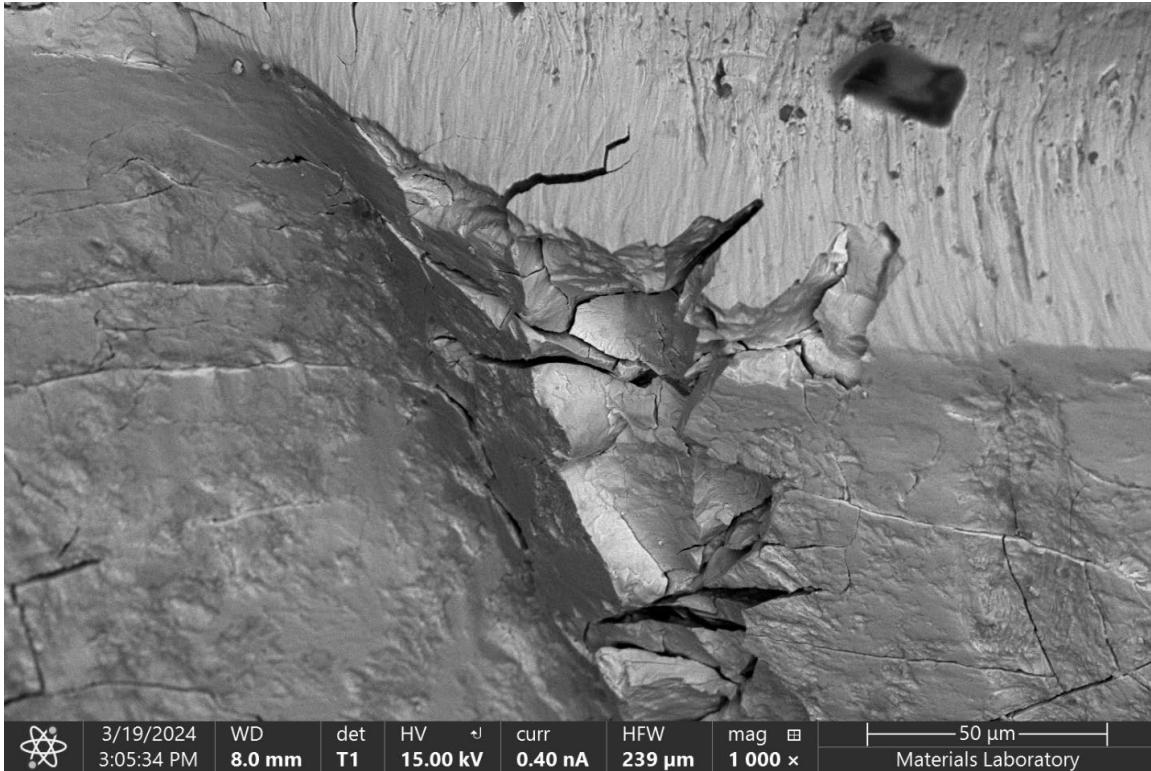
**Figure 47.** BE micrograph of a closer view of the spalled area of the depression corner in Figure 42, with cracks emanating outward.

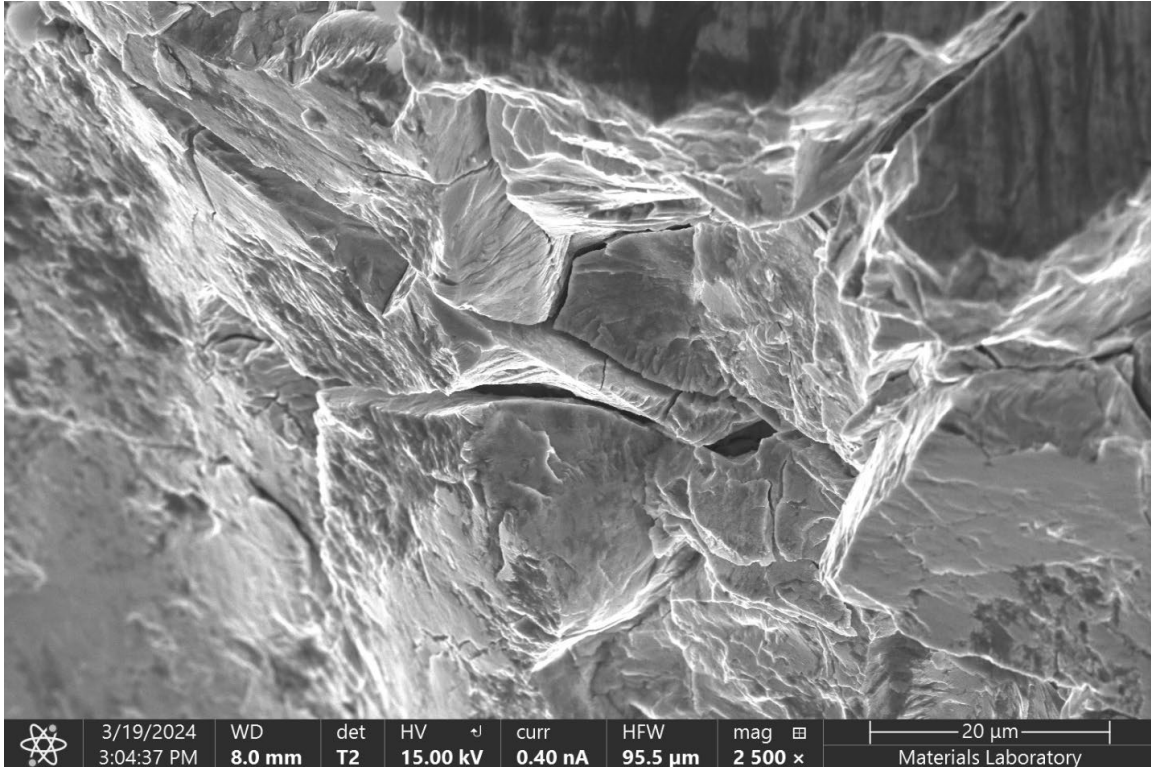
**Figure 48.** SE micrograph of the cleavage fracture patterns in the spalled area in Figure 43.

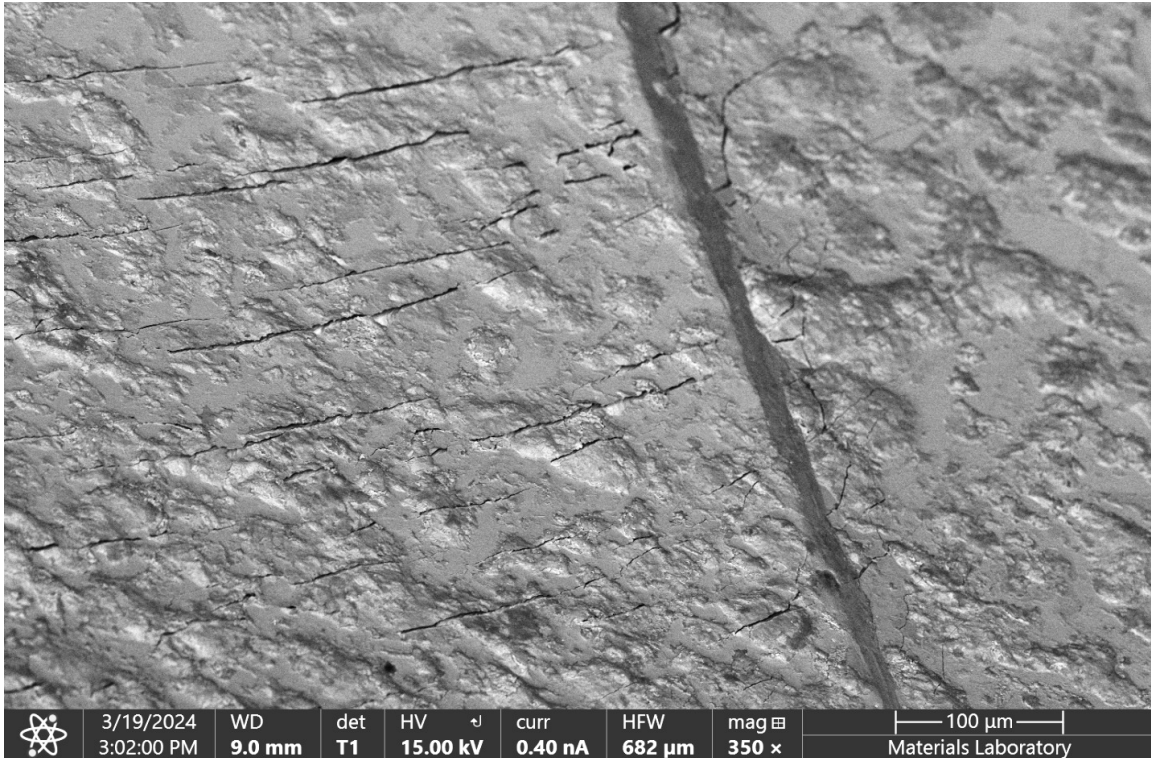
Parallel cracks occurred along the surface with the indent (see Figure 49). In several locations, mainly where these cracks were closely spaced (less than 50 mm), regions of material had spalled. As shown in Figure 50, this spalling exhibited rounded regions, with some areas of cleavage fracture features and some areas of smearing, consistent with post-fracture wear.

**Figure 49.** BE micrograph of parallel horizontal cracks in the depression area on the slot 2 face.

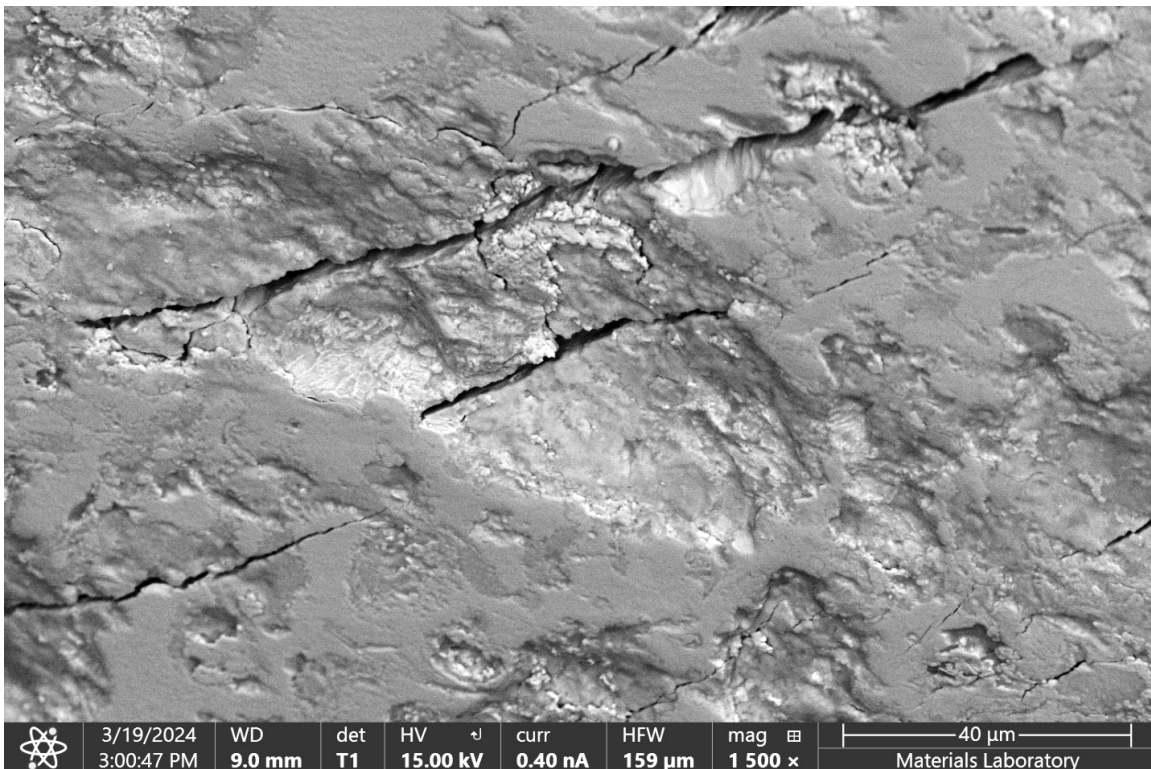
**Figure 50.** BE micrograph of a closer view of the cracks in Figure 50, showing material spalling.

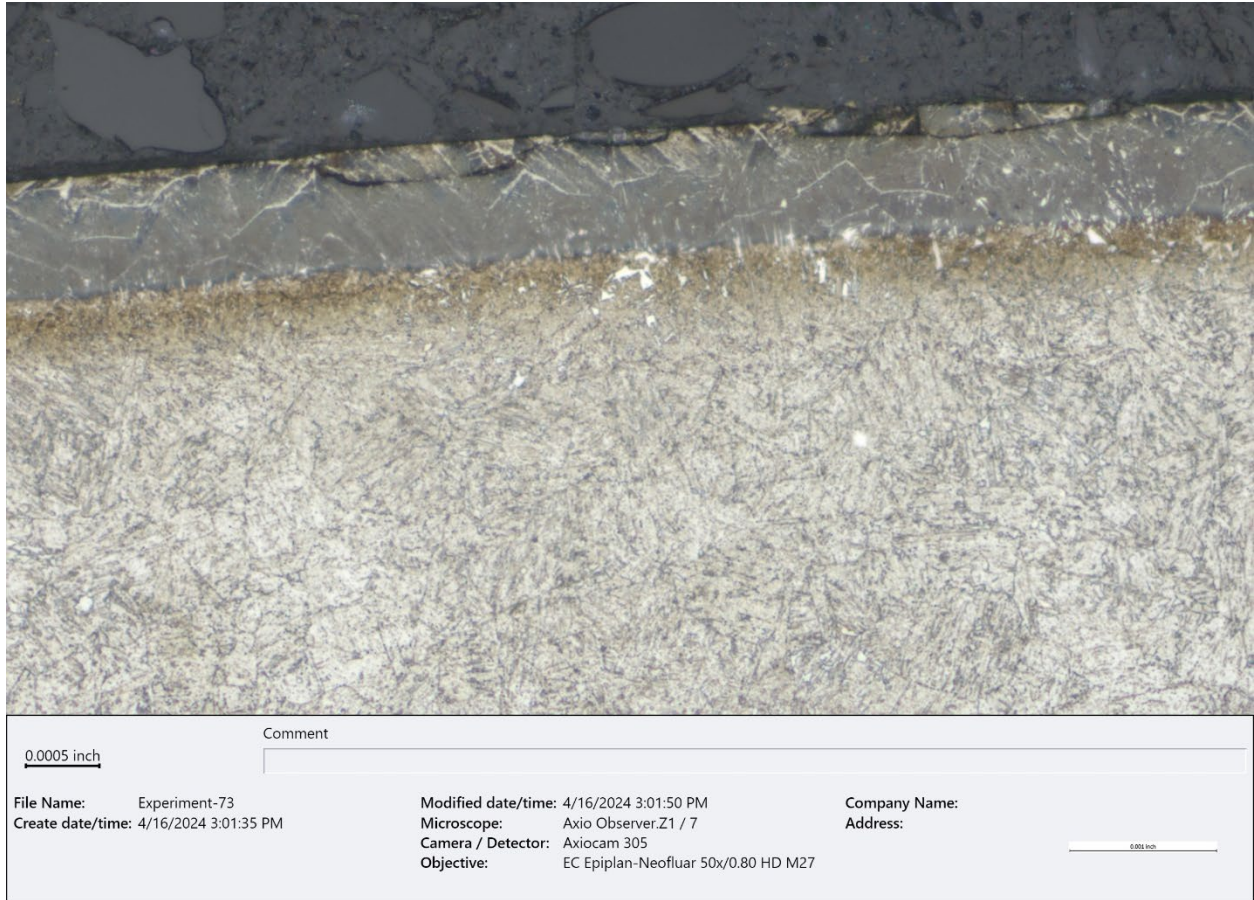
The camshaft was cross-sectioned, mounted, polished, and etched with Fry's Reagent. Figure 51 shows a typical view of the cross-section, showing the exterior nitriding layers on both the exterior and internal surfaces. Figure 52 shows a typical area of the core microstructure, exhibiting a tempered martensitic structure with well-dispersed precipitates typical of the chemical composition. Figure 54 shows closer views of the nitriding layer. This layer was between 0.001 and 0.002 inches in thickness. Several areas of the nitride layer exhibited cracking, as illustrated in Figure 53 and Figure 54.

**Figure 53.** BF optical micrograph of a surface nitride layer of the camshaft, showing parallel cracking open to the surface (~320X, etched Fry's Reagent).

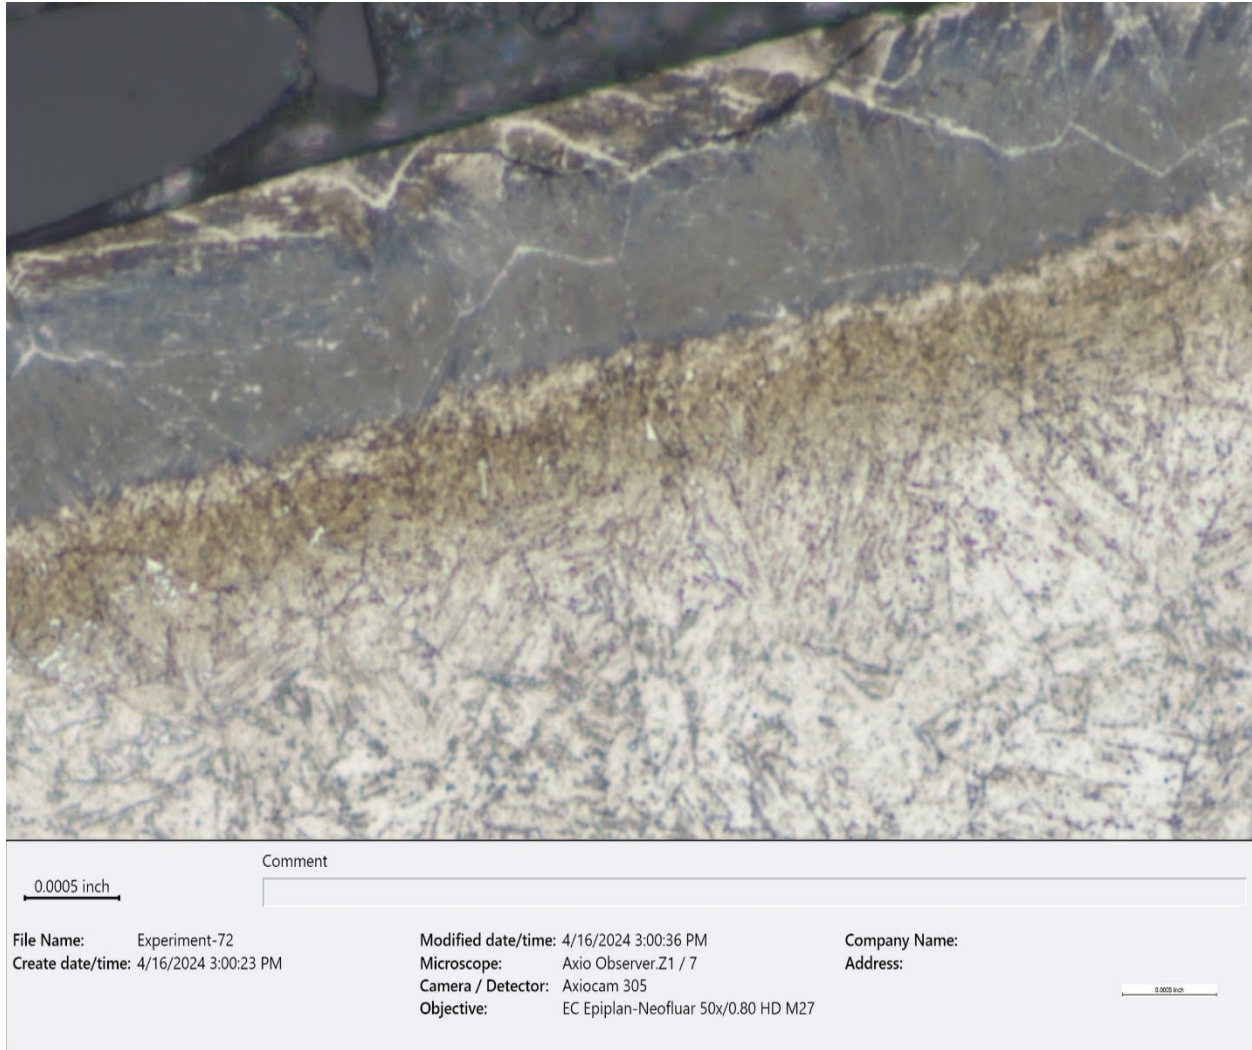
**Figure 54.** BF optical micrograph of a surface nitride layer of the camshaft, showing a subsurface crack (~500X, etched Fry's Reagent).

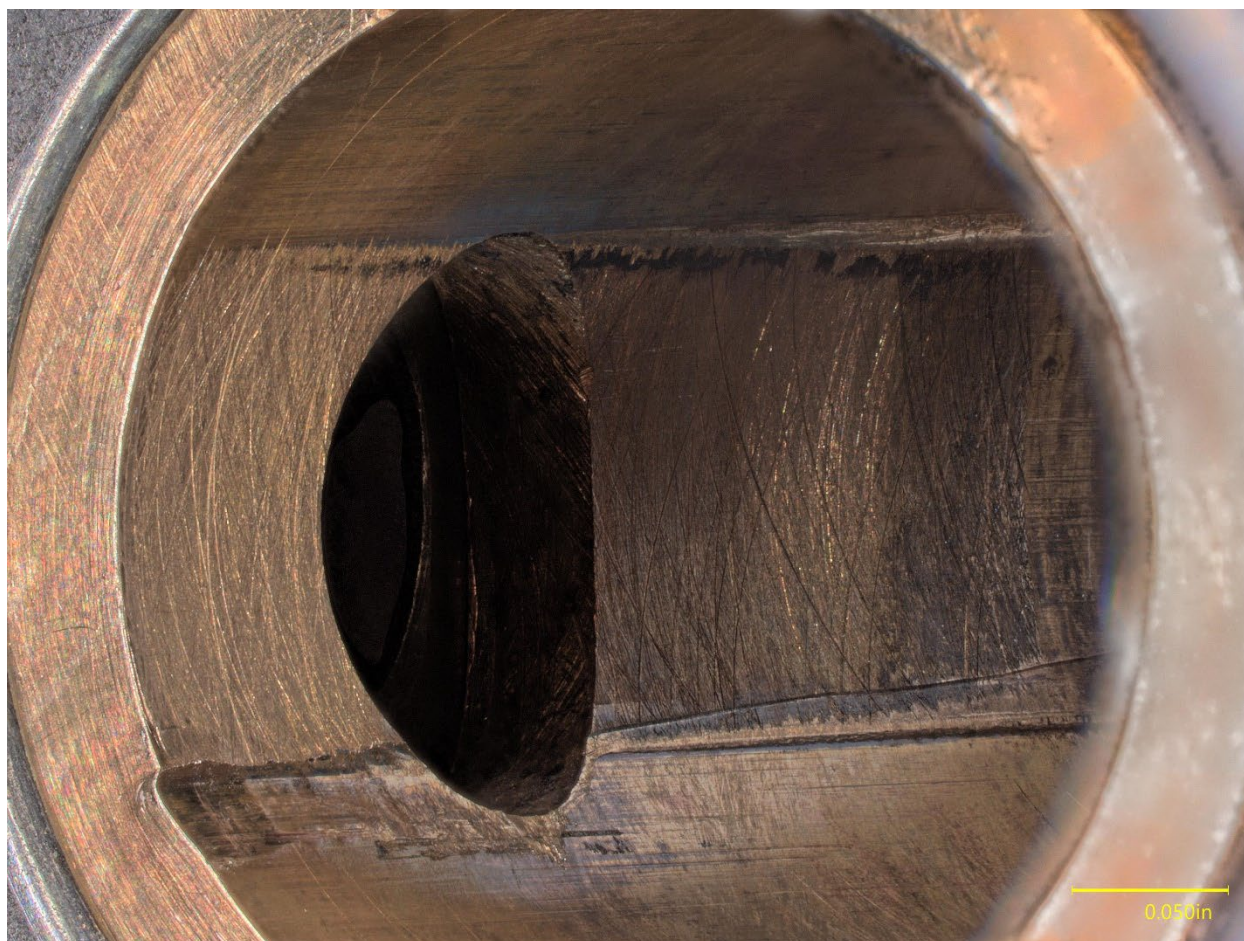
In contrast, the surrounding areas exhibited more longitudinal wear marks, consistent with movement against the camshaft exterior. As shown in Figure 56, outward deformation of the interior edge of the bushing coincided with the most pronounced longitudinal wear marks, consistent with the corner of slot 1.

**Figure 56.** Angled view of the bushing interior that mated with slot 1 of the shaft, after cleaning.

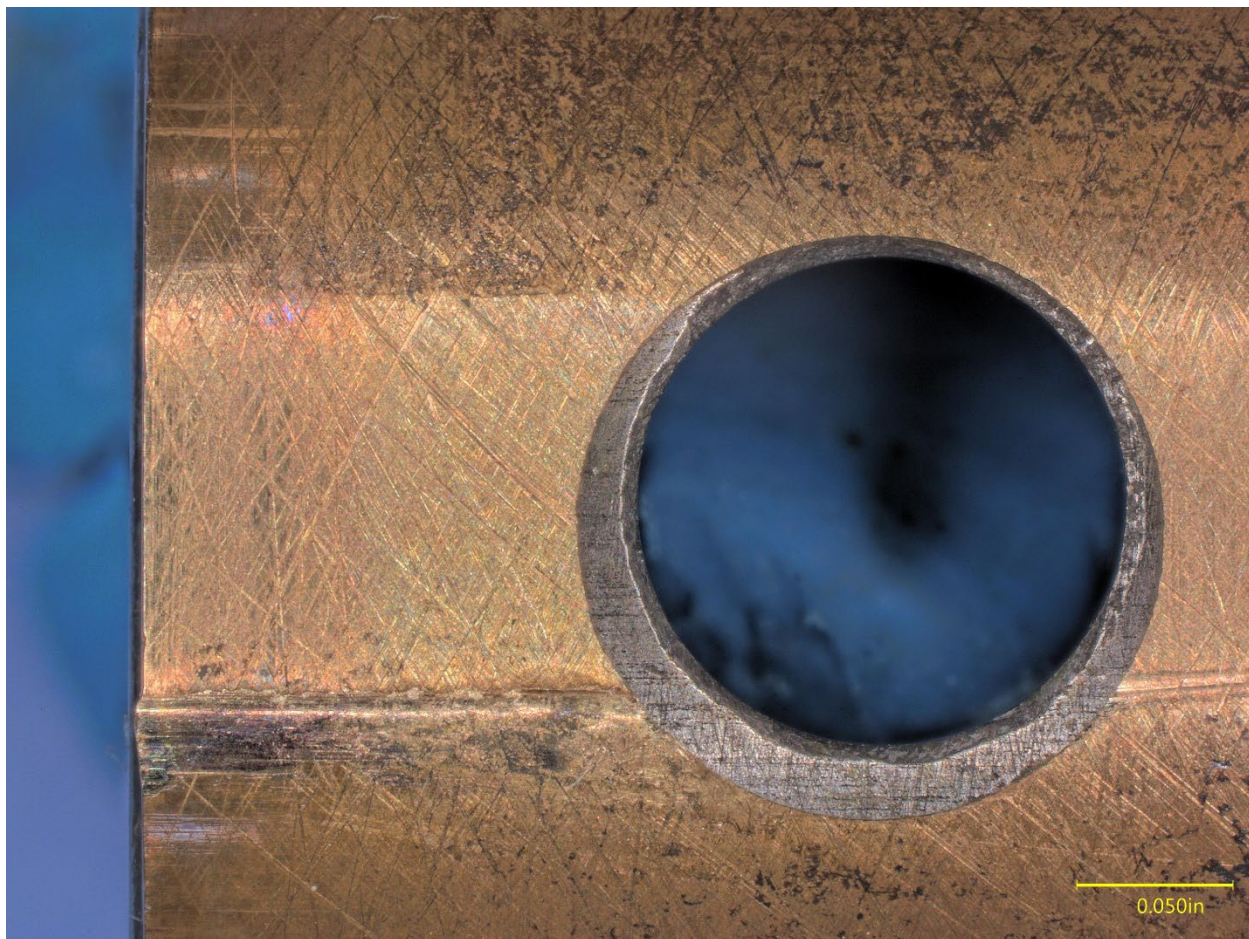
Along with the camgear, the bushing was sectioned, with these surfaces shown in Figure 57. On both sides, the longitudinal wear regions coincide with the pin holes. Figure 58 shows a closer view of the bushing end interior near the mating damage of slot 1 of the shaft. Figure 59 shows the bushing interior edge near the slot 2 corner.

**Figure 58.** Closer view of the end of the bushing interior near the slot 1 damage.

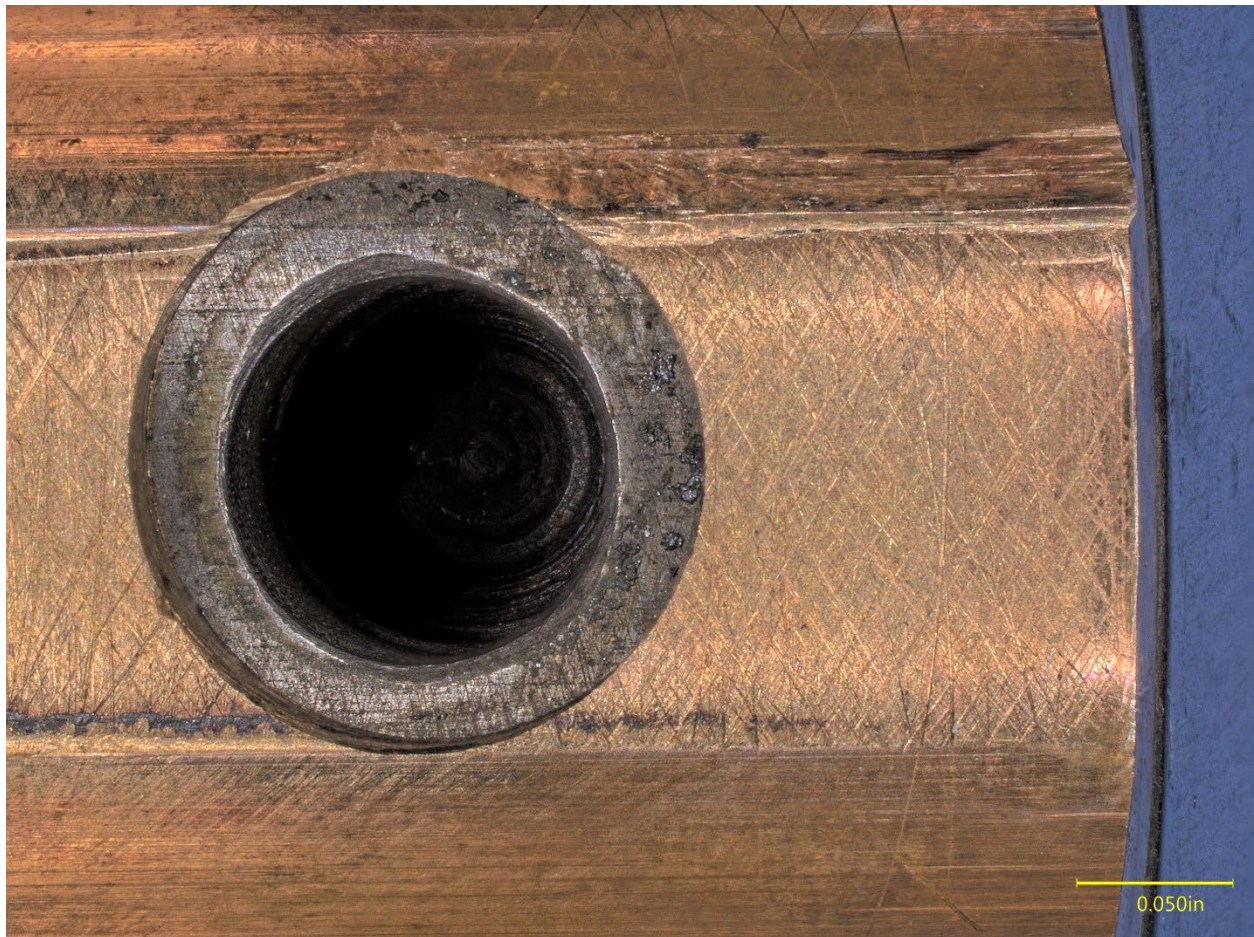
**Figure 59.** Closer view of the bushing interior near the edge with the slot 2 corner damage.

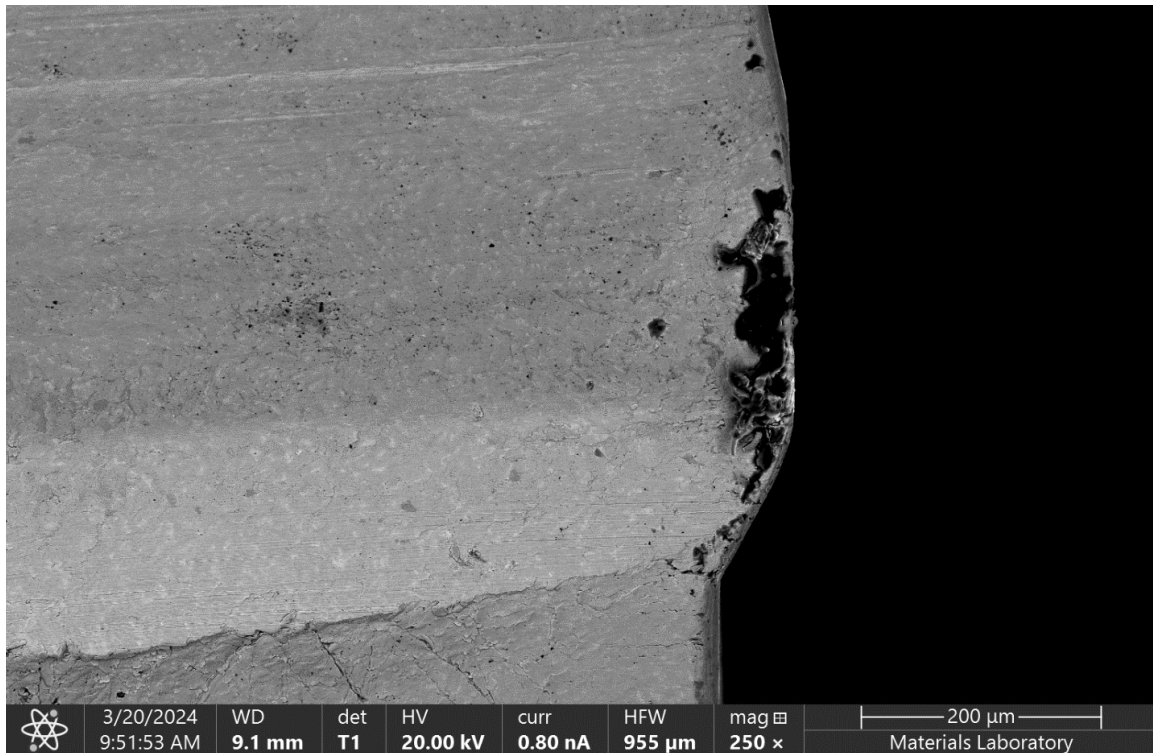
Both bushing interior surfaces exhibited deeply gouged areas with protruding plastic deformation on the edges. These areas were examined using a SEM. Figure 60 shows the outward deformation of the slot 1 area of the bushing interior. The edge exhibited foreign material, which manifest as the darker regions along the protrusion in the figure. Examination of this material found it to be consistent with carbon-based nonmetallic compounds.

**Figure 60.** BE micrograph of the bushing protrusion deformation in **Figure 58**.

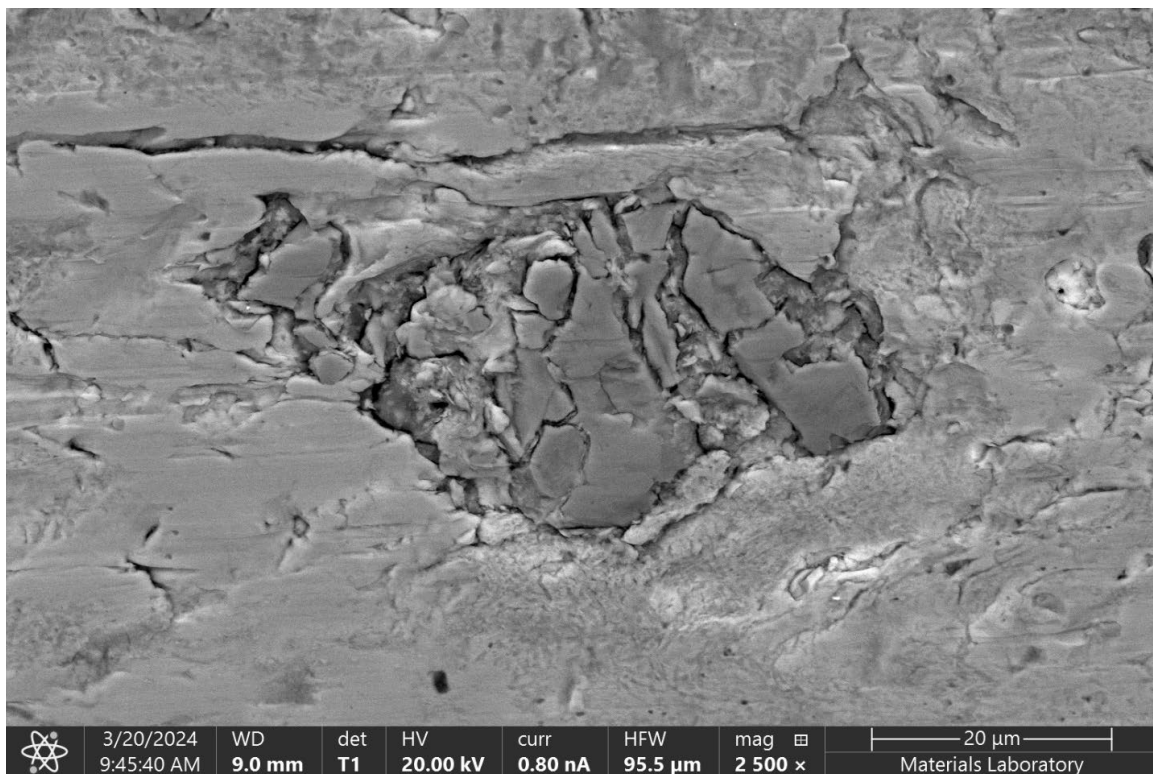
Embedded materials were commonly found along the worn bushing areas as illustrated in Figure 61. These materials were often fractured in multiple locations, and their edge morphologies were mirrored in the surrounding bushing material. These features were consistent with harder material embedded in softer material. EDS probes of the embedded material in Figure 61 were consistent with the nitrided steel of the mating camshaft.

**Figure 61.** BE micrograph of the boxed area in **Figure 60**, showing dissimilar material embedded in the bushing.

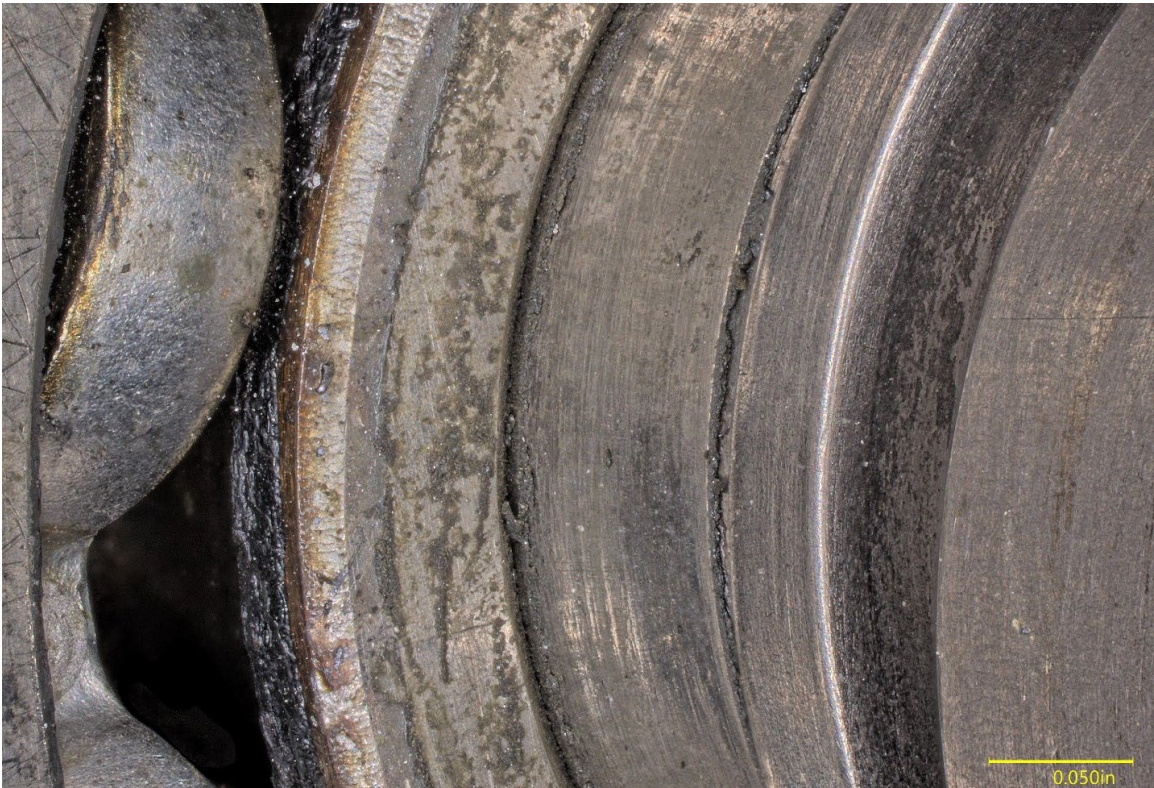
The bearing balls were still in place with no loose debris, as shown in Figure 64. The race surfaces facing the balls did exhibit dark material buildup, as illustrated in Figure 65.

**Figure 65.** Angled view of the inner race outer surface with the cage, showing darker deposits between the surface.

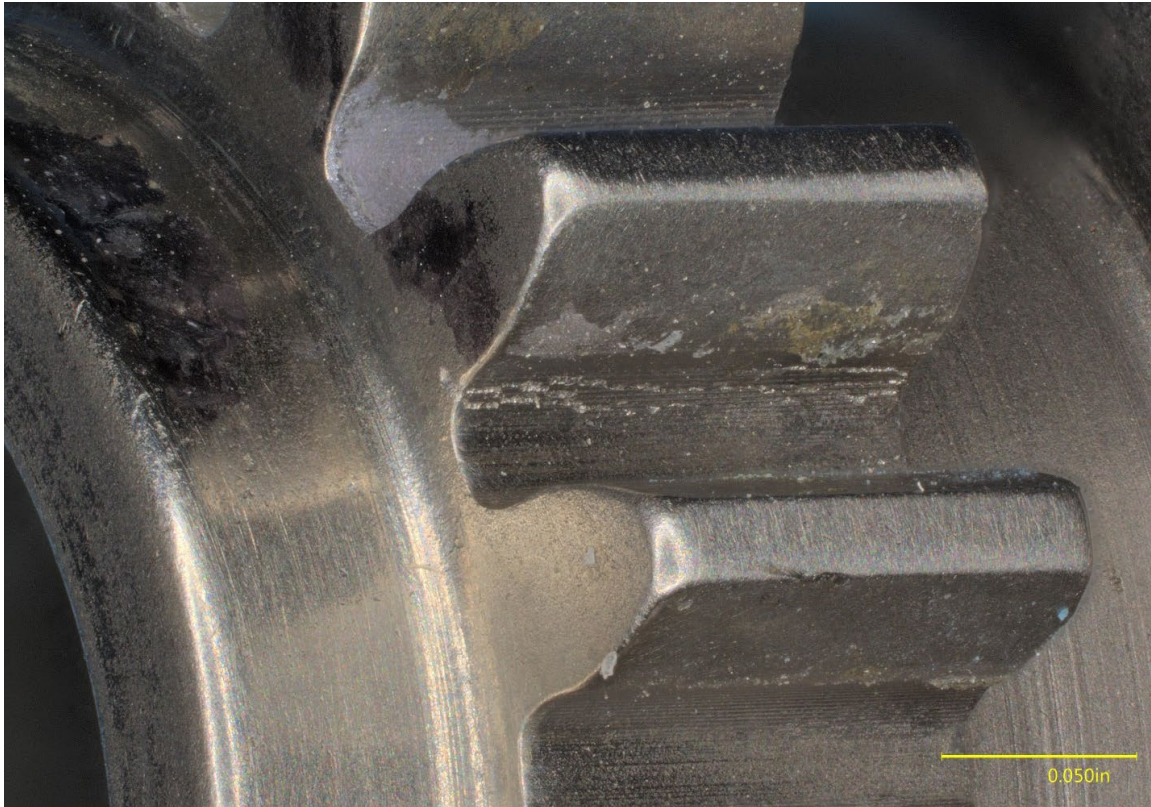
Figure 66 shows some of the teeth of the pinion gear of the camshaft. While the teeth were intact, they exhibited cracking or material spalling areas. The most damaged tooth was the one illustrated in Figure 67. There were larger areas of discolored wear along the face of the tooth.

**Figure 67.** Closer view of the central teeth in **Figure 66**.

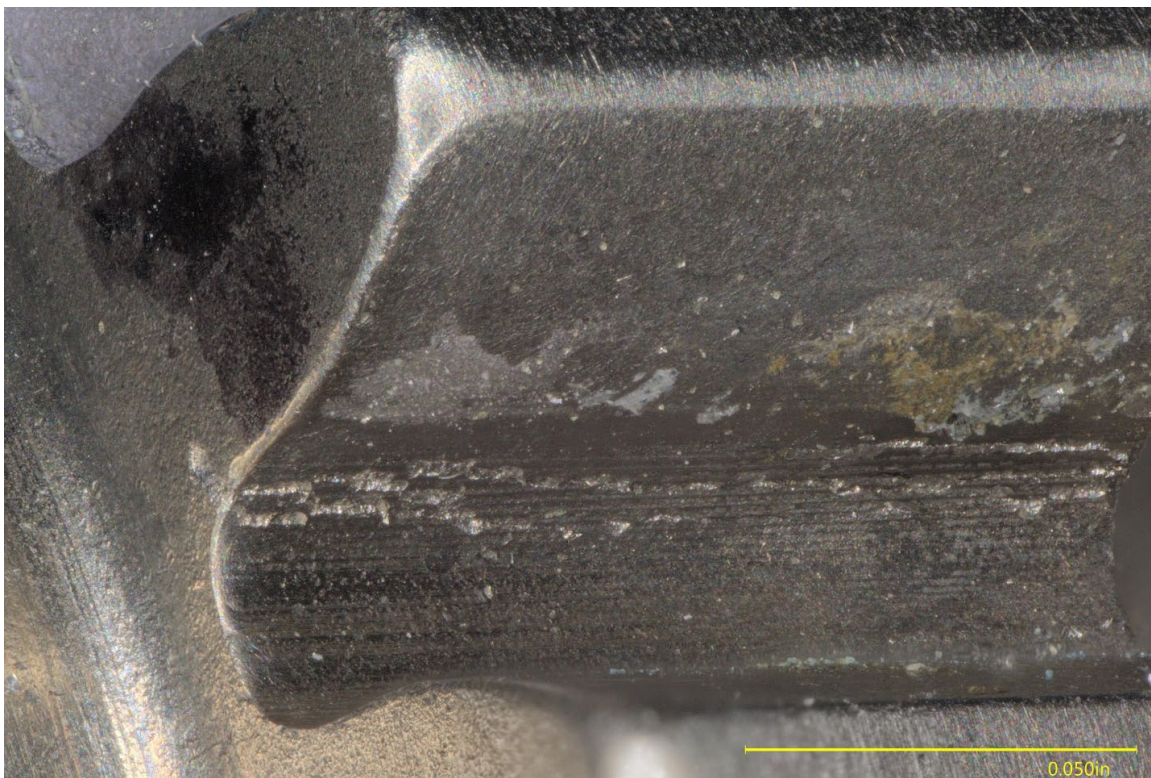
Along the flank of the tooth closer to the bottom land, there were areas of parallel cracking features, shown in Figure 68. While the wear on the face was similar in size and shape to the reverse face of the same tooth (Figure 69), there was an absence of the same kind of cracking along the flank, as demonstrated in Figure 70.

**Figure 68.** View of the center-positioned tooth in **Figure 67**.

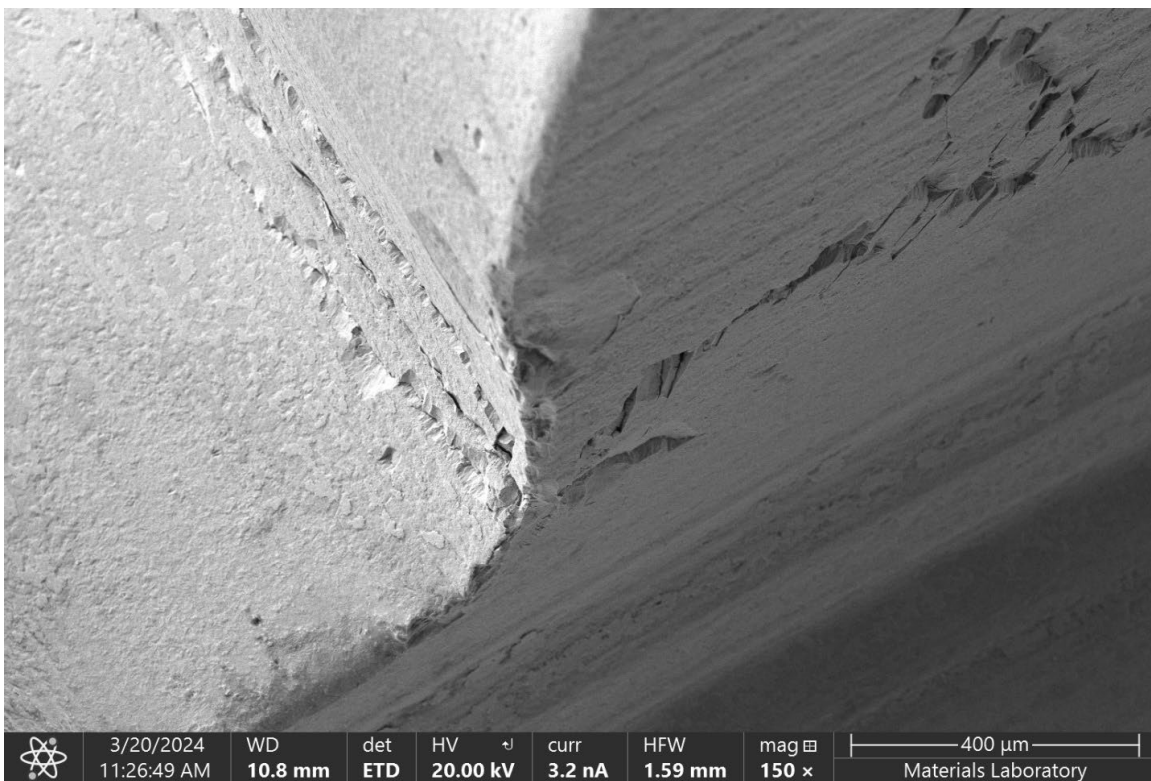
Figure 72 shows a closer view of the cracking. The cracks on both surfaces exhibit branching as the cracks move away from the corner—this was consistent with the cracking originating at the corner. Much of the cracks exhibited angular regions of missing material. As demonstrated in Figure 73, this was consistent with limited material spalling adjacent to the cracks.

**Figure 72.** BE micrograph of the tooth corner in **Figure 71**, showing spalling and cracking.

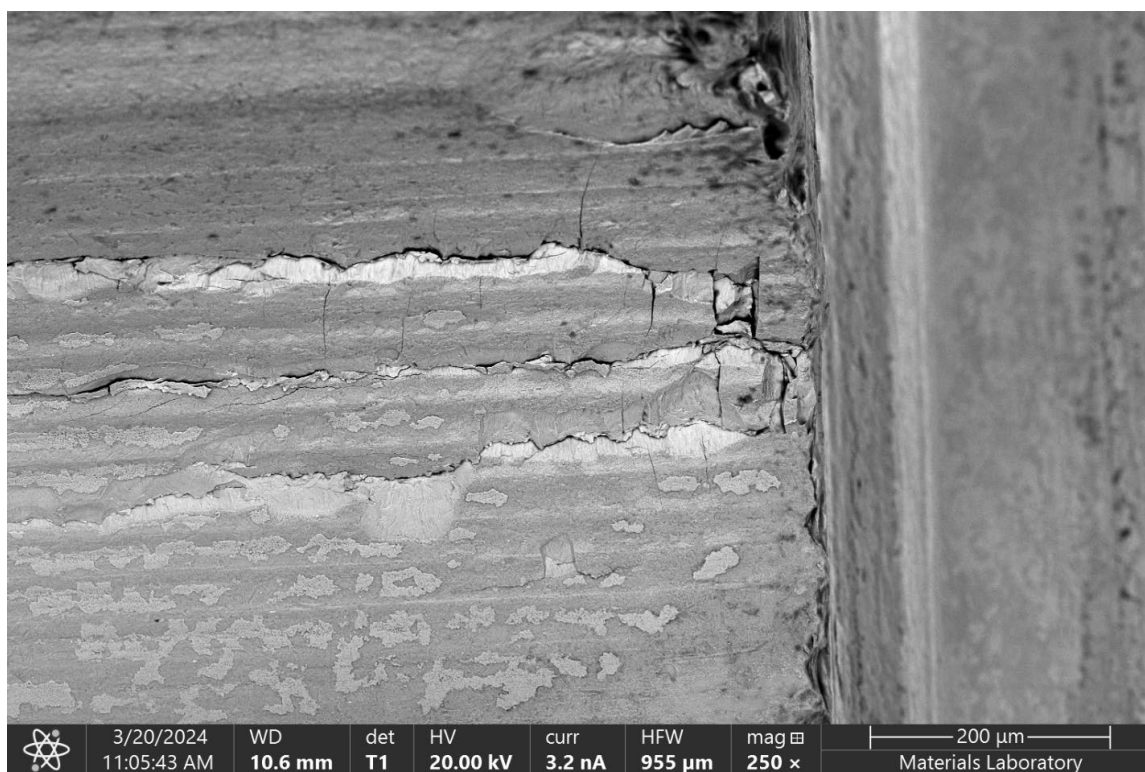
Figure 74 and Figure 75 show closer views of the cracking along the flank and the nearby fillet radius. This area exhibited three parallel longitudinal cracks that had branched out just to the left of the corner, as shown in Figure 74. Secondary cracking was observed teeing off these cracks in a vertical direction. As shown in Figure 75, some spallation areas exhibited a clamshell shape. Figure 76 shows a closer view of the spalled regions. This figure exhibited cleavage fracture features, consistent with that observed in the nitriding layer on the shaft near the slot.

**Figure 74.** BE micrograph of the fillet radius of the gear tooth, showing longitudinal cracking.

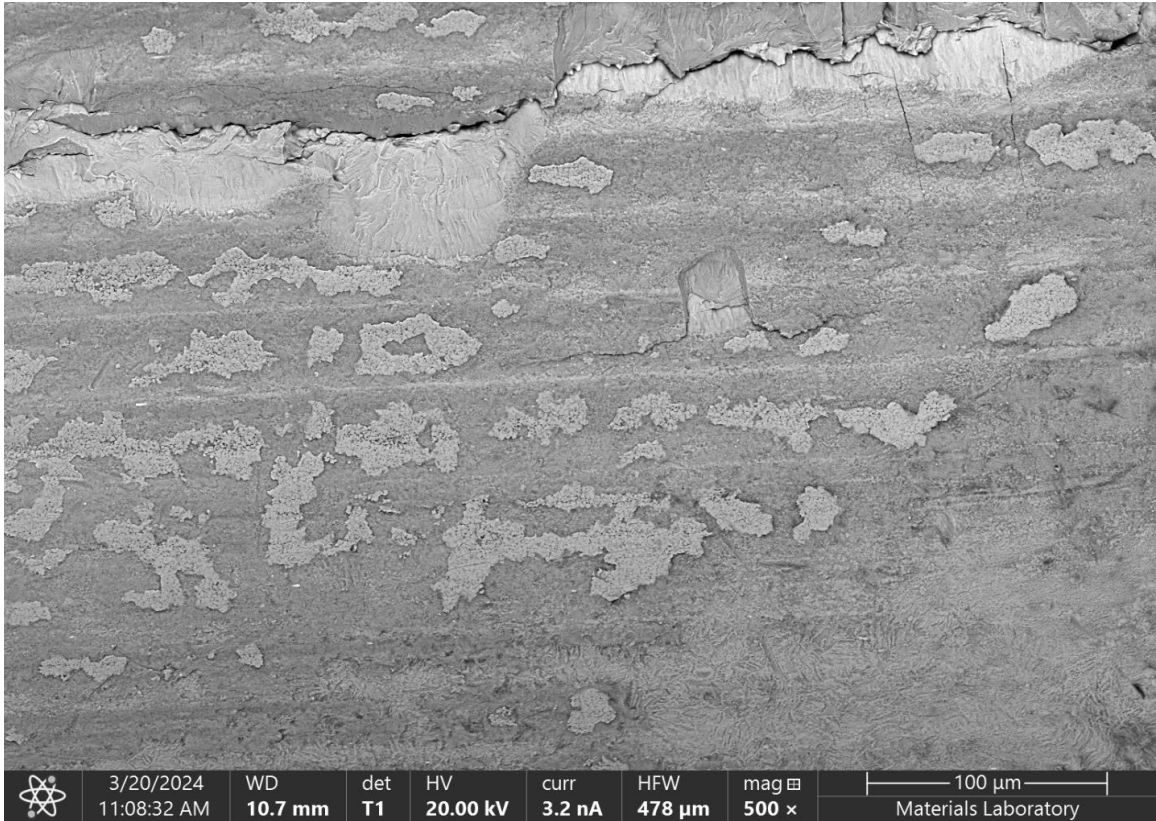
**Figure 75.** BE view of spalled material adjacent to cracking in **Figure 74**.

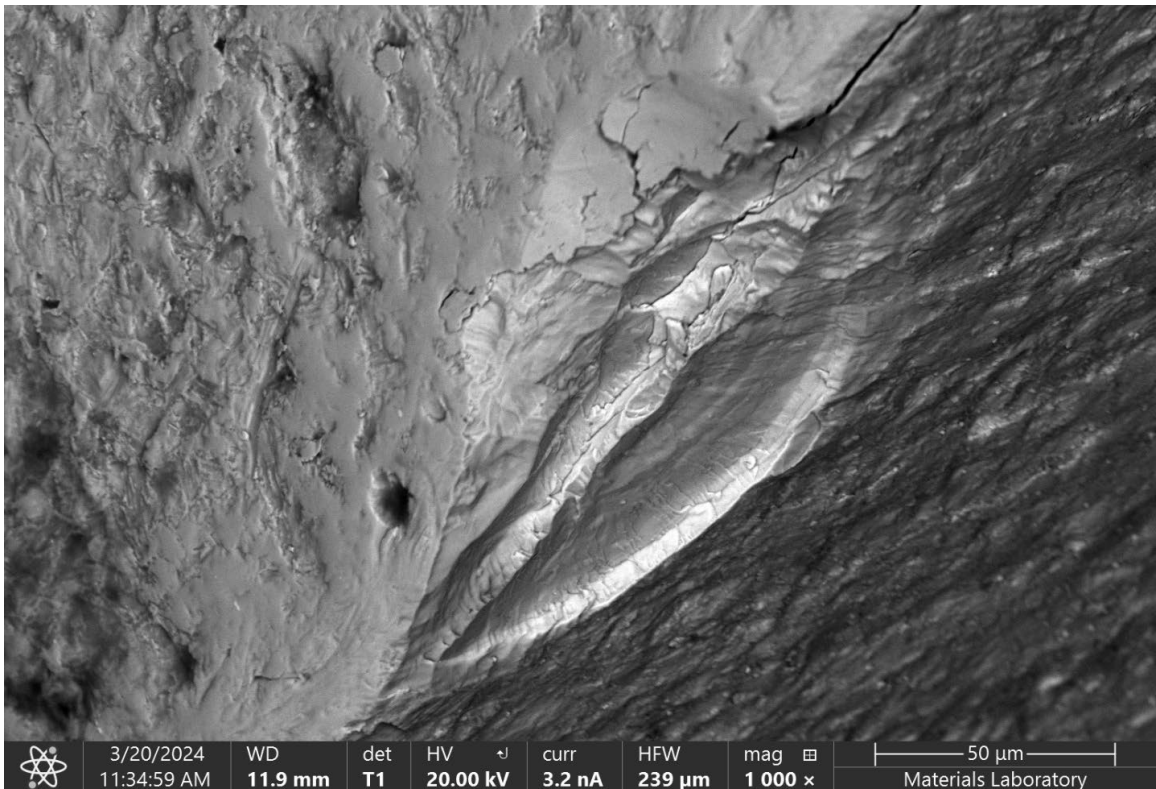
The opposite corner is shown in Figure 78. This corner also displays cracking on the flank and front face of the tooth. Of note is the corner in the figure, where cracking emanates from an area of spalled material. Figure 79 shows a closer view of the

**Figure 78.** BE micrograph of the tooth corner in **Figure 78**, showing a spalled corner section.
