# National Transportation Safety Board

CEN23LA232

## POWERPLANTS

Group Chair's Factual Report

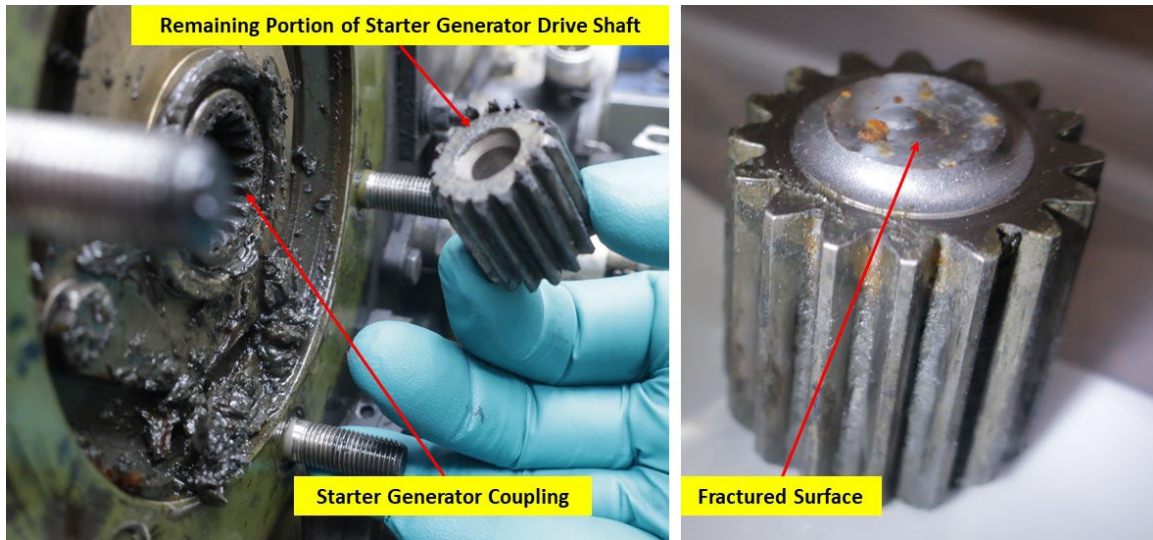
**Photo 6. Remaining Section Starter Generator Drive Shaft**

The starter/generator was not attached to the engine but was found separated during the on-scene wreckage exam. During the engine exam, a portion of the starter/generator drive shaft was found still contained within the accessory gearbox coupling. (**Photo 6**).

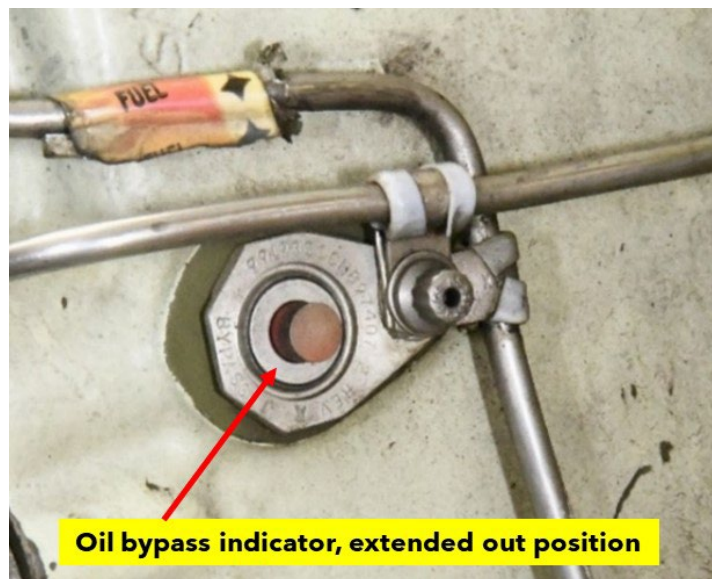
**Photo 7. Oil Bypass Indicator - Extended/Out Position**

The oil bypass valve indicator, located on the side of the accessory gearbox (accessory case), was found in the extended (out) position and according to Honeywell this could have occurred as a result of the aircraft impacting the ground (**Photo 7**).

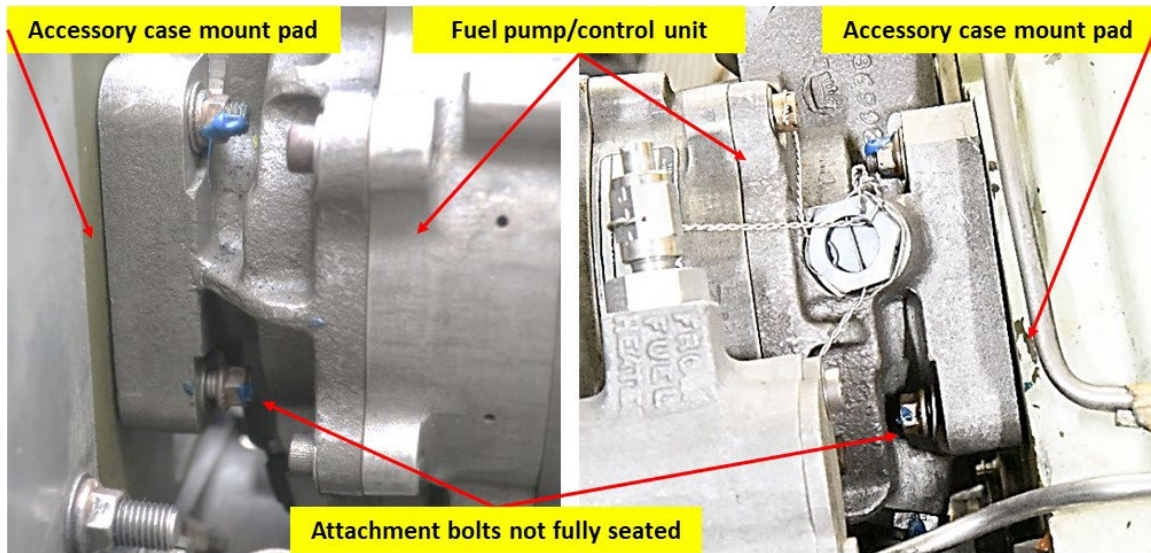
**Photo 8. FCU Lower Left Side (L) and Lower Right Side (R)**

During the as-received inspection, the FCU was found to be loose and displaced slightly aft of the accessory gearbox mount pad. The two bottom stud nuts were not fully seated, nor in contact with the fuel pump flange (**Photo 8**). The blue torque indication stripes, typically put in place at the time of installation, were also broken.

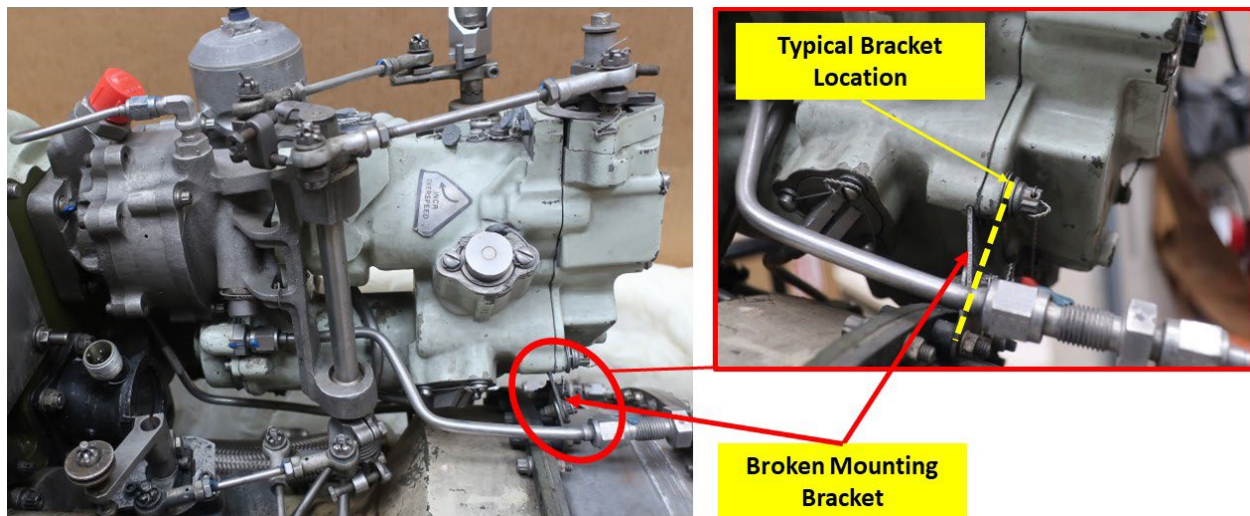
**Photo 9. Broken FCU Attachment Bracket**

The FCU mounting bracket, located at the lower left side and at the aft end of the FCU and attached to the compressor case flange, was found to be broken at the FCU bolt location (**Photo 9**).

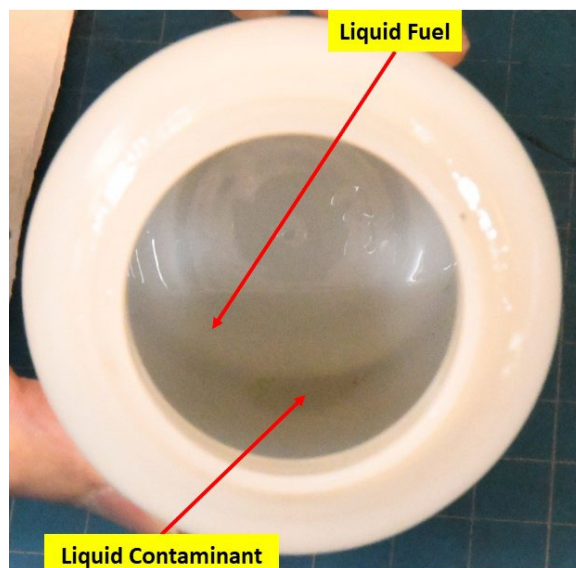
**Photo 11. Fuel Sample with Contamination**

Honeywell's failure lab's evaluation of the stage 1 nozzle found no metal spray was present on the nozzle vanes but did reveal spots where the thermal barrier coating had spalled off. Honeywell's evaluation of the torsion shaft determined the fracture surface features were indicative of torsional overload. Honeywell's evaluation of the fuel sample taken from the fuel filter bowl determined the fuel was typical of Jet A fuel and the liquid contaminant was water.

A fuel sample was taken from the bottom of the FP filter bowl. Visual examination of the fuel samples revealed what appeared to be a separation of two different density liquids; the fuel sample was held for future analysis (**Photo 11**). The fuel filter element was removed from the fuel filter housing; no evidence of damage or contamination was observed.

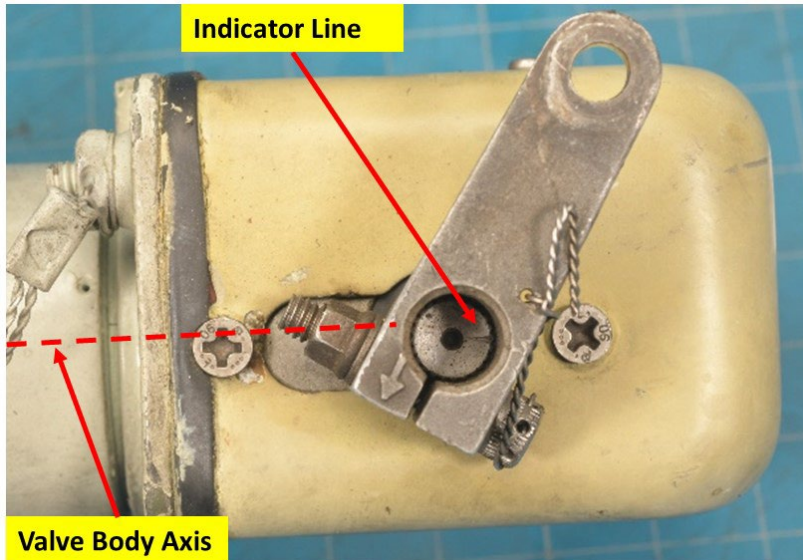
**Photo 12. Fuel Flow Shutoff Valve, Shown Mechanically in the Open Position**

The mechanical indicator of the fuel shutoff valve was observed to be in the open position as seen by the indicator line (**Photo 12**) being in line with the valve body. However low pressure air could not be passed through it confirming that in fact the fuel shutoff valve<sup>4</sup> was actually in the closed position.

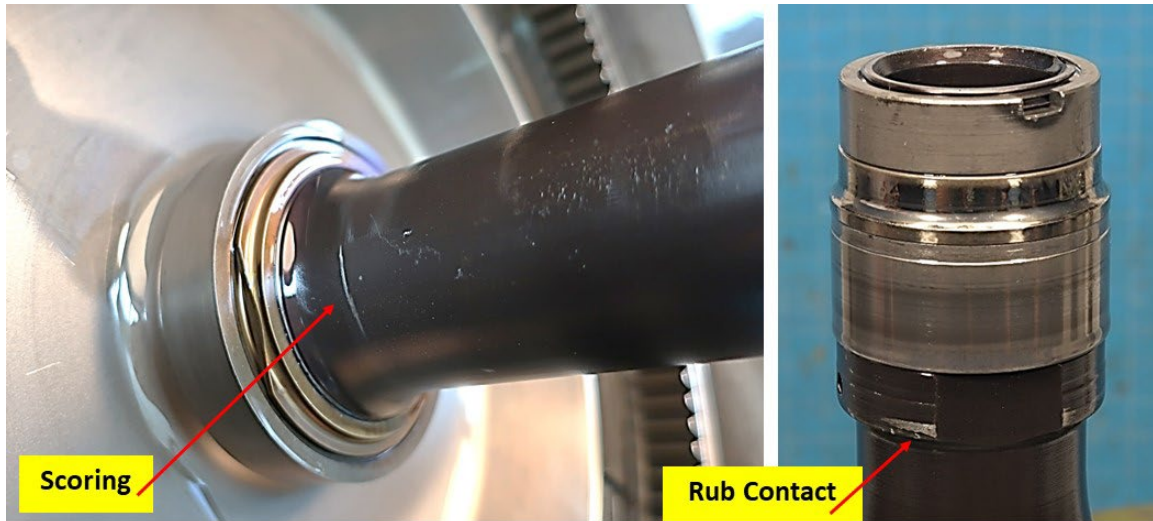
**Photo 18. Propeller Shaft Scoring (L) and Shaft Rub/Contact (R)**

A circumferential score mark was found on the propeller shaft, approximately 1.5 inches in length near the mid shoulder (?) which corresponds to an area of rough (raised material) on the aft ID of the gear bore (**Photo 17**). Additional rubbing contact was observed on the aft end of the propeller shaft (**Photo 18**).

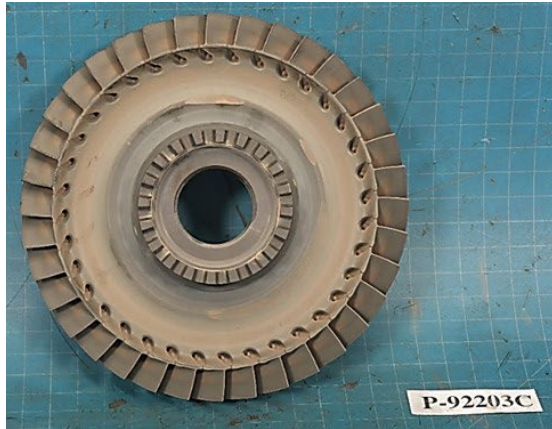
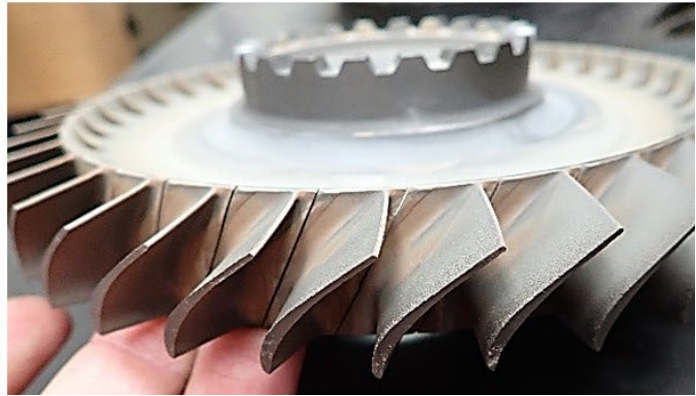
**Photo 22. Stage 1 Turbine Rotor (L) and Stage 1 Turbine Blade Tips (R)**

All stage 1 turbine rotor blades were present, intact, and found to be undamaged with no signs of rub/contact on the blade tips. The stage 1 turbine rotor curvic teeth were in good condition and earthen material found on the turbine 1 rotor. (**Photo 22**)

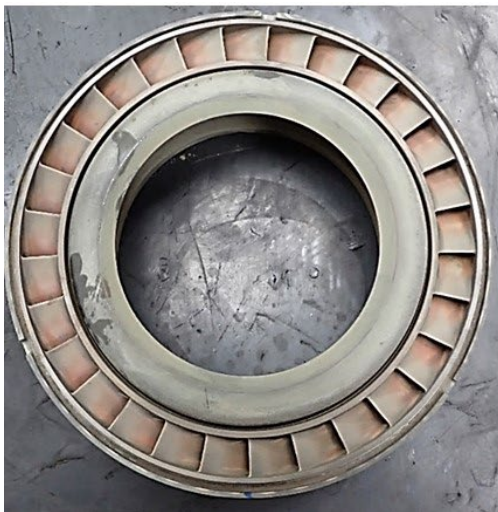
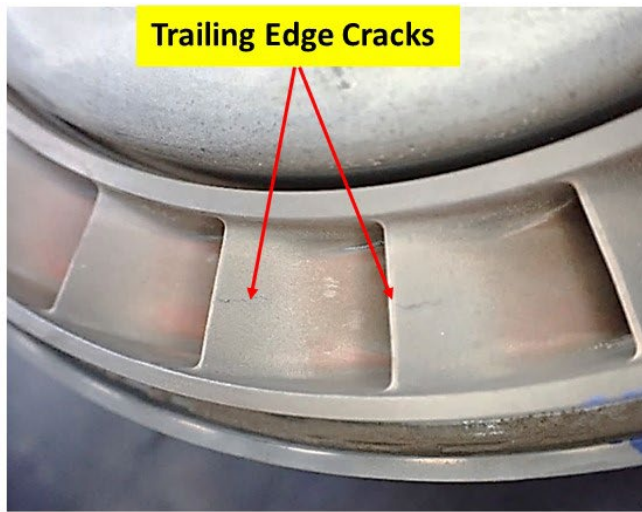
**Photo 23. Stage 1 Nozzle (L) with Trailing Edge Cracks (R)**

All the vanes of the stage 1 nozzle were present and intact but were found with cracks emanating from the trailing edge of the majority of the vanes (**Photo 23**) and earthen material was observed on the stage 1 nozzle.

Honeywell used scanning electron microscopy (SEM) and energy dispersive x-ray (EDX) to evaluate the stage 1 nozzle for and the presence of metal spray and to determine the fracture mode of the torsion shaft. Honeywell's analysis of the stage 1 nozzle found no metal spray present on the nozzle vanes but did reveal spots where the thermal barrier coating had spalled off and exposed based metal material.

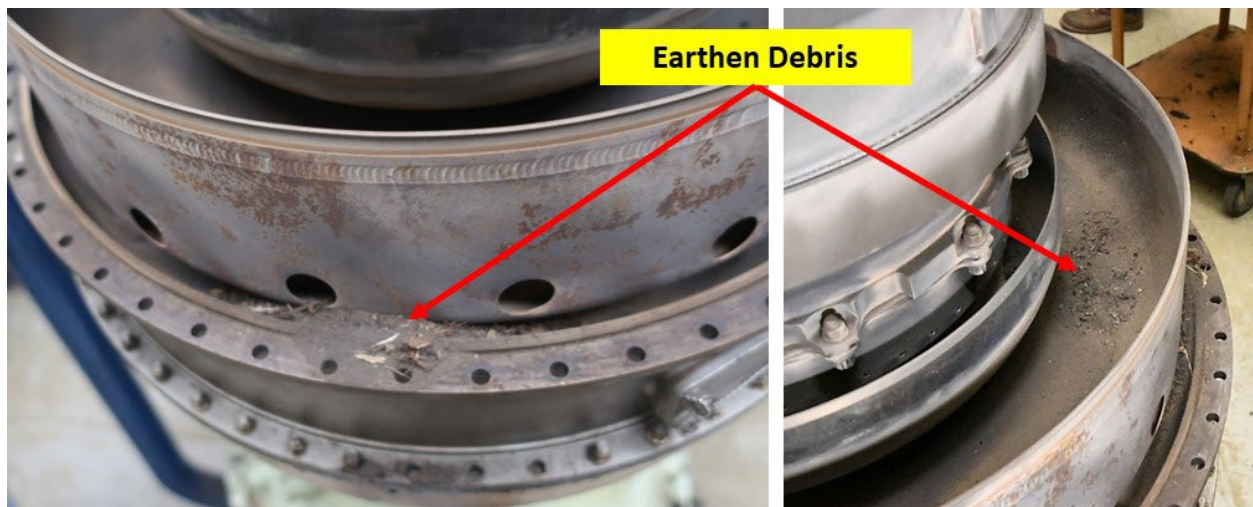
**Photo 24. Earthen Debris Within the Combustion Chamber**

The combustion chamber appeared in good condition and the presence of earthen debris within the combustor was observed. There was no evidence of burn-throughs, hot spots, or fuel nozzle streaking patterns on any of the combustor panel (**Photo 24**).

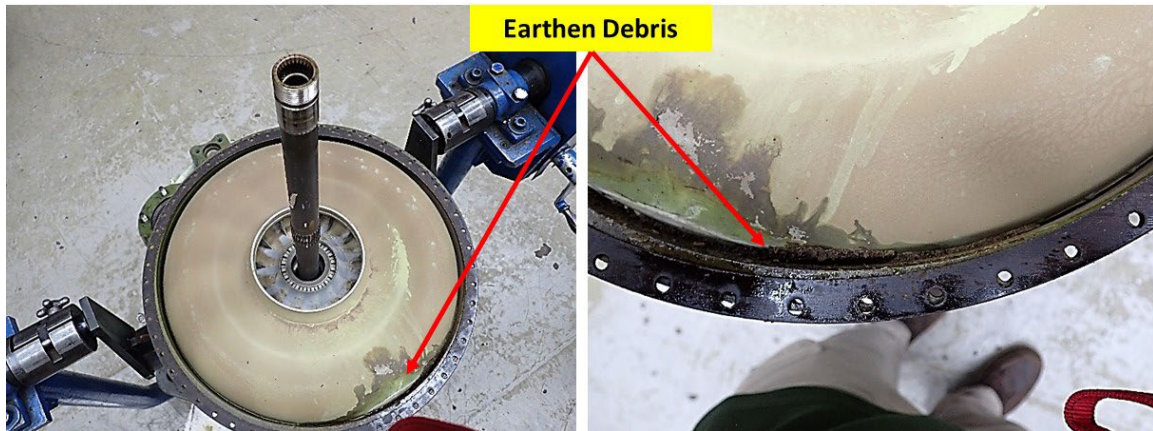
**Photo 26. 1<sup>st</sup> Stage Compressor Crossover Duct (L), Earthen Debris (R)**

Earthen debris was found on the aft side of the stage 1 crossover duct (**Photo 26**) at the 6:00 o'clock position.

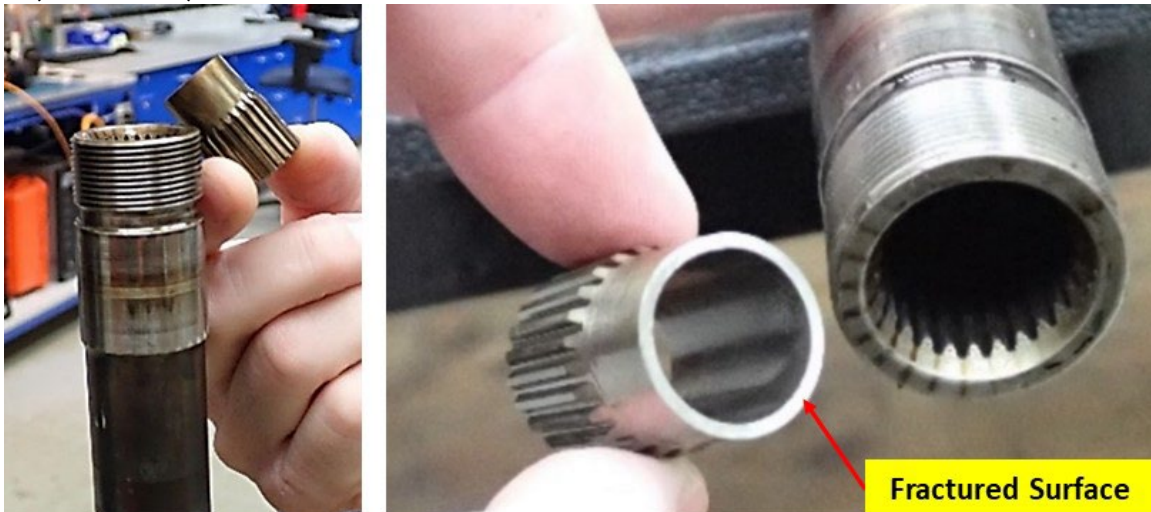
**Photo 27. Torsion Shaft (L), Fractured End Piece (R)**

The aft end of the torsion shaft was found fractured and still splined into the main shaft with the fracture surface approximately 1.25 inches from the aft end of the torsion shaft (**Photo 27**).

The torsion shaft had separated 1.224 inches from the aft end. Honeywell performed SEM examination of the fracture surface on the torsion shaft that revealed fracture features indicative of torsional overload as indicated by elongated dimples in the counterclockwise direction. Analysis of the torsion shaft base material by EDX found the material conformed to the material specification.

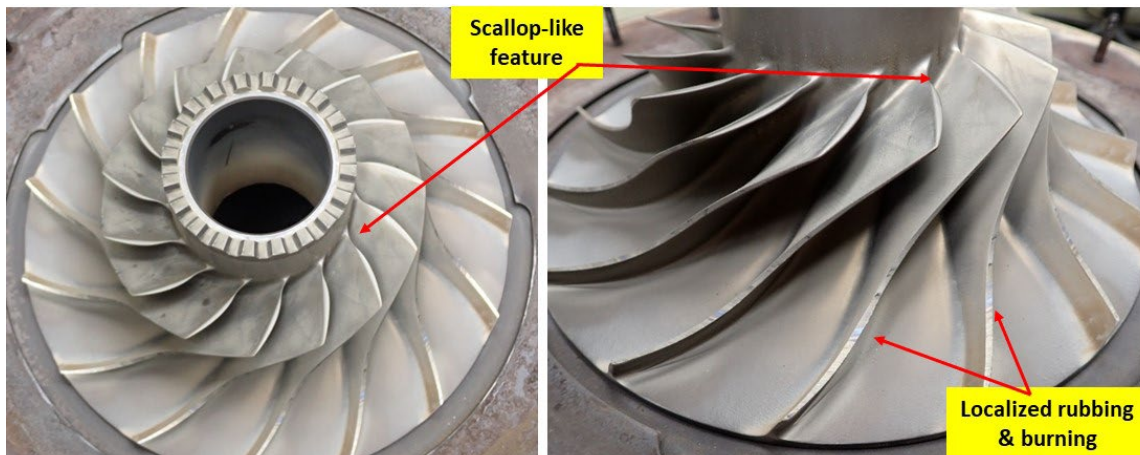
**Photo 29. Stage 2 Impeller, Localized Circumferential Rubbing Contact**

The stage 2 impeller showed evidence of circumferential rub on all of the impeller blades (**Photo 29**) that corresponds with the circumferential rubbing located on the impeller shroud (**Photo 30**). Honeywell indicated the leading edge of the impeller (inducer) appeared to be misshapen and all leading edge blade fillets contained a scallop-like feature.

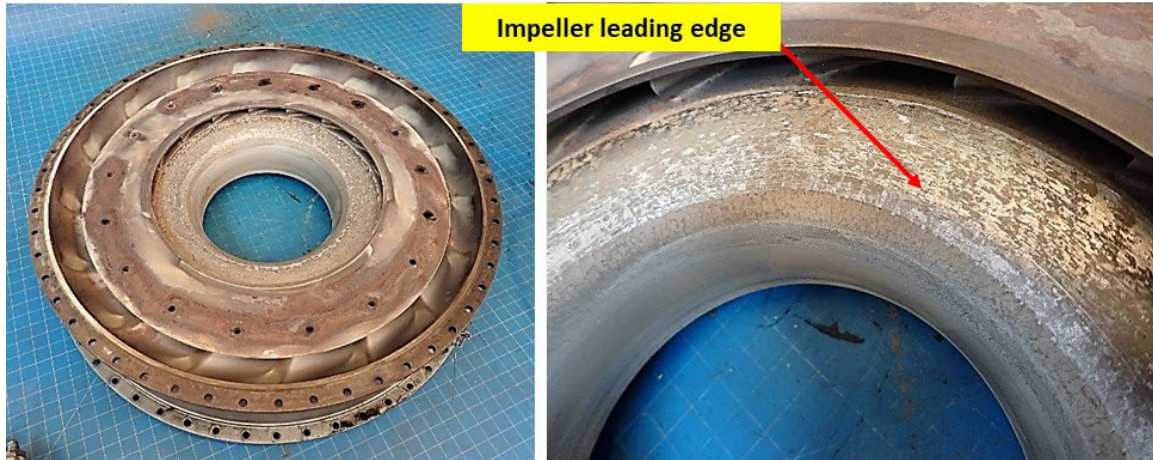
**Photo 30. Stage 2 Impeller Shroud with Circumferential Contact/Rub**

The stage 2 impeller shroud and crossover duct showed evidence of circumferential rub (**Photo 30**) corresponding to the rub observed on the stage 2 impeller.

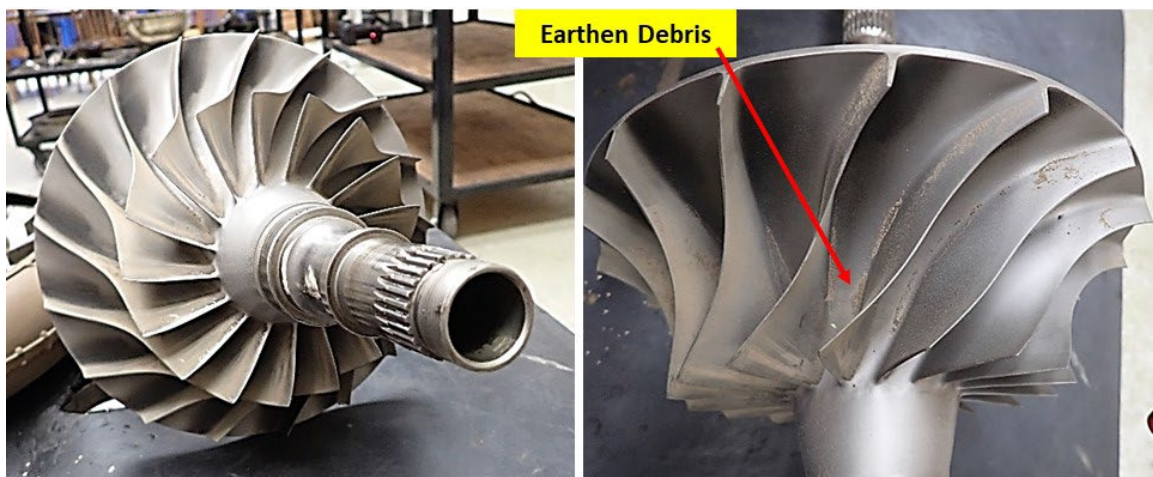
**Photo 31. Stage 1 Impeller & Main Shaft (L) with Earthen Debris (R)**

The stage 1 impeller showed no evidence of damage or rubbing contact but earthen debris was present (**Photo 31**).

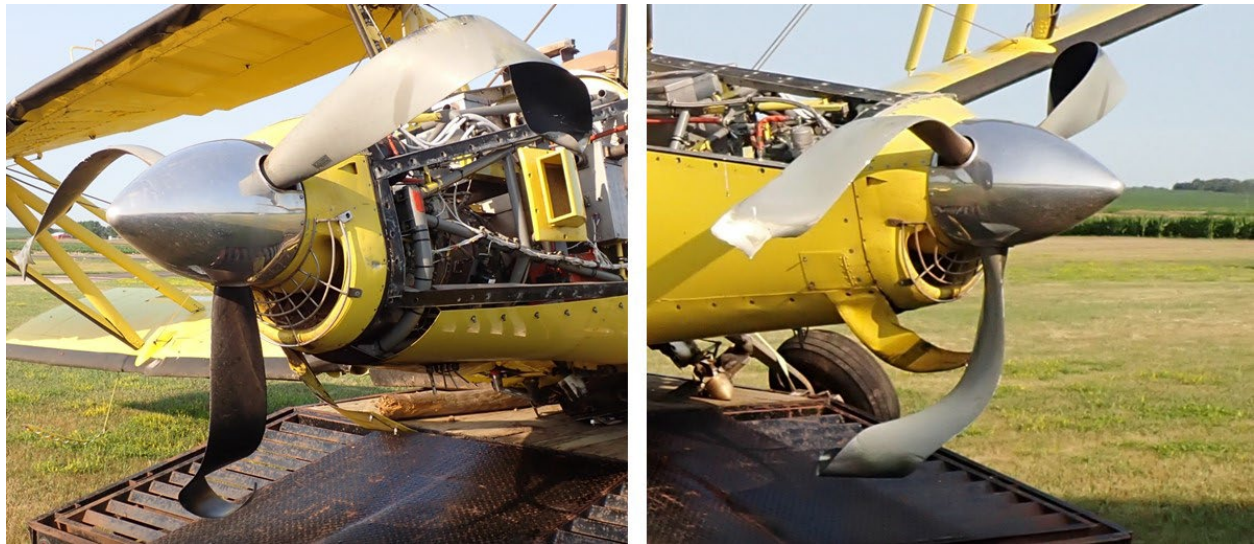
**Photo 34. Three Bladed Hartzell Propeller (Courtesy of Honeywell)**

based on the condition and damage seen in the photographs. Hartzell's assessment stated: all three propeller blades exhibited chordwise/rotational scoring on what appears to be predominantly on the camber (front) side of each blade, all three propeller blades exhibited compound bending/twisting and what appears to be bending in the direction opposite of rotation, one propeller blade exhibited a tip fracture and one propeller blade exhibited some bending in the forward/thrust direction (**Photo 34**).

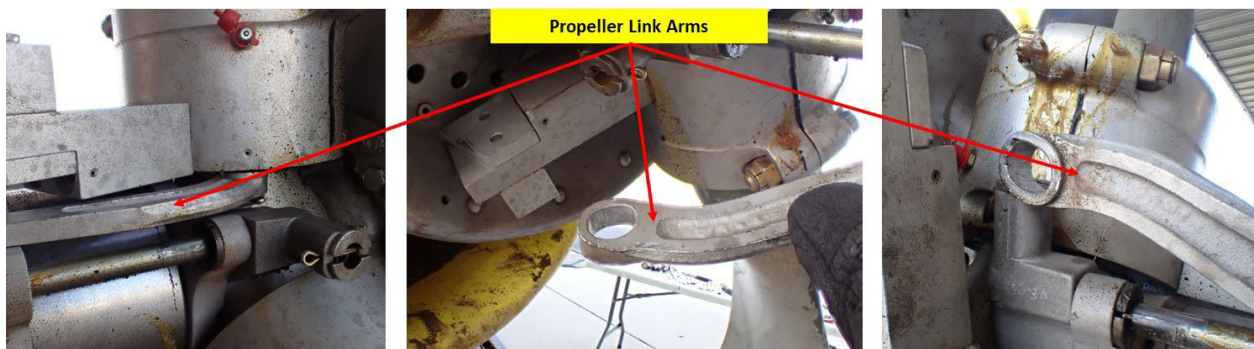
**Photo 35. Propeller Blade Clamps (Courtesy of Honeywell)**

Hartzell's assessment also stated: the two propeller blades/clamps that pulled from their link arms appear to have forcefully rotated towards high pitch, this might explain the forward bending on the one blade (**Photo 35**). This is a common signature of producing thrust at initial impact.

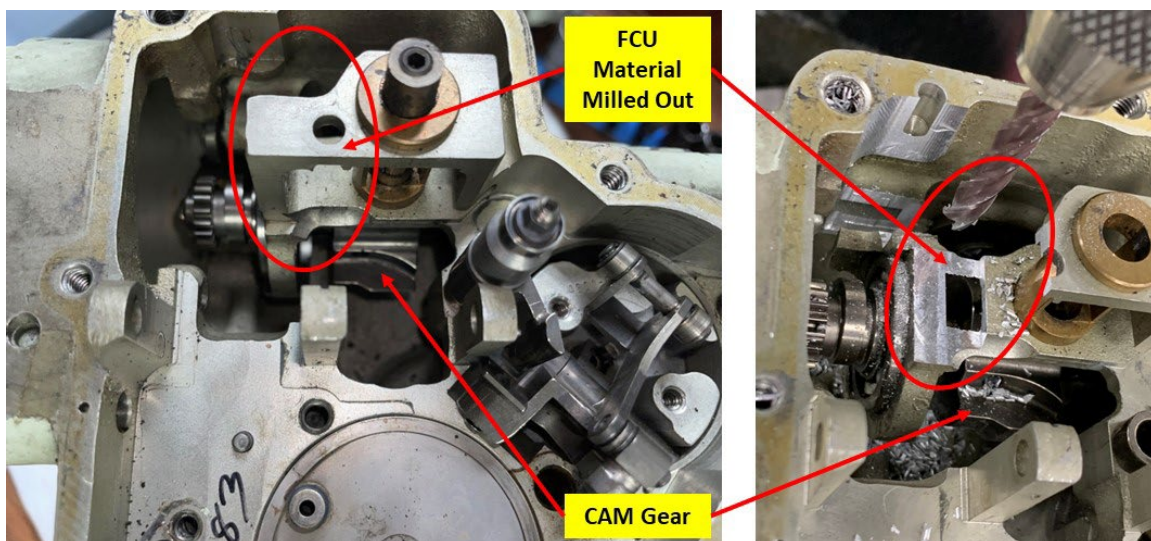
**Photo 37. Cam Gear and Cam Shaft Removal**

Bench testing of the FCU was performed according to acceptance test specification TSP-1629. Several test points were out-of-range based on the test standard as noted on the test report (Attachment 1). Test results appeared consistent with the cam gear travel being limited, but not seized, on the cam shaft during testing. A position indicator installed during testing verified that the cam shaft was able to translate, but with limited travel. The position indicator revealed movement of the cam shaft stop with a Pt2 of about 11 pounds per square inch absolute (psia).

Removal of the cam shaft and gear from the FCU housing could not be accomplished during normal disassembly because they were seized together, also preventing any further disassembly. Portions of the FCU housing were machined/milled out to facilitate removal of the cam gear and cam shaft from the FCU as one piece (**Photo 37**). According to Woodward Inc., all other internal FCU components appeared undamaged and typical of a used FCU. The 3D cam shaft assembly was shipped to the NTSB metallurgy lab for further examination.

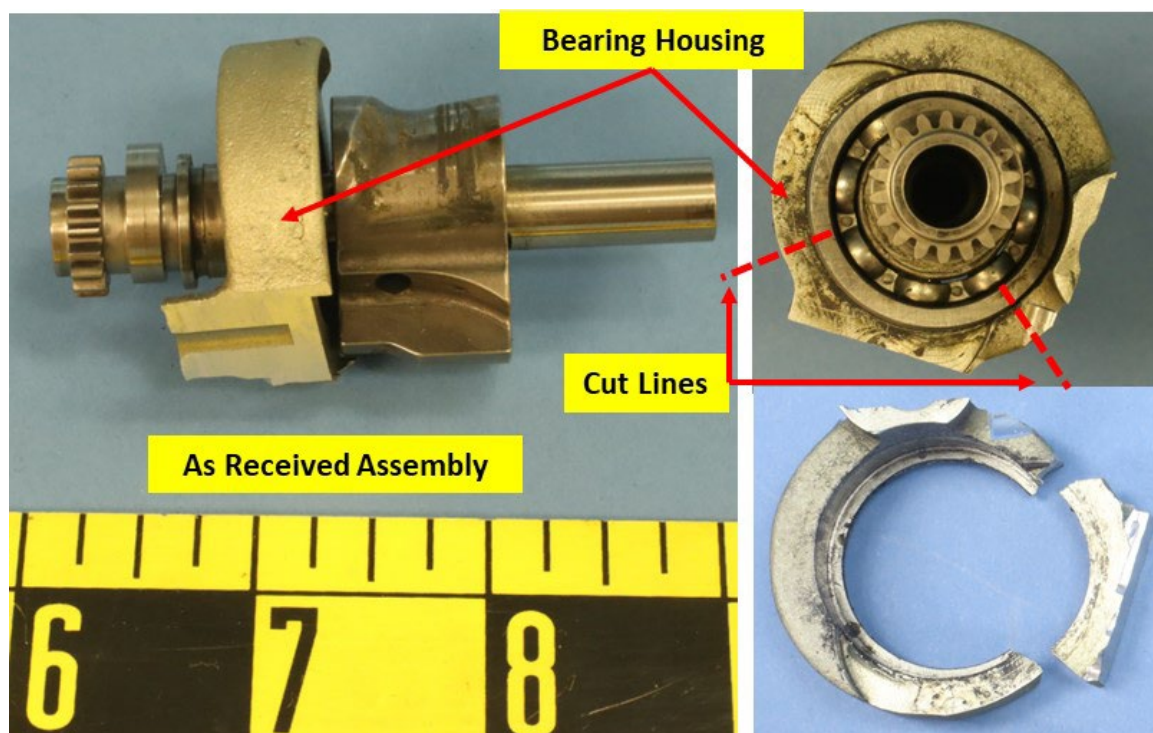
**Photo 39. 3D Cam Shaft Assembly As-Received (L), Bearing Housing Removed (R)**

As received photography and visual examination (**Photo 39**) was performed and, as noted in the FCU testing section, the 3D cam was seized in place on the cam shaft. To facilitate examination, the remaining FCU housing that houses the cam shaft bearing was cut away, exposing the bearing out race, and the assembly was ultrasonically cleaned in an acetone bath.

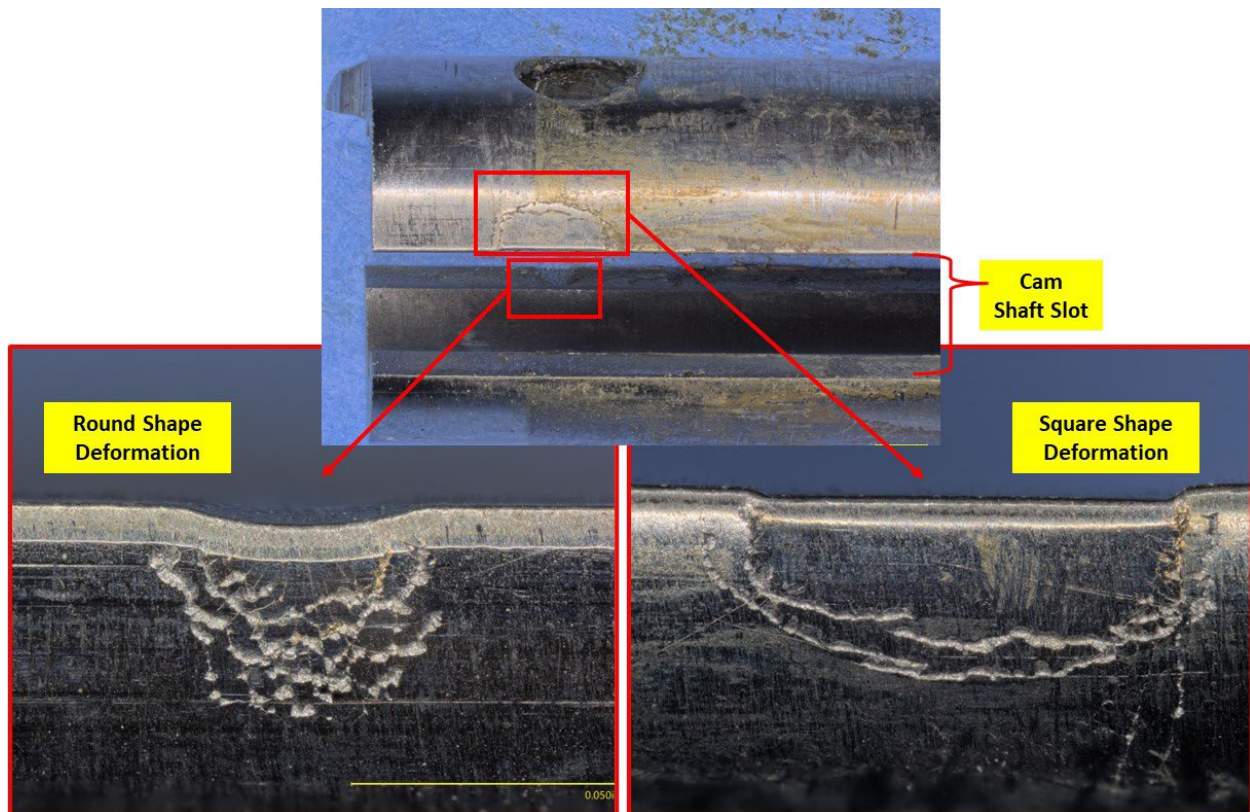
**Photo 41. Cam Shaft Damage**

Examination of the cam shaft found two depressions on opposite corners of the cam shaft slot, one depression was round in shape while the other was rectangular in shape (**Photo 41**). The shaft outer diameter, away from the areas of deformation damage measured 0.3735 inches, whereas the outer diameter measured in a plane incorporating both the areas of shaft deformation was as wide as 0.3780 inches. Reexamination of the 3D cam shaft pin by Woodward personnel revealed corresponding damage to the square portion of the pin shank.

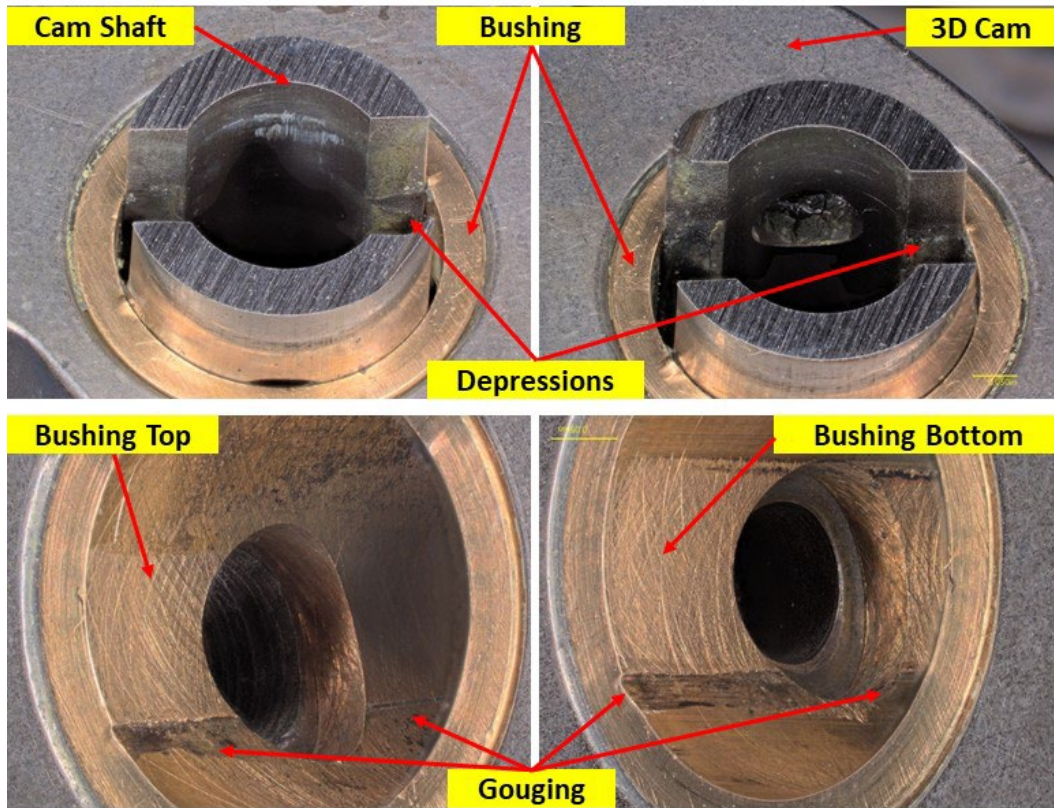
**Photo 42. 3D Cam Bushing Damage**

The 3D cam bushing, made of a copper alloy, located at the inner diameter of the 3D cam, appeared to have areas of wear and distinct gouges located axially within the cam bushing on either side of the assembly pin hole (**Photo 42**) and correspond to the cam shaft slot edges. The 3D cam was sectioned in half to expose the surface of the bushing (**Photo 43**).

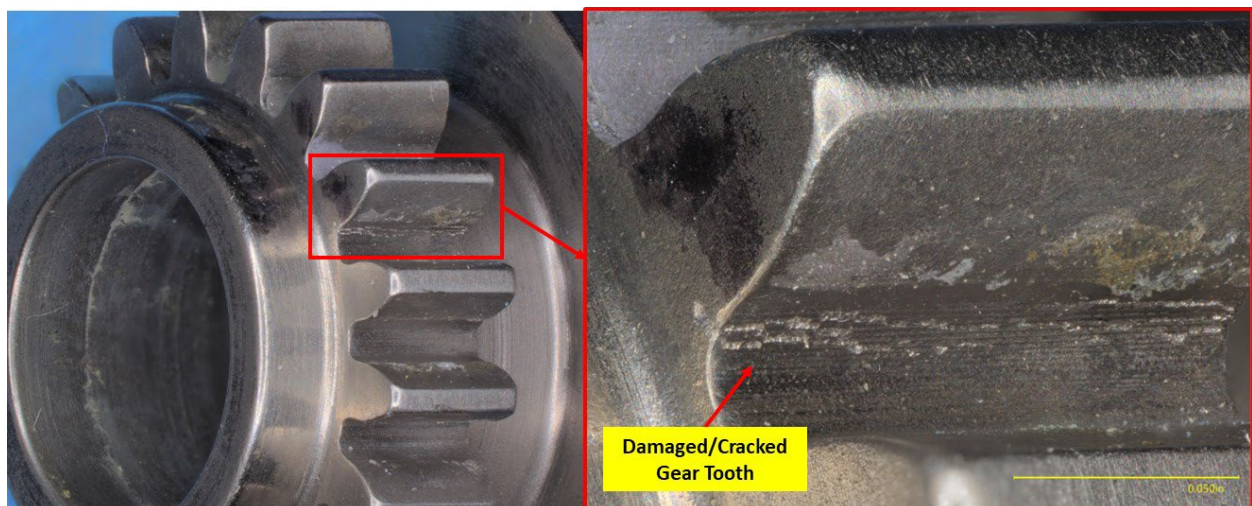
**Photo 44. Cam Shaft Gear - Damaged Tooth**

Examination also found that one gear tooth on the cam shaft exhibited signs of spalling damage and cracking across the entire length of the tooth (**Photo 44**). Woodward personnel reexamined the rack gear, which drives the cam shaft gear, and found damage between two gear teeth that corresponds to the damage found on the cam shaft gear tooth.
