# National Transportation Safety Board

CEN23LA232

## **POWERPLANTS**

Honeywell Lab Analysis Report

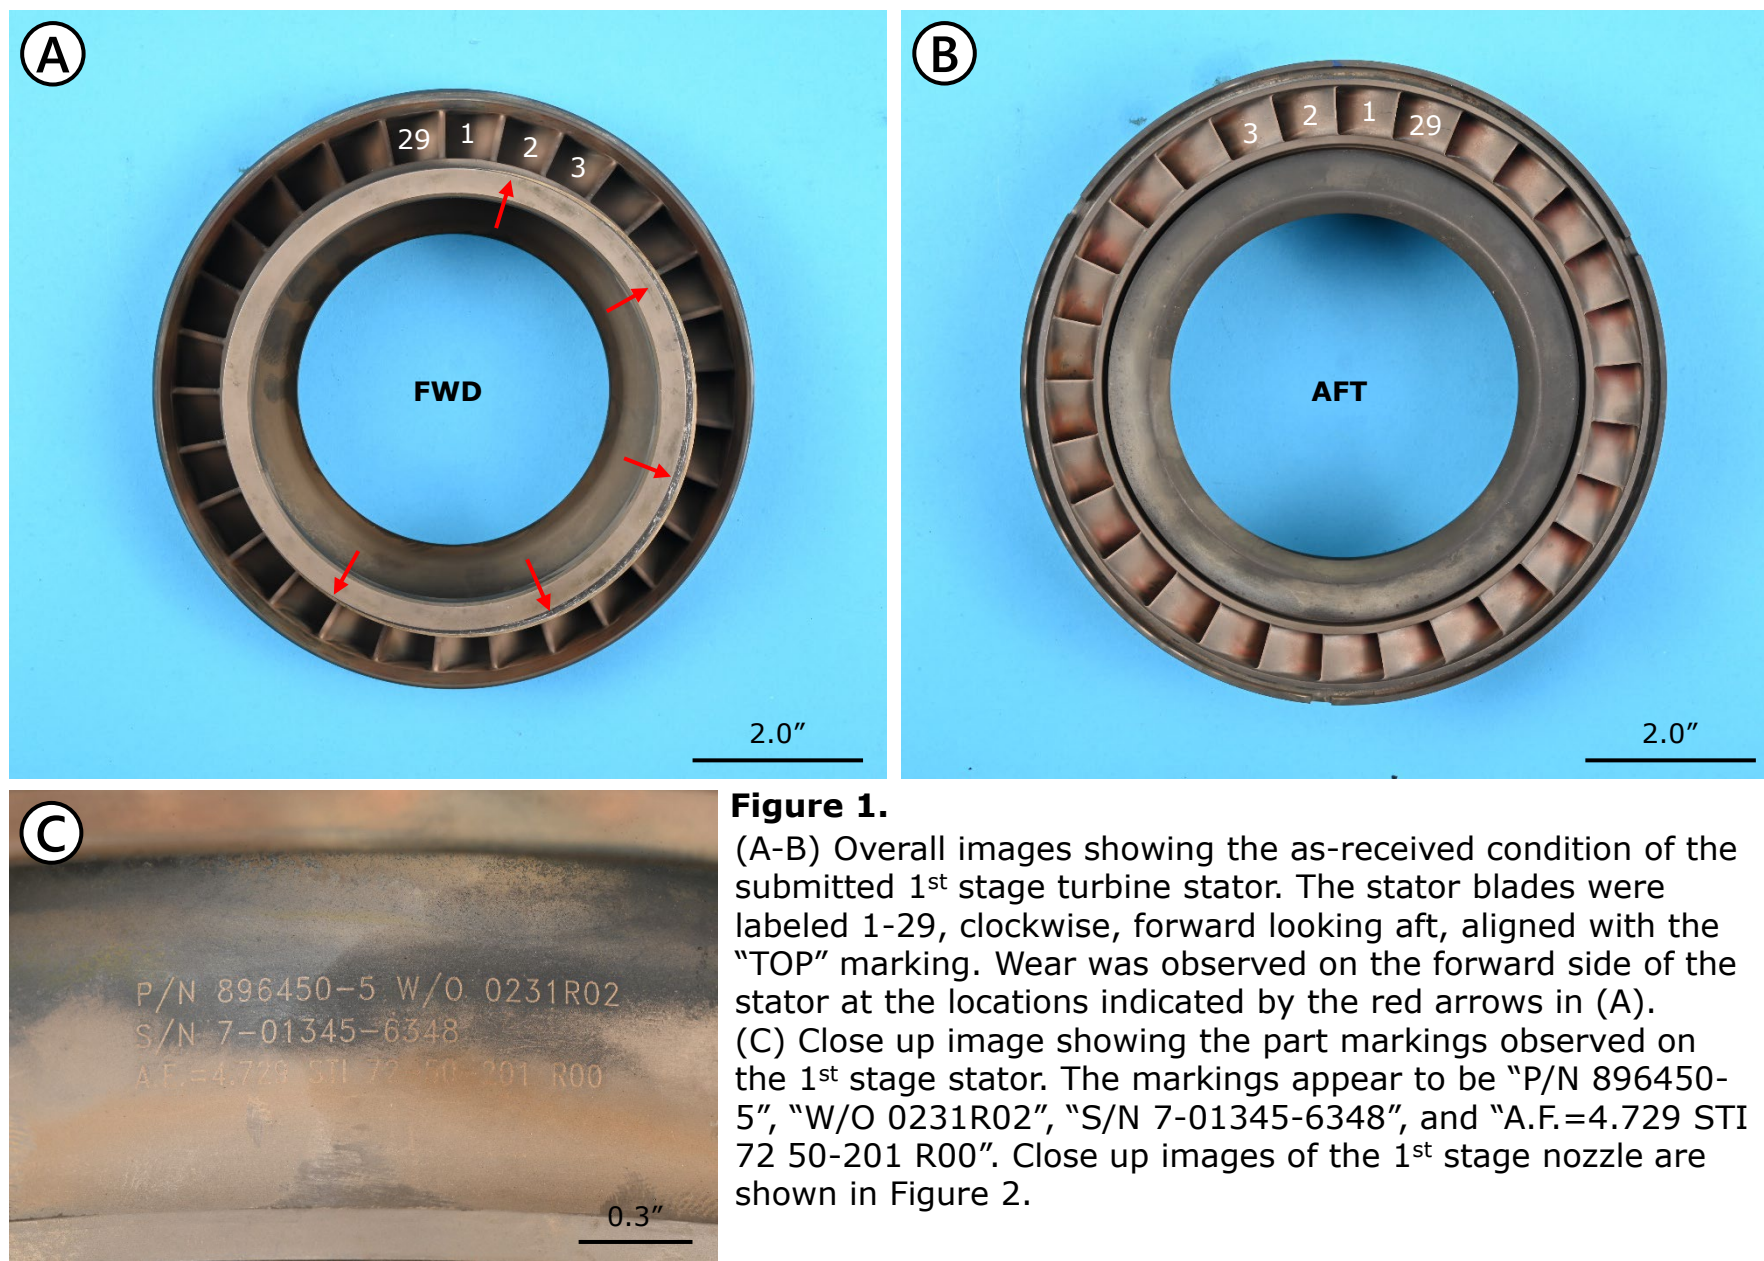
Overall images showing the 1<sup>st</sup> stage stator in the as-received condition are shown in Figures 1-2. The stator blades were labeled 1-29, clockwise, forward looking aft, aligned with the "TOP" marking.

The part markings observed on the 1<sup>st</sup> stage stator appeared to be "P/N 896450-5", "W/O 0231R02", "S/N 7-01345-6348", and "A.F.=4.729 STI 72 50-201 R00" (Figure 1C).

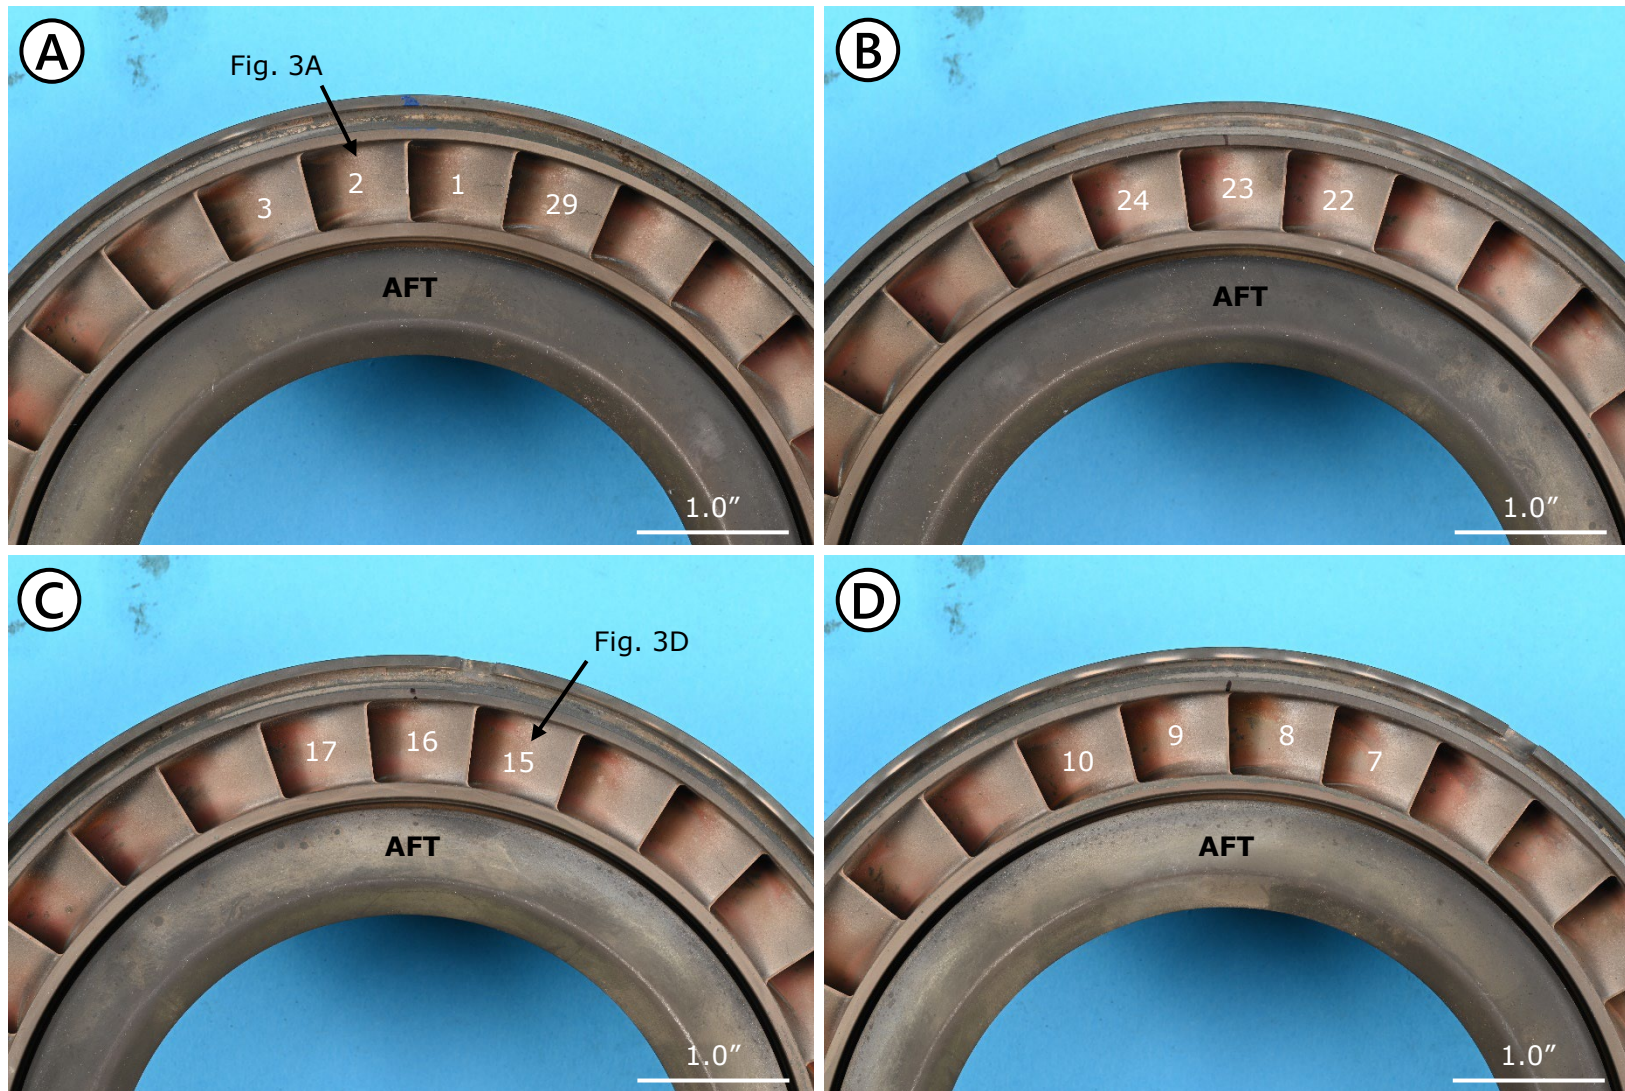
**Figure 2.**

(A-D) Close up images showing the aft side of the 1<sup>st</sup> stage nozzle (reference Figure 1B). Scanning electron microscope (SEM) images of the representative blades identified in (A) and (C) are shown in Figure 3, as indicated.

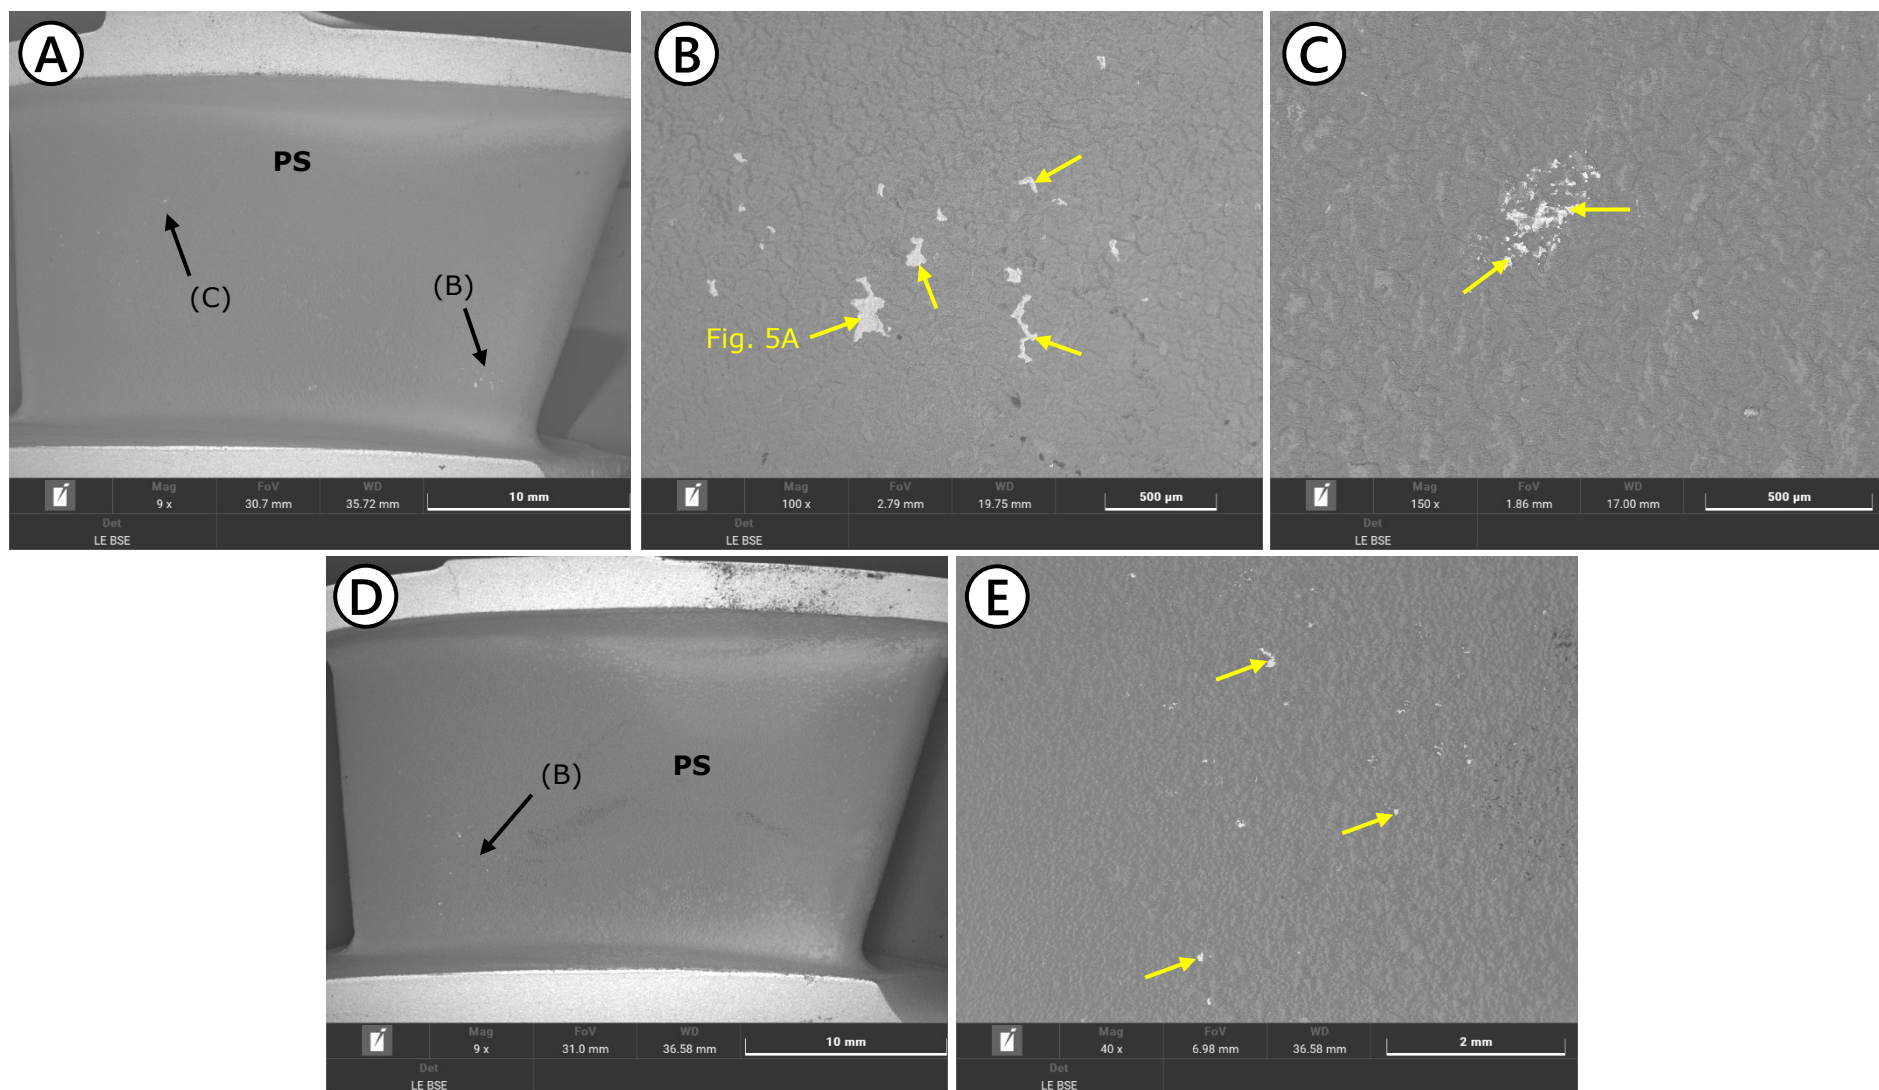
**Figure 3.**

Backscattered electron (BSE) scanning electron microscope (SEM) examination of representative Blades 2 and 15 are shown in Figure 3. Energy dispersive X-ray (EDX) spectrum generated from analysis of the various areas on the pressure side of the blades were suggestive of the specified IN713 base material (Figure 4A), suggesting that the coating had spalled off revealing the blade base material. No evidence of metal spray was observed on the 1<sup>st</sup> stage stator blades.

(A-F) Backscattered electron (BSE) SEM images of representative 1<sup>st</sup> stage stator blades at the locations indicated in Figures 2A and 2C. The yellow arrows in (B-C) and (E) identify areas where the coating was missing from the 1<sup>st</sup> stage nozzle. Energy dispersive X-ray (EDX) spectra generated from analysis of the areas is shown in Figure 5A. Note that no evidence of metal spray was observed on the representative 1<sup>st</sup> stage stator blades.

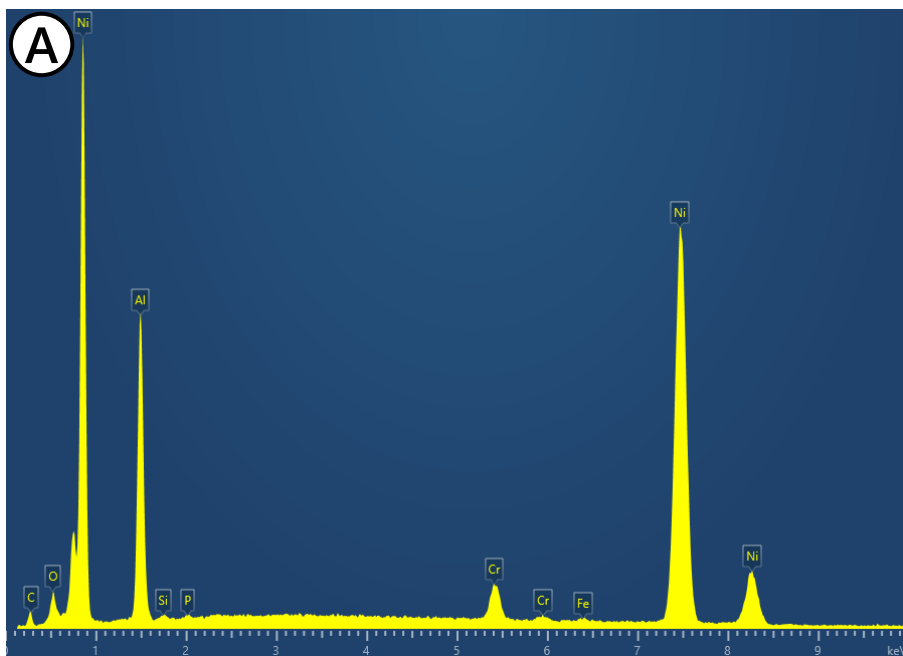
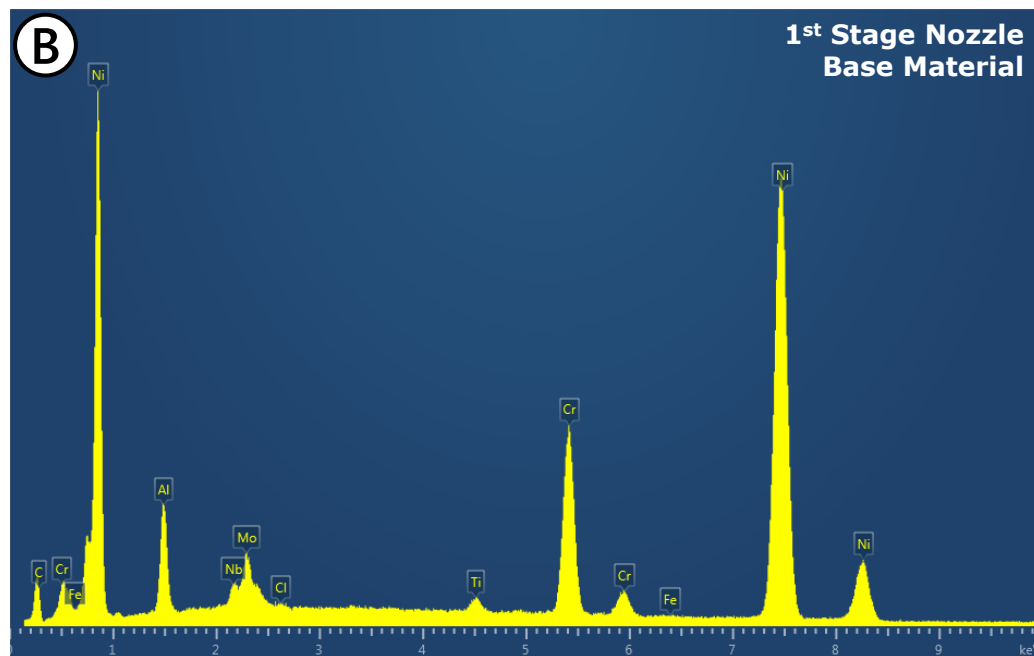
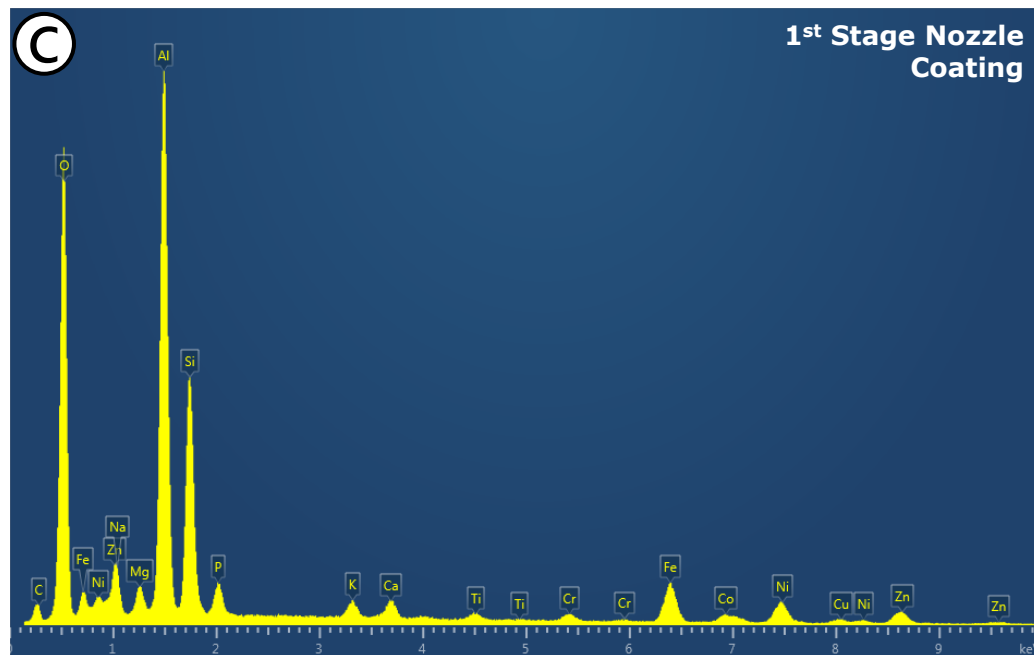
**Figure 4.**

Representative EDX spectra generated from analysis of the 1<sup>st</sup> stage stator blade base material and coating were suggestive of the specified IN713 base material and simple aluminide coating, respectively (Figure 4).

(A) Representative EDX spectrum generated from analysis of the areas identified by the yellow arrows in Figure 3. The spectrum was indicative of a nickel alloy similar to the specified IN713 base material.

(B) Representative EDX spectrum generated from analysis of the 1<sup>st</sup> stage blade base material was suggestive of the specified IN713 nickel alloy.

(C) Representative EDX spectrum generated from analysis of the 1<sup>st</sup> stage stator coating. The spectrum was rich in aluminum, oxygen, and silicon, with lower concentrations in other elements, suggestive of the specified simple aluminide coating.

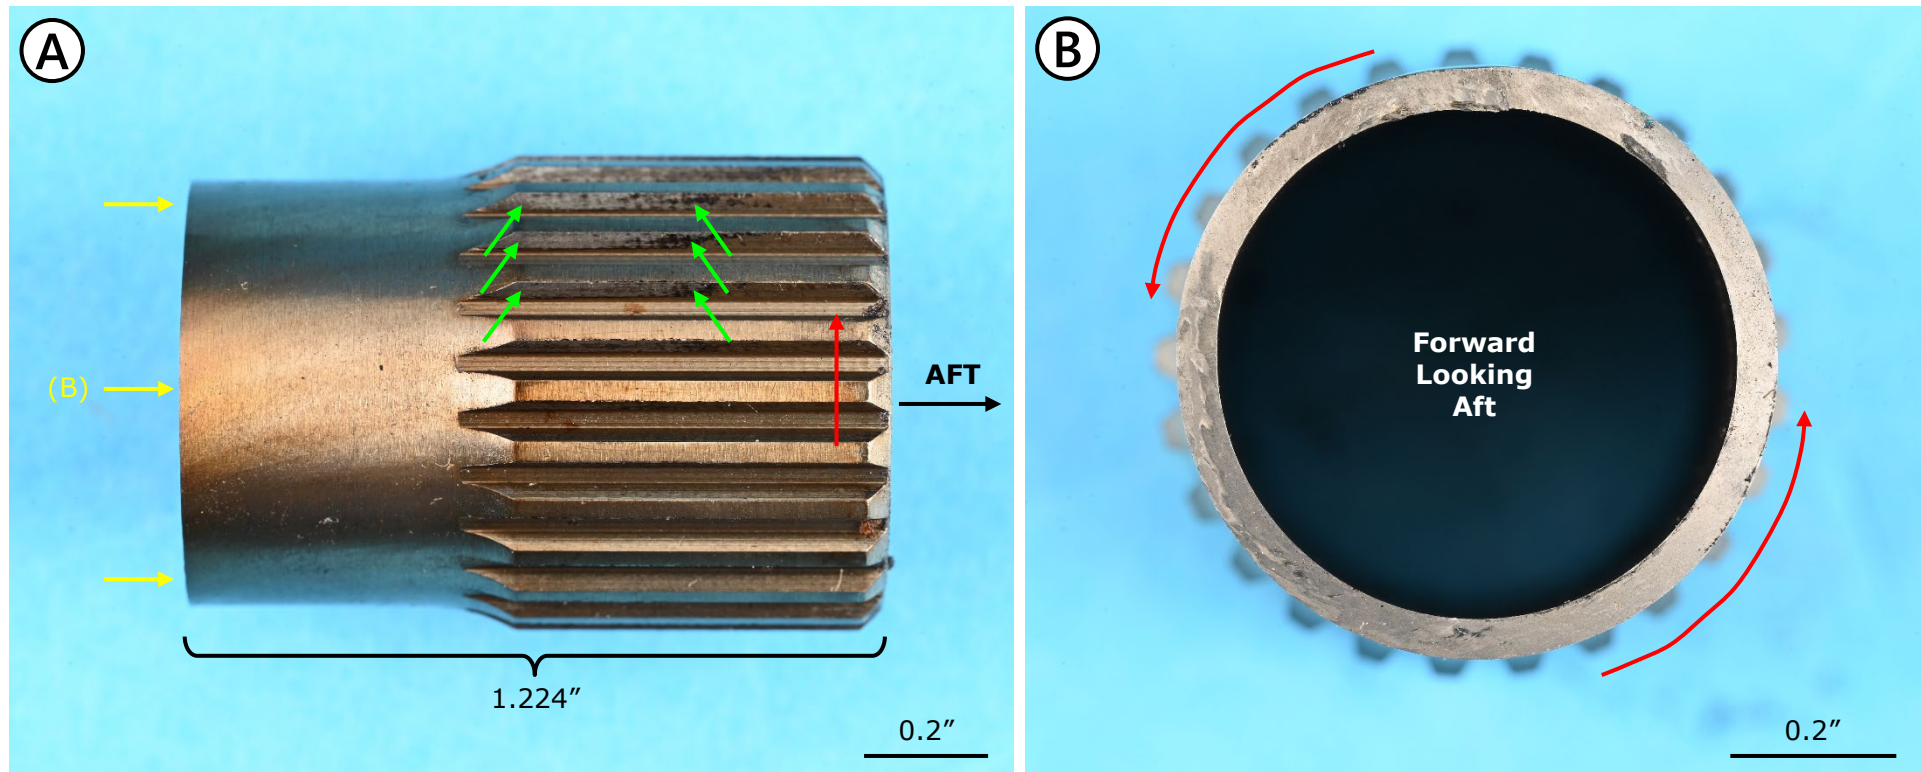
**Figure 5.**

The as-received condition of the submitted torsion shaft is shown in Figure 5. The shaft had separated 1.224" from the aft end. Wear was observed on the loaded side of the external spline teeth.

(A) Close up image showing the aft end of the fractured torsion shaft. The torsion shaft had separated 1.224" from the aft end (yellow arrows in (A)) . Wear was observed on the loaded side of the external spline teeth (green arrows in (A))). (C) Image showing the fracture surface on the aft side of the shaft separation. The red arrows indicate the specified direction of the shaft rotation within the engine (counterclockwise, FLA). Scanning electron microscope (SEM) images of the separated shaft fracture surface are shown in Figure 6.

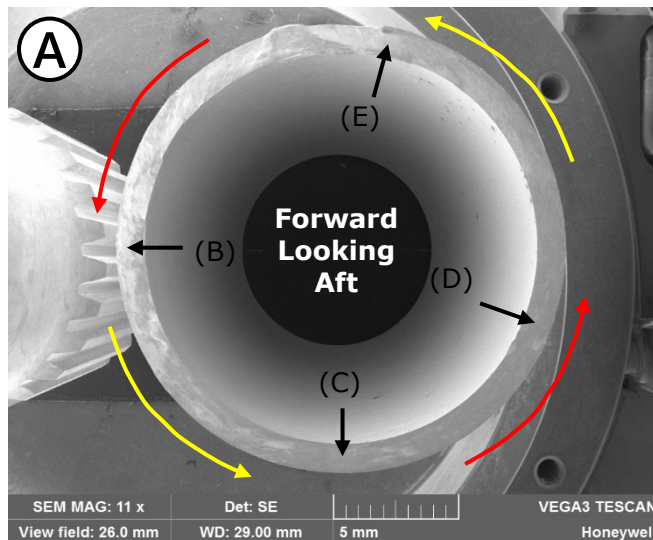
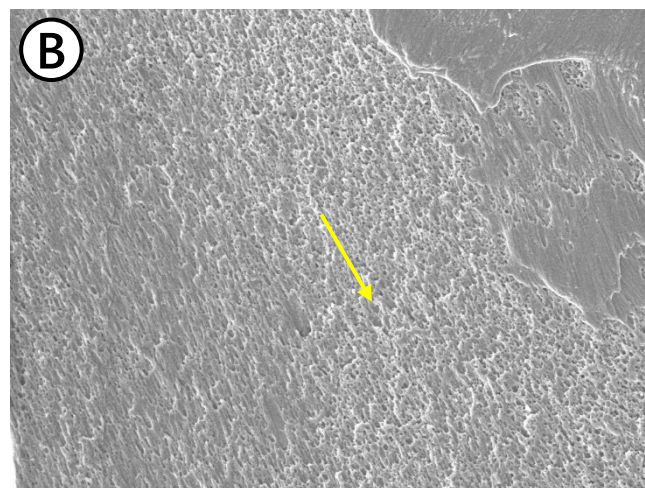
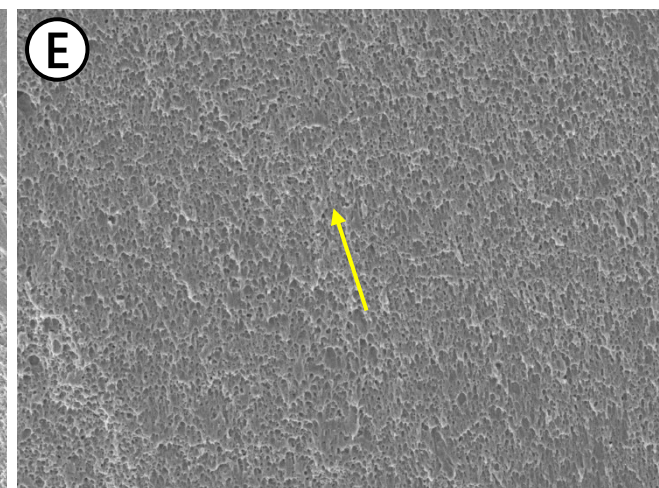
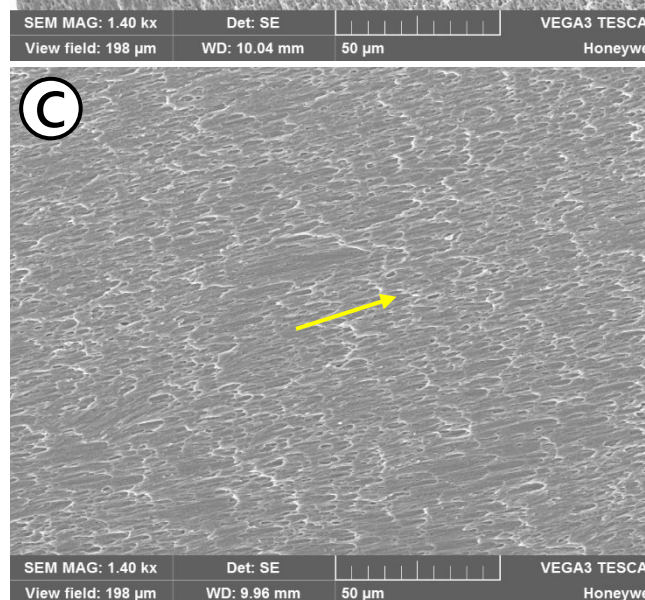
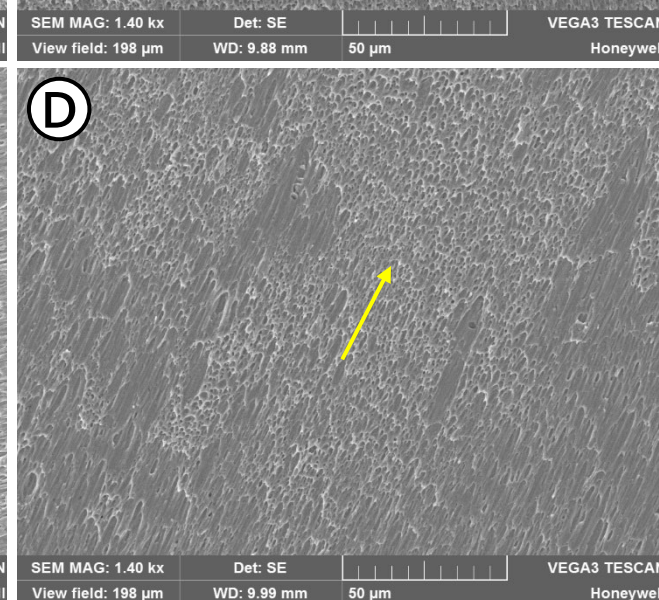
SEM examination of the separated torsion shaft revealed fracture features indicative of torsional overload as indicated by the elongated dimples in the counterclockwise direction, forward looking aft (Figure 6).

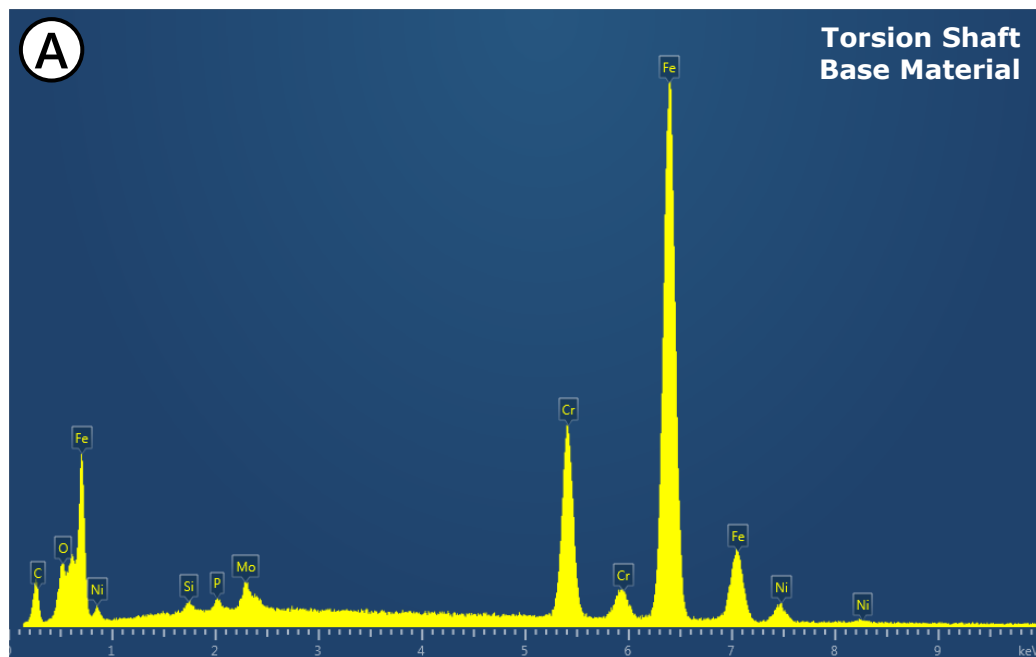
**Figure 7.**

Representative EDX spectrum generated from analysis of the torsion shaft was indicative of the specified AM355 base material (Figure 7).

(A) Representative EDX spectrum generated from analysis of the torsion shaft base material. (B) Laboratory standard reference EDX spectrum for AM355. The spectrum in (A) was indicative of the specified AM355 base material.

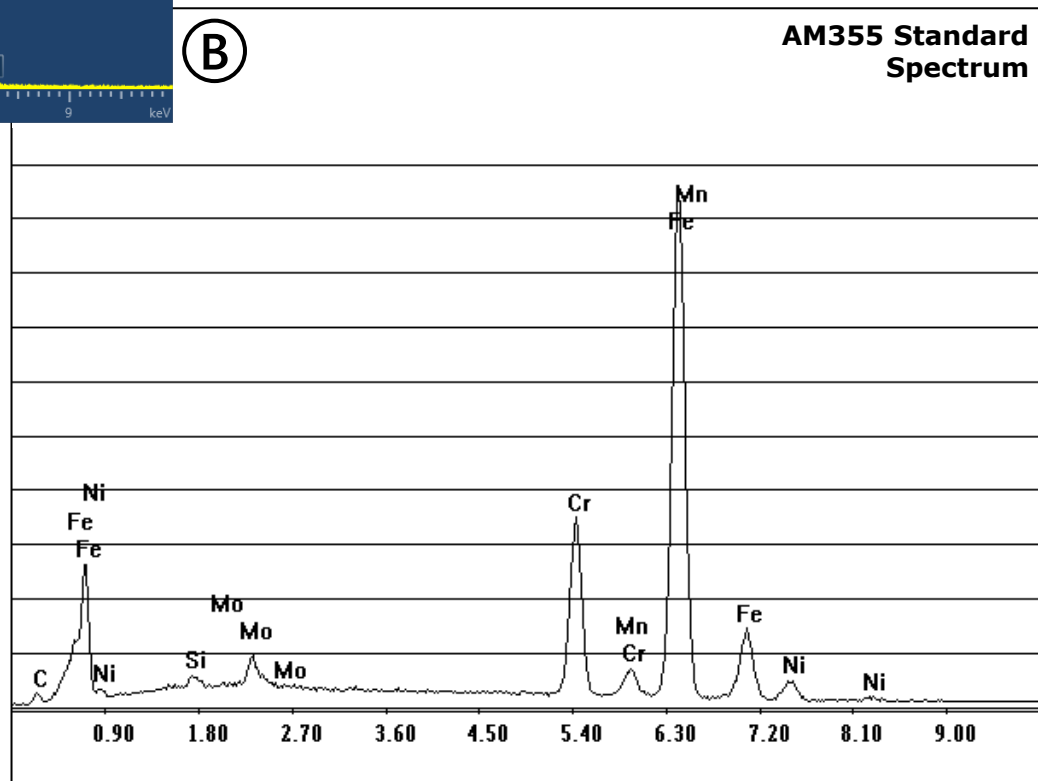
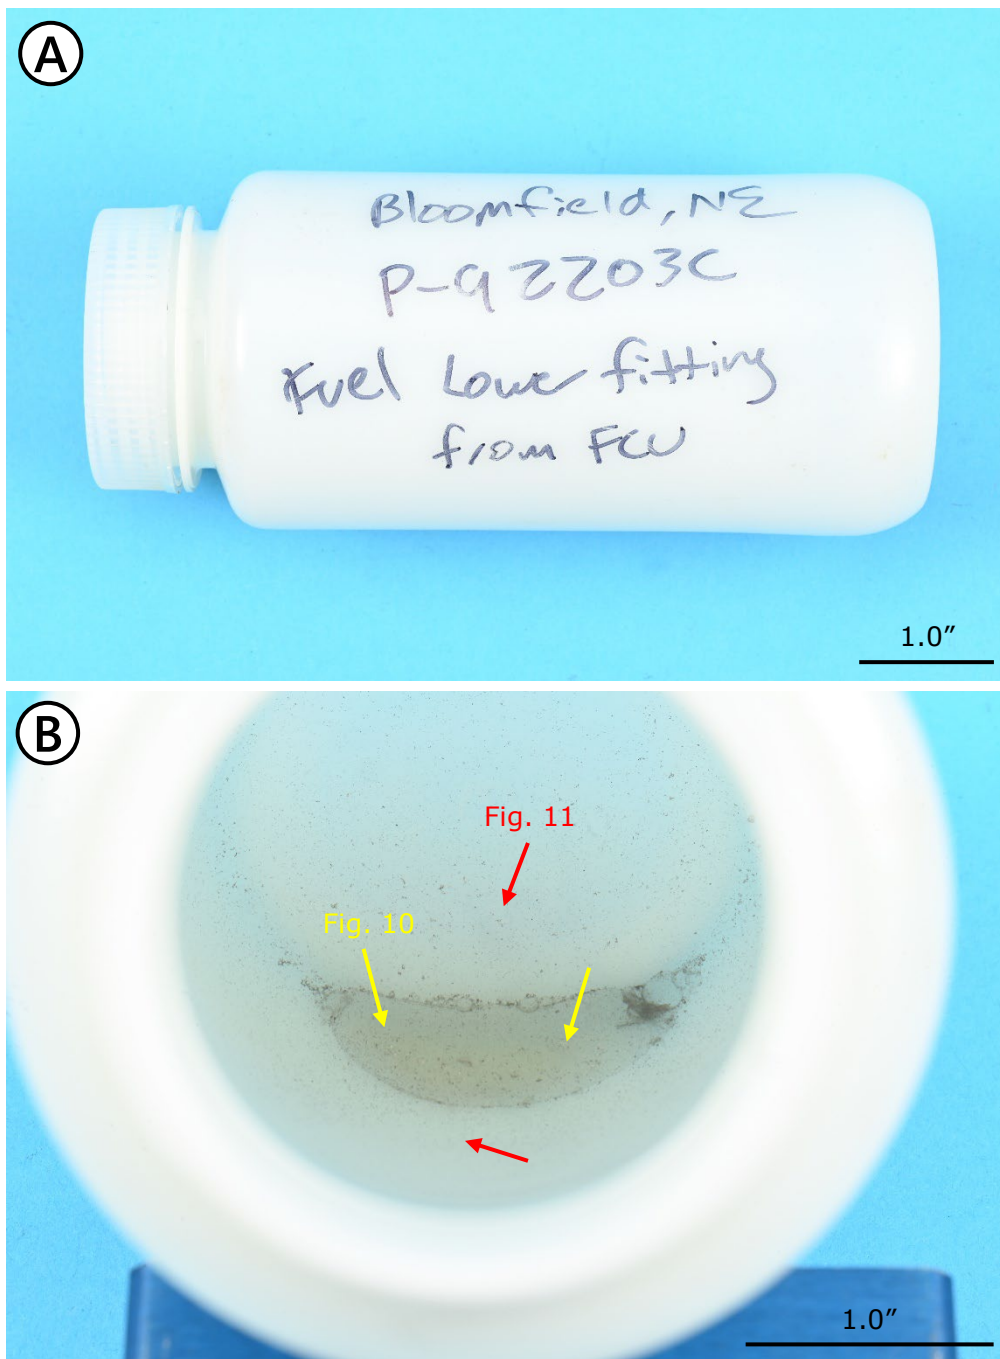
**Figure 8.**

Images showing the fuel collected from the fuel control unit (FCU) lower fitting are shown in Figure 8. Two liquids were identified and analyzed using Fourier transform infrared (FTIR) spectroscopy. The majority liquid was a 90% match to a jet A fuel (Figure 9) and the bubble sample was a 96% match to water (Figure 10).

(A-B) Images showing the as-received condition of the liquid collected from the fuel control unit (FCU) lower fitting. The two liquids identified by the yellow and red arrows in (B) were analyzed using Fourier transform infrared (FTIR) spectroscopy and are shown in Figures 9-10, respectively.

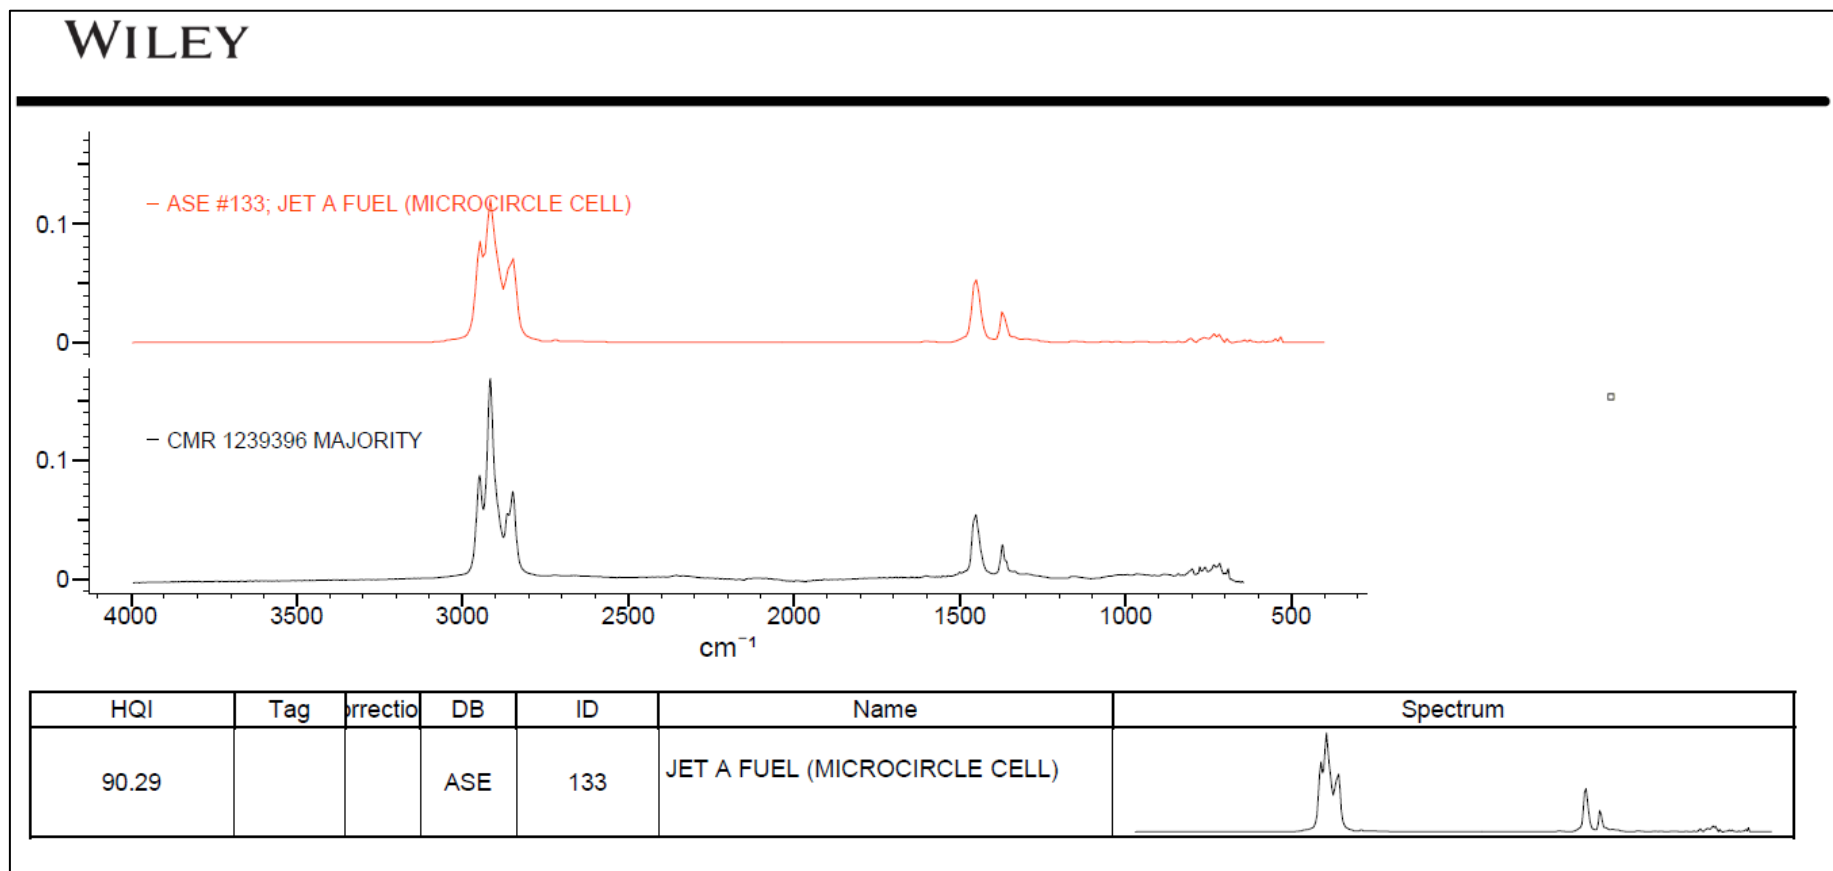
**Figure 9.**

FTIR spectrum generated from analysis of the majority liquid identified by the yellow arrows in Figure 8B. The spectrum was a 90% match to jet A fuel.

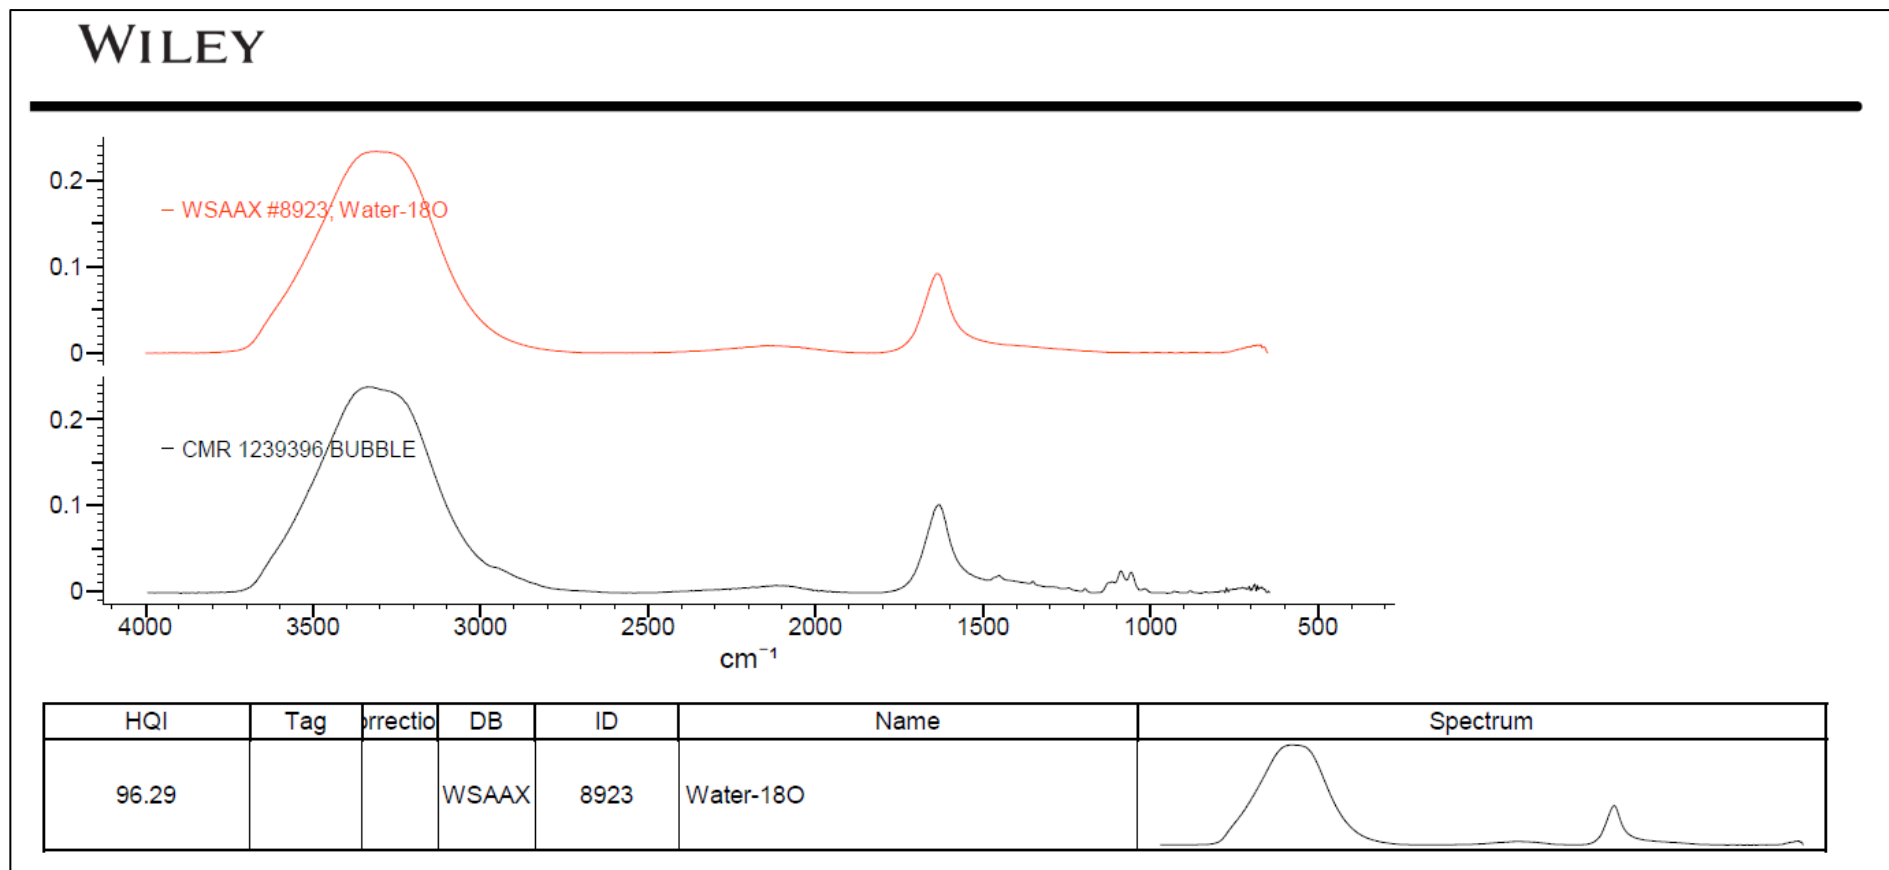
**Figure 10.**

FTIR spectrum generated from analysis of the bubble sample identified by the red arrows in Figure 8B. The spectrum was a 96% match to water.
