# National Transportation Safety Board

CEN23LA232

## **POWERPLANTS**

Woodward Inc's Final Reports

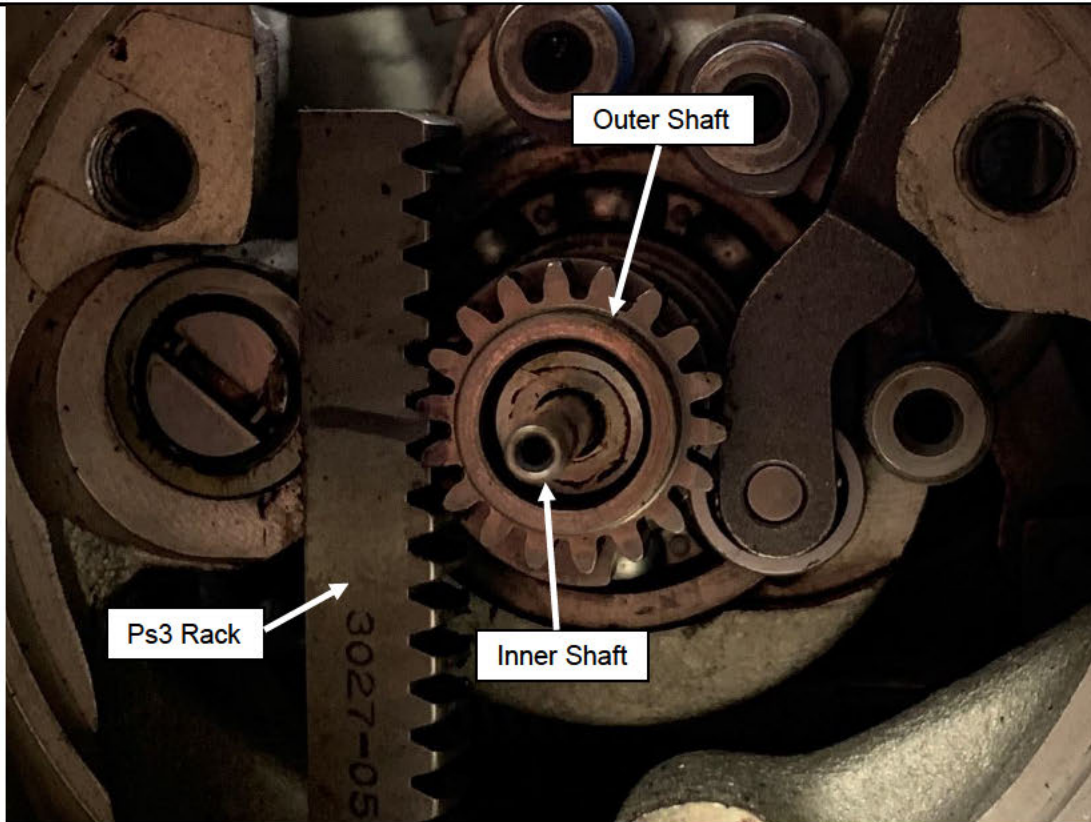
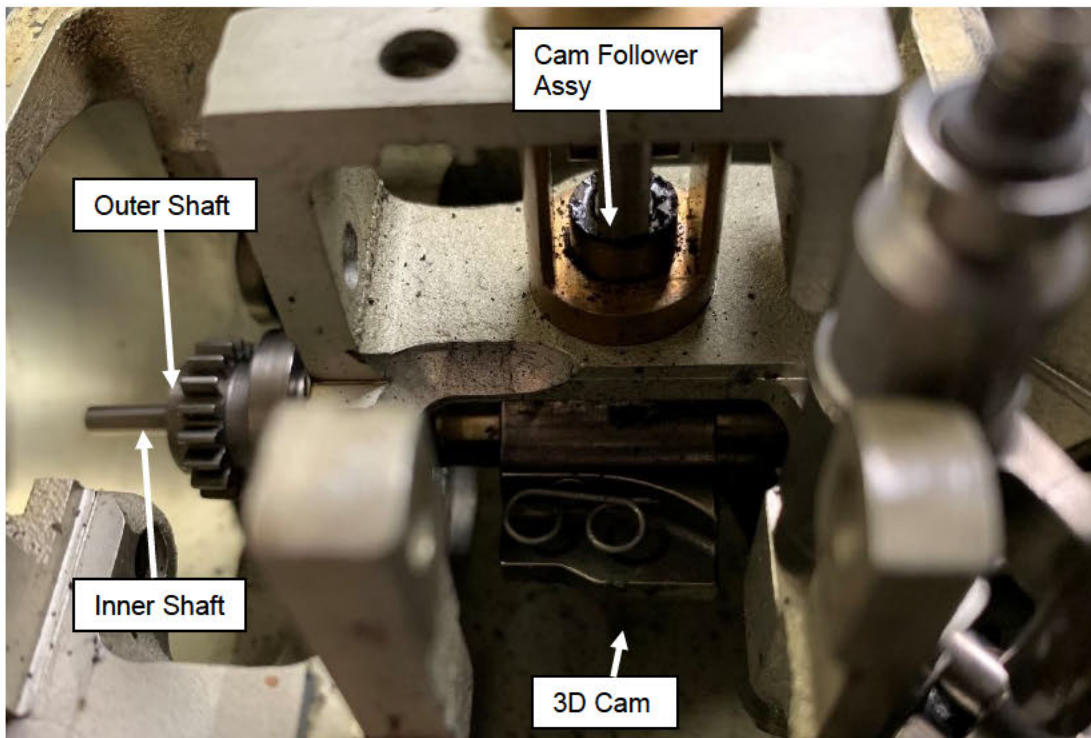
The unit was then disassembled. The Pt2 bellows was removed and appeared to be in good condition. The Pt2 amplifier servo was removed so that the 3D cam shaft assembly could be accessed. The cam shaft assembly consists of two concentric shafts. The 3D cam is attached to both shafts with a pin. The outer shaft rotates with Ps3 pressure and the inner shaft moves axially with Pt2 pressure (see Figures 1 and 2). It was noted that the inner shaft could not be pushed by hand.

Figure 1. Cam shaft assembly viewed from Pt2 bellows bore with Pt2 amplifier servo removed

Figure 2. Cam shaft assembly viewed from cover with linkage assembly removed

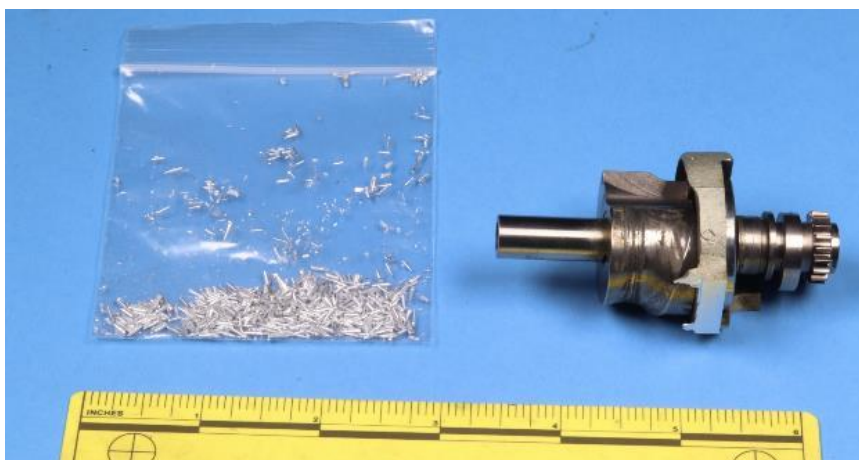
The cam shaft assembly was sent to the NTSB for materials analysis (report # CEN23LA232). The assembly was visually inspected and photographed prior to any disassembly. The assembly consisted of the cam shaft, 3D cam, bearing, and a remnant of the housing (see Figure 3). The housing remnant was sectioned and removed along with the shim that was installed between the bearing and housing (see Figure 4). Compounds exhibiting a dull black and yellowish-orange color were observed between the cam and shaft. The compounds were extracted and collected for analysis. The assembly was then cleaned with acetone in an ultrasonic bath. Inspection under magnification found evidence of deformation and damage on the shaft and the bushing inside the cam where the bushing inner surface was in contact with the cam shaft.

Figure 3. Cam shaft assembly sent to NTSB

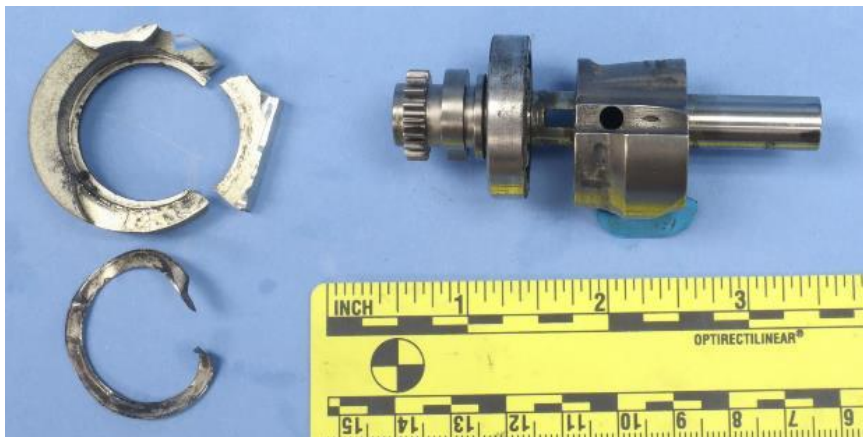
Figure 4. Cam shaft assembly after removal of housing remnant

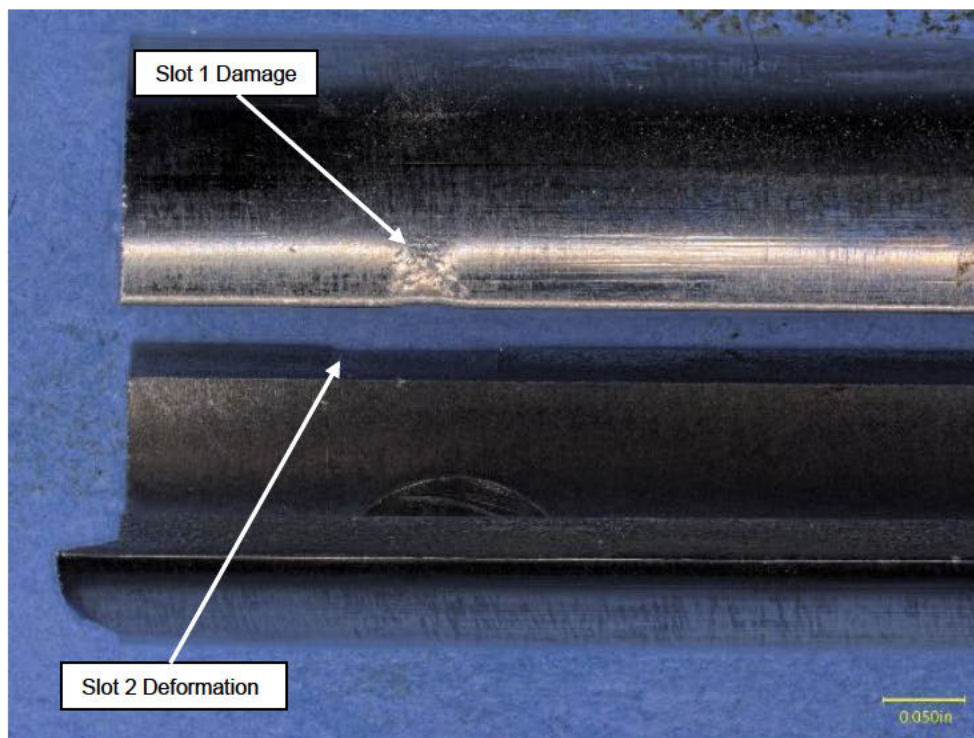
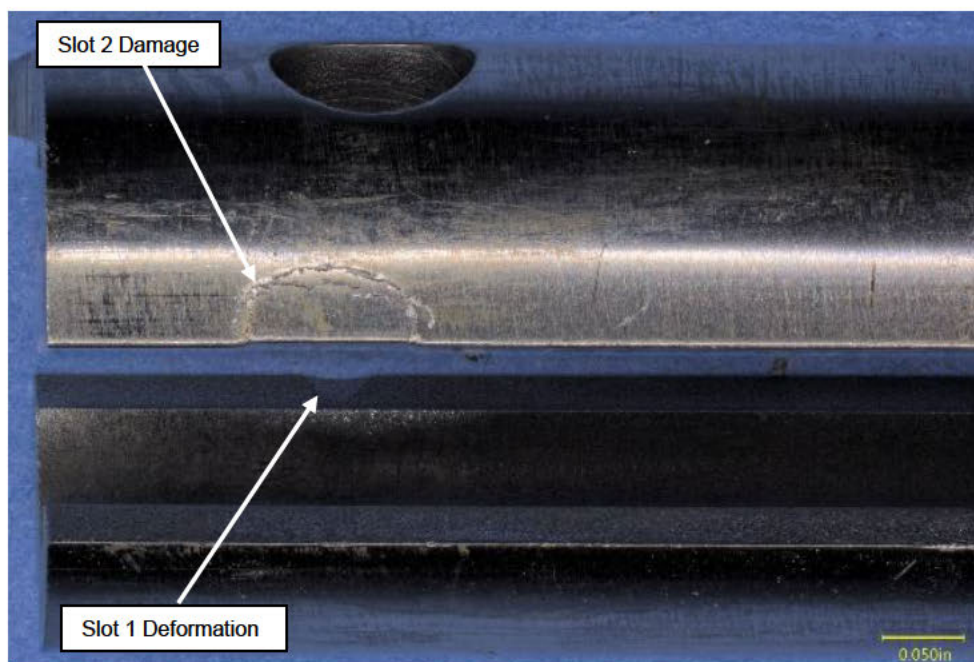
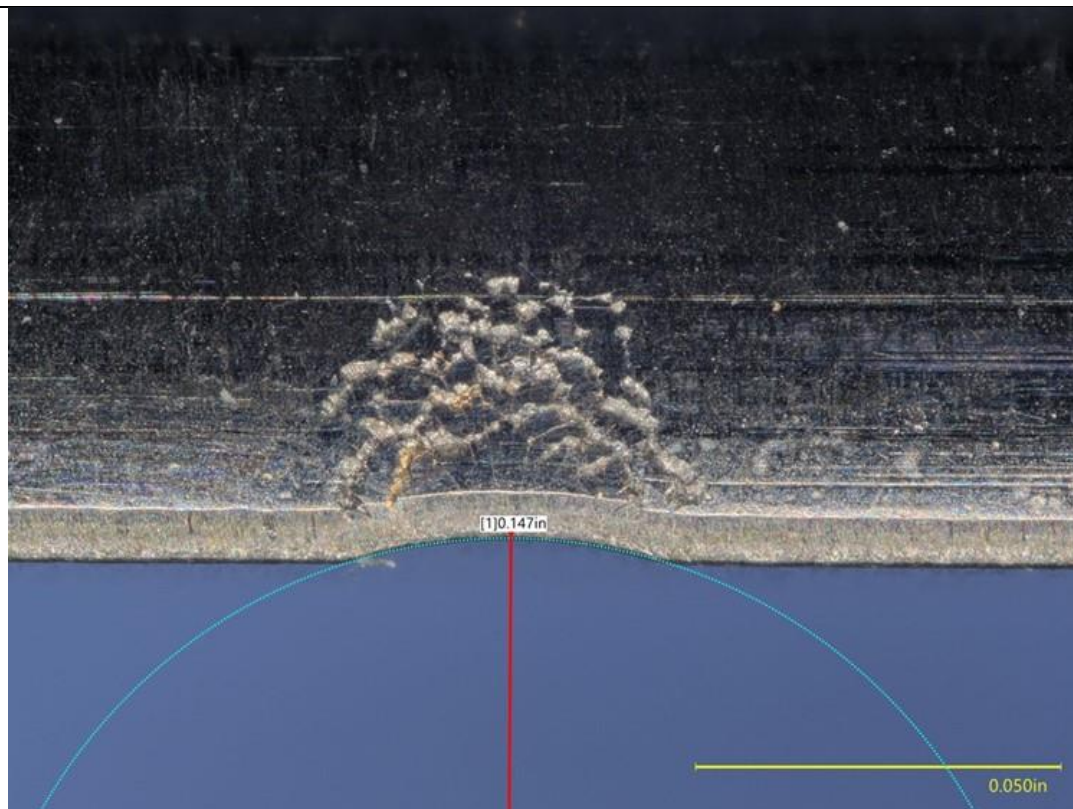
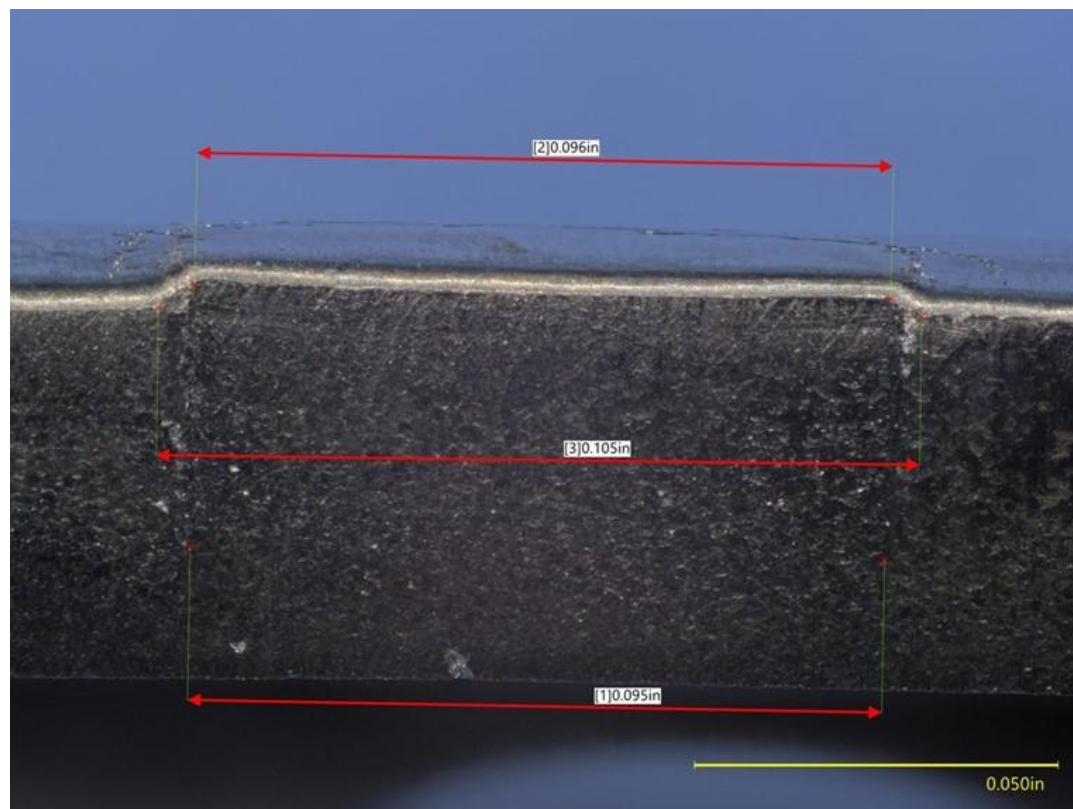
The cam shaft was then sectioned between the bearing and the cam. Once sectioned, the cam readily slid off the shaft. The shaft was cleaned in an ultrasonic bath of acetone and the areas of damage were inspected. There were two areas of damage identified on the shaft, one on the edge of each slot. The damaged areas both exhibited an indentation at the slot face which were found to align with each other axially (see Figures 5 and 6). The damage on the slot identified as Slot 1 had a circular indentation pattern. The diameter fitted to this indent was approximately 0.14 inches (see Figure 7). The damage on the slot identified as Slot 2 had an impression that was angled and flat with an interior distance of 0.094 inches (see Figure 8).

Figure 5. Damage on cam shaft viewed from Slot 1

Figure 6. Damage on cam shaft viewed from Slot 2

Figure 7. Damage on Slot 1

Figure 8. Damage on Slot 2

The shaft was examined using a SEM, which confirmed cracking pattern and localized areas of spalled material consistent with cleavage fracture. This type of fracture on this material is consistent with the higher hardness and lower ductility properties typical of a nitride surface. Examination using EDS found material composition consistent with 17-4 precipitation-hardened stainless steel and nitrogen content typical of nitriding processes. Some of the spalled areas contained material with a higher atomic number. This material was found to have a composition consistent with C660 copper alloy that is prescribed for the mating bushing.

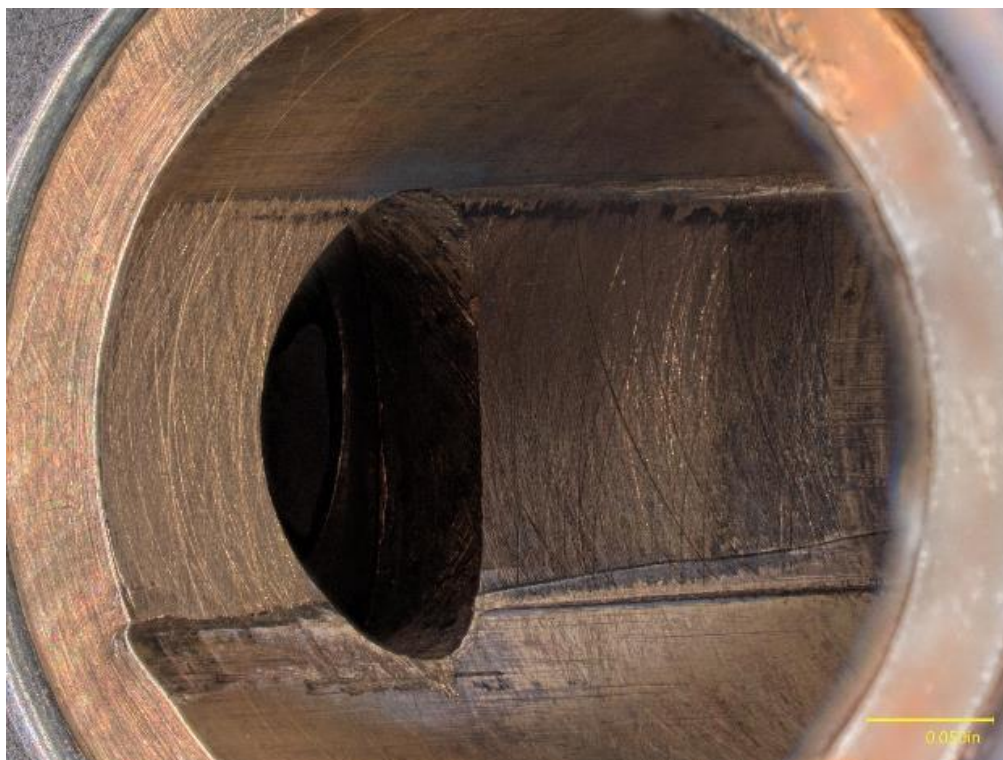
The bushing exhibited longitudinal witness marks consistent with the dimensions of the slots in the mating camshaft. Outward deformation of the edge of the bushing coincided with the most pronounced longitudinal wear marks (see Figure 9).

Figure 9. Witness marks on ID of cam bushing

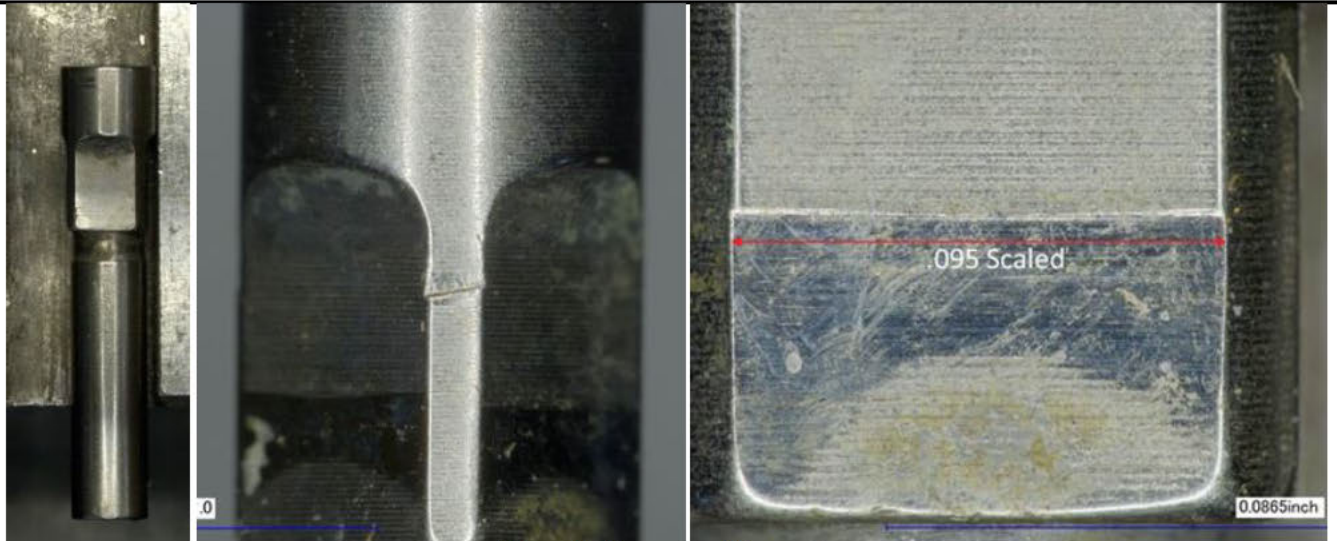
The 3D cam pin, 3D cam follower, and Ps3 rack, previously disassembled at Woodward, were then examined closely for any damage related to the findings from the NTSB Materials Lab inspection. The 3D cam pin is installed through the cam and through the slots in the cam shaft such that the cam will rotate with the shaft but can move axially within the slot. The 3D cam pin has two diameters and an area with four machined flats (see Figure 10). When assembled the smaller pin diameter is installed through the slot identified as Slot 1 and the area with four machined flats is installed in Slot 2. Damage was observed on the corners of the flats and the width of the flat was found to match the measured width of the deformation in Slot 2. No significant damage was observed on the smaller pin diameter. The pin diameter is 0.124 inches which is similar to the deformation measured in Slot 1.

Figure 10. Damage on 3D cam pin

The damage observed on the cam shaft, pin, cam follower adjuster, and Ps3 rack tooth is consistent with side loading of the 3D cam against the cam follower assembly. One scenario that can cause this kind of damage is if Ps3 pressure is increased beyond the normal range and the 3D cam rotates such that the cam follower leaves the active cam surface. Since the cam follower is spring loaded against the cam surface, if the cam rotates too far in the increasing Ps3 direction the cam follower will drop down and be loaded against the inactive surface of the cam (see Figure 13). When Ps3 is decreased the inactive face of the cam will load against the cam follower. This is most likely to occur during assembly bench setting or during test calibration when the main cover is not installed since the cover includes a stop screw to limit the travel of the Ps3 rack in the increasing direction. However the damage observed on the cam shaft corresponds to side loading in the increasing Ps3 direction and therefore cannot be explained by this scenario.

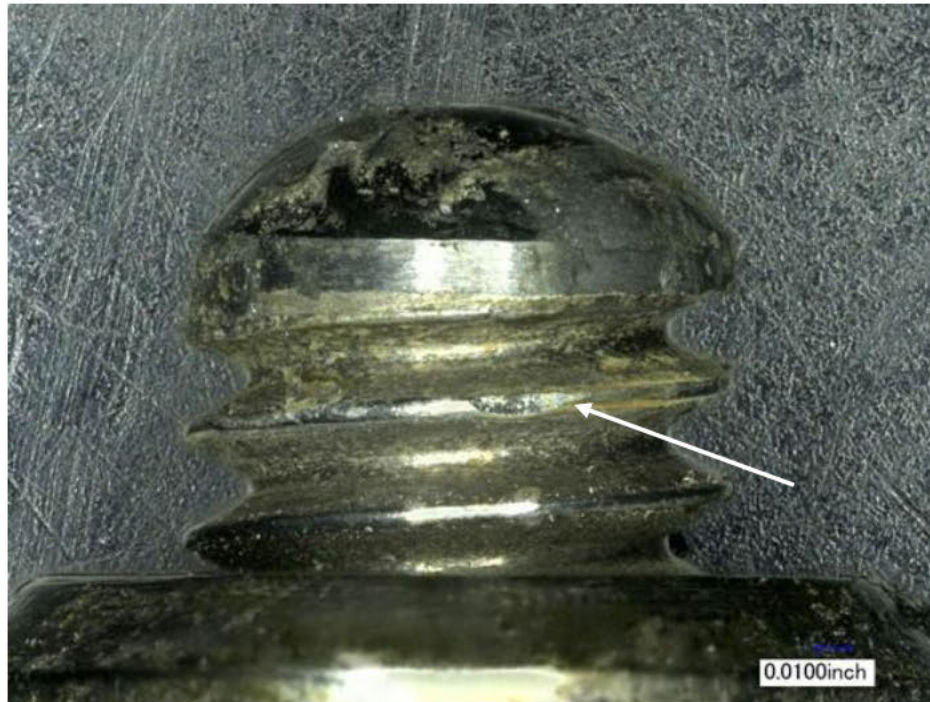
The cam follower assembly was visually inspected under magnification and a flat spot was observed on one of the threads of the cam follow adjuster (see Figure 11). The deformation on the thread is consistent with side loading of the adjuster.

Figure 11. Damage on cam follower thread

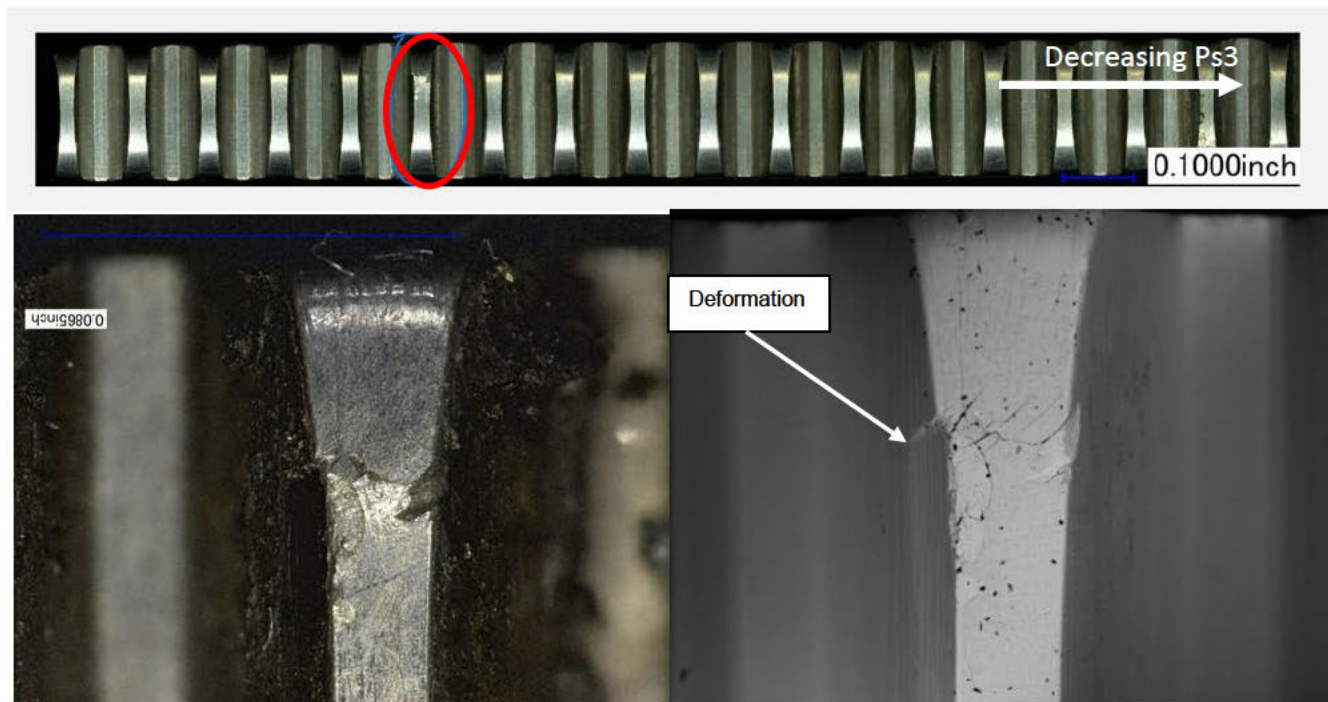
Visual inspection of the Ps3 rack found one tooth with damage and deformation (see Figure 12). The deformation was on the face of the tooth consistent with a high load in the increasing Ps3 direction.

Figure 12. Damage and deformation on tooth of Ps3 rack

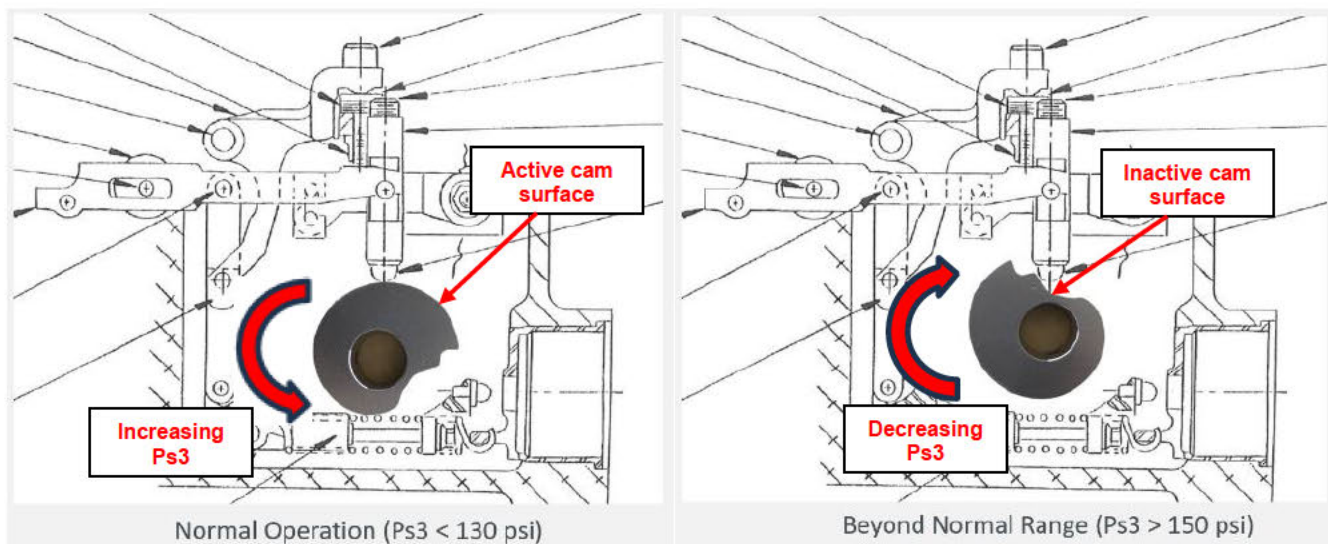
Figure 13. Illustration of rotating the 3D cam beyond its normal range
