# National Transportation Safety Board

CEN23LA254

## **AIRCRAFT EXAMINATION NOTES**

Location: Gregory, Michigan  
Date: 6/21/2023  
Time: 1530 EDT  
Glider: LET L-23 Super Blanik glider

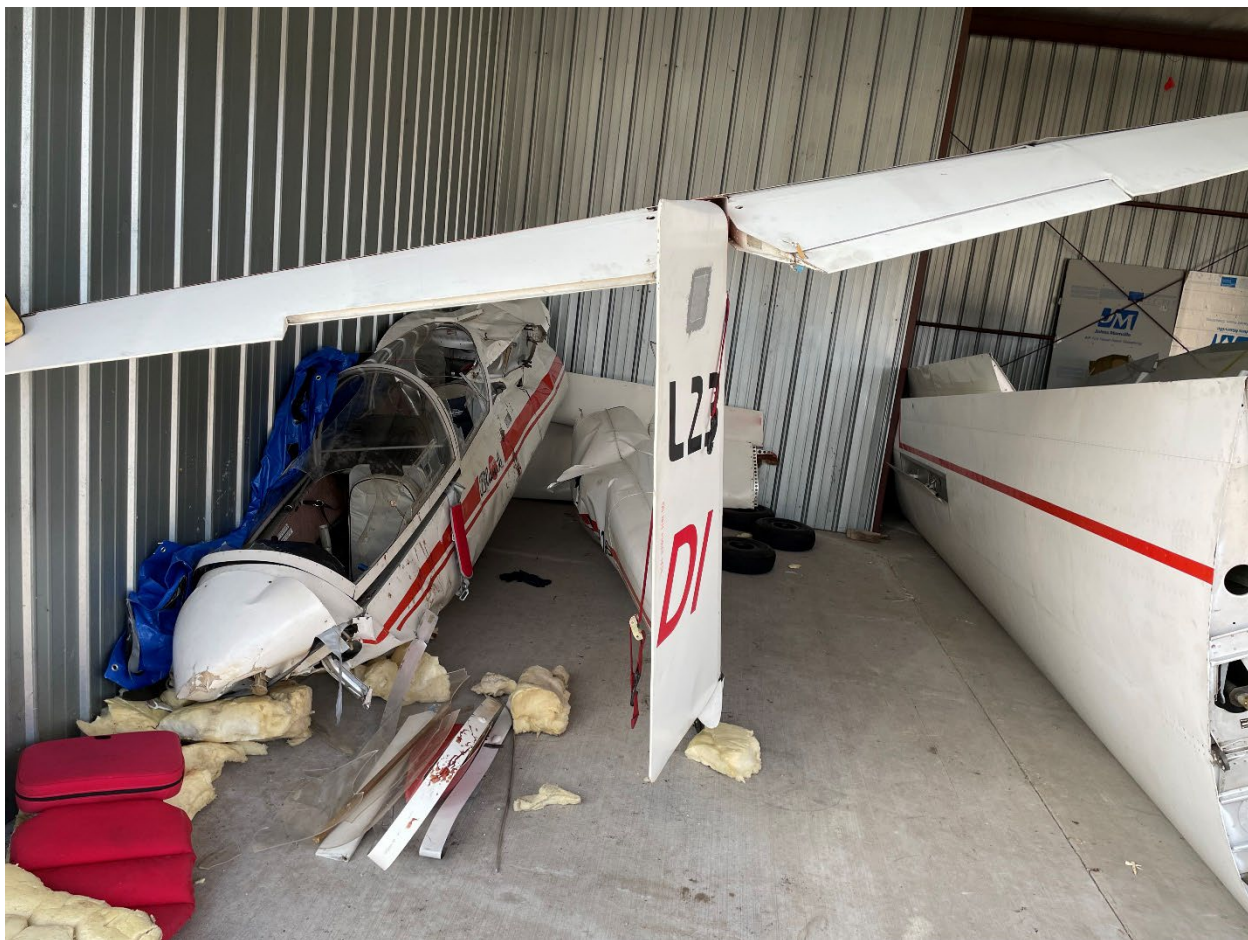
The fuselage was predominately intact but with a cut approximately mid-length that was made by the recovery crew for transport of the glider. At this cut location, the two rudder cables, the two elevator cables, and the two pitch trim cables had been cut by the recovery crew. The bottom of the forward fuselage was pushed upward and rearward by impact forces. The bending of the lower fuselage prevented full movement of the flight control sticks in the fore-aft direction, but full movement could be achieved in the left-right direction.

Figure 1. View of the glider fuselage during examination

Although limited fore-aft movement was achievable, movement of the forward cockpit control stick fore and aft resulted in movement of the aft cockpit control stick fore and aft, and movement of both elevator cables at the location where the fuselage had been cut. Side to side movement of the forward control stick resulted in side to side movement of the aft control stick, and movement of the aileron bellcrank located in the fuselage near the wing roots. The pushrods that connect this bellcrank to the bellcranks in the wing roots were in-place and intact and had been disconnected at their outboard ends. Movement of the spoiler control resulted in

movement of the spoiler torque shaft at the wing root. No preimpact anomalies were detected with respect to the fuselage or control system components within the fuselage.

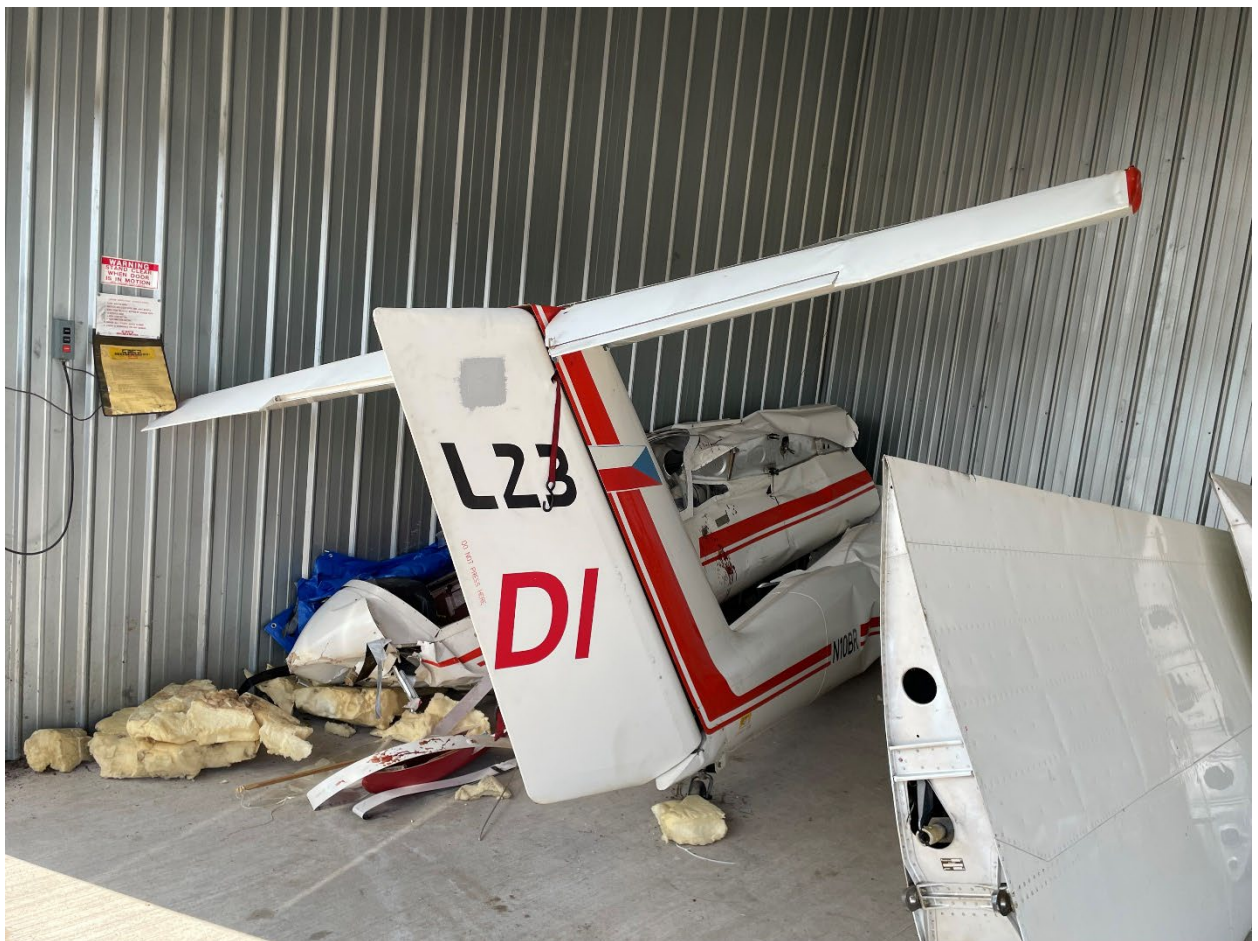
The empennage was intact and still attached to the fuselage except for the left elevator trim tab, which was separated. As previously mentioned, the rudder, elevator, and trim cables had been cut by the recovery crew for transport. Continuity of the cables was established from the fuselage cut to the control surfaces by pulling on the cables while noting movement of the appropriate control surface. No preimpact anomalies were detected with respect to the empennage.

Figure 2. Photo of the glider's empennage.

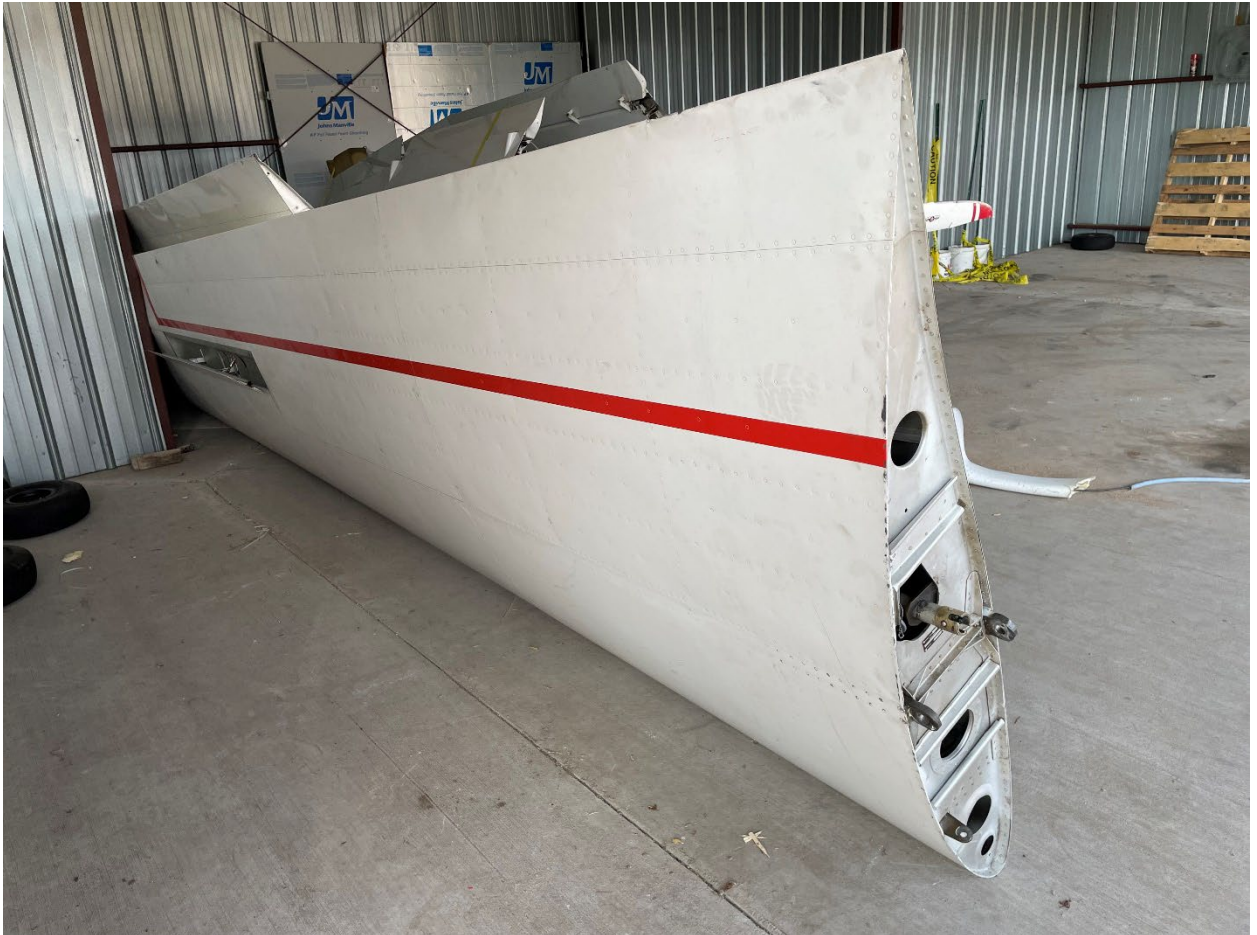
The right wing was intact and the spoiler deflected when the torque shaft was rotated. The aileron deflected when the wing root bellcrank was moved. No anomalies were detected with respect to the right wing.

Figure 3. Right wing of glider during examination.

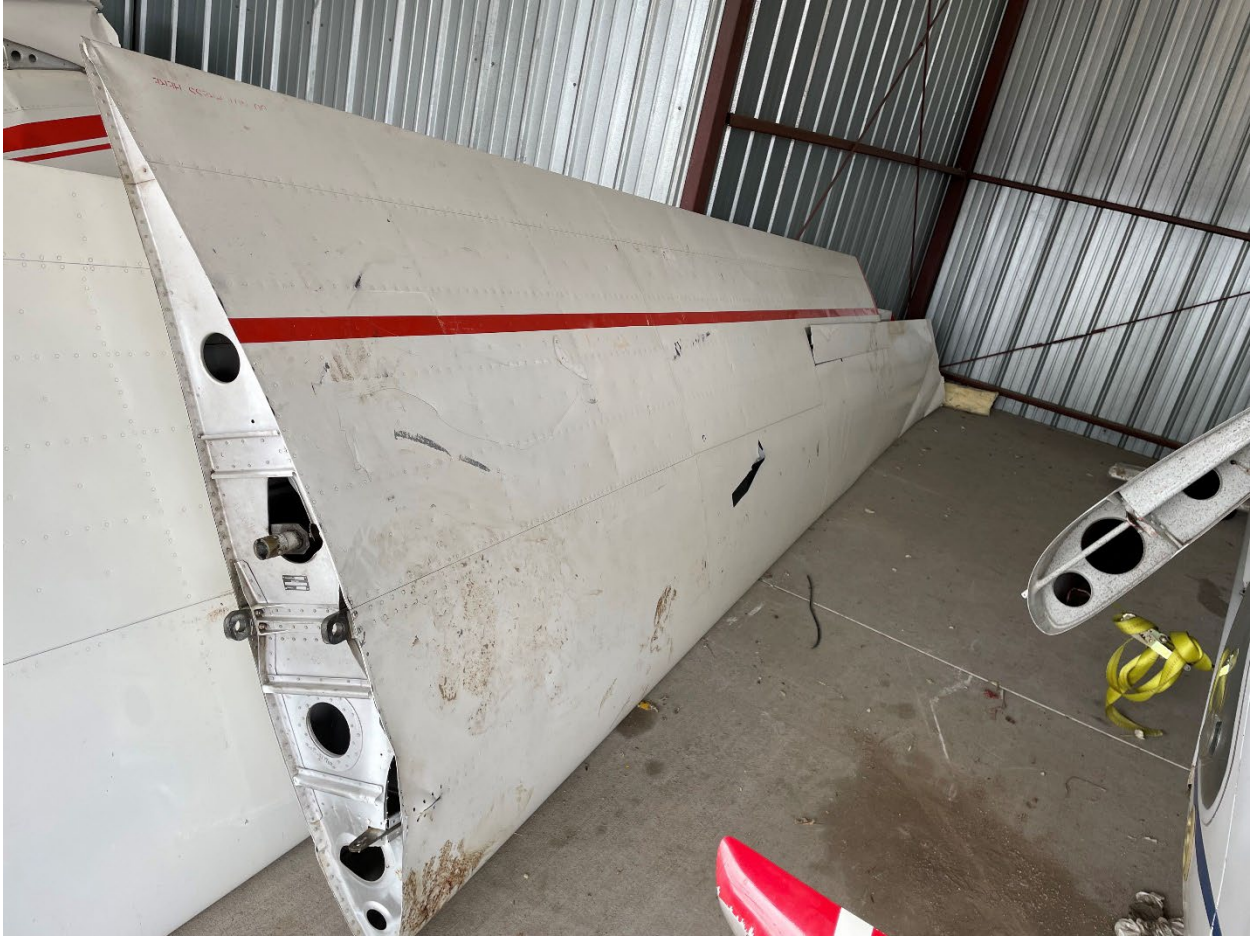
The outboard approximately 6 feet of the left wing, including the aileron was separated from the inboard portion of the wing. A portion of the rod end remained attached to the aileron and was separated from the pushrod in the wing. Movement of the aileron wing root bellcrank resulted in movement of the broken pushrod. Movement of the spoiler torque shaft resulted in movement of the spoiler. No pre-impact anomalies were detected with respect to the left wing.

Figure 4. Left wing of glider during examination.

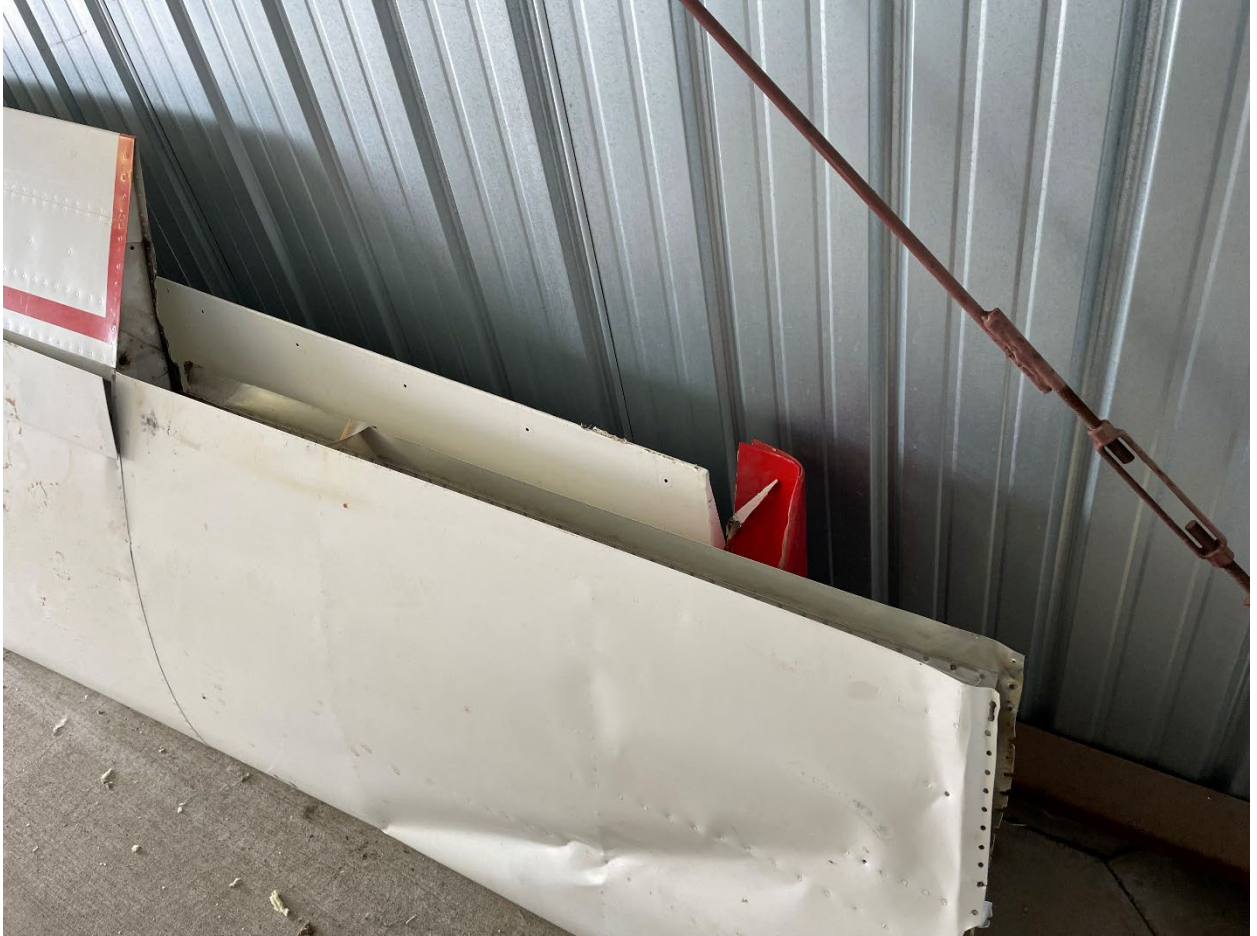
Figure 5. Photo showing the end of the left wing at the separation location.

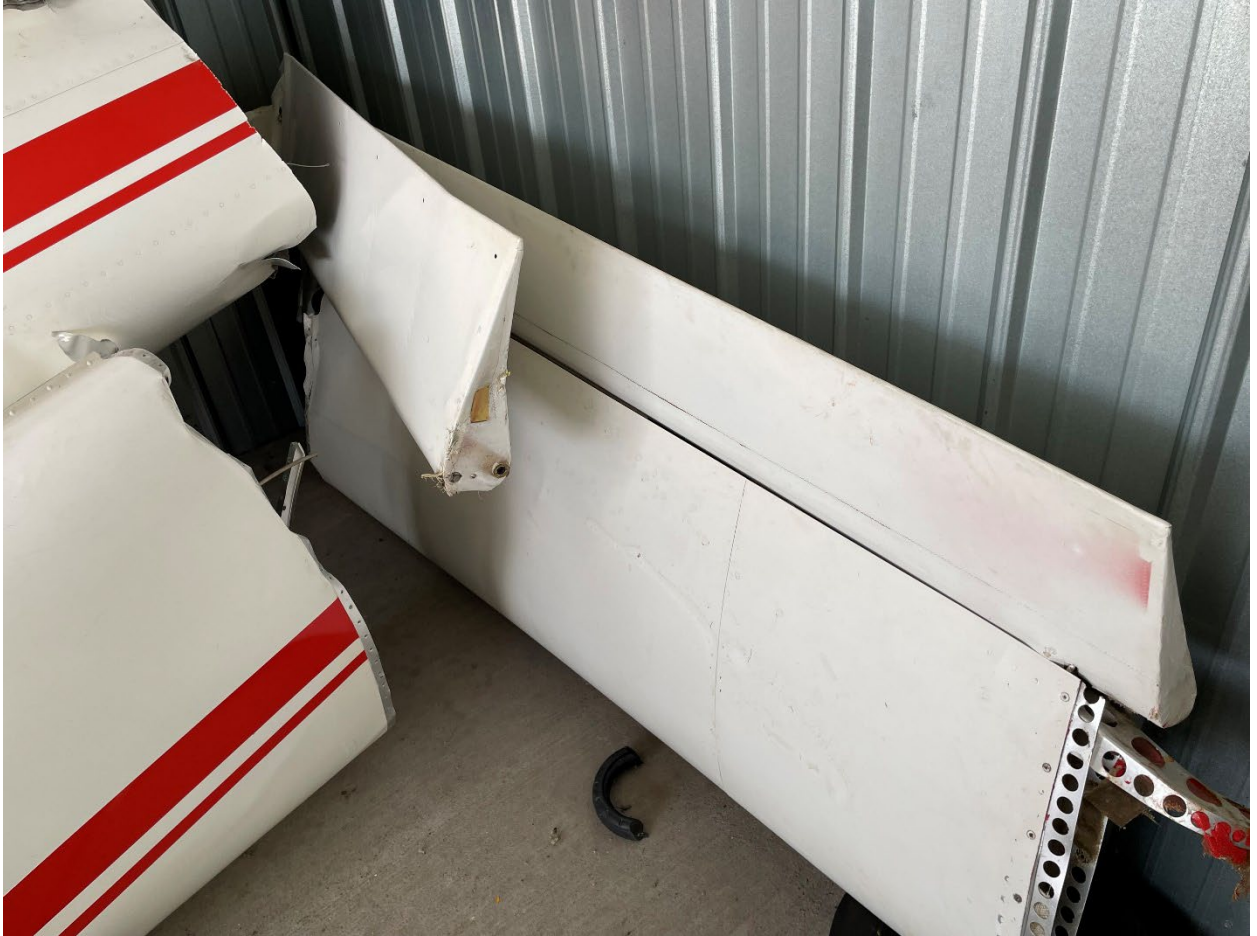
Figure 6. Separated section of left wing and left aileron.
