CEN23LA266

## INVESTIGATION PHOTOGRAPHS

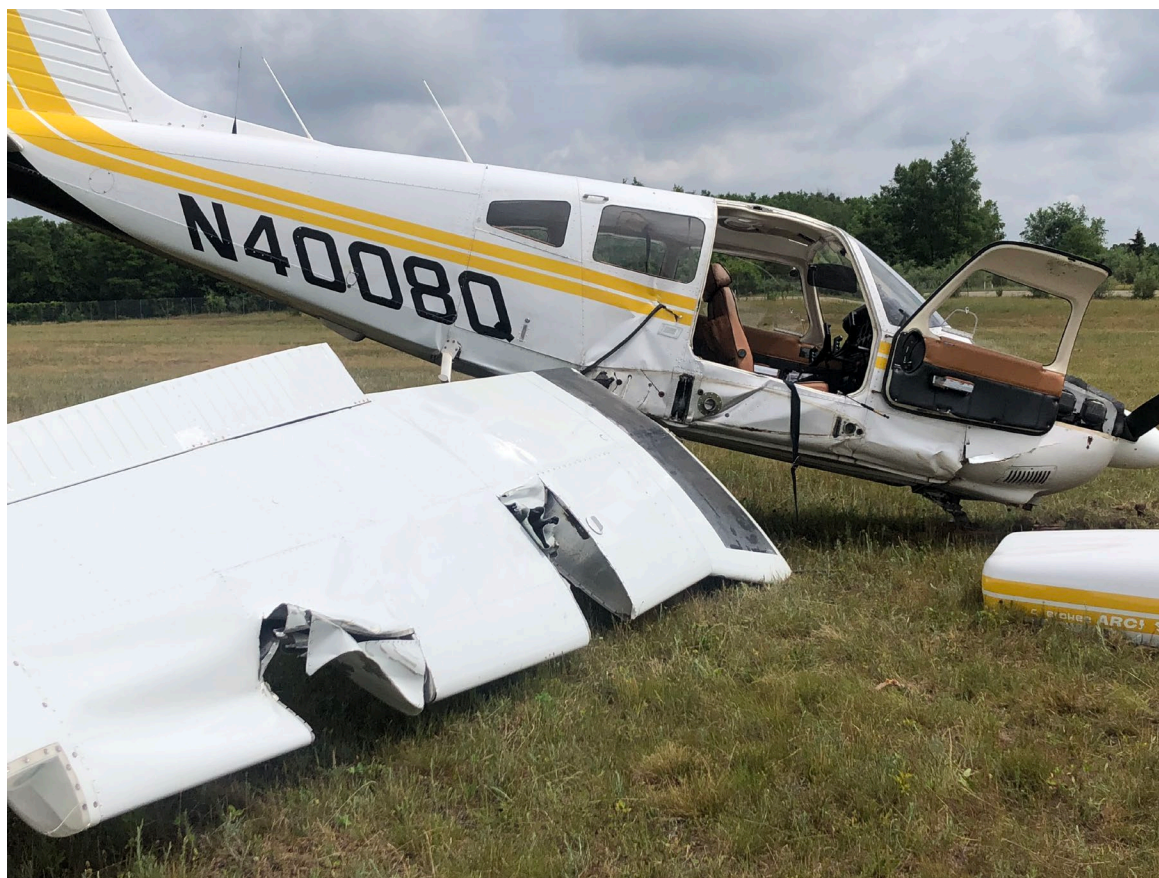
**Photograph 1 - Right side of wreckage (Courtesy of Federal Aviation Administration)**

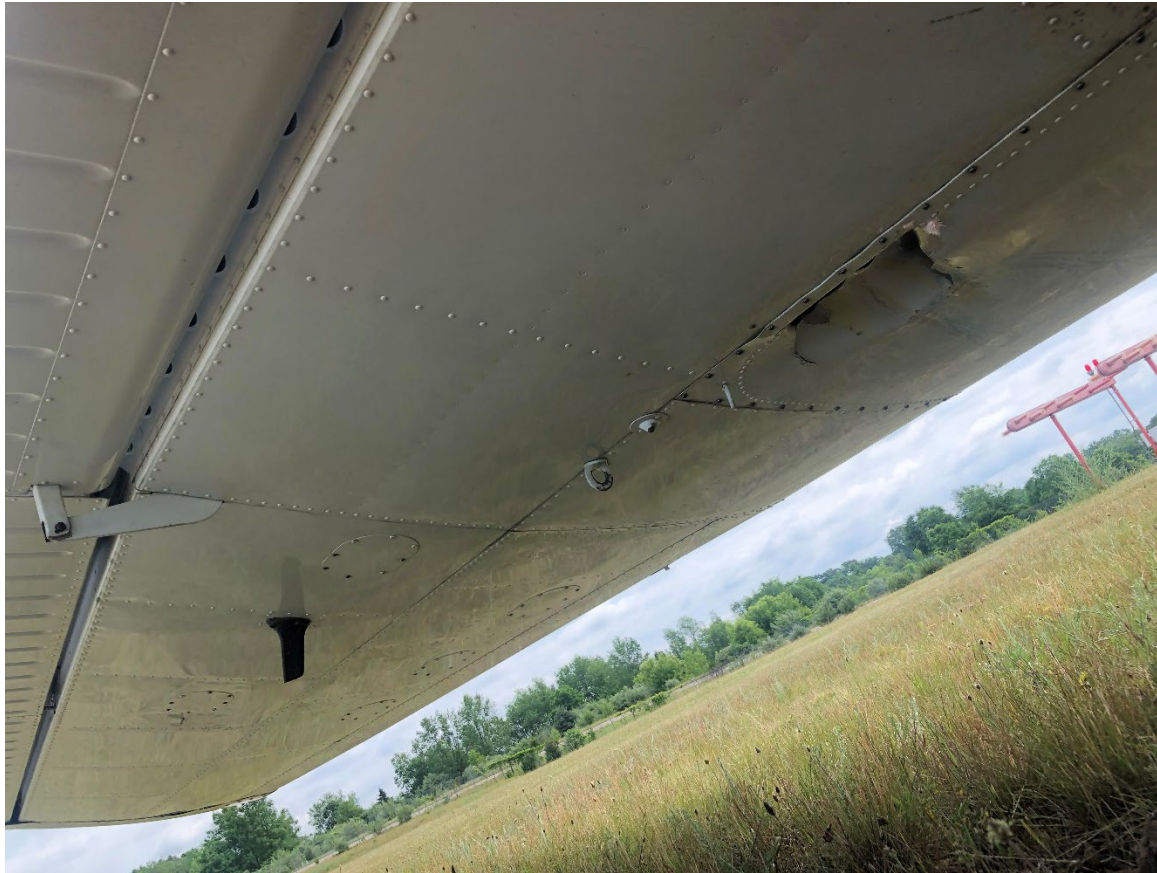
**Photograph 2 - Under side Left wing (Courtesy of Federal Aviation Administration)**
