CEN23LA267

## INVESTIGATION PHOTOGRAPHS

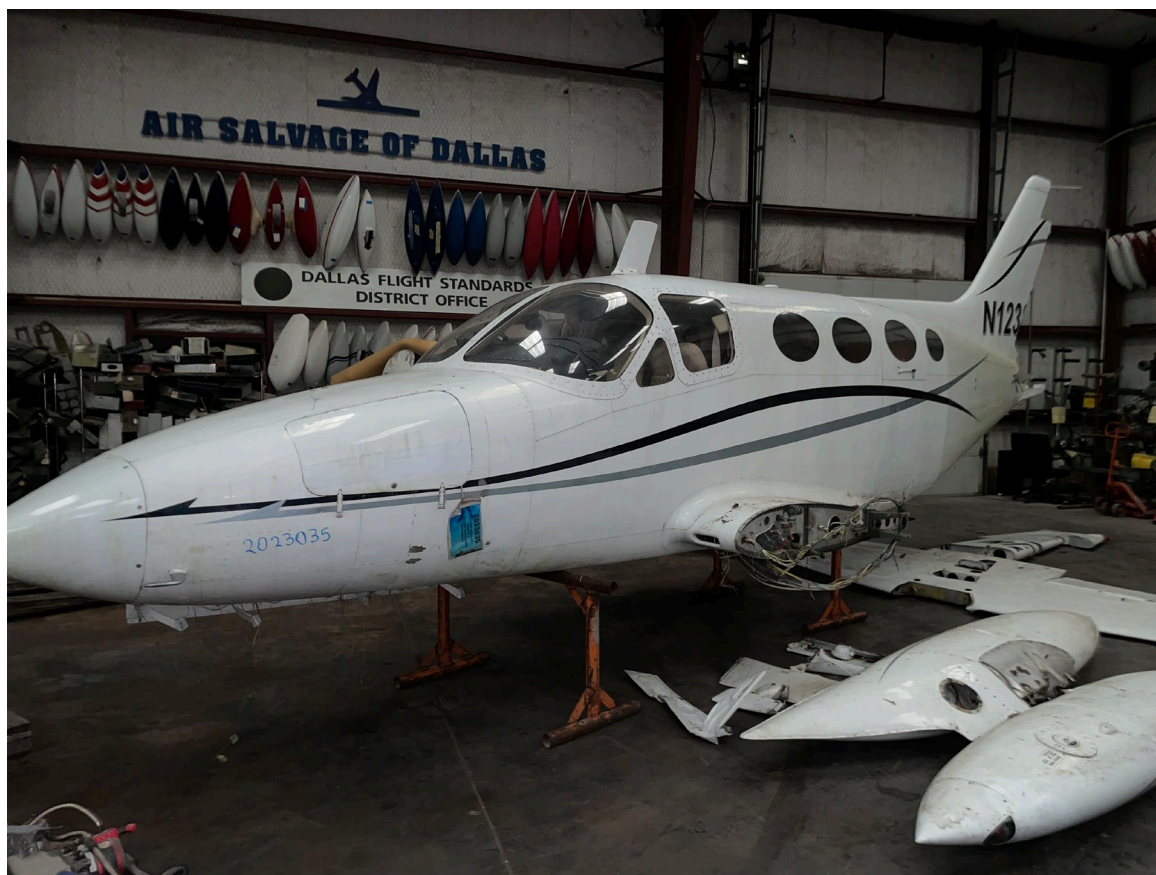
**Photograph 1 - Fuselage during postaccident examination (NTSB Photo)**

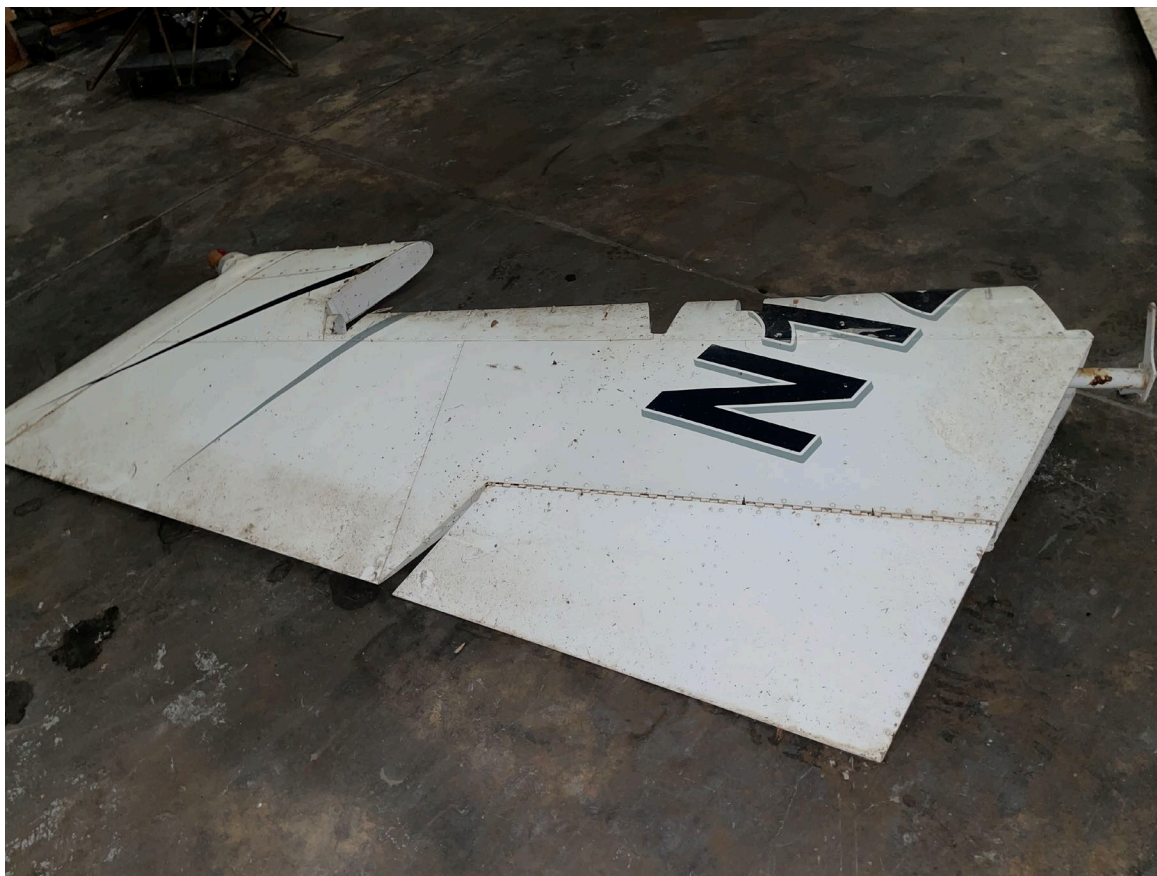
**Photograph 2 - Rudder during postaccident examination (NTSB Photo)**

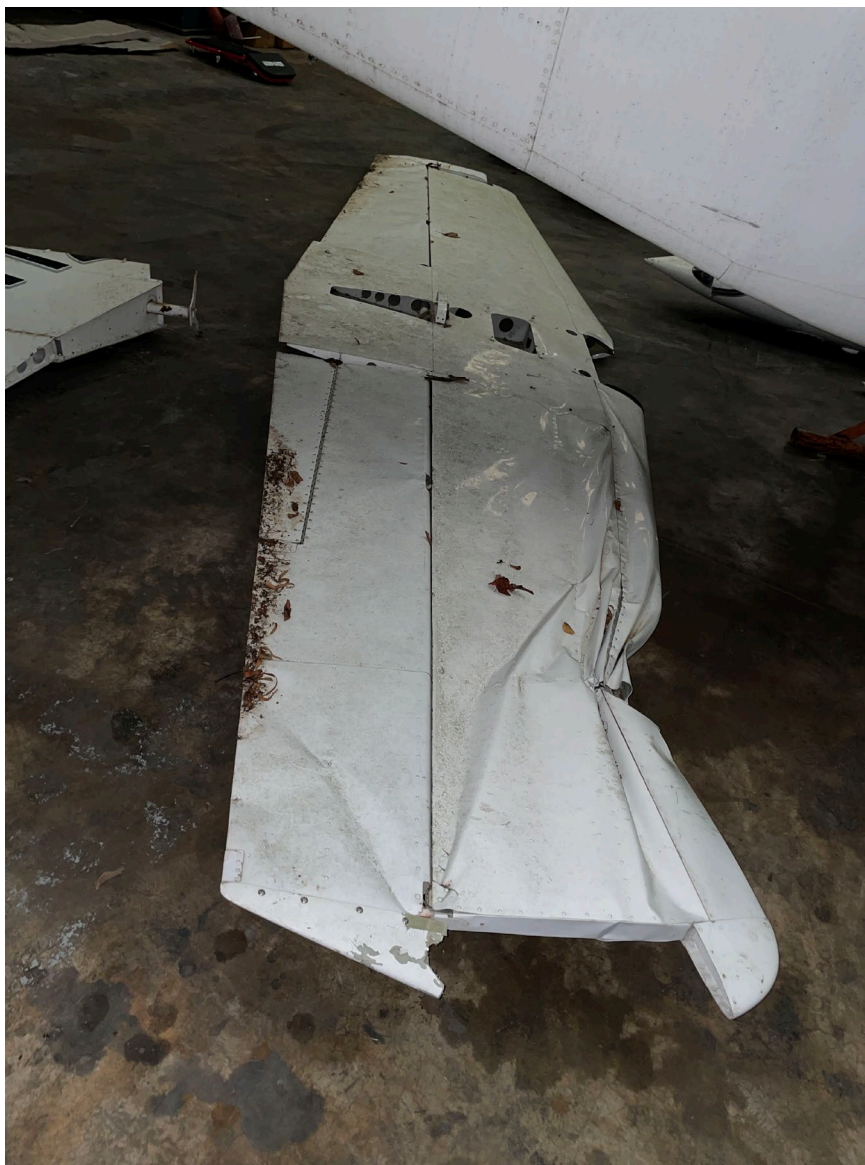
**Photograph 3 - Stabilizer during postaccident examination (NTSB Photo)**

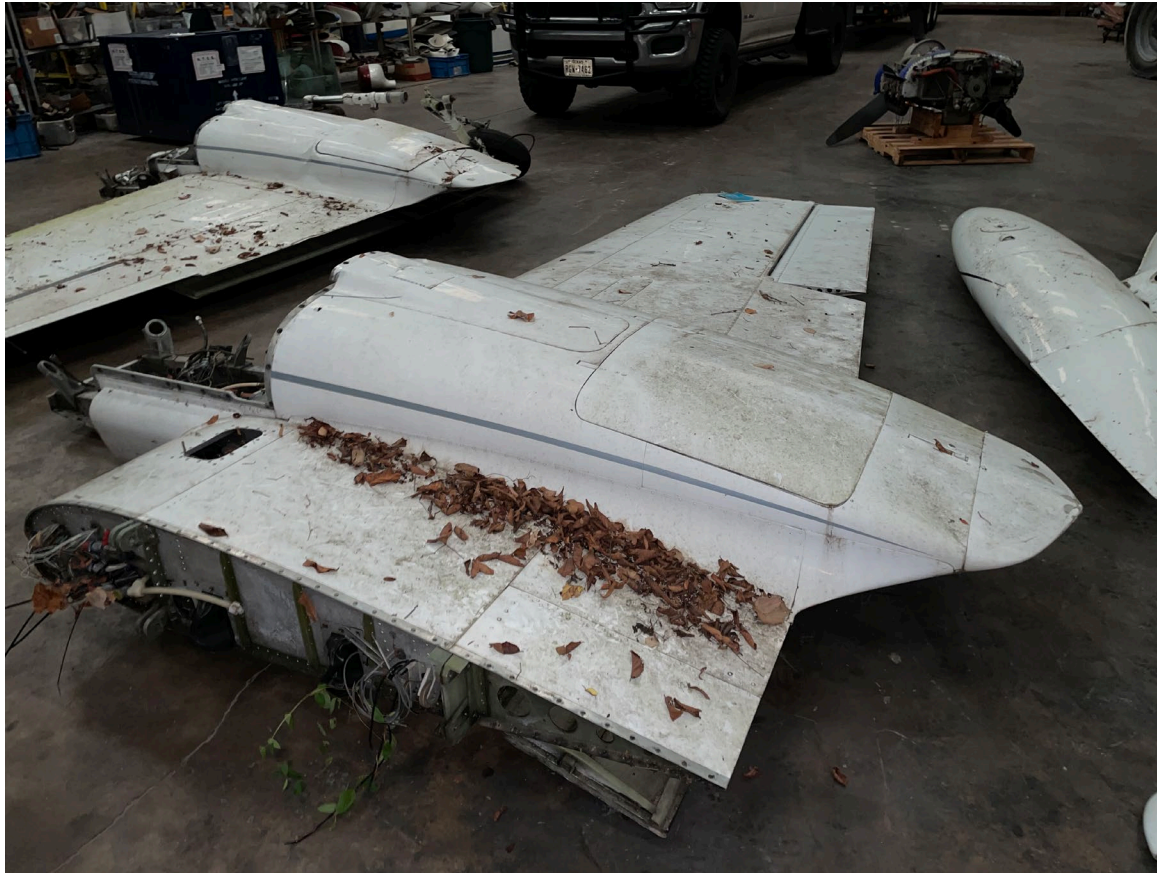
**Photograph 4 - Right wing during postaccident examination (NTSB Photo)**

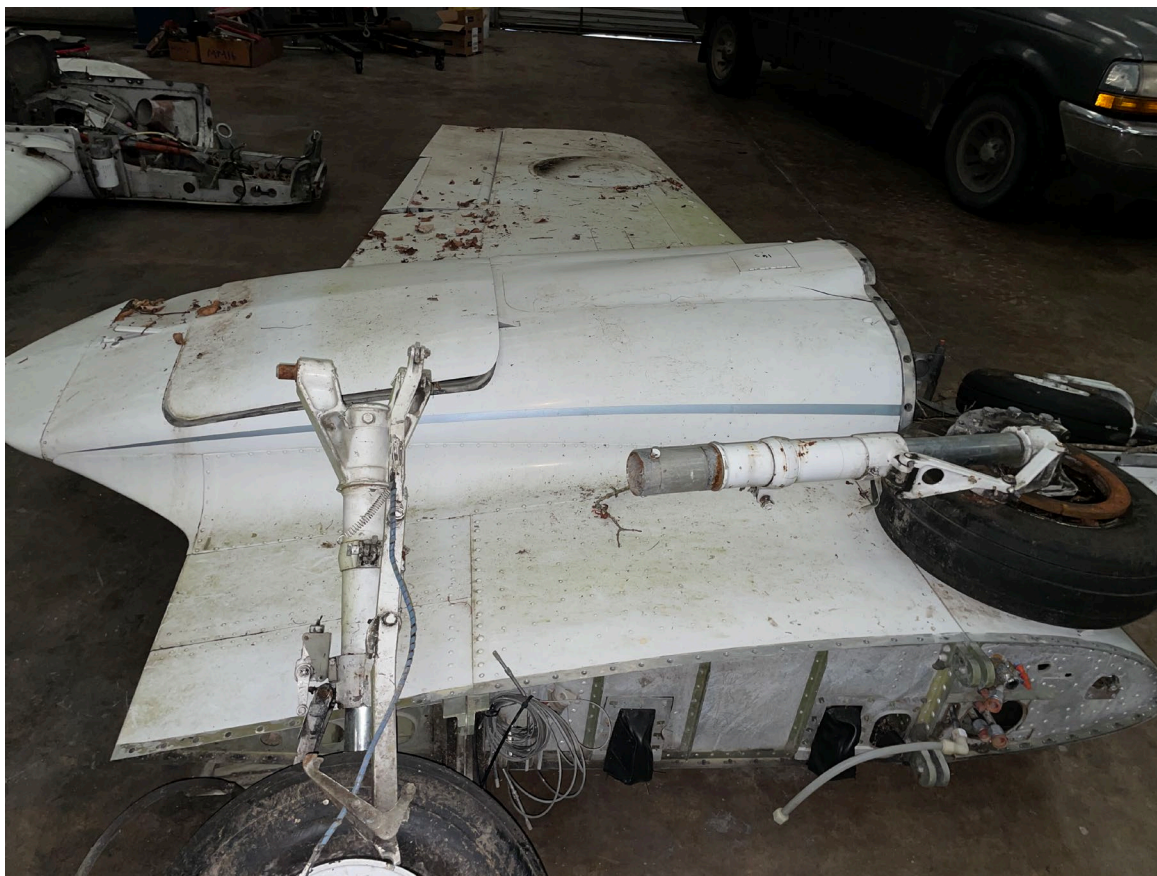
**Photograph 5 - Left wing during postaccident examination (NTSB Photo)**

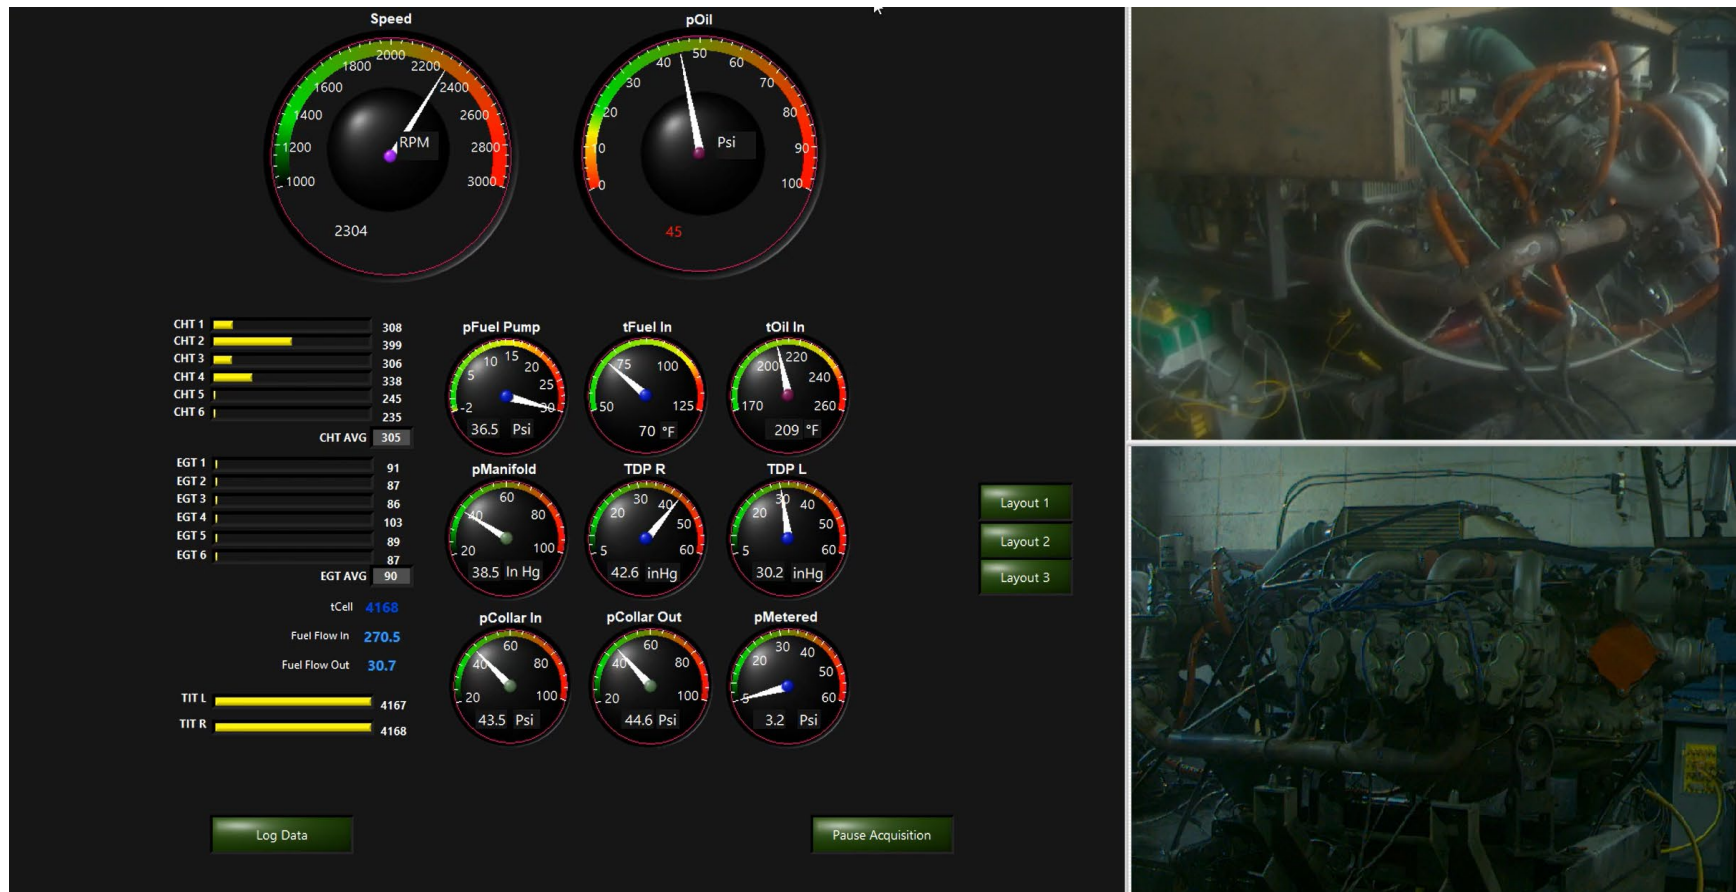
**Photograph 6 - Right engine test run image (NTSB Photo)**

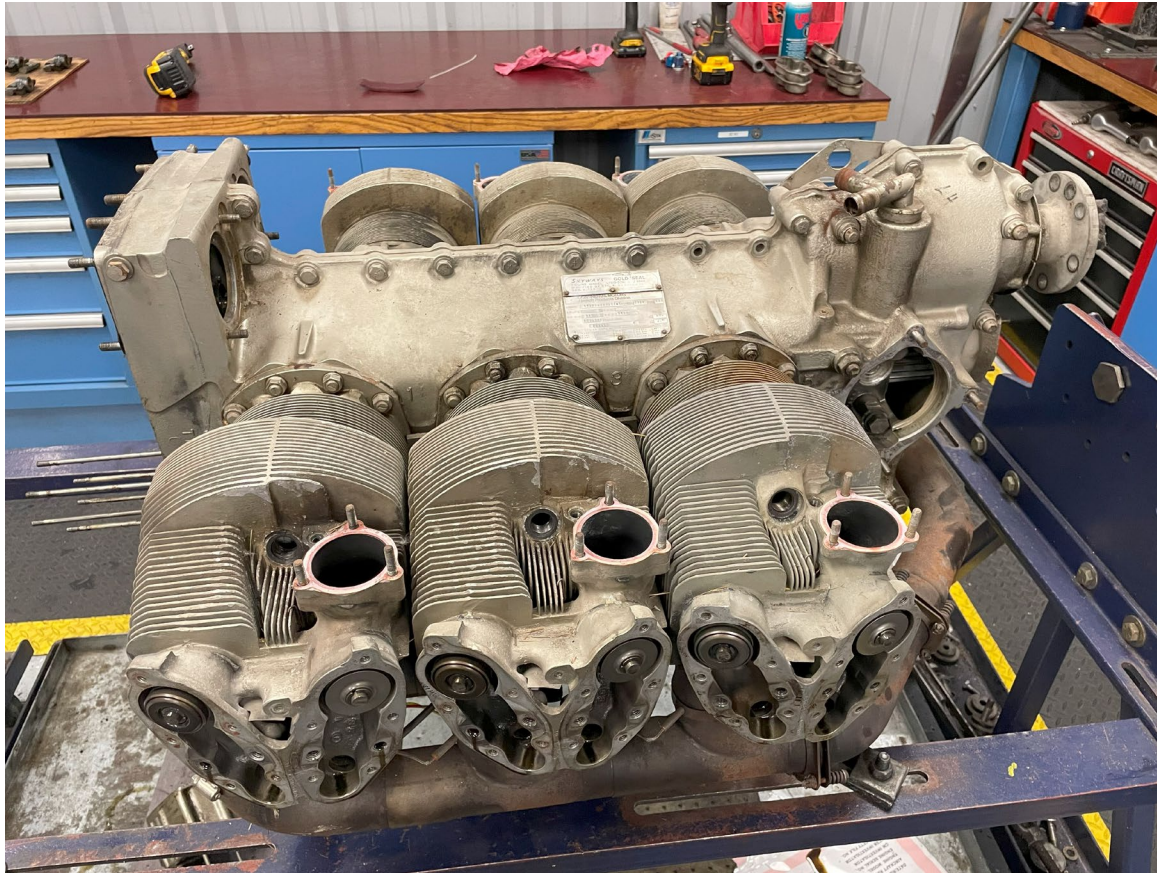
**Photograph 7 - Left engine during postaccident examination (NTSB Photo)**

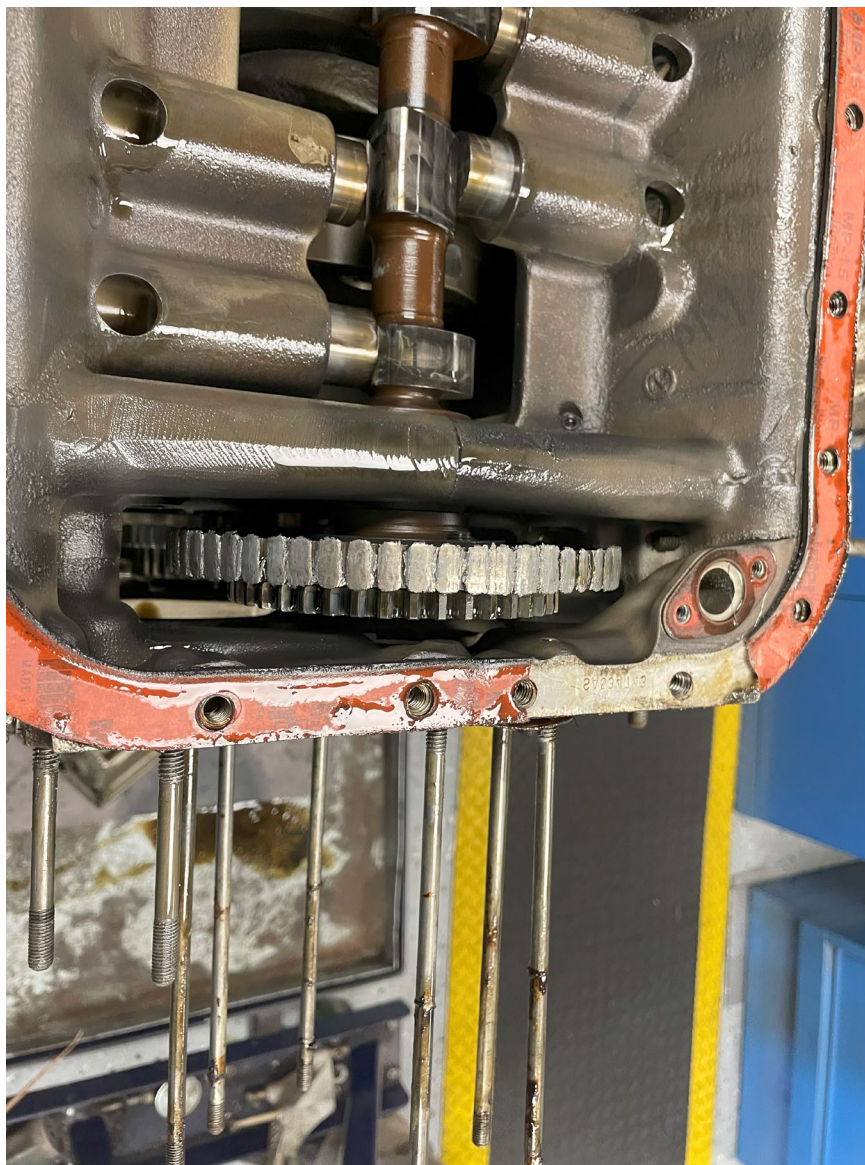
**Photograph 8 - Left engine camshaft gear (NTSB Photo)**

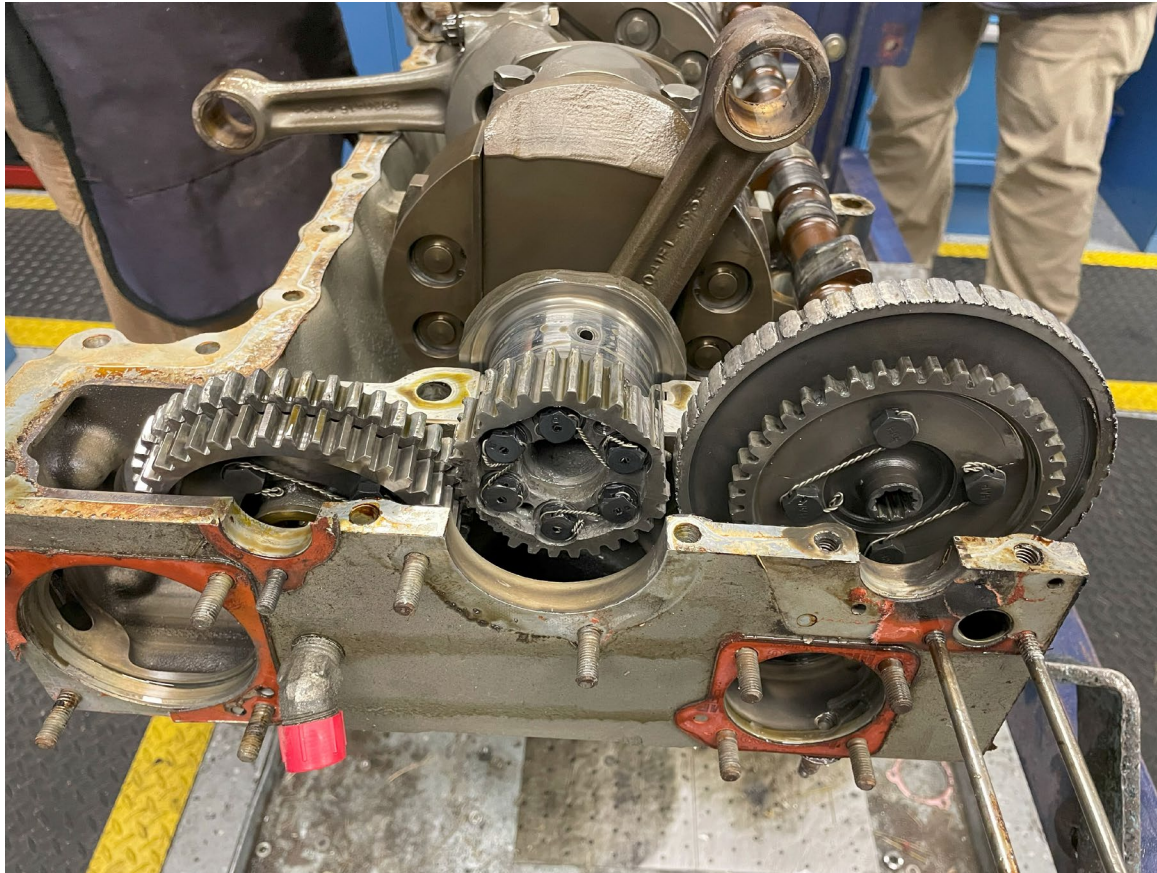
**Photograph 9 - Left engine accessory gears (NTSB Photo)**

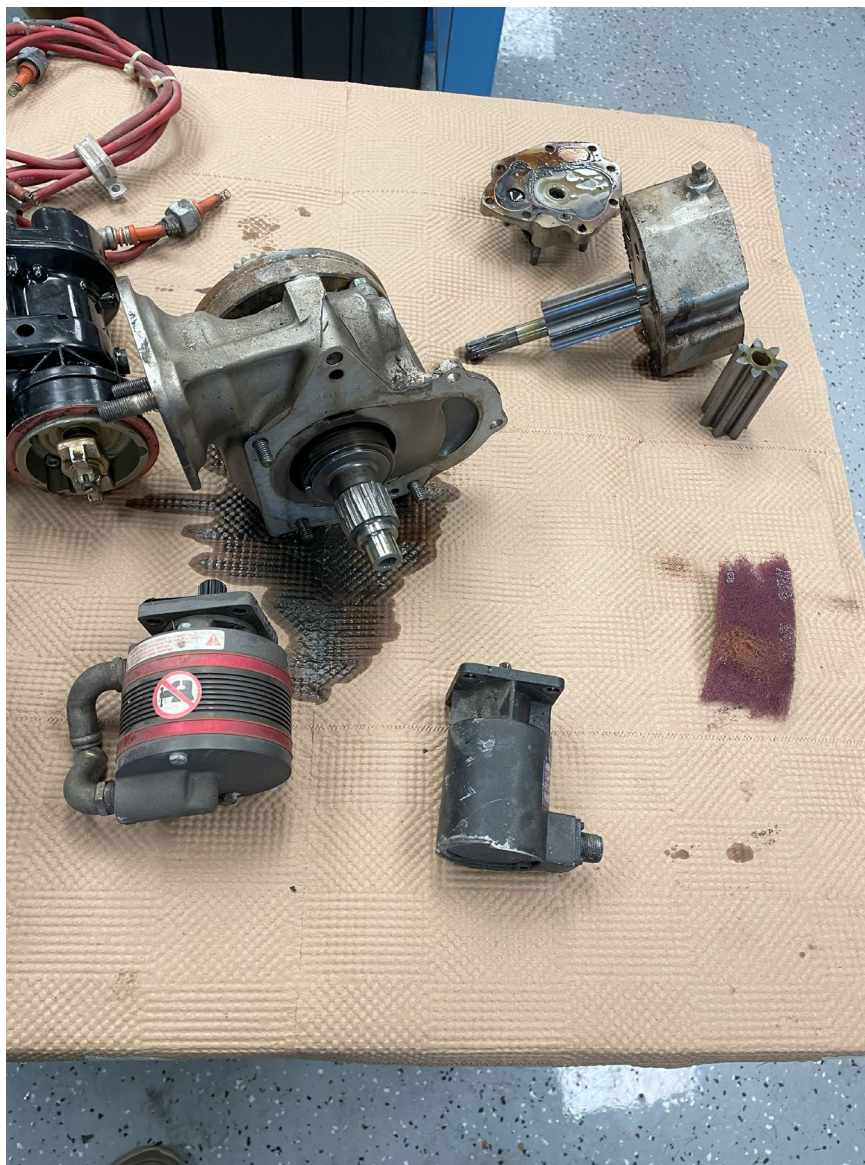
**Photograph 10 - Left engine starter drive adapter (NTSB Photo)**
