# National Transportation Safety Board

CEN23LA267

## **ENGINE TEARDOWN FACTUAL OBSERVATIONS**

Location: Rockport, TX  
Date: June 24, 2023  
Time: 1615 CDT  
Airplane: N123SM

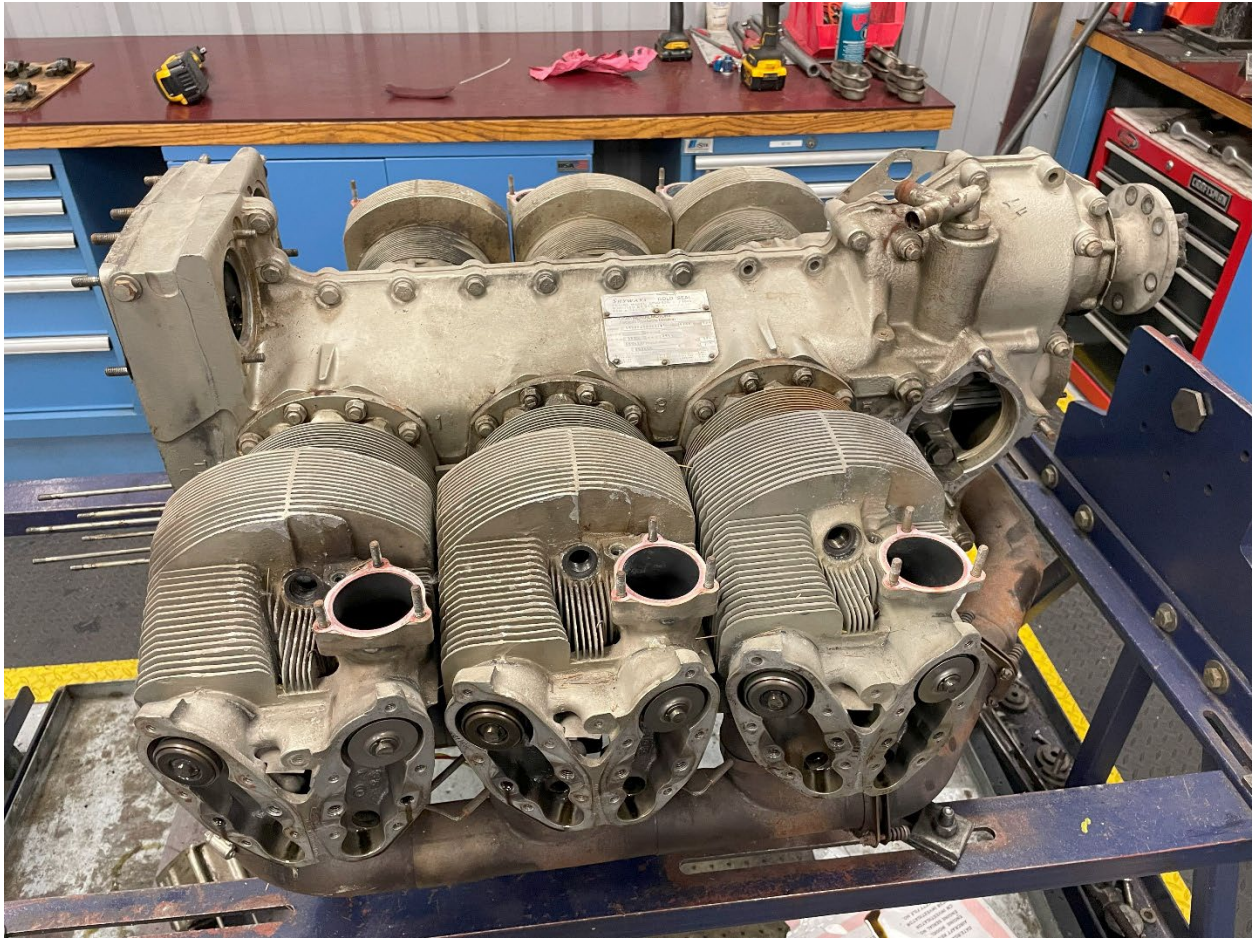
Figure 1. Left engine during teardown Examination (NTSB Photo)

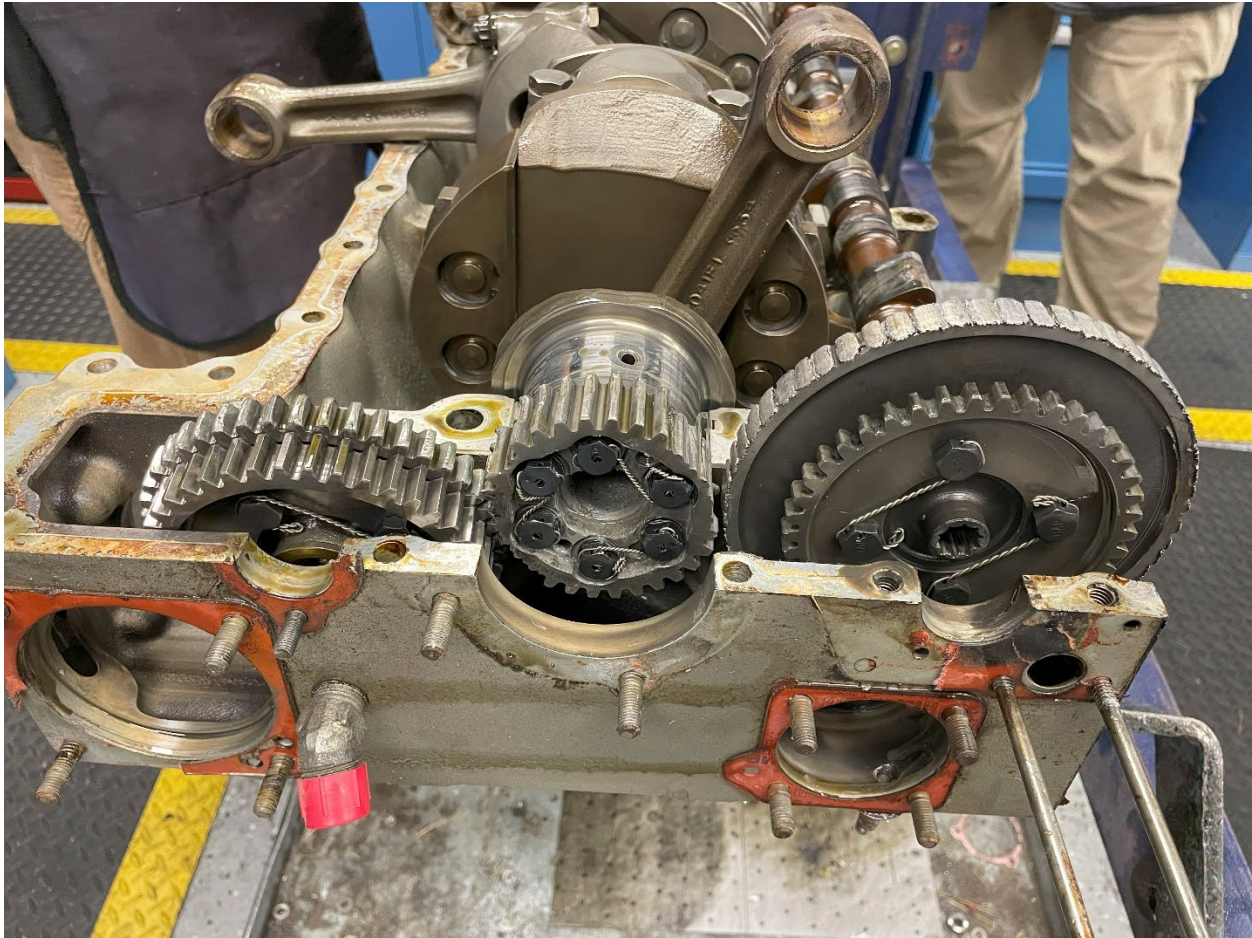
The left engine was shipped to the Continental Aerospace facilities in Mobile, Alabama, for either teardown examination or for engine test run as appropriate. After uncrating and initial preparations for test run in a Continental Aerospace engine test cell, it was determined that there was internal damage that would prevent being able to run the engine. A full teardown examination of the engine was performed. It was found that the starter adapter drive gear was broken into many pieces, portions of which were found in the engine oil sump. Additionally, the broken gear had resulted in damage to other gears in the accessory section of the engine, including stripping of the gear teeth from the camshaft gear. Due to the small pieces of gear remaining in the oil sump, the presence of pieces from other accessory gears, and secondary

damage to the main part of the gear still attached to the accessory housing metallurgical examination was deemed to not be feasible. No further preimpact defects were detected that would have precluded normal operation.

Figure 2. Accessory gear section showing stripped teeth on crankshaft gear and camshaft gear. (NTSB Photo)

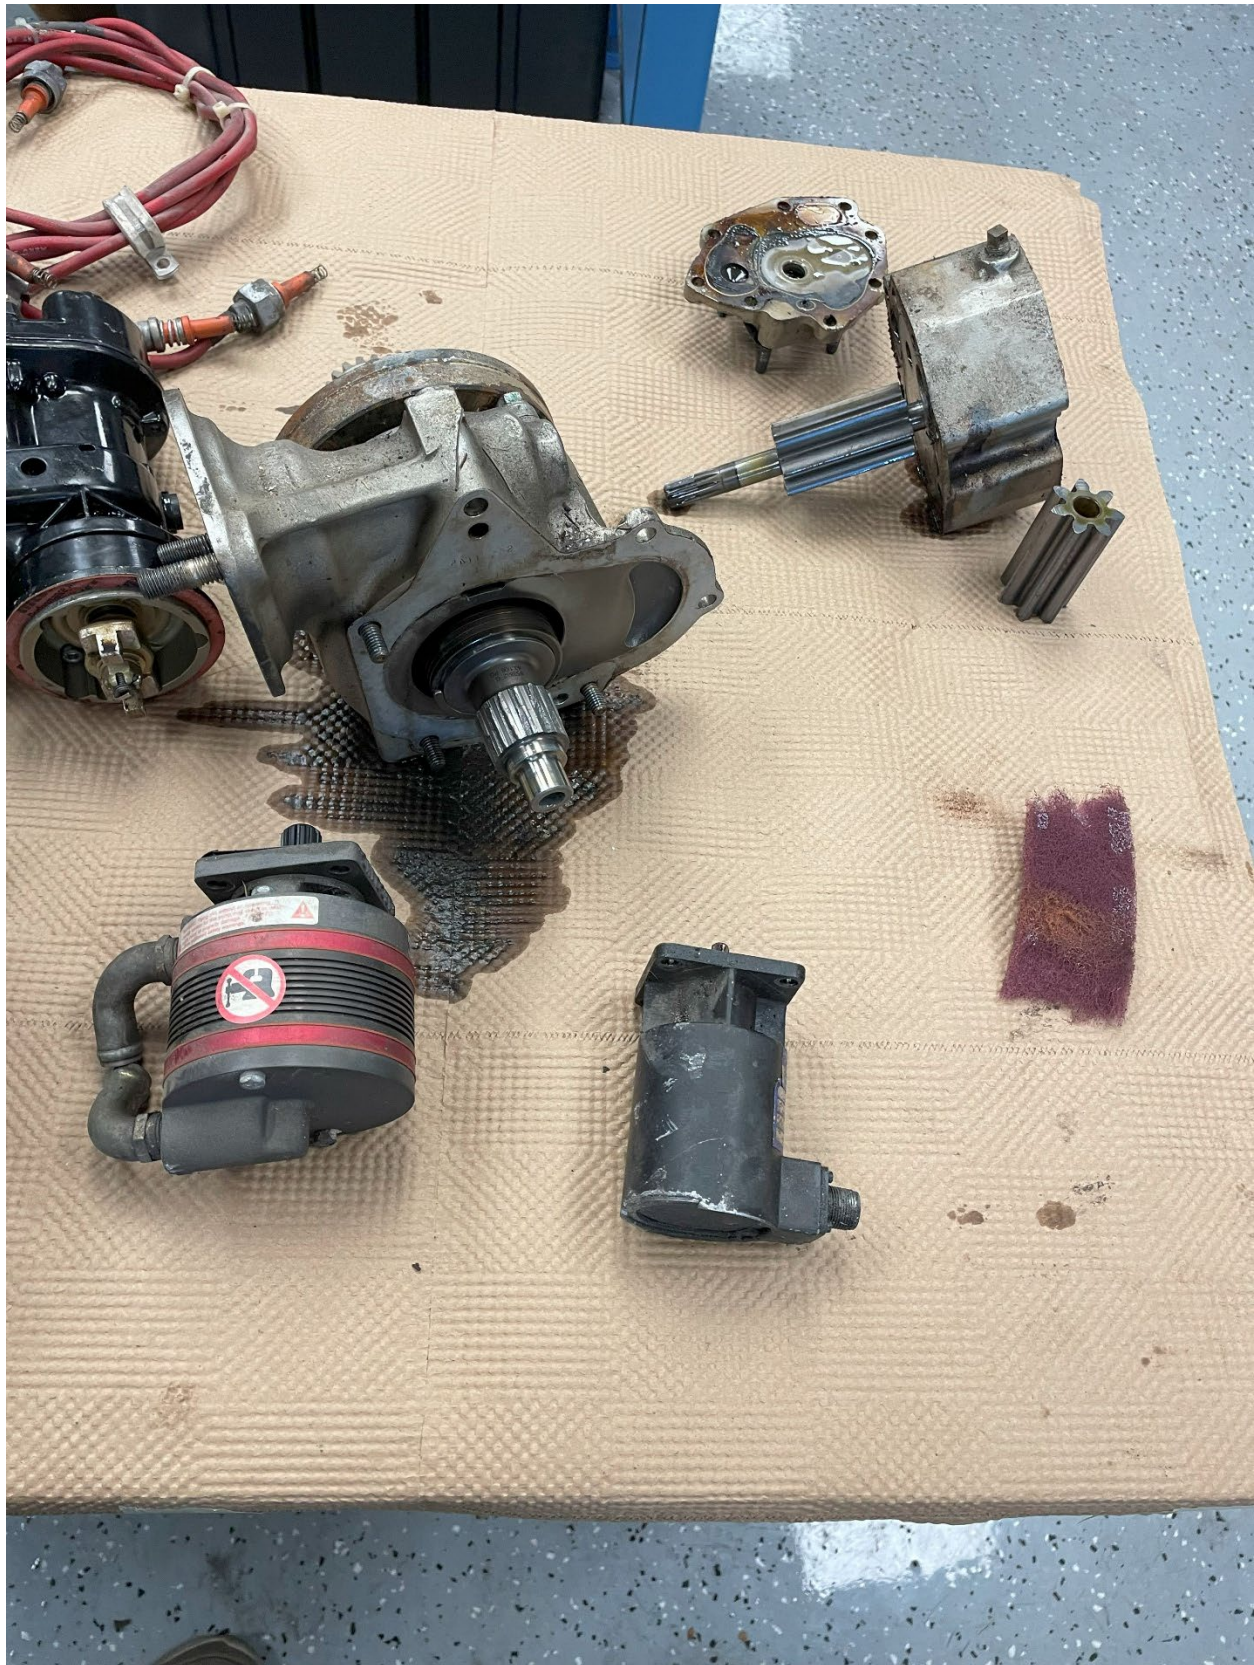
The starter adapter was the subject of FAA Airworthiness Directive 2007-05-15, which was issued "to prevent failure of the starter adapter assembly and or crankshaft gear, resulting in failure of the engine and possible forced landing." The AD required compliance with Continental Motors Mandatory Service Bulletin (SB) MSB94-4H. The SB detailed inspection and replacement procedures for the starter adapter assembly and crankshaft gear. One section of the SB detailed a visual backlash check of the viscous damper installed on the starter adapter. This check was to ensure that excessive wear was not present on the gears of the crankshaft or starter adapter gears. During the engine examinations, the backlash check was performed on the airplane's intact right engine and excessive backlash was not detected. Damage precluded performing the check on the left engine.

Figure 3. Starter gear adapter showing stripped teeth. (NTSB Photo)

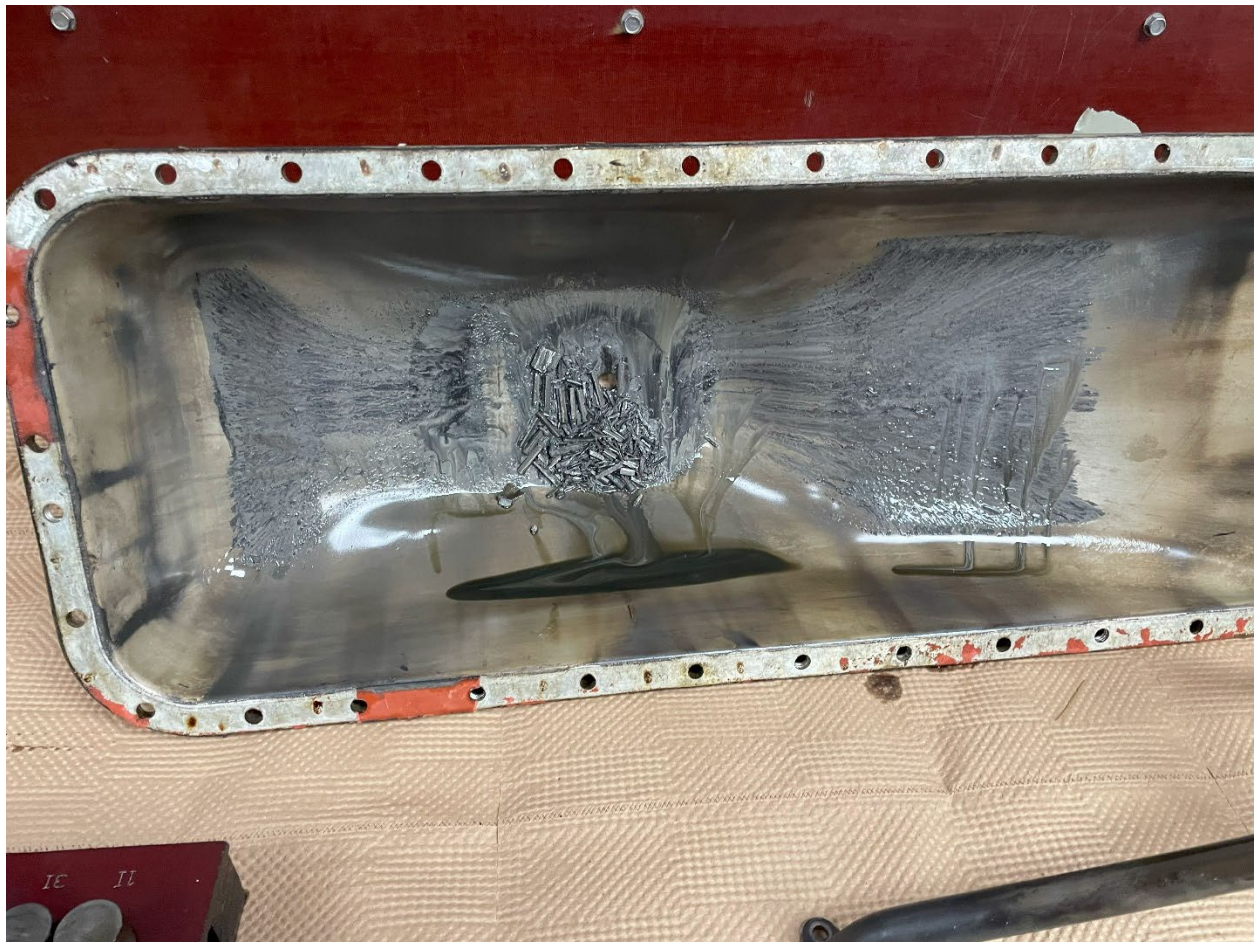
Figure 4. Remnants of gear teeth in engine oil sump. (NTSB Photo)
