# National Transportation Safety Board

CEN23LA267

## **ENGINE TEST RUN FACTUAL OBSERVATIONS**

Location: Rockport, TX  
Date: June 24, 2023  
Time: 1615 CDT  
Airplane: N123SM

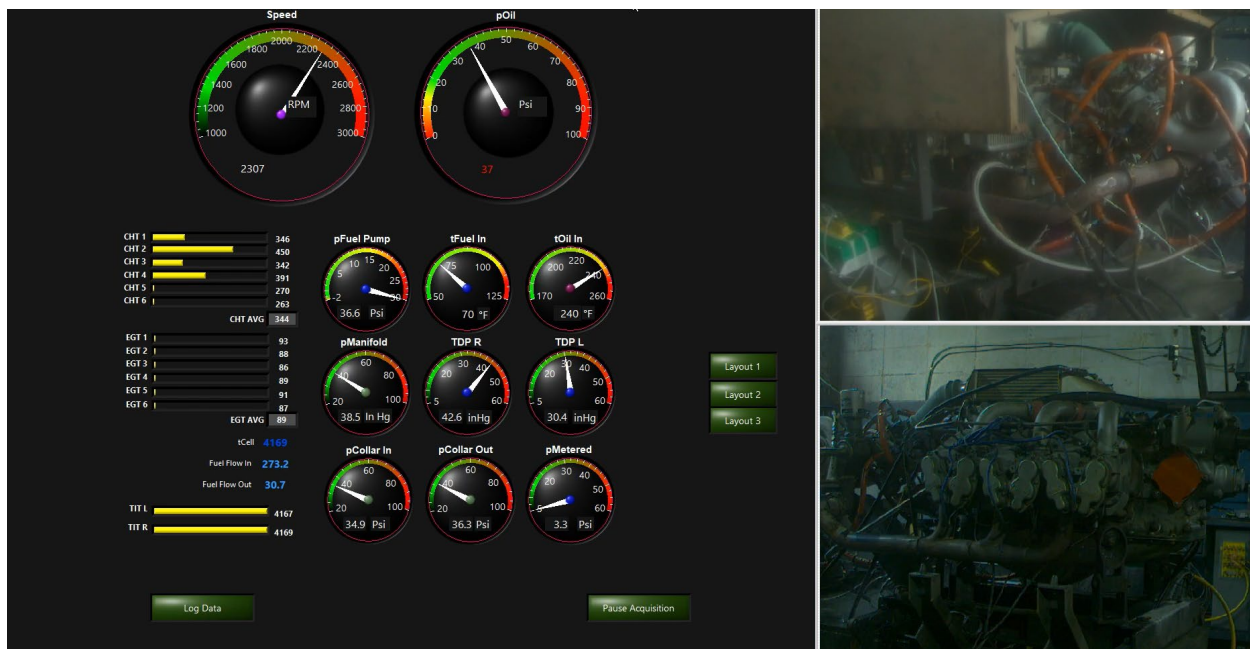
On March 10, 2025, the same individuals re-convened to complete the test running of the right engine. The engine was prepared as before using components from the engine installation in the airframe except for the exhaust piping and wastegate actuator. Again, the engine would not develop full power. It was noted that, as before, the wastegate was remaining fully open. It was decided to remove the slave wastegate actuator and install the actuator from the aircraft for testing which required changing of bracketry to fit on the slave exhaust piping. Once the original actuator was installed the wastegate actuated as expected. During initial running, it was discovered that the engine fuel flow was too high and was not in the range specified by the engine manufacturer. Because of this, the engine would stumble due to a rich mixture in mid-range operation. Adjustment was made to the aneroid adjustment on the engine driven fuel pump to bring the fuel flow parameter within the engine manufacturer's specifications. While performing this adjustment, it was discovered that the aneroid adjustment screw locking nut was not tight. Once fuel flow adjustment was accomplished, the engine was run and developed full power. The engine was able to accelerate smoothly from idle to full throttle with normal advancement of the throttle control. With the engine at full power, the engine test cell gauges indicated about 2,300 rpm at 38.7 inches of manifold pressure. The previous unsuccessful engine runs were deemed to be a result of an unknown incompatibility with the slave components used for testing. When using the original airframe components the engine was able to run and develop full power. The unsuccessful previous engine runs appeared to be a result of an unknown incompatibility between the wastegate controller and the slave wastegate actuator.

Figure 1. Engine test cell monitor image during the final test run. (NTSB Photo)
