CEN23LA268

## INVESTIGATION PHOTOGRAPHS

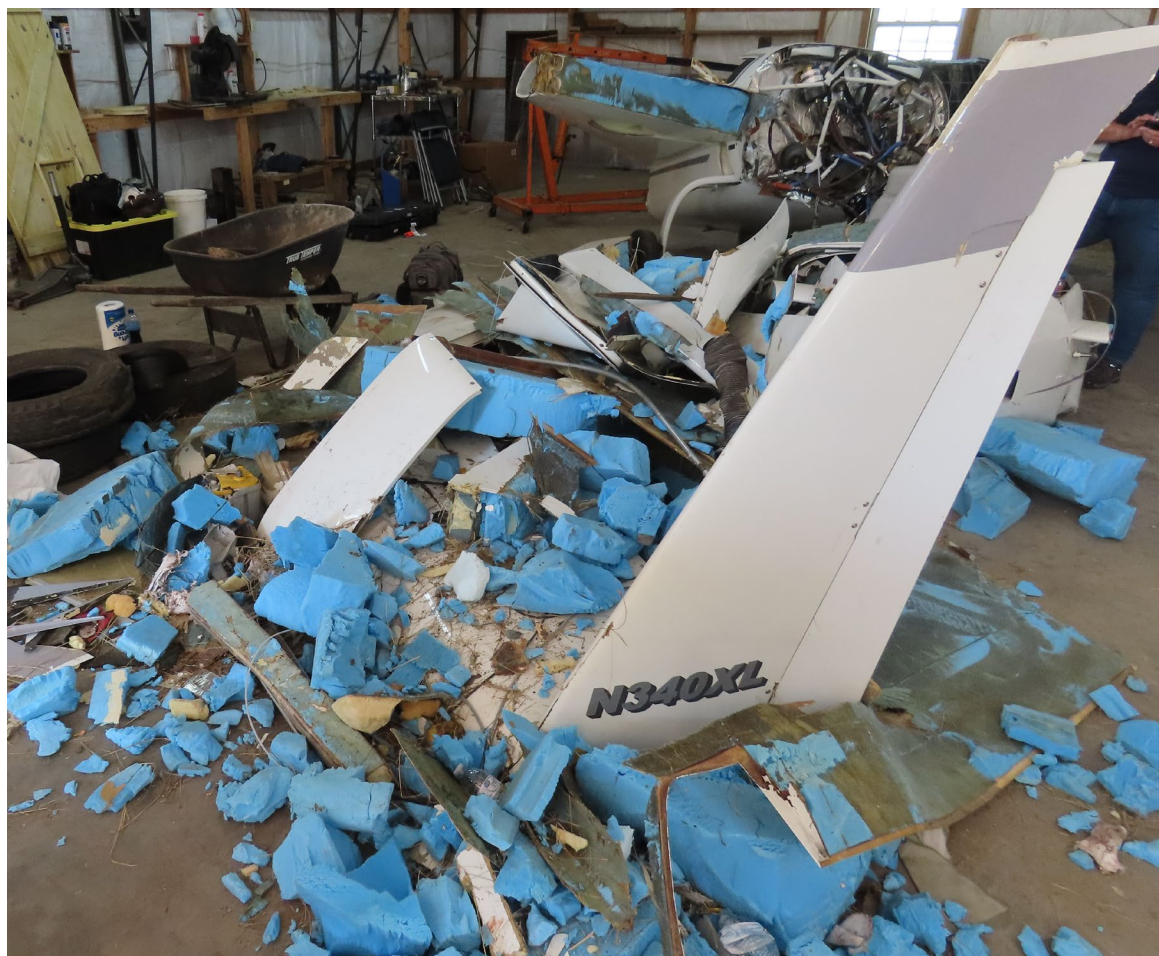
**Photograph 1 - Fragmented Airplane (Courtesy of NTSB)**

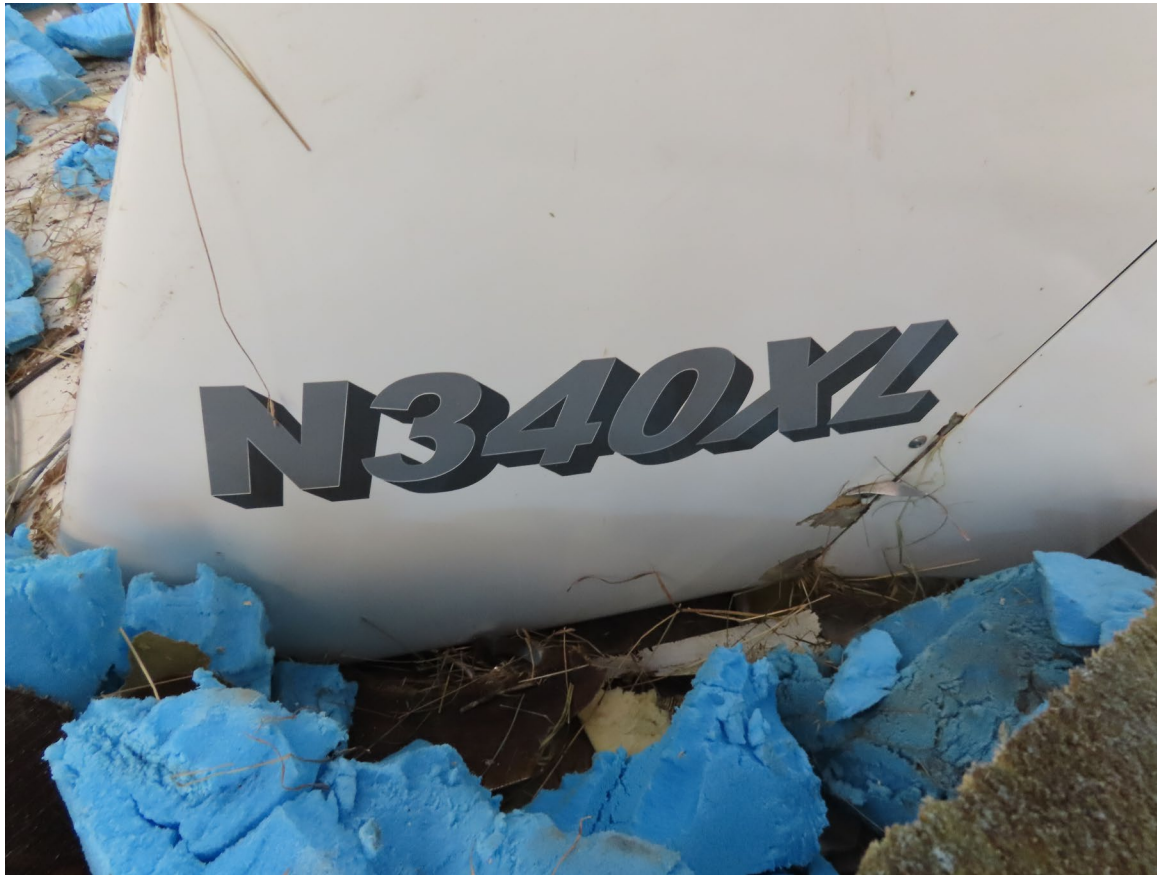
**Photograph 2 - Vertical Stabilizer (Courtesy of NTSB)**

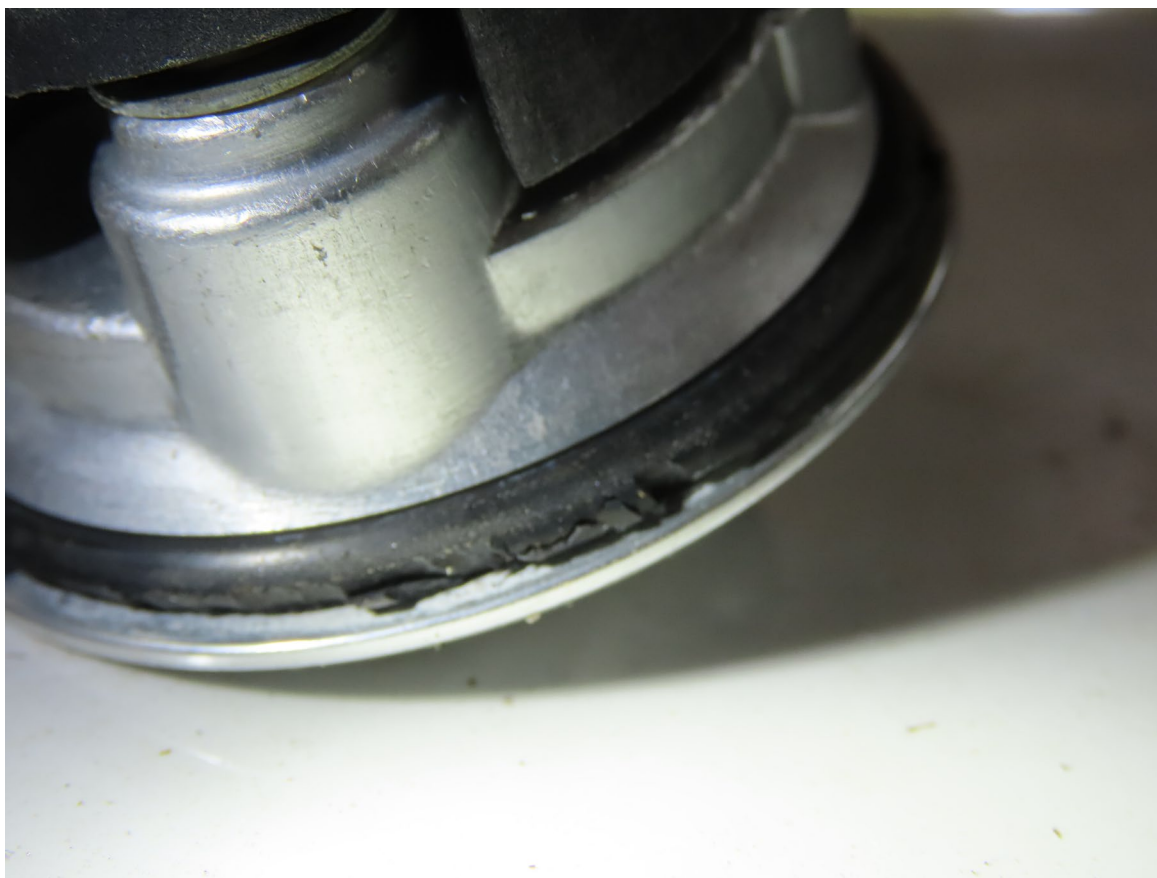
**Photograph 3 - Left Fuel Cap with Cracked O-Ring (Courtesy of NTSB)**

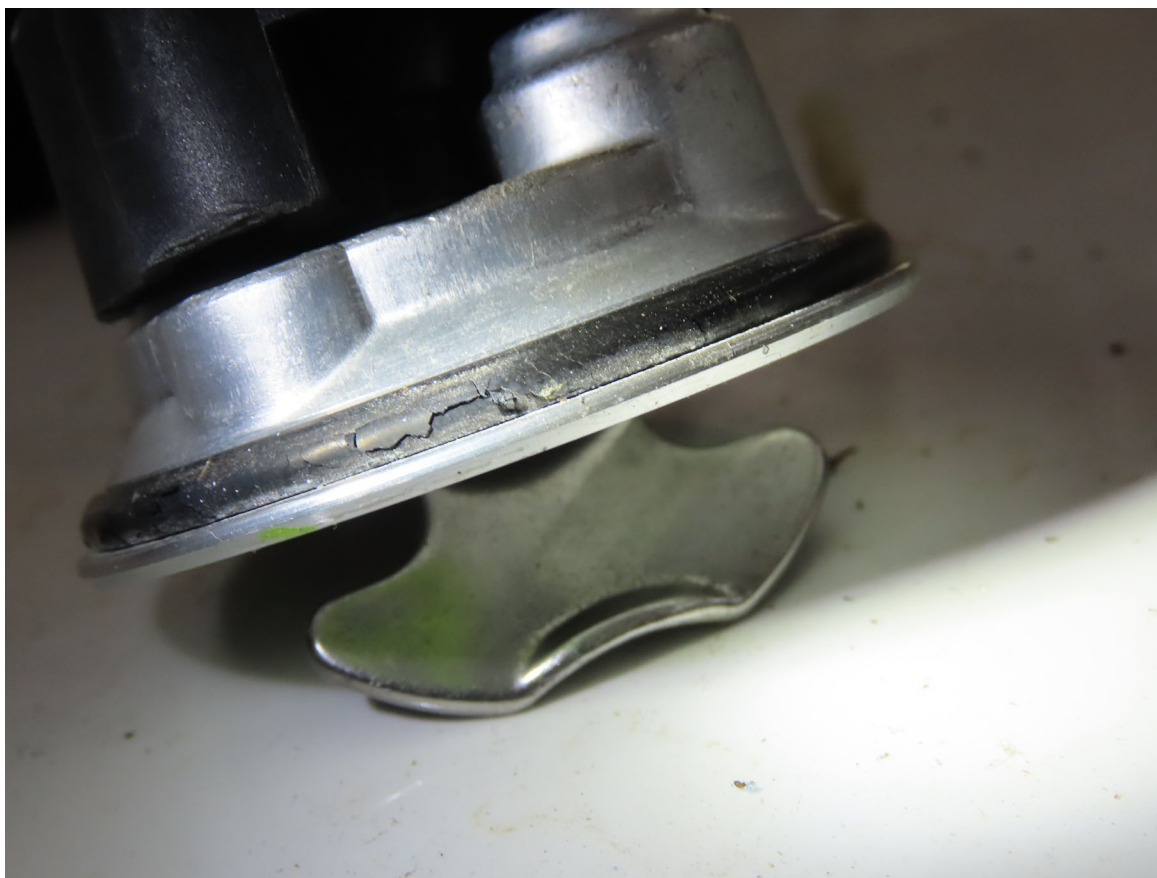
**Photograph 4 - Right Fuel Cap with Cracked O-Ring (Courtesy of NTSB)**
