CEN23LA271

## INVESTIGATION PHOTOGRAPHS

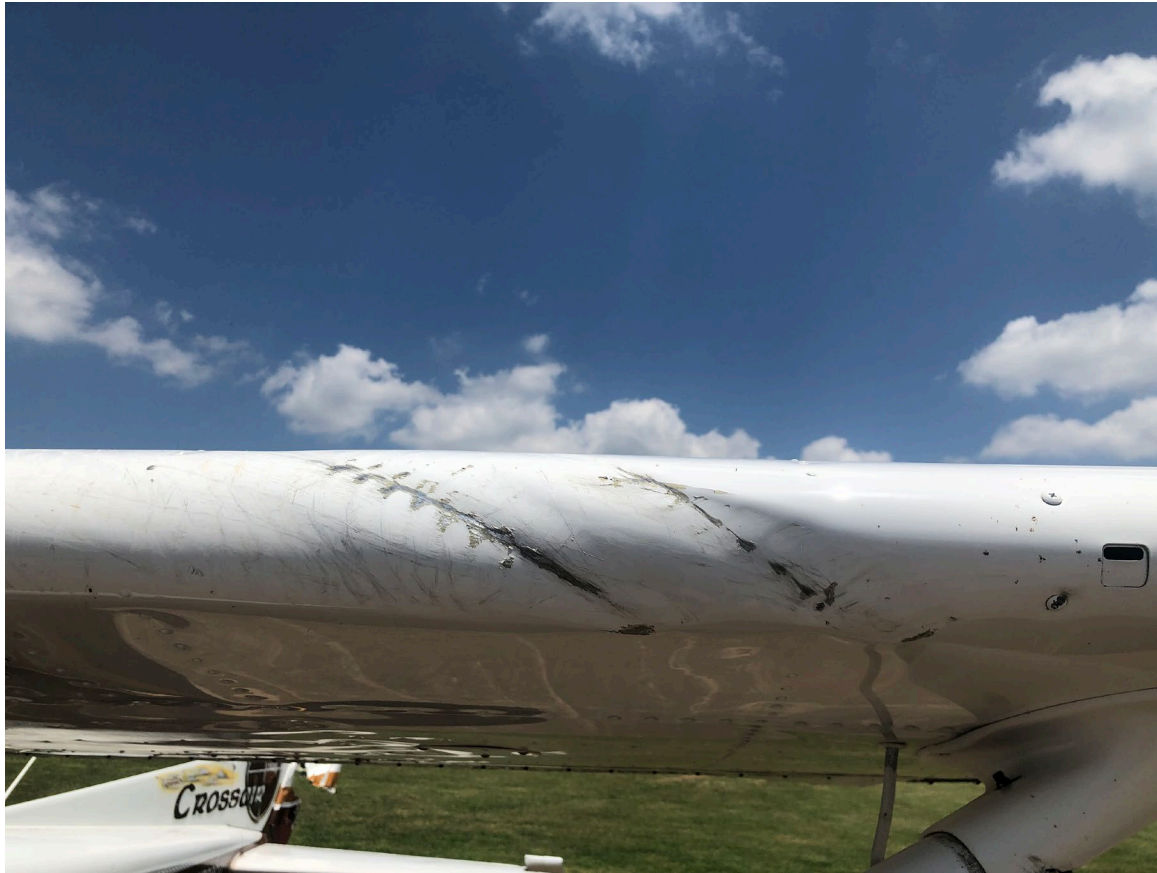
**Photograph 1 - Left Wing Leading Edge (Courtesy of FAA)**

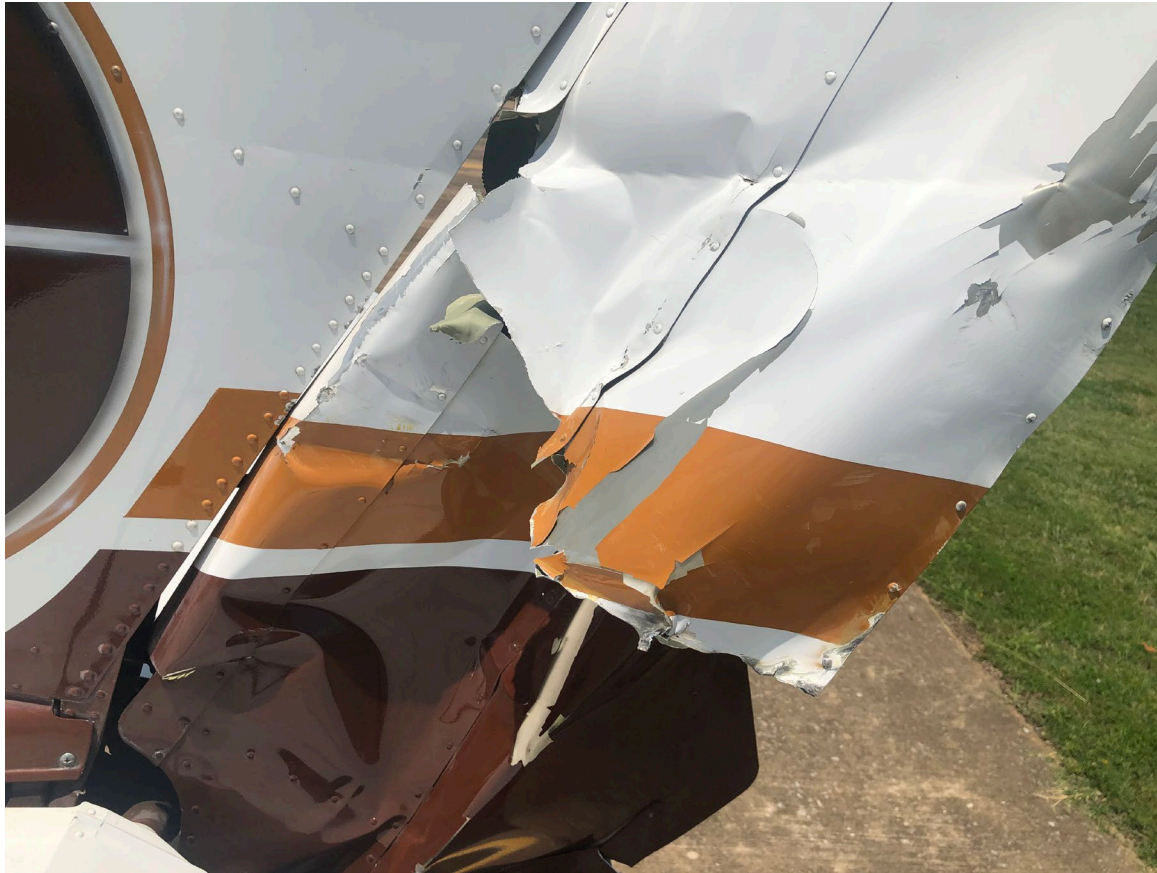
**Photograph 2 - Damaged Rudder (Courtesy of FAA)**

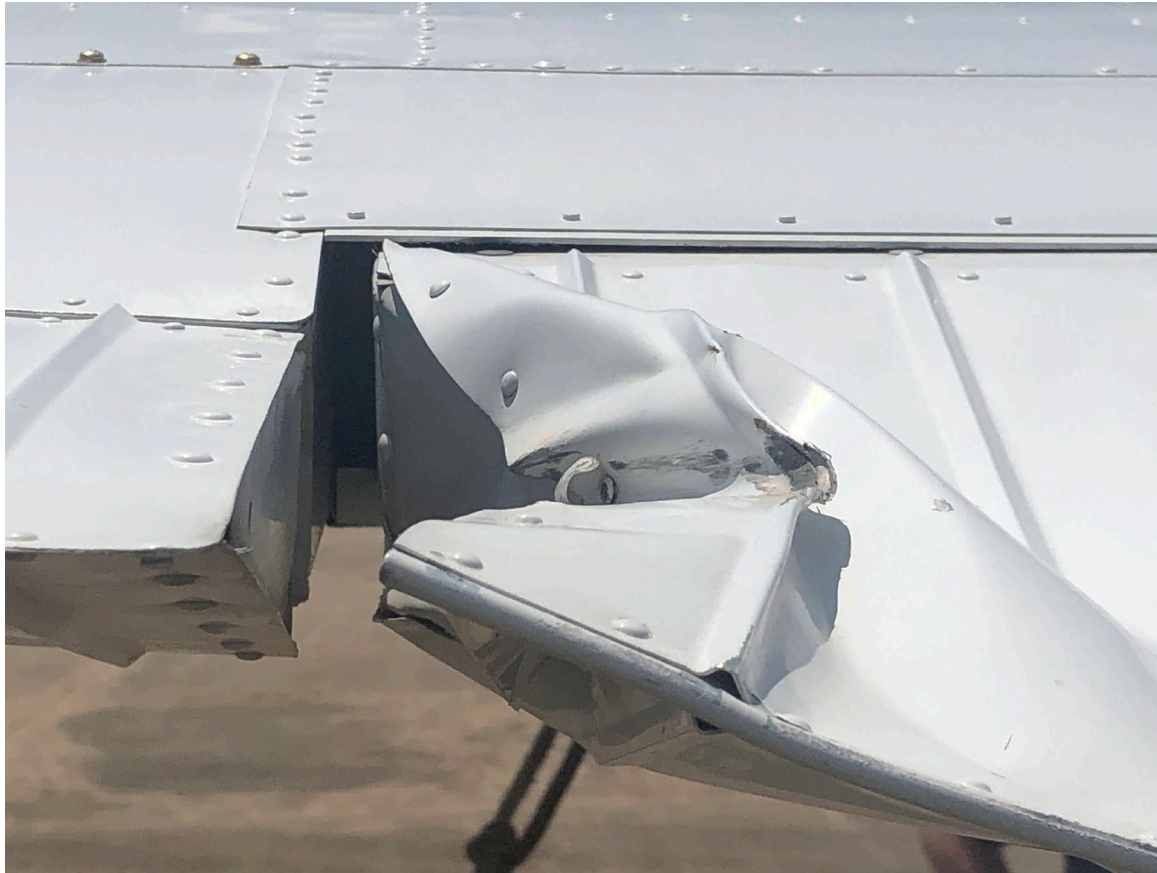
**Photograph 3 - Damaged Left Flap (Courtesy of FAA)**
