CEN23LA306

## INVESTIGATION PHOTOGRAPHS

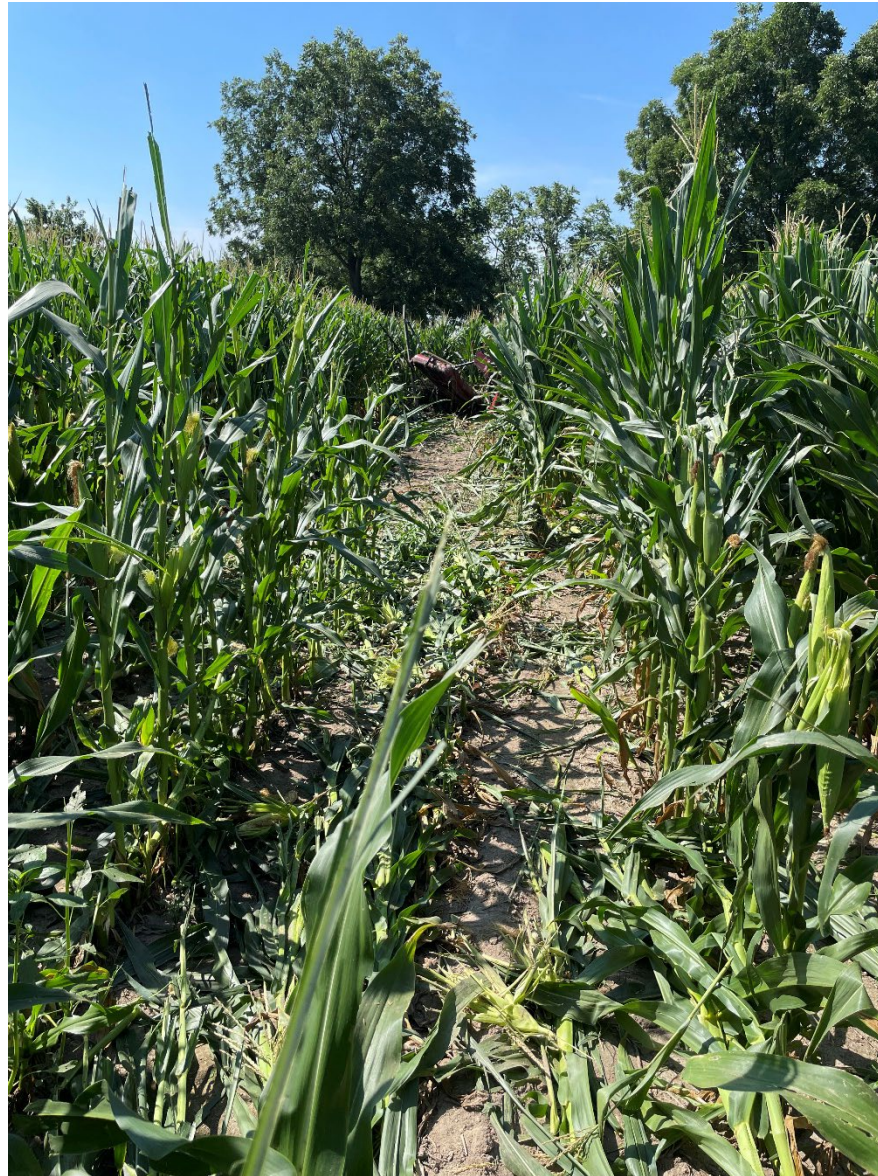
**Photograph 1 - Impact and debris field (Courtesy of the Federal Aviation Administration)**

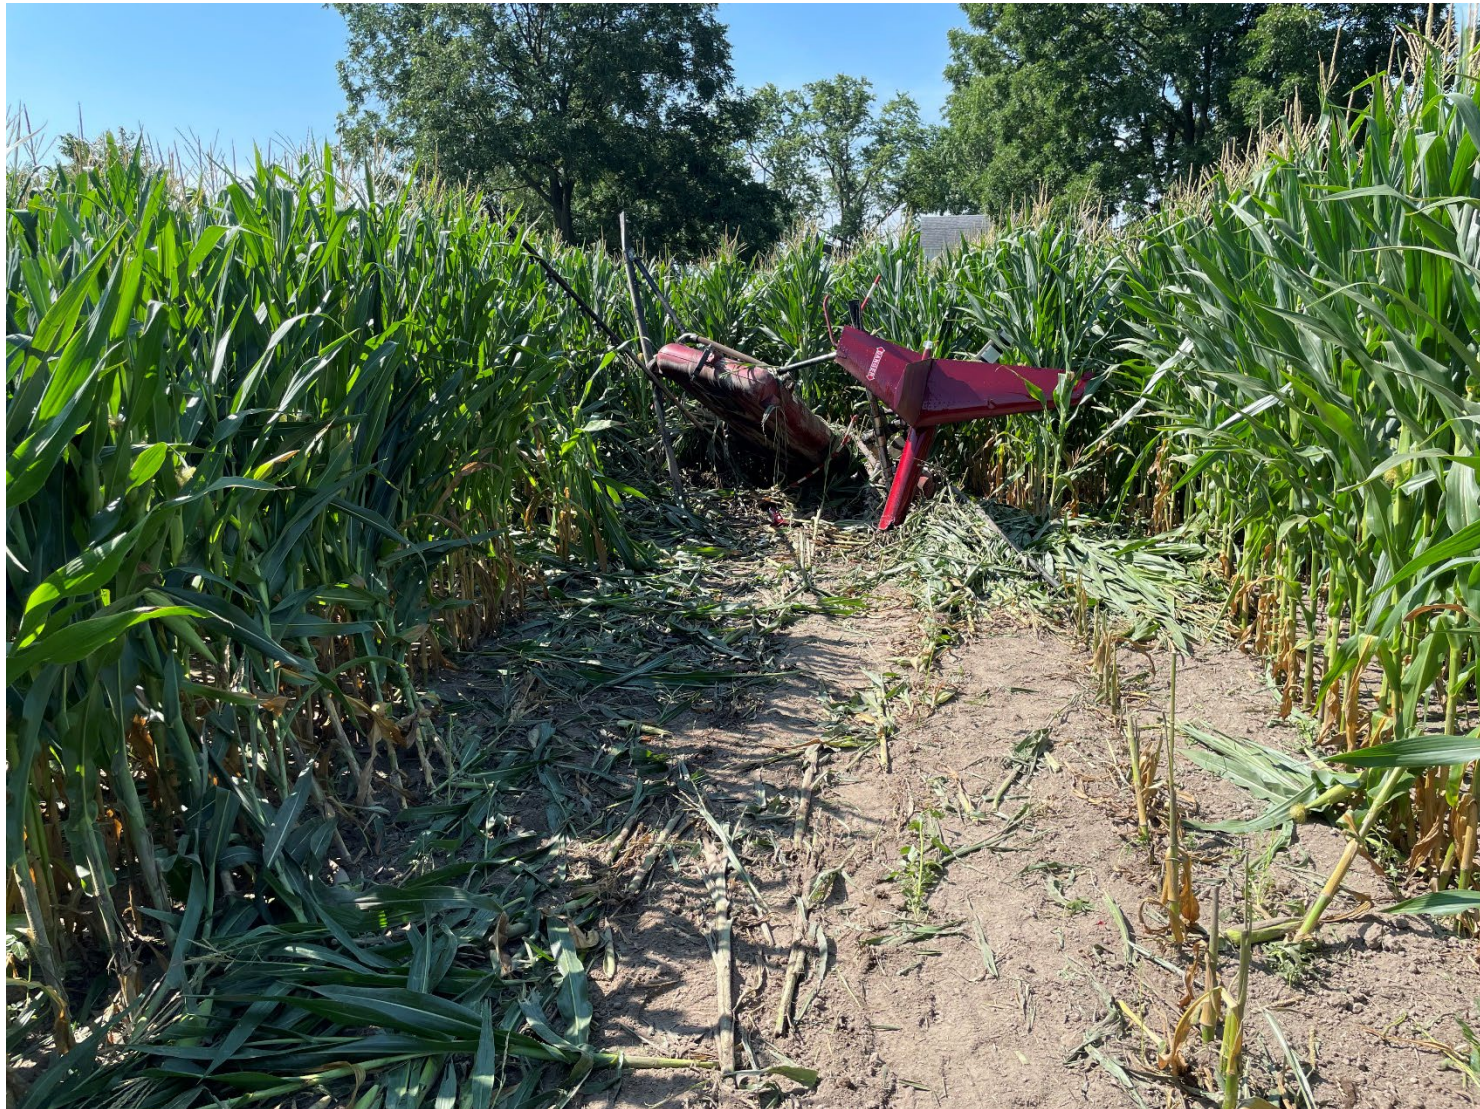
**Photograph 2 - Separated landing gear and tail boom (Courtesy of Federal Aviation Administration)**

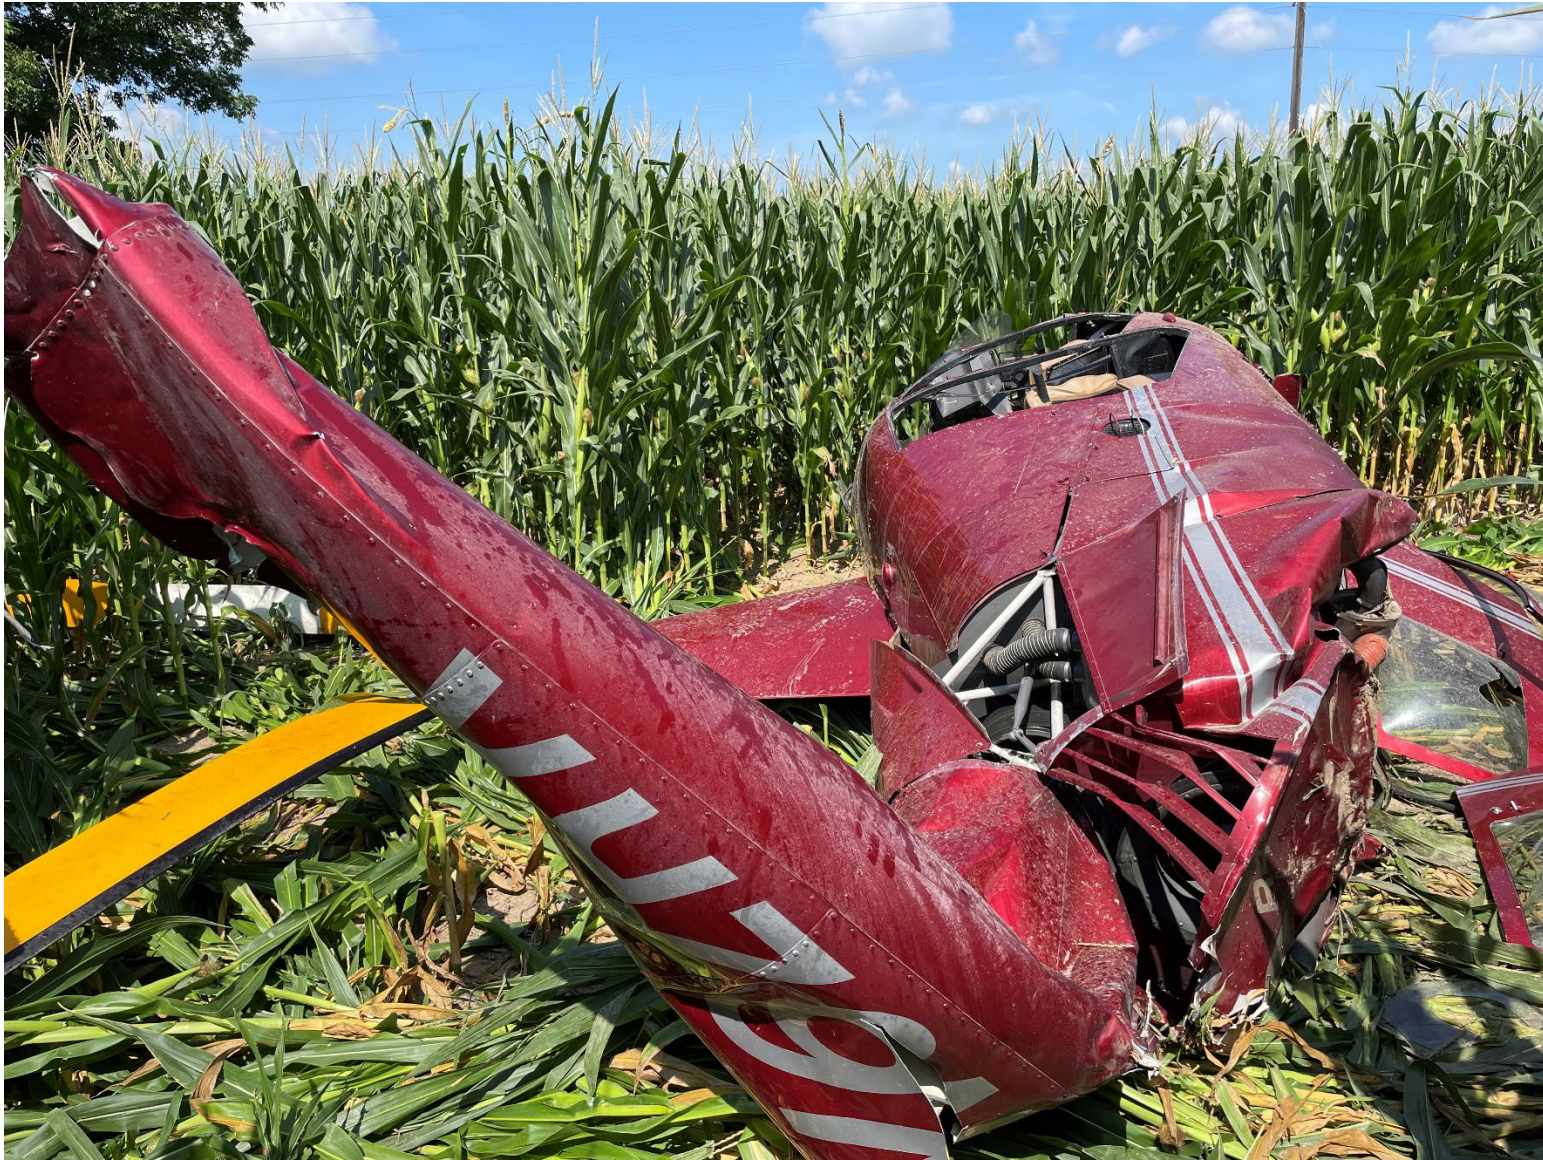
**Photograph 3 - Main wreckage (Courtesy of Federal Aviation Administration)**
