CEN23LA311

## INVESTIGATION PHOTOGRAPHS

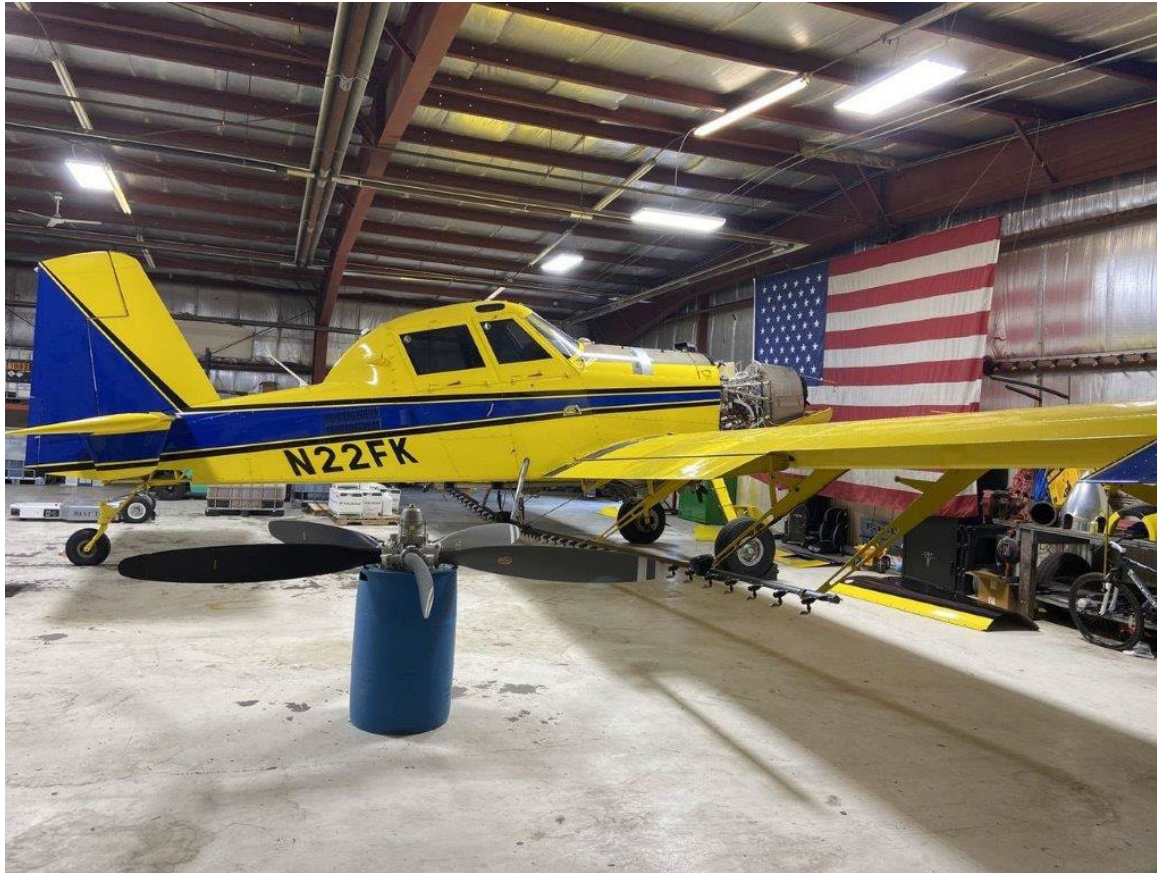
**Photograph 1 - Propeller and right view of airplane (Courtesy of the FAA)**

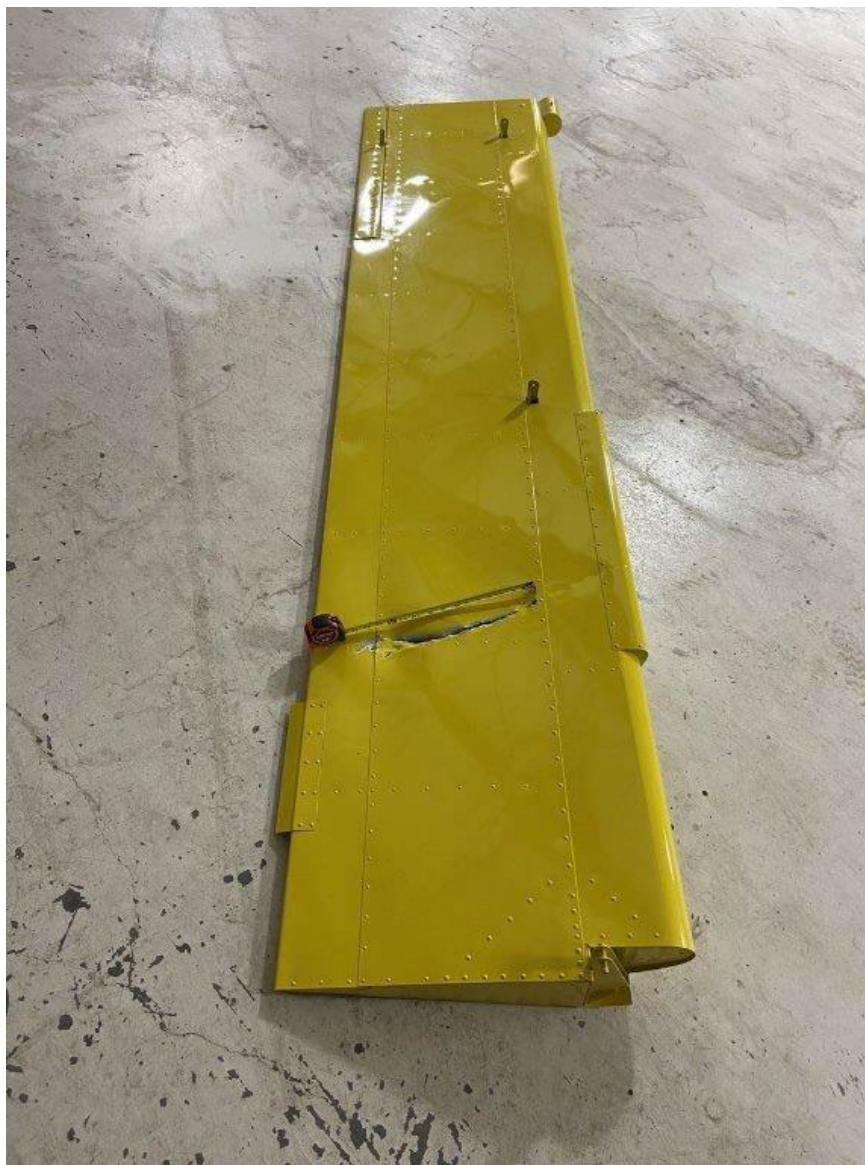
**Photograph 2 - Tears to the aluminum skin of the right aileron (Courtesy of the FAA)**
