# National Transportation Safety Board

CEN23LA319

## **MATERIALS LABORATORY**

Factual Report 24-049

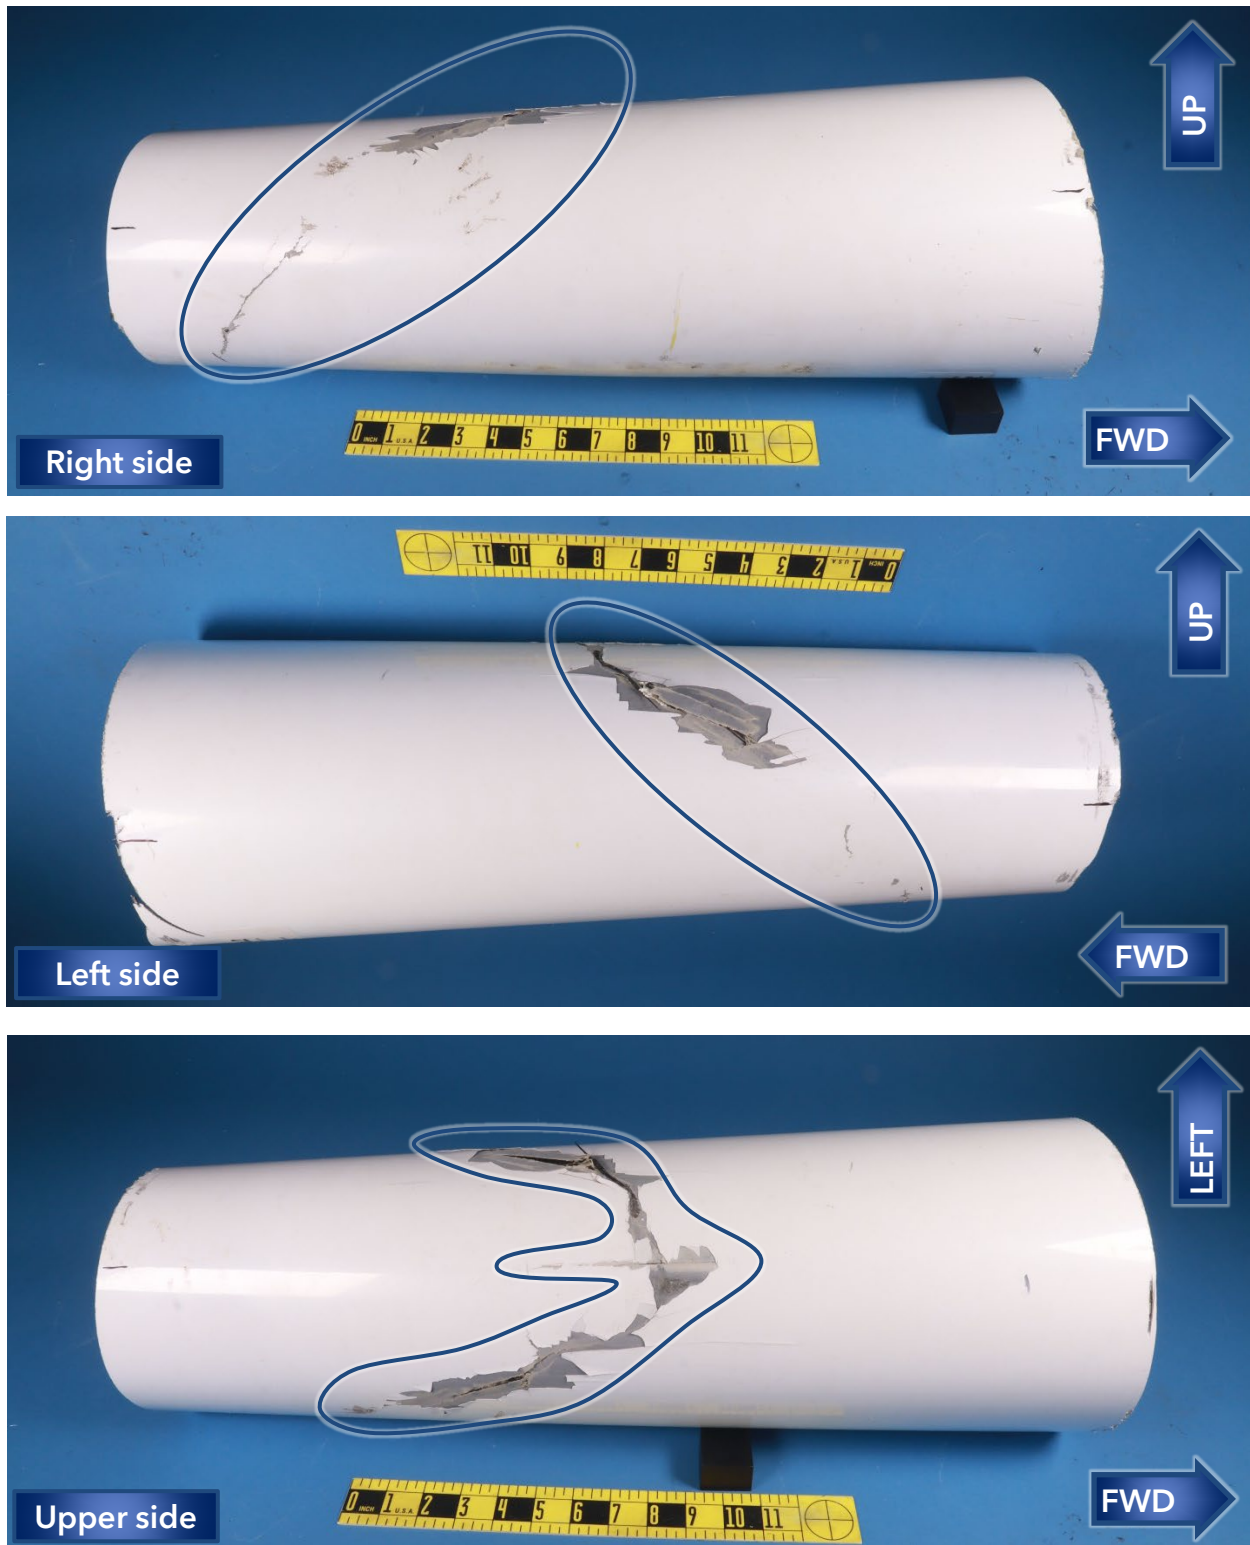
Skin cracks observed on the sectioned piece are shown circled in figures 1 and 2. As shown in the side views in figure 1, the skin cracks were oriented approximately 45° relative to the transverse plane on both the left and right side. Additionally, longitudinal cracks were observed on the upper and lower sides of the skin. The 45° cracks intersected the longitudinal crack at the upper side of the skin as indicated by the continuous boundary around the cracked areas. On the lower side of the fuselage, the cracks oriented at 45° were separate from the longitudinal crack as indicated with separate circled areas shown in figure 2.

**Figure 1.** Overall views of the submitted fuselage section showing the right side (upper image), left side (middle image), and upper side (lower image). Locations of cracks are outlined.

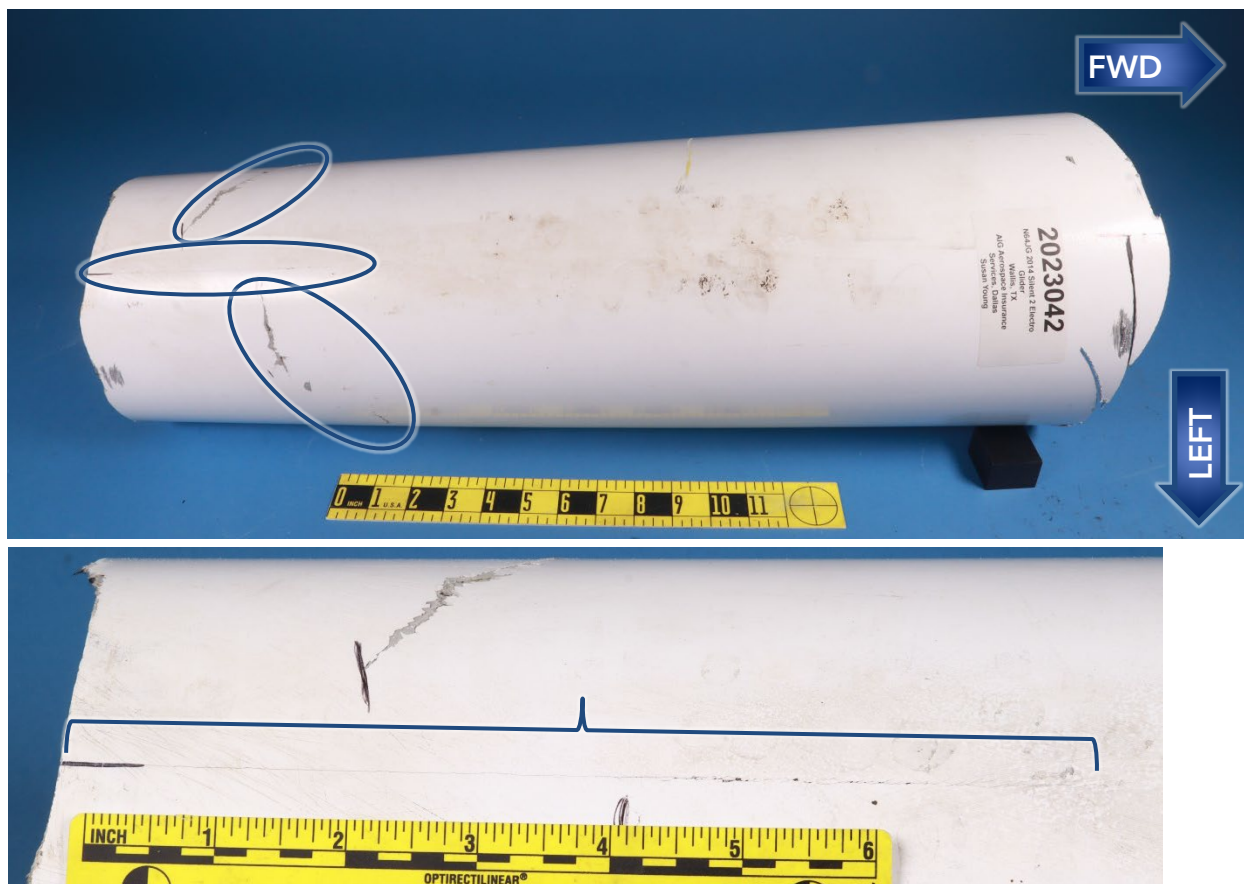
**Figure 2.** Overall view of the lower side of the submitted fuselage section (upper image), where locations of cracks are outlined. The lower image shows a closer view of the longitudinal crack as indicated with an unlabeled bracket after the surface was rubbed with a fine black powder to help reveal the forward end of the crack in the white paint.

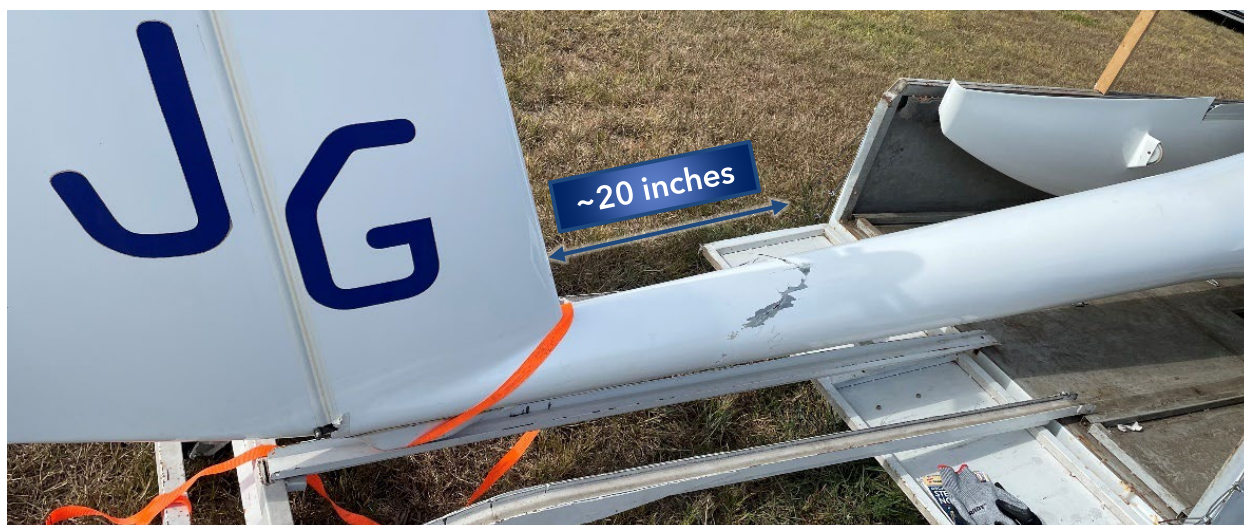
Overall views of the submitted fuselage piece are shown in figures 1 and 2. The 26-inch long piece was from the aft end of the fuselage forward of the empennage. The damaged area of the fuselage is shown in figure 3 before it was sectioned from the aircraft. As shown in the image, cracks on the upper side of the fuselage were located up to approximately 20 inches forward of the vertical stabilizer.

**Figure 3.** View of the damaged fuselage before it was sectioned from the aircraft. (Image provided by the Federal Aviation Administration)

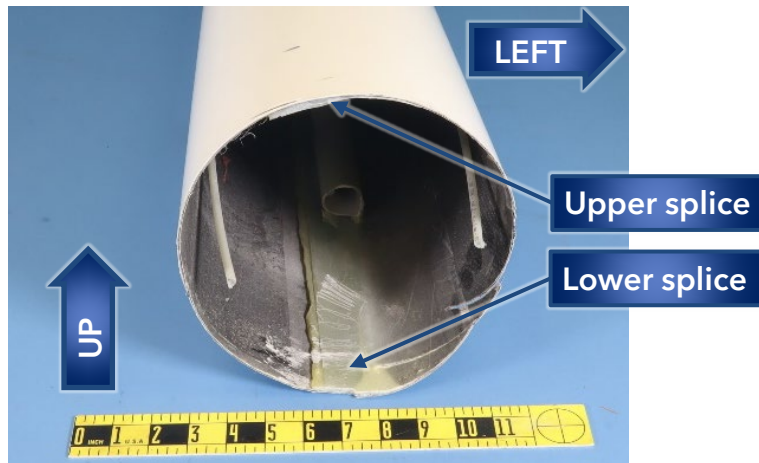
The fuselage skin was made from fiber reinforced polymer composite materials with both glass fiber and carbon fiber fabric reinforcement. The fuselage skin was constructed of two halves (left half and right half) that were spliced together at the upper and lower sides as indicated in figure 4. At each splice location, the skin layers butted together, and strips of glass-fiber reinforced fabric were bonded to the interior surfaces to form single strap butt joints.

**Figure 4.** End view of the fuselage section showing longitudinal splice locations for the fuselage skin halves.

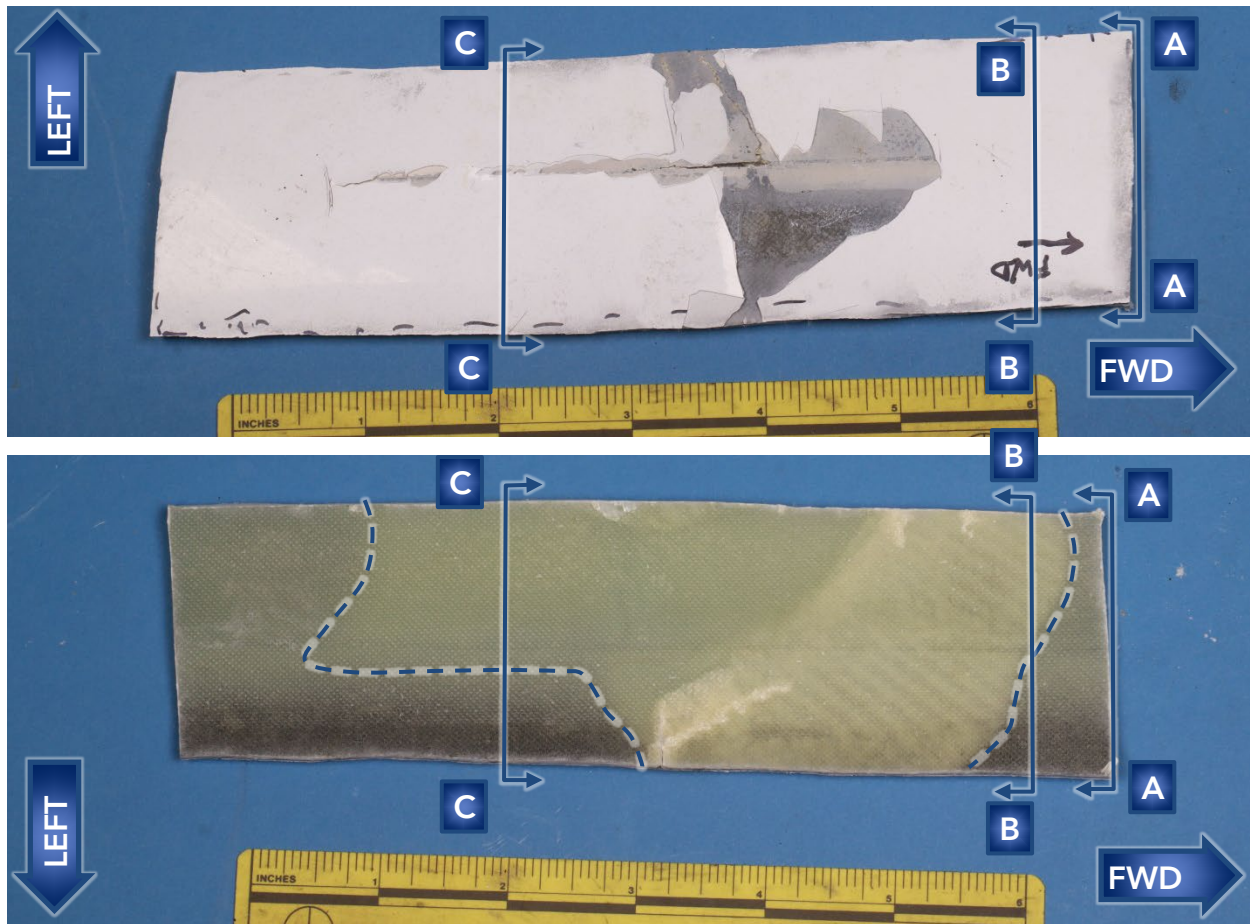
A portion of the upper skin containing the longitudinal crack and a section of the upper splice was cut from the remainder of the fuselage skin using a hand-held cutting tool with an oscillating diamond-coated blade. Views of the exterior and interior surfaces of the sectioned piece are shown in figure 5. On the interior side, a

portion of the strap had a lighter appearance within the region shown bounded by dashed lines in the lower image in figure 5. The change in color was consistent with a disbond between the strap and the skin.

**Figure 5.** Piece of fuselage skin removed from the cracked upper splice. Arrowed lines A-A indicate the location of the transverse materialographic section shown in figures 6 through 8. Lines B-B and C-C indicate locations of transverse sections shown in figure 10. Dashed lines in the lower image indicate a lighter region likely associated with strap disbonding.

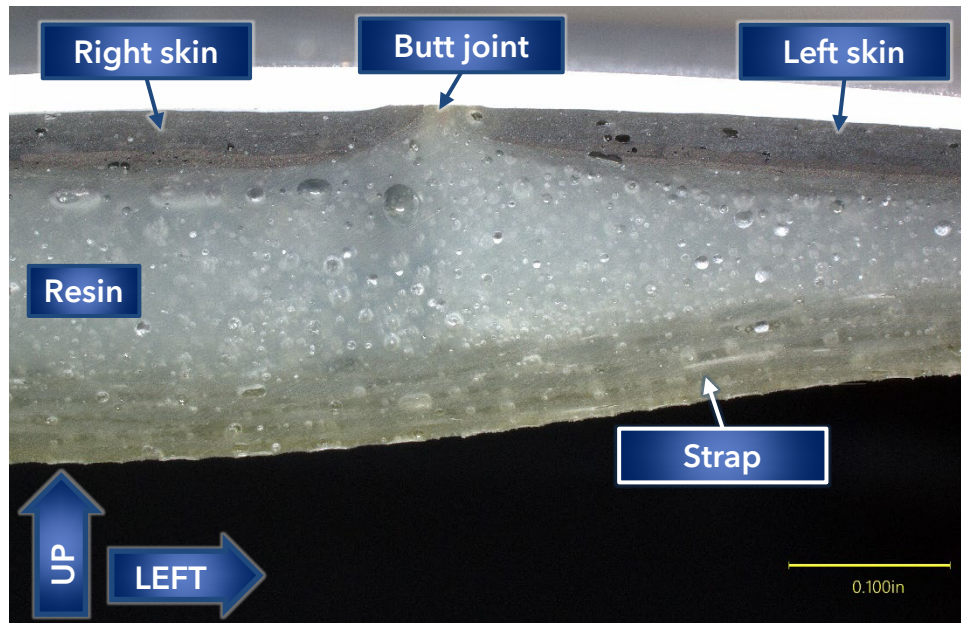
The middle of the splice between the left and right skin halves is shown in figure 6. Resin filled the gap between the butt ends of the left and right skin layers and the area between the strap and the skins. The resin layer was approximately 0.10 inch thick on the right side of the splice and became thinner toward the left side as shown in figure 7. The skin and strap layers were closely bonded to each other at the left side of the splice.

**Figure 6.** Materialographic section A-A showing the middle of the single strap splice where the butt ends of the fuselage skin halves were joined.

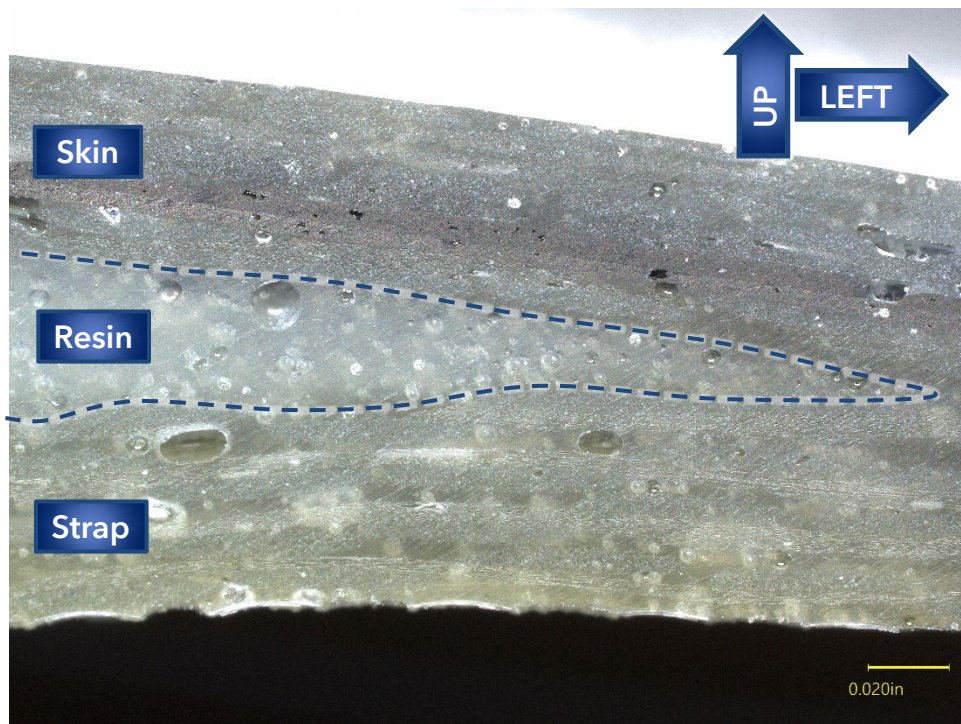
**Figure 7.** Materialographic section A-A showing the left end of the resin pocket (outlined with a dashed line) between the strap and the fuselage left skin half.

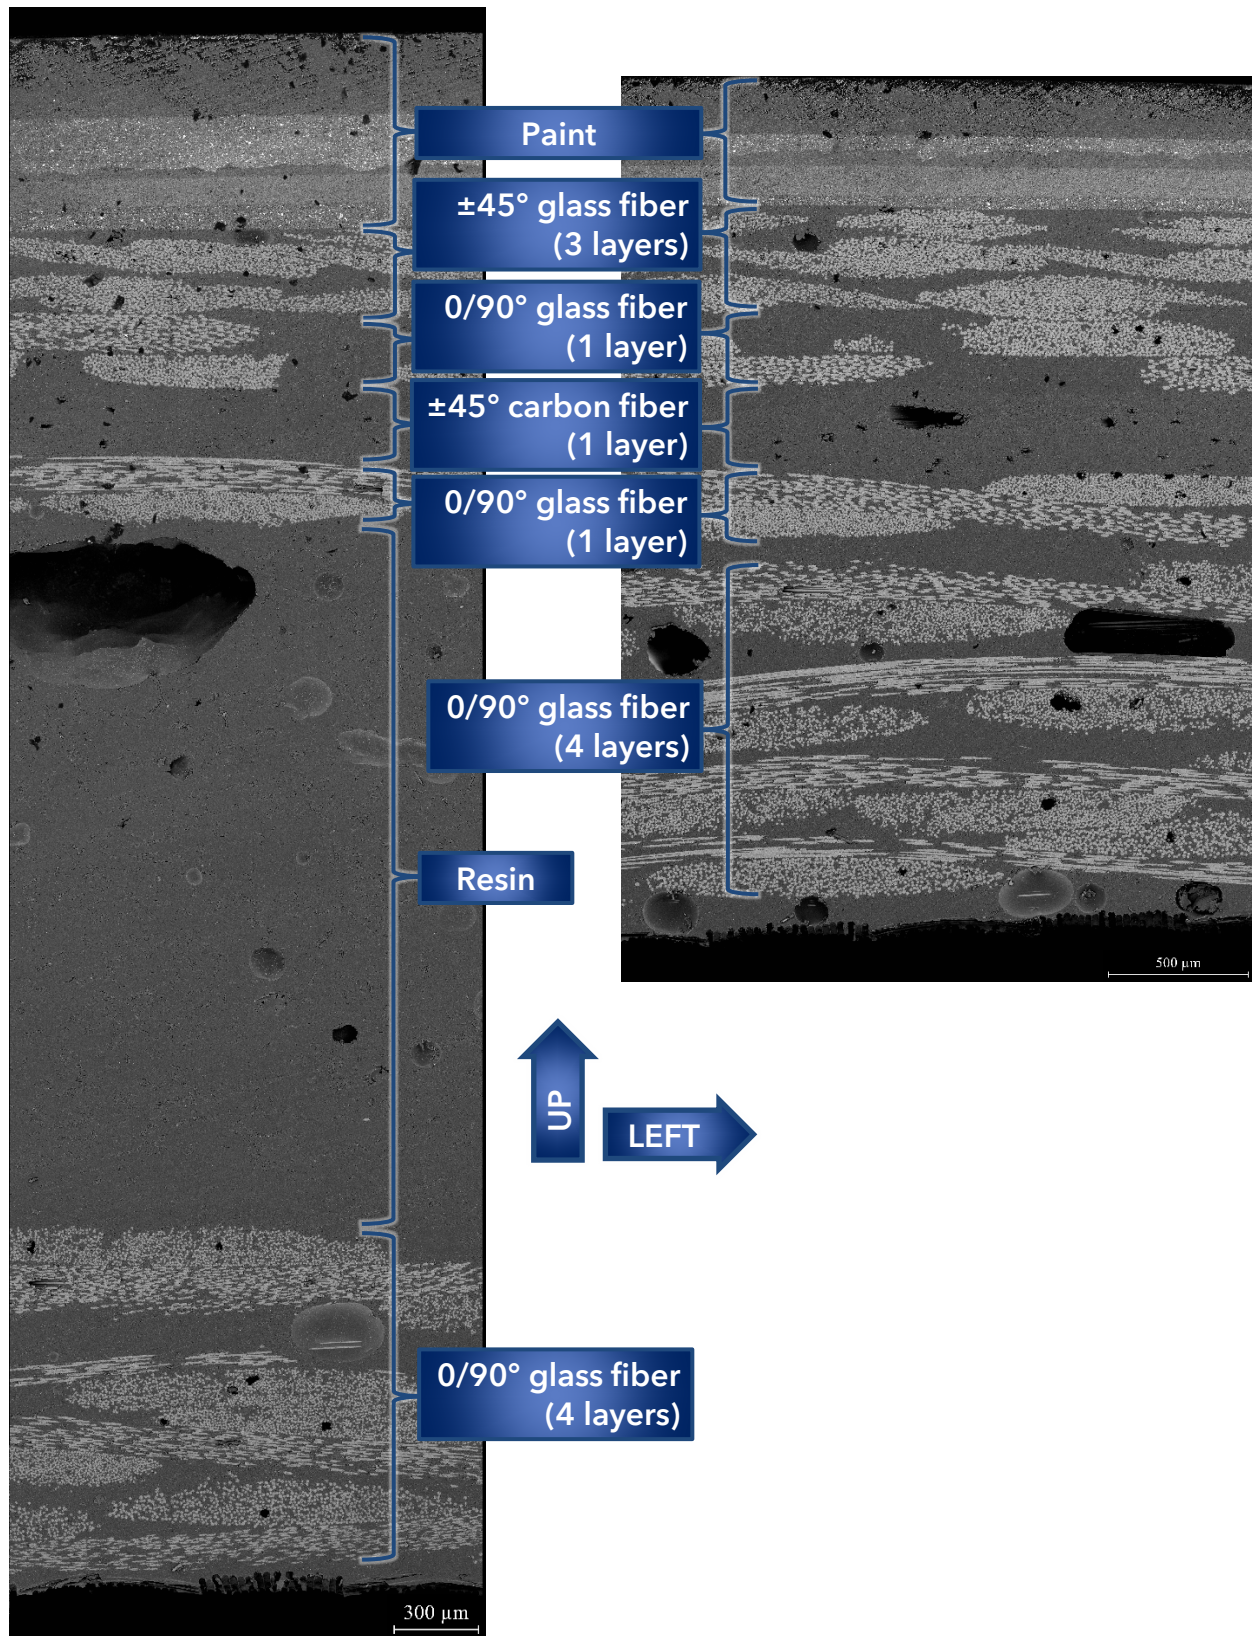
The SEM images of the cross-section shown in figure 8 were obtained using a backscatter detector in composition mode.<sup>1</sup> The displayed images are collections of individual SEM images that were stitched together to show overall views of the layup in the single strap splice to the left and right of the butt joint. Glass fibers appear lighter gray relative to the carbon fibers and resin, and voids appear relatively dark. Fiber orientations were determined by relative elongation of fibers ends where they intersected the transverse plane with little or no elongation to 0-degree fibers, intermediate elongation to  $\pm 45$ -degree fibers, and relatively high elongation associated with 90-degree fibers. All fibers were observed in bundles consistent with fabric construction. No evidence of glass fiber roving was observed, including in the resin pocket between the strap and the skin.

**Figure 8.** SEM images stitched together to show materiallographic section A-A on the right side (left image) and left side (right image) of the single strap splice.

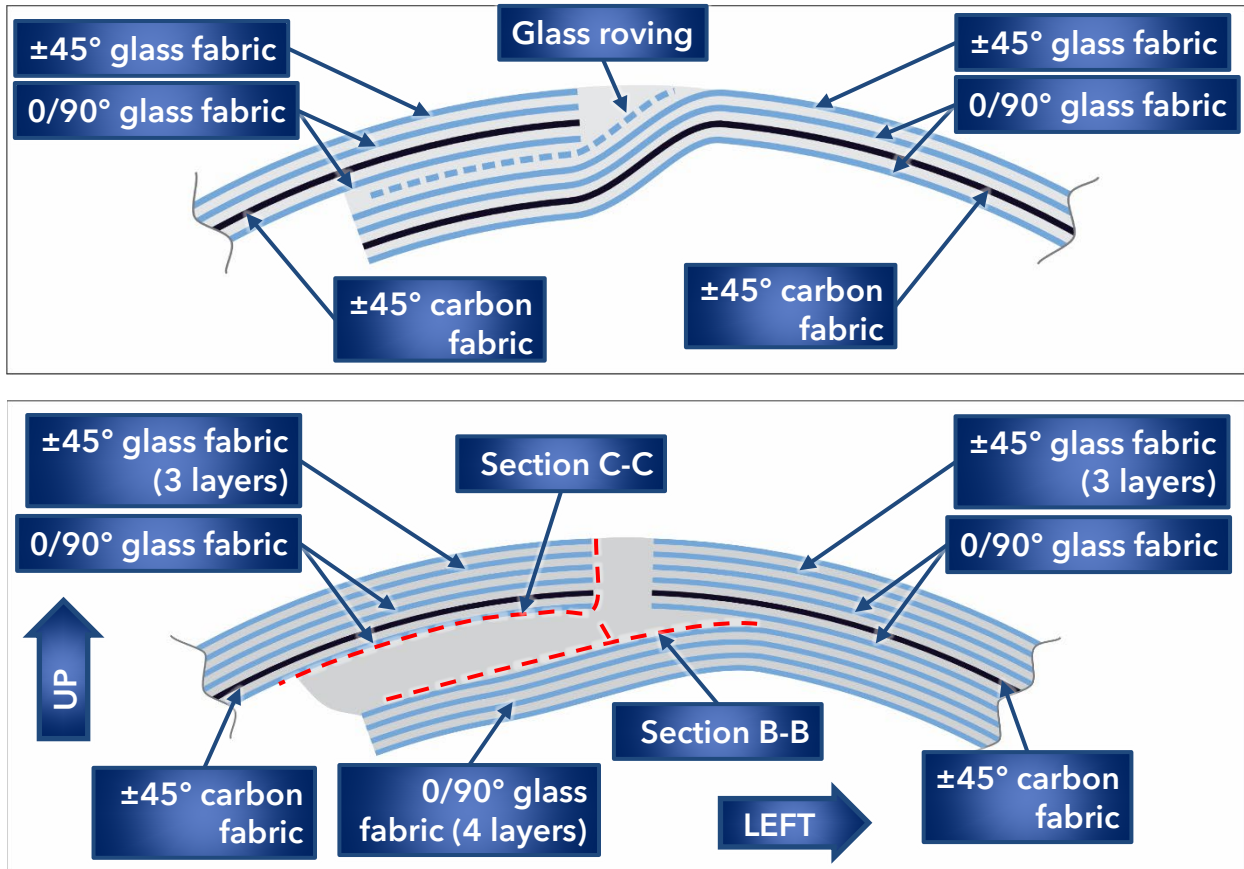
Availability of information about the construction of the fuselage for the accident aircraft was limited. Alisport engineering drawing T-SE-X37017, revision 4, dated August 6, 2004, titled Silent Ellisse (Silent 2) fuselage lamination scheme was obtained and reviewed. The drawing indicated each half of the fuselage skin at the damaged location forward of the empennage would consist of 1 layer  $\pm 45^\circ$  glass fiber, 1 layer 0/90° glass fabric, 1 layer  $\pm 45^\circ$  carbon fiber, and 1 layer 0/90° glass fiber starting from the outside surface as shown in the upper image in figure 9. The longitudinal joint between the halves was shown as an overlap joint with 6 threads of glass roving (represented by a blue dashed line in figure 9) in the dished portion of

The accident aircraft was serial number 2067 manufactured in 2014. The as-built construction at the location of the materialographic section as illustrated in the lower image in figure 9 showed skins with 2 additional  $\pm 45^\circ$  glass fabric layers on the exterior relative to the reference build drawing. Additionally, the joint between the two halves was a single strap butt joint instead of the overlap splice shown in the reference drawing. The strap consisted of four layers at the centerline and to the right of the butt joint. To the left of the joint, the layers of the strap tapered to 1 layer ending approximately 4 inches from the butt splice. No evidence of  $0^\circ$  glass roving was observed in the as-built splice. Although the skin layers had a mix of fabric orientations with some layers in the  $0/90^\circ$  orientation and others in the  $\pm 45^\circ$  orientation, all four layers of the strap were oriented in the  $0/90^\circ$  orientation.

**Figure 9.** Diagrams of the layup for the skin at the upper splice between the two fuselage halves showing a comparison between the skin layup schedule as presented in an Alisport engineering drawing from 2004 (upper image) and the as-built structure, manufactured in 2014, observed in a cross-section of the accident aircraft fuselage (lower image). Glass fiber reinforcement layers are shown in blue, and carbon fiber reinforcement layers are shown in black. Dashed red lines in the lower image indicate the approximate crack paths in the joint at transverse sections B-B and C-C (see figures 5 and 10).

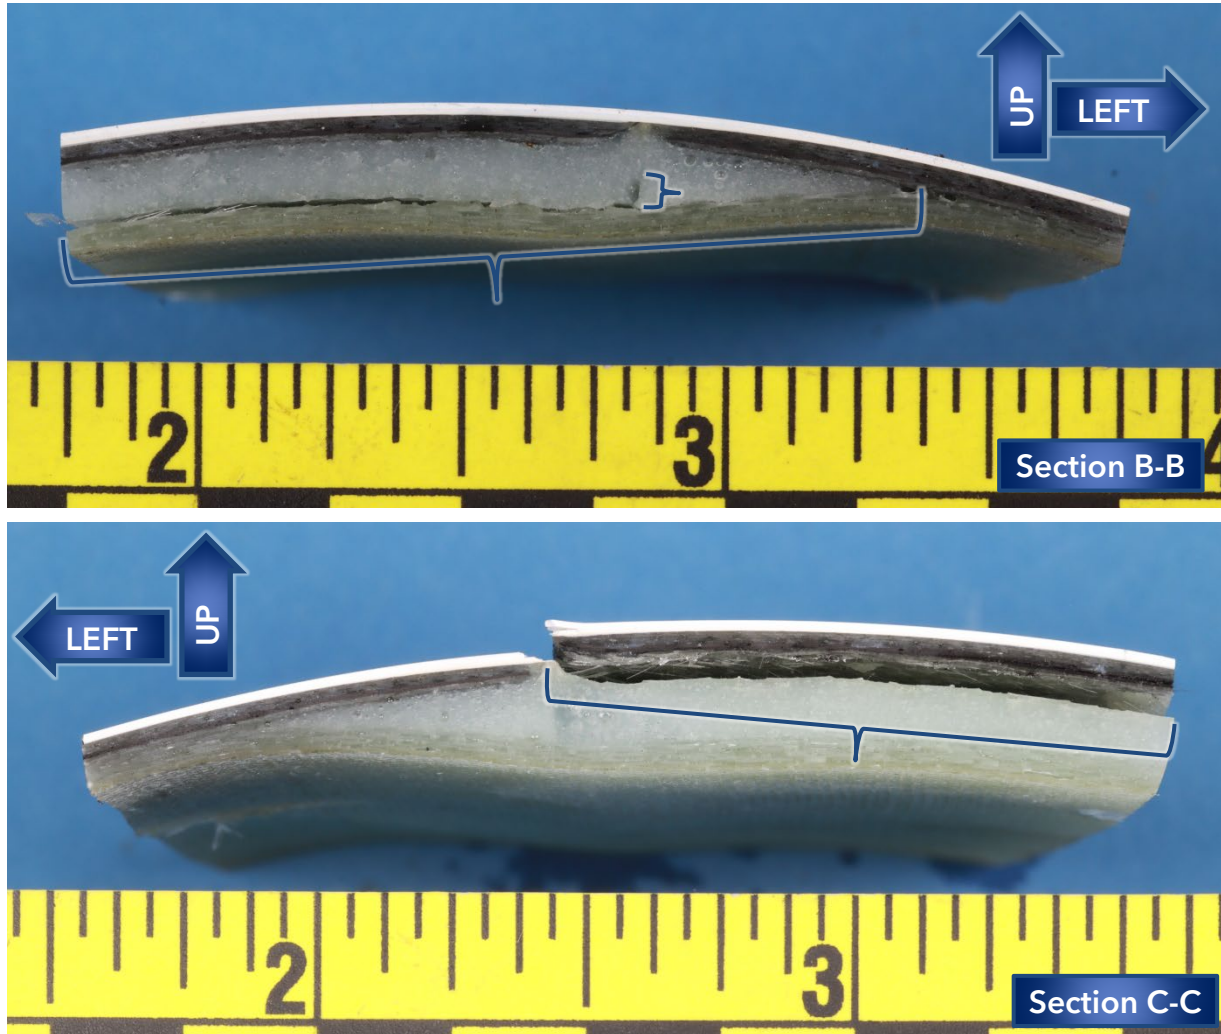
The cut faces from transverse sections B-B and C-C through the piece shown in figure 5 were photographed as shown in figure 10. In section B-B, a transverse crack was observed between the resin pocket and the strap as indicated with the larger bracket in the upper image in figure 10. A smaller vertical crack was observed extending upward into the resin near the middle of the joint. In section C-C, the skin on the right side of the joint was separated from the resin pocket as indicated with the bracket in the lower image in figure 10. Red dashed lines in the lower image in figure 9 illustrate the locations of the observed cracks at sections B-B and C-C as represented in the layup diagram.

**Figure 10.** Overall views of transverse cut surfaces showing sections B-B and C-C (see figure 5). Unlabeled brackets indicate cracks intersected by the cuts.
