CEN23LA319

**INVESTIGATION PHOTOGRAPH**

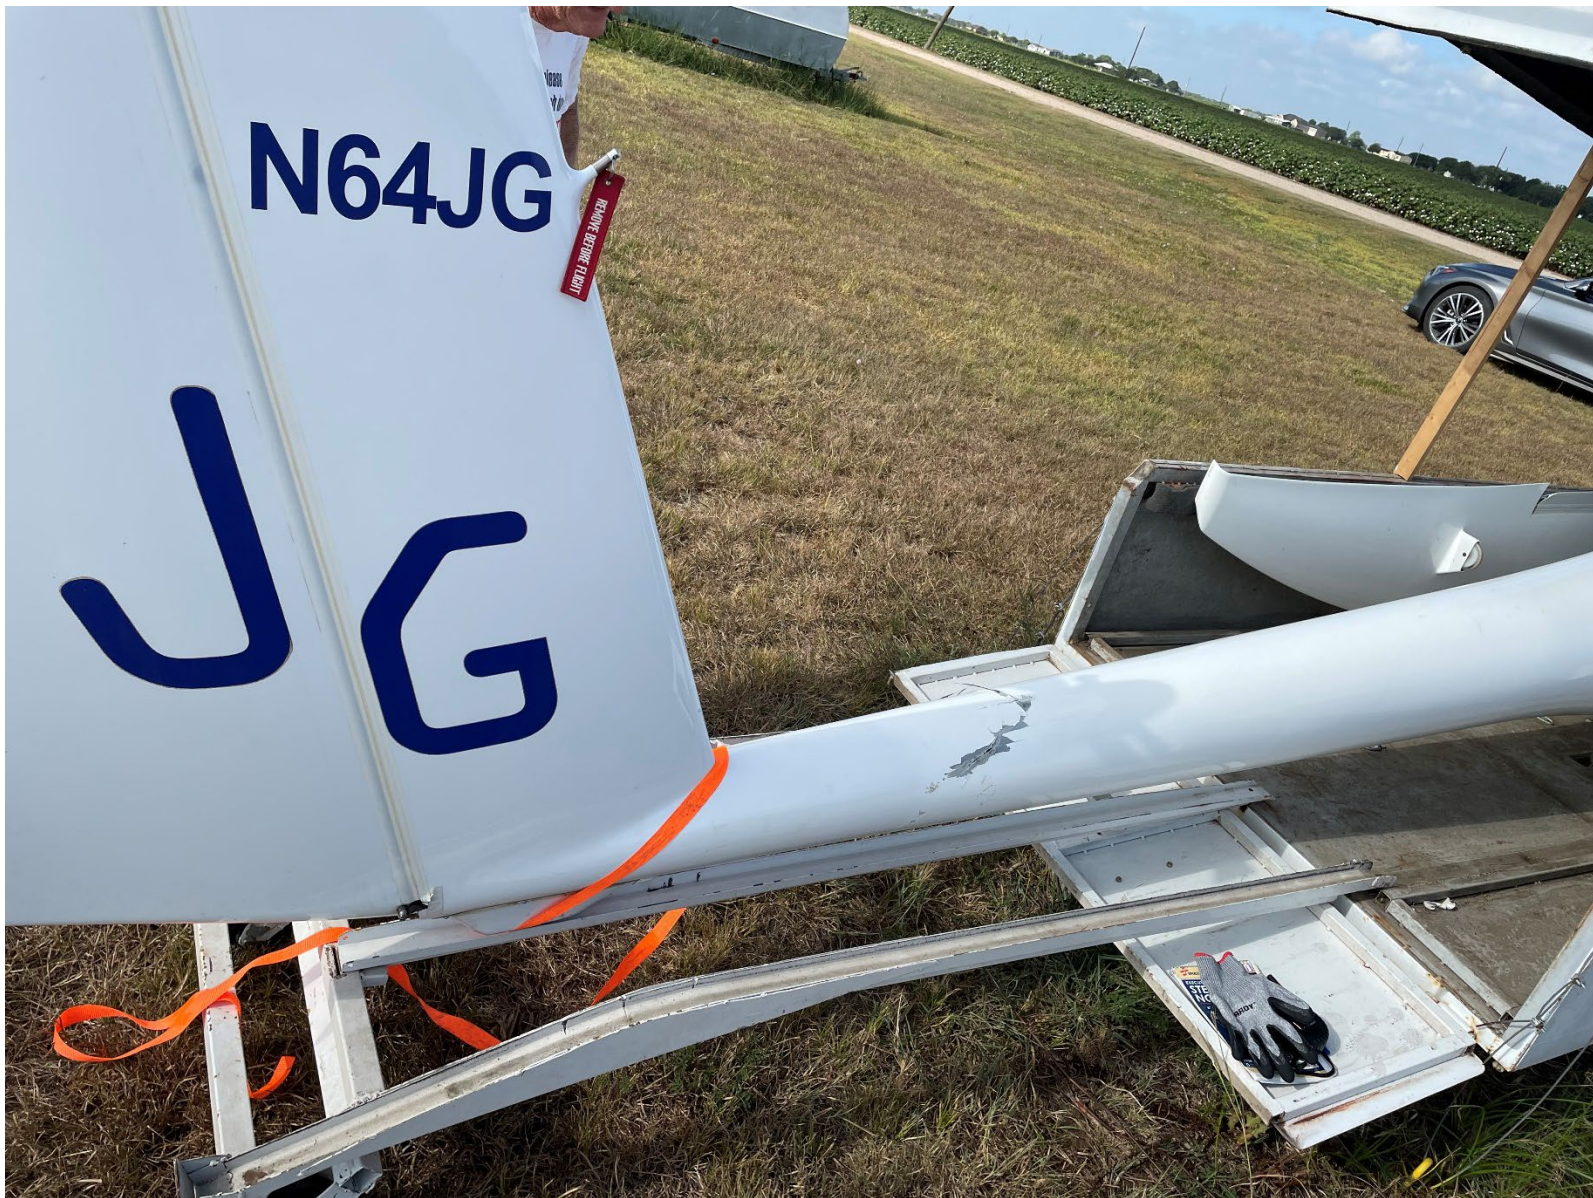
**Photograph 1 - Accident glider tail boom (Source: Federal Aviation Administration)**

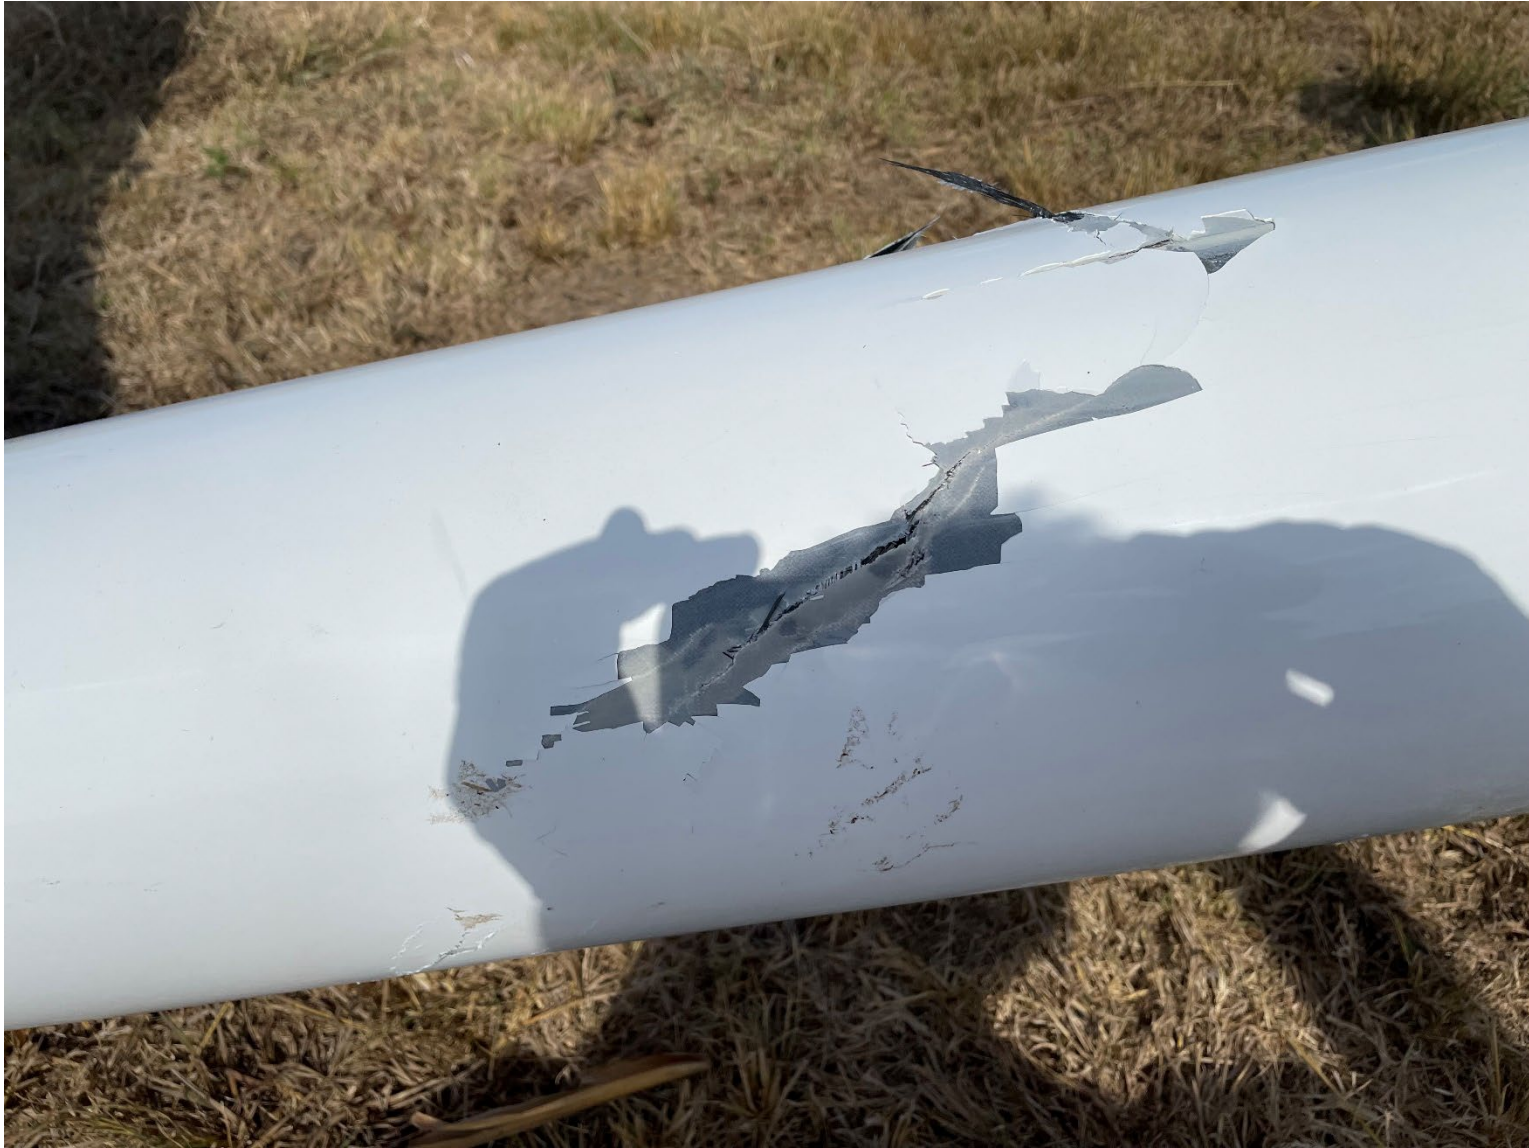
**Photograph 2 - Damaged tail boom (Source: Federal Aviation Administration)**
