# National Transportation Safety Board

CEN23LA329

## **AIRCRAFT EXAMINATION**

Location: Green Lake, WI  
Date: July 27, 2023  
Time: 1233 CDT  
Airplane: N5601G, Varga 2150A

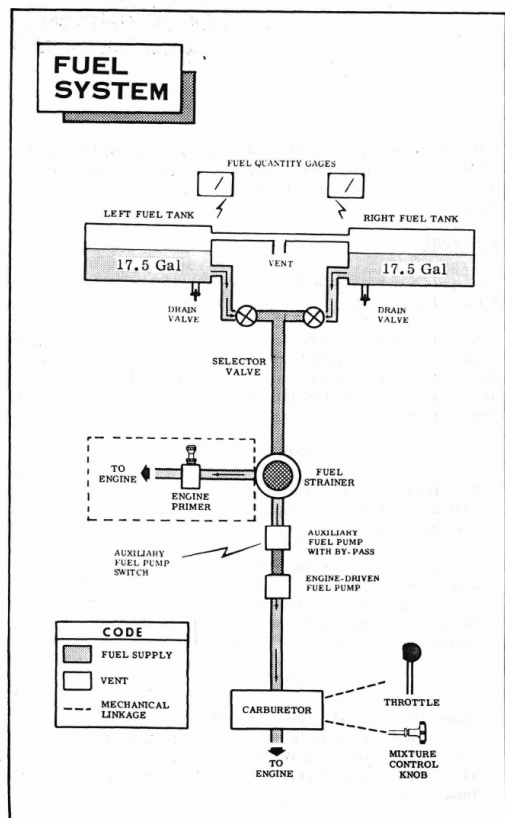
The wings had been removed and had little damage. Since the wings had been removed, the fuel tanks had been disconnected from the remainder of the fuel system. Examination of the wings and wing fuel tanks did not reveal any leaks. Examination of the remainder of the fuel system did not reveal any anomalies. The airplane's battery had been disconnected and the electric fuel pump was not tested.
