CEN23LA334

## INVESTIGATION PHOTOGRAPHS

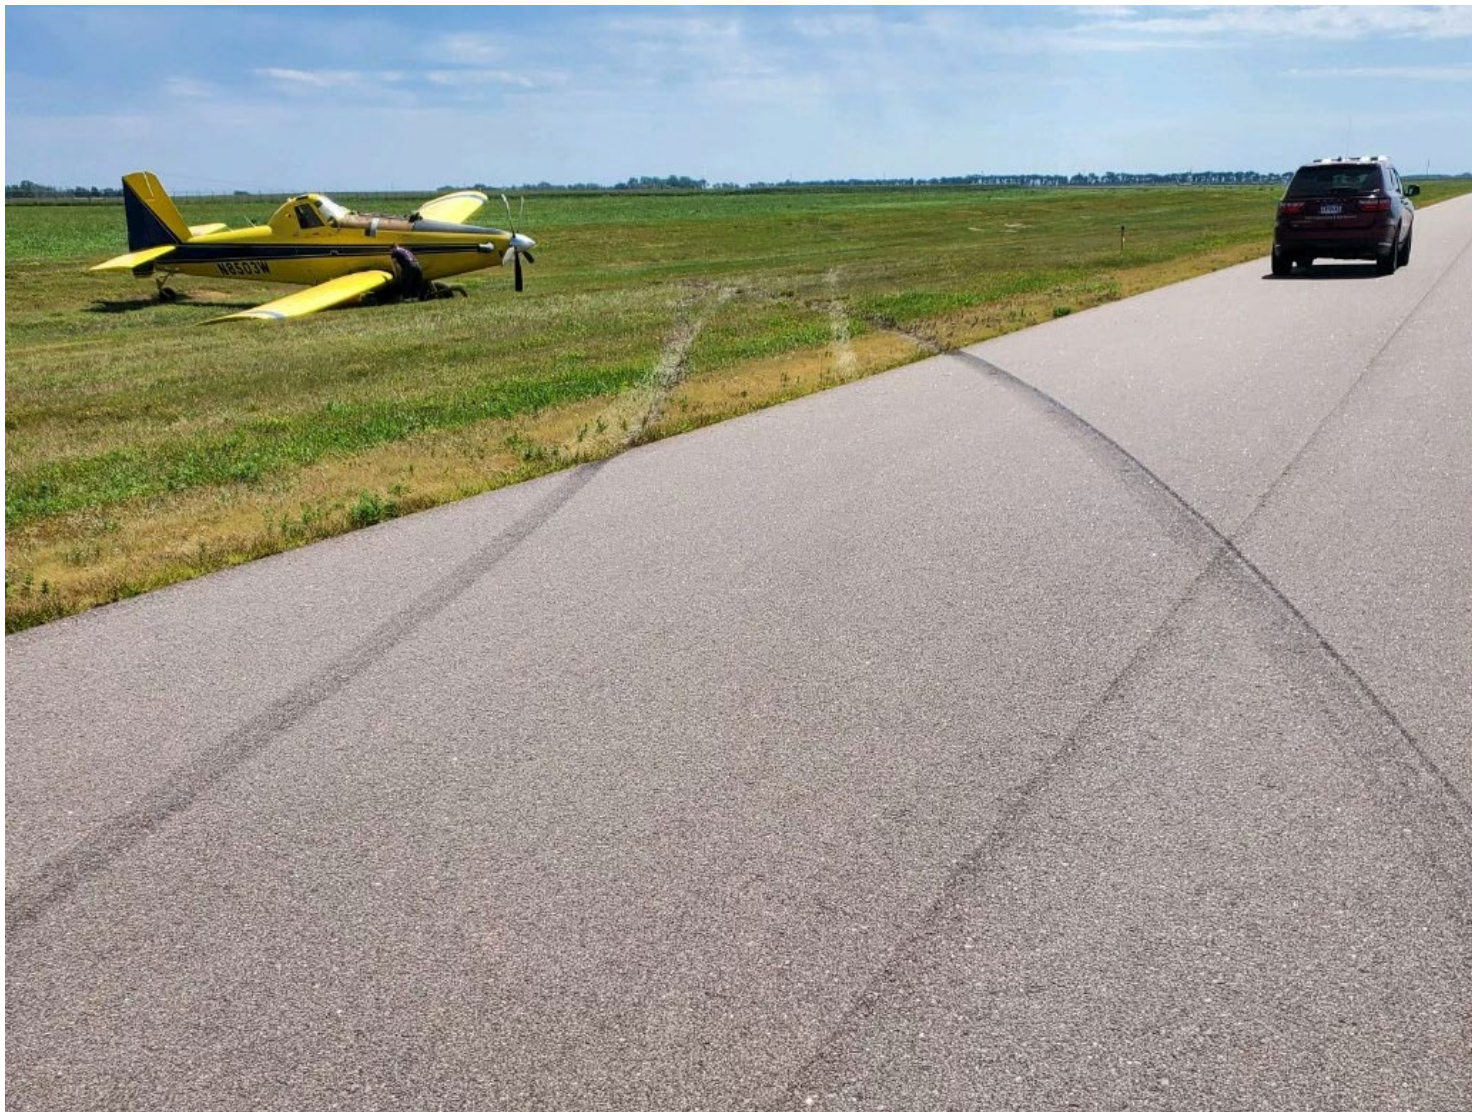
**Photograph 1 - Black skid marks leading to wreckage from taxiway C (Courtesy of FAA)**

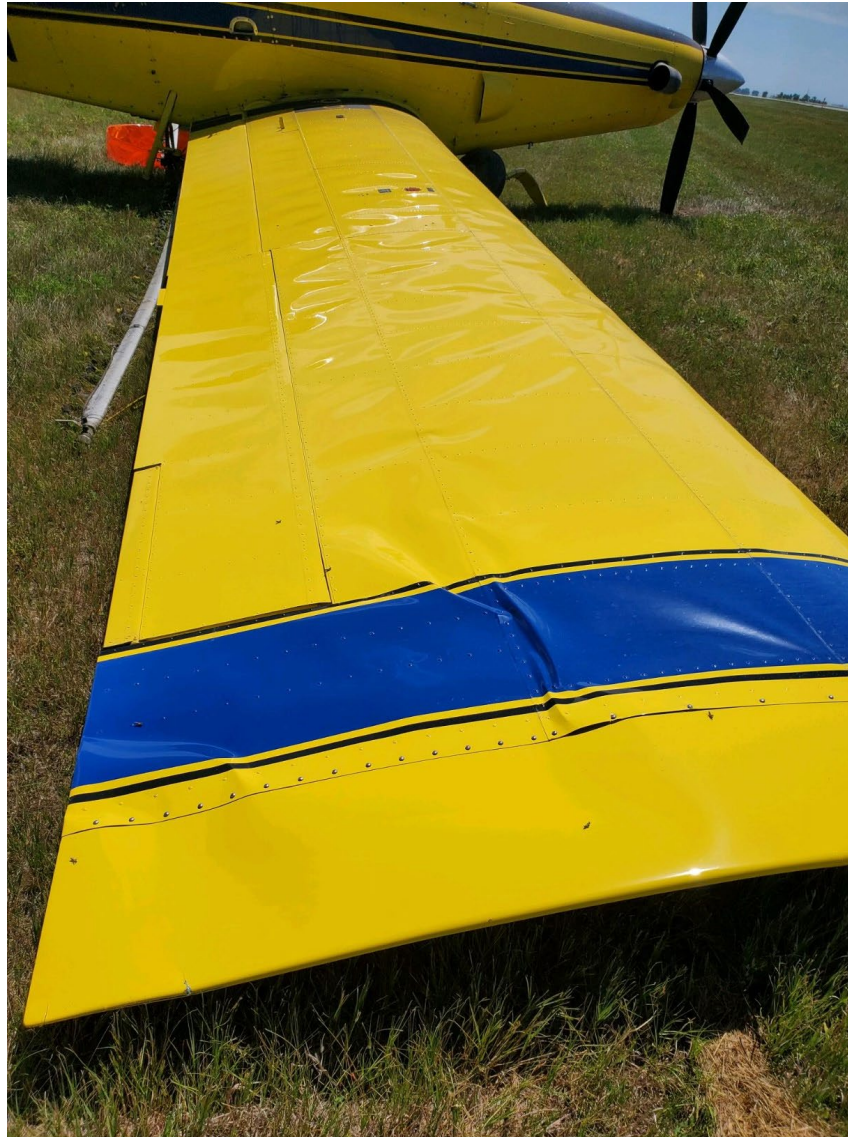
**Photograph 2 - Substantially damaged right wing (Courtesy of FAA)**

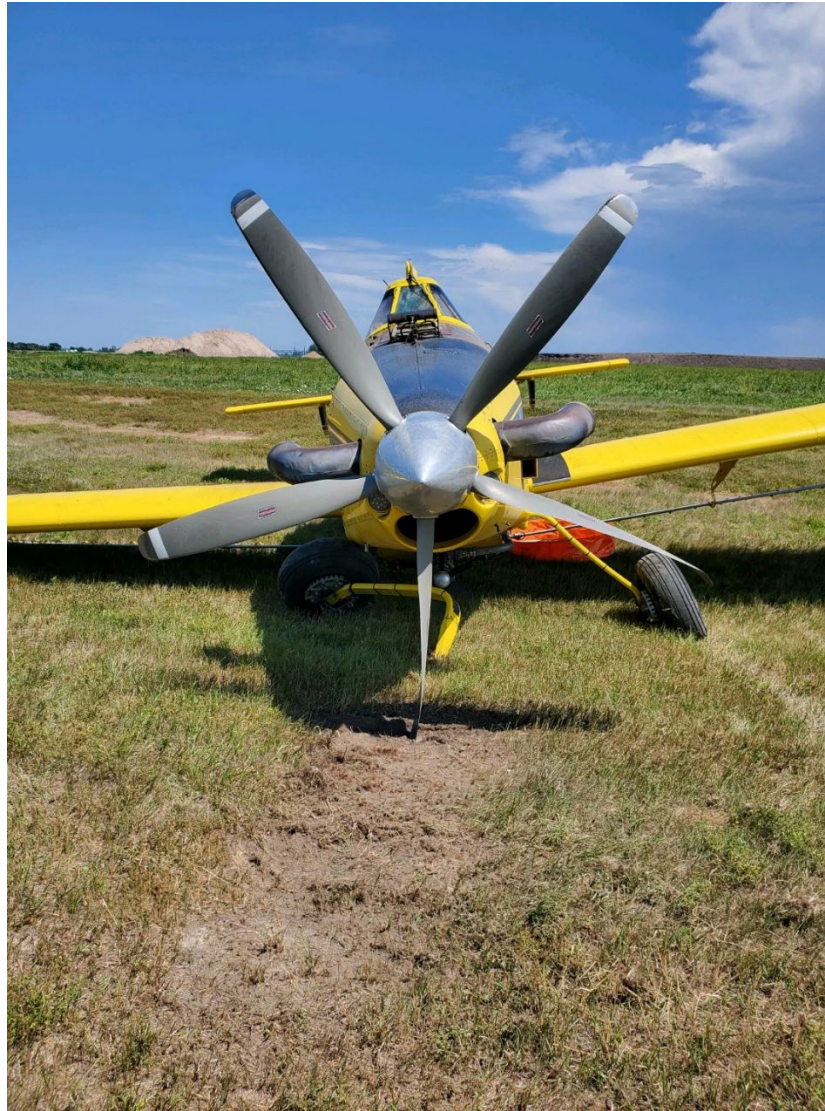
**Photograph 3 - View looking aft of airplane at the accident site (Courtesy of FAA)**

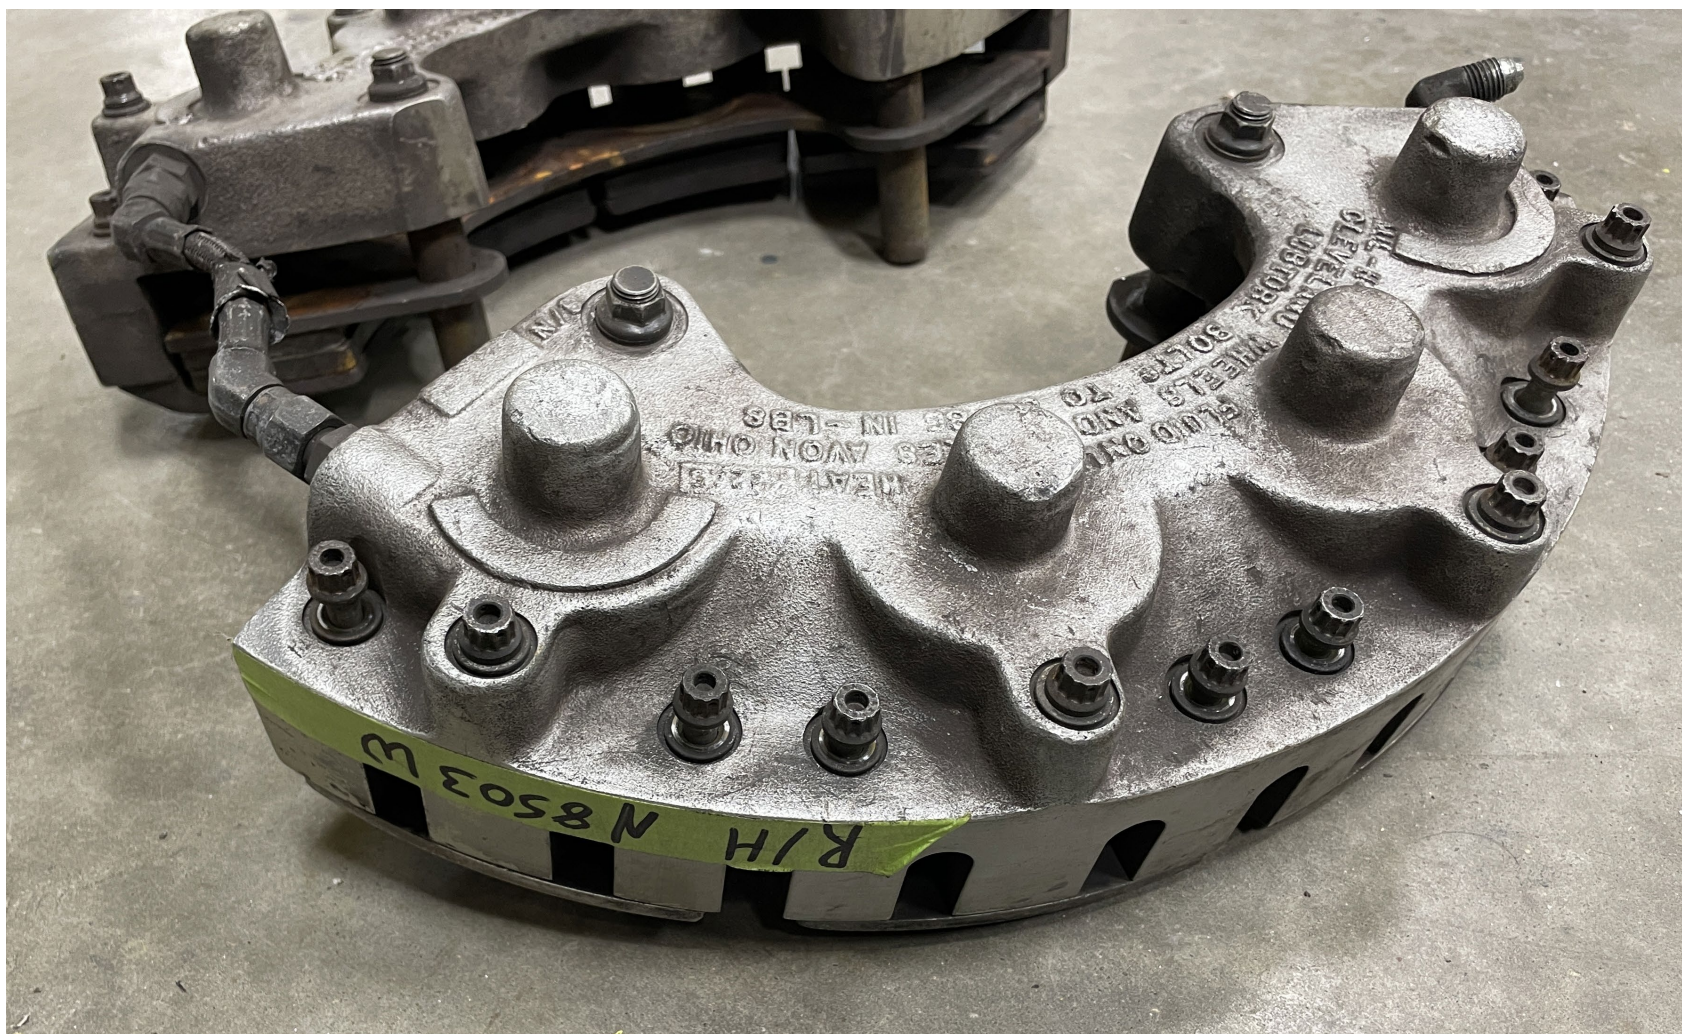
**Photograph 4 - Right brake caliper assembly (Courtesy of NTSB)**

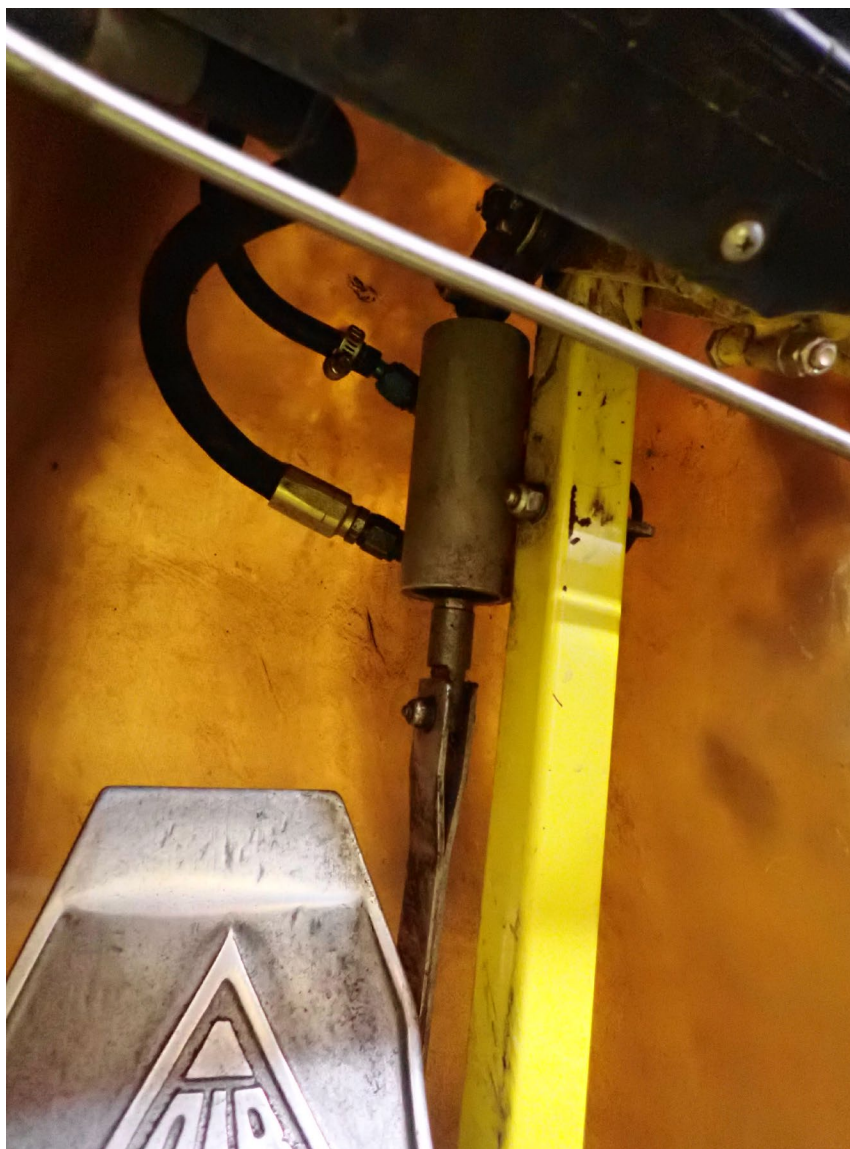
**Photograph 5 - Right brake master cylinder (Courtesy of Air Tractor)**

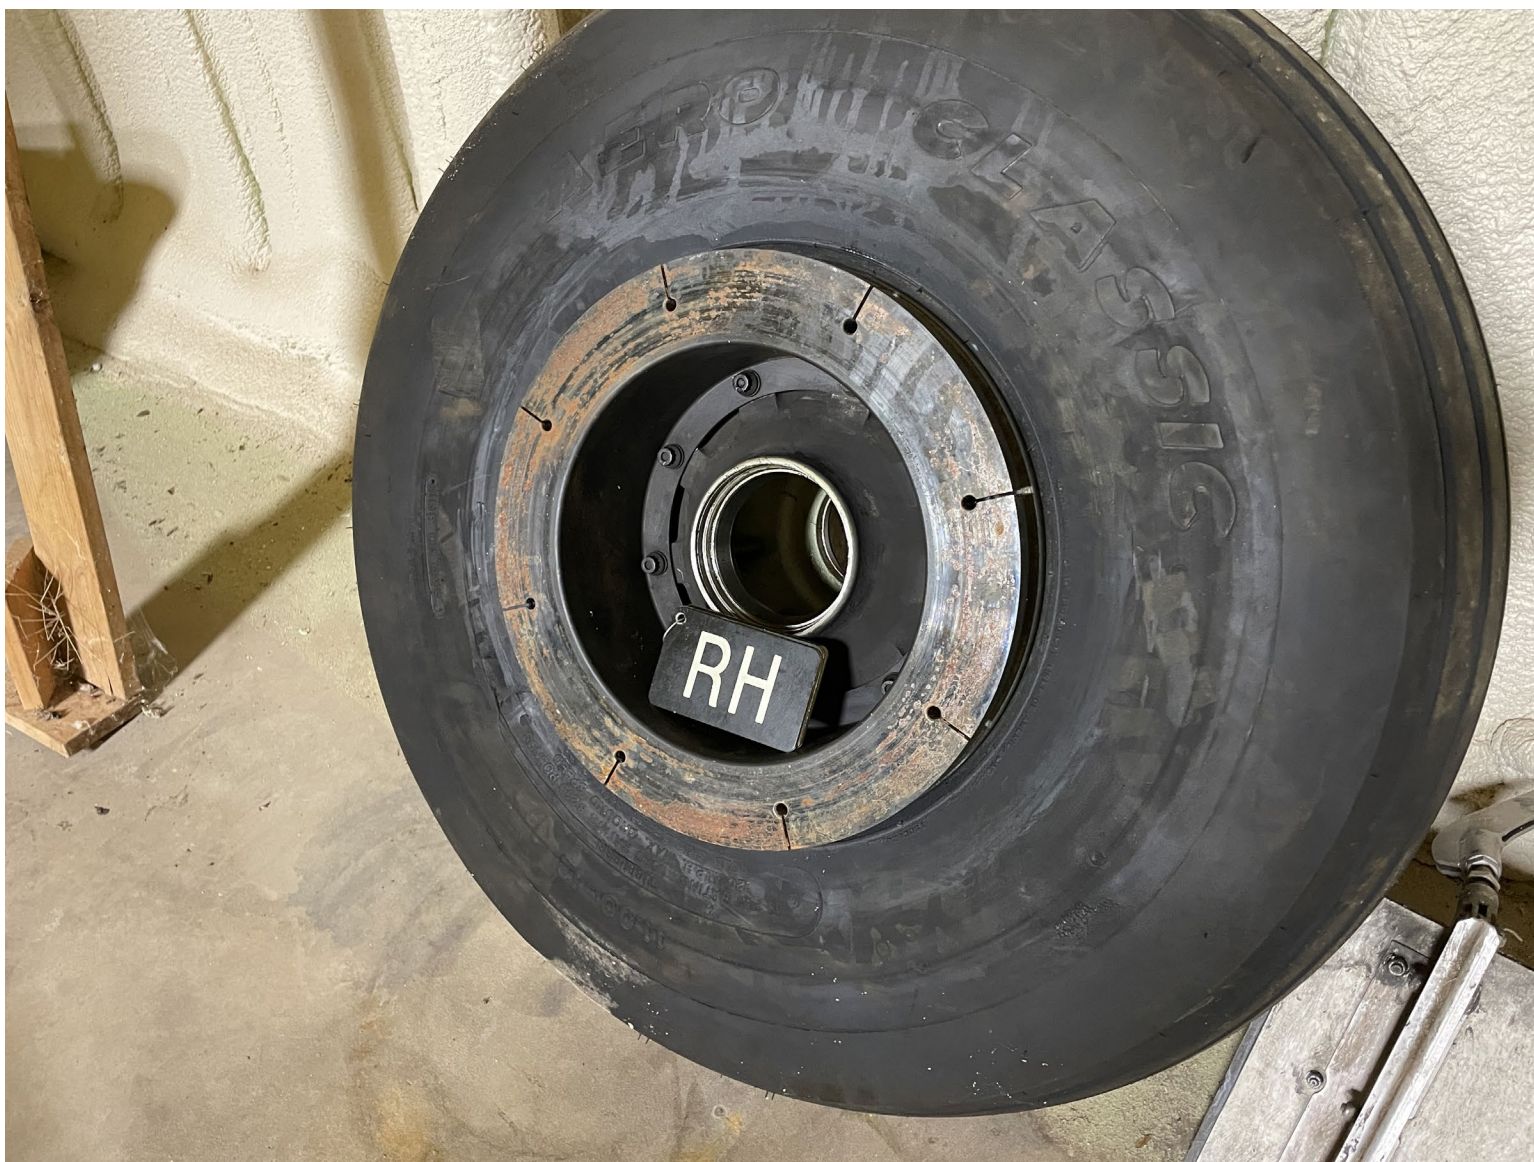
**Photograph 6 - Right main wheel assembly and brake disc (Courtesy of NTSB)**

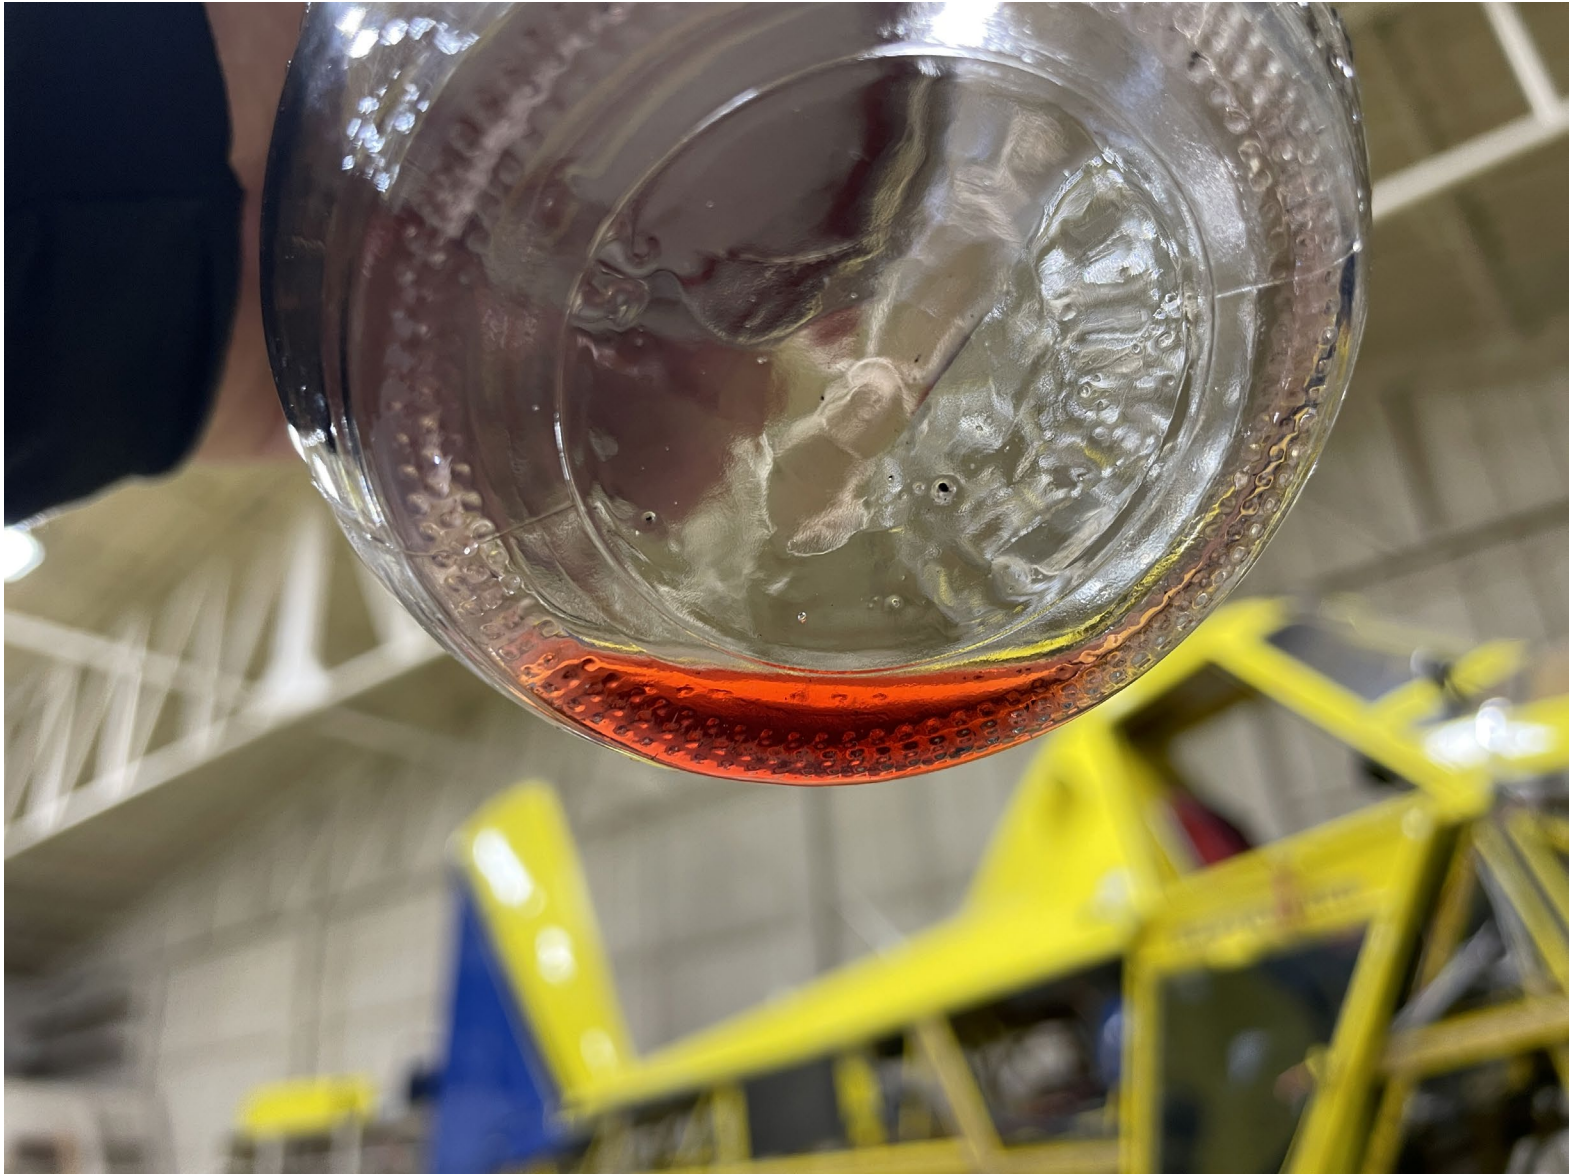
**Photograph 7 - Brake fluid recovered from right brake system (Courtesy of NTSB)**

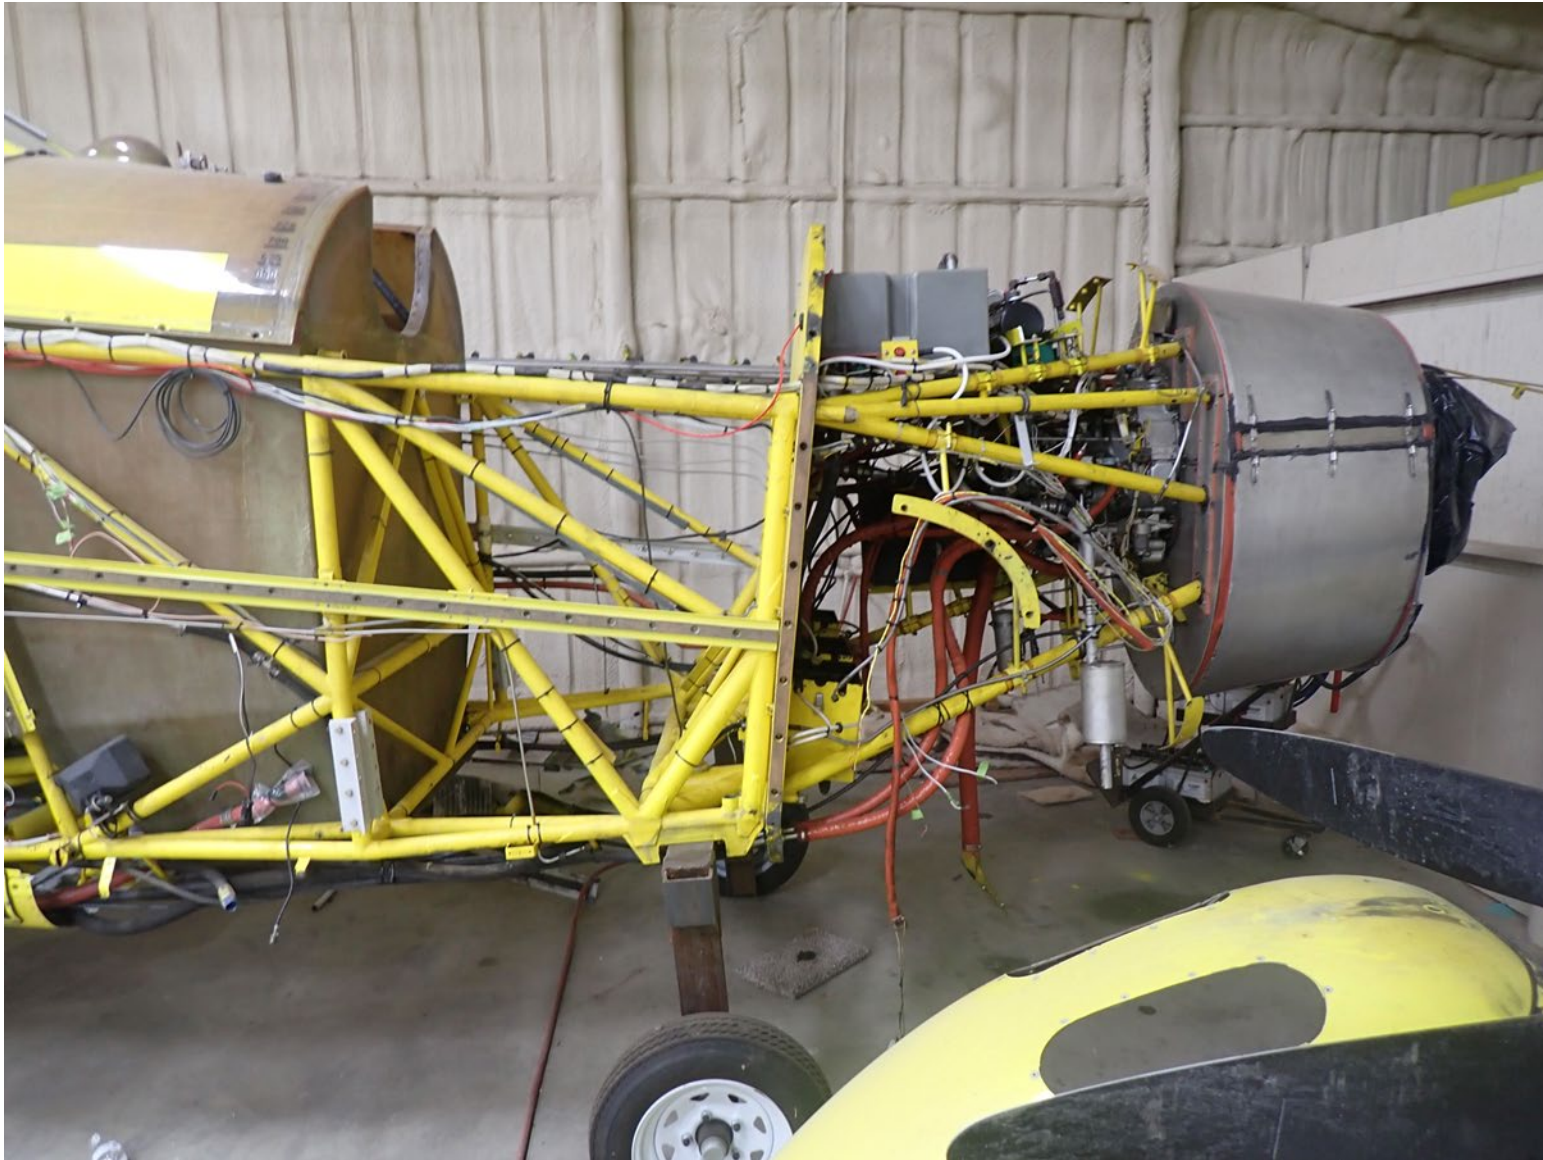
**Photograph 8 - Airframe as examined after recovery (Courtesy of Air Tractor)**
