CEN23LA337

## INVESTIGATION PHOTOGRAPHS

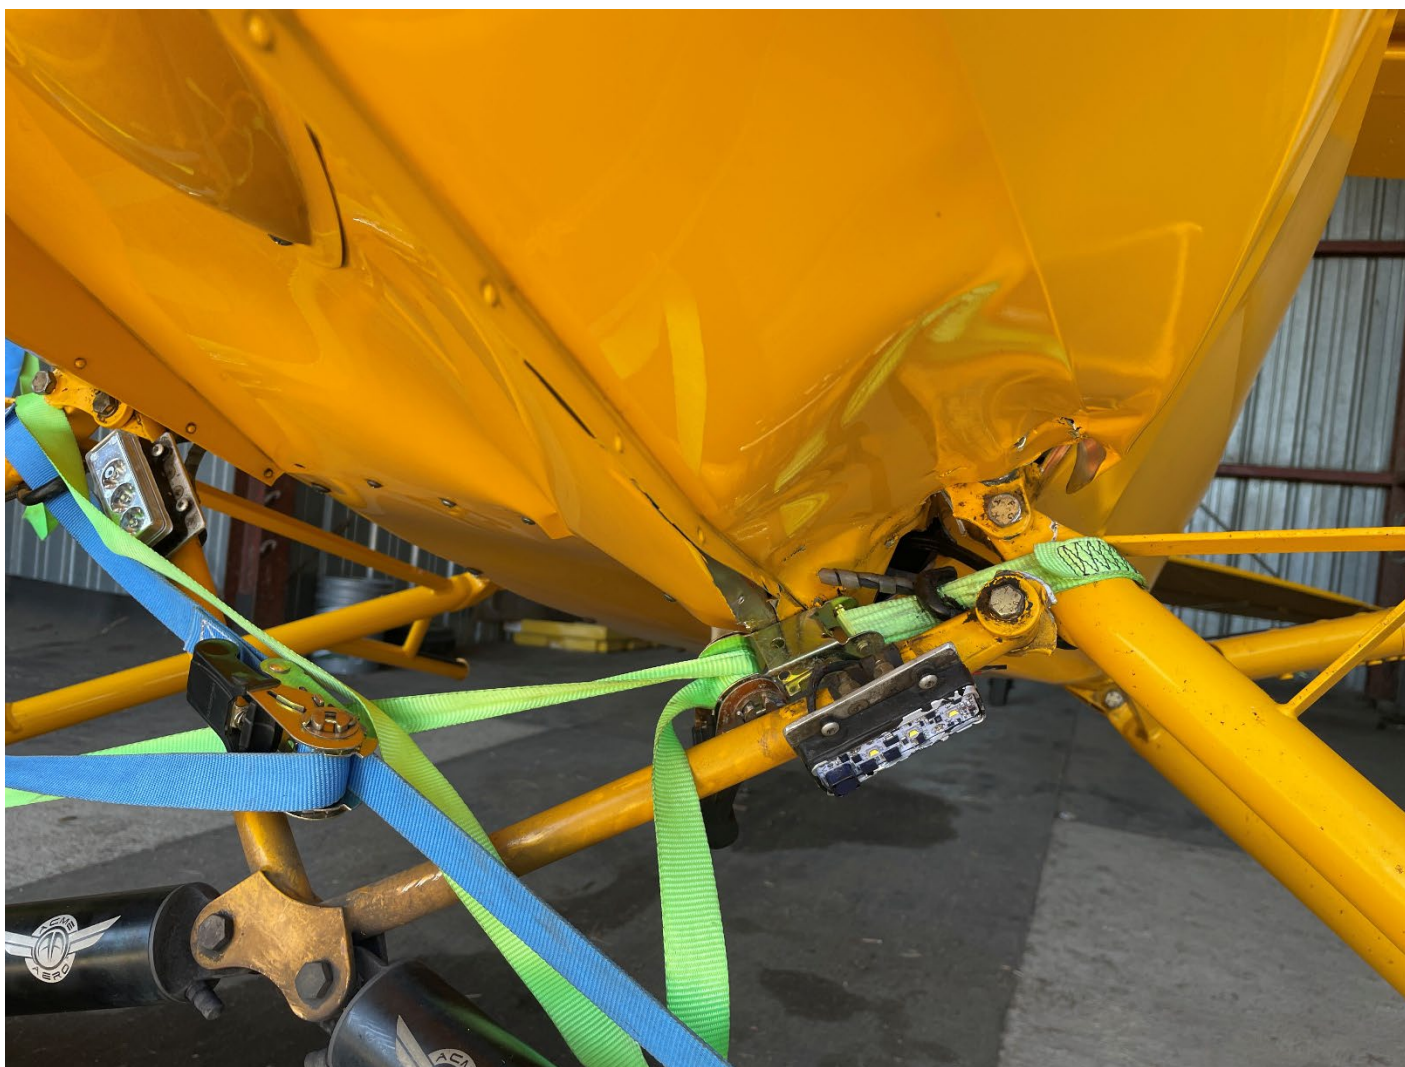
**Photograph 1 - Forward lower fuselage and right main landing gear attach area; localized skin crushing and wrinkling near the fractured gear fitting. (Courtesy of FAA)**

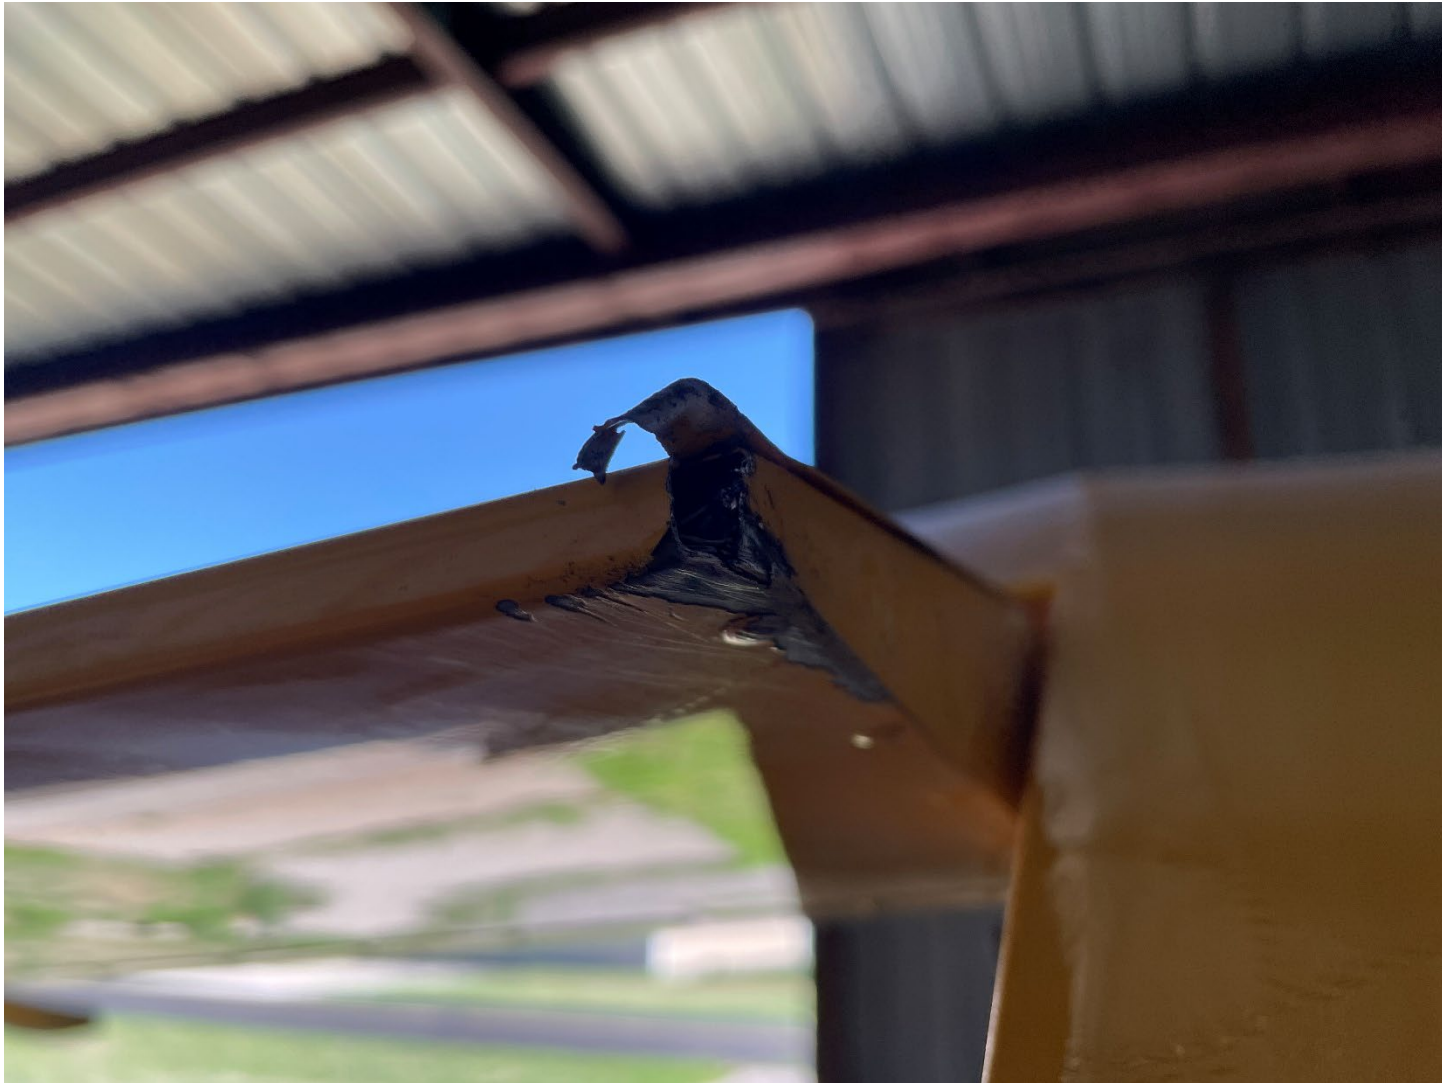
**Photograph 2 - Right aileron, outboard trailing-edge damage (Courtesy of FAA)**
