CEN23LA339

## INVESTIGATION PHOTOGRAPHS

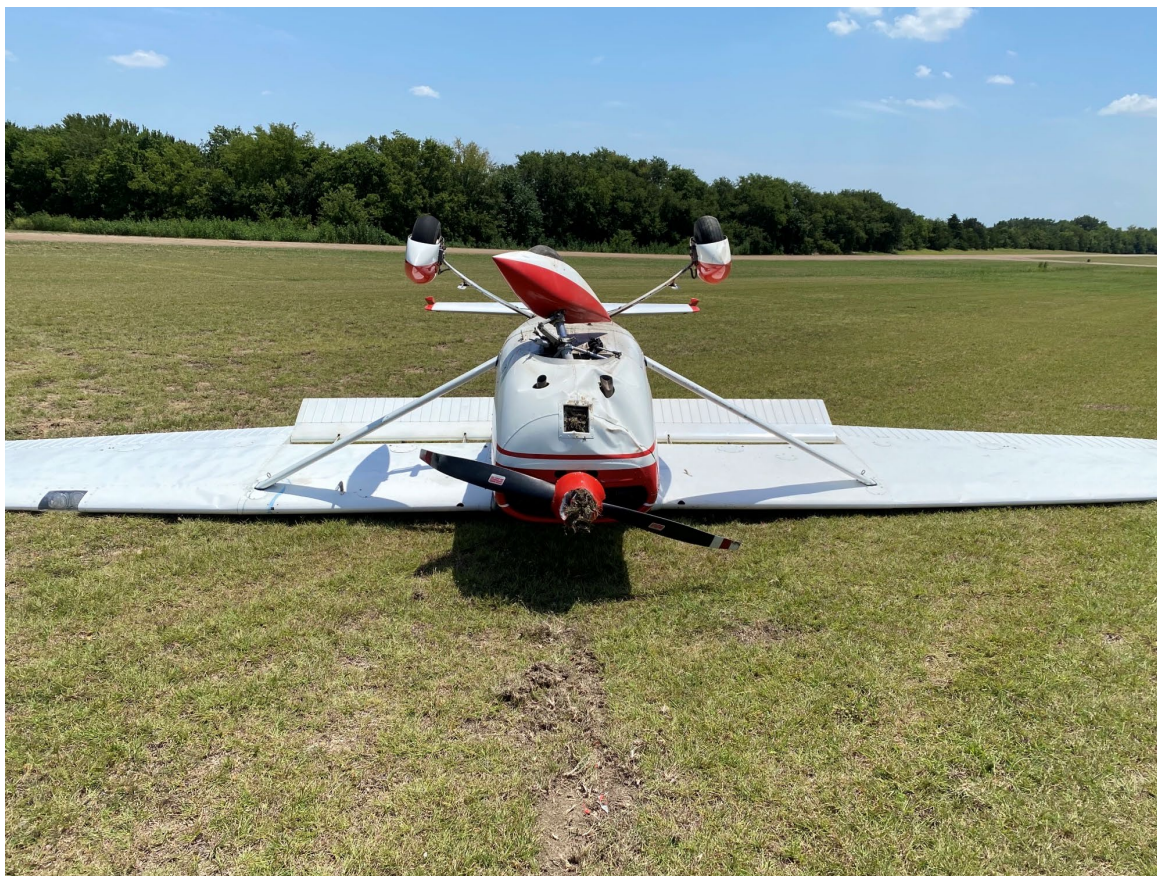
**Photograph 1 - Front view of airplane and deformation noted to the left wing (Courtesy of FAA)**

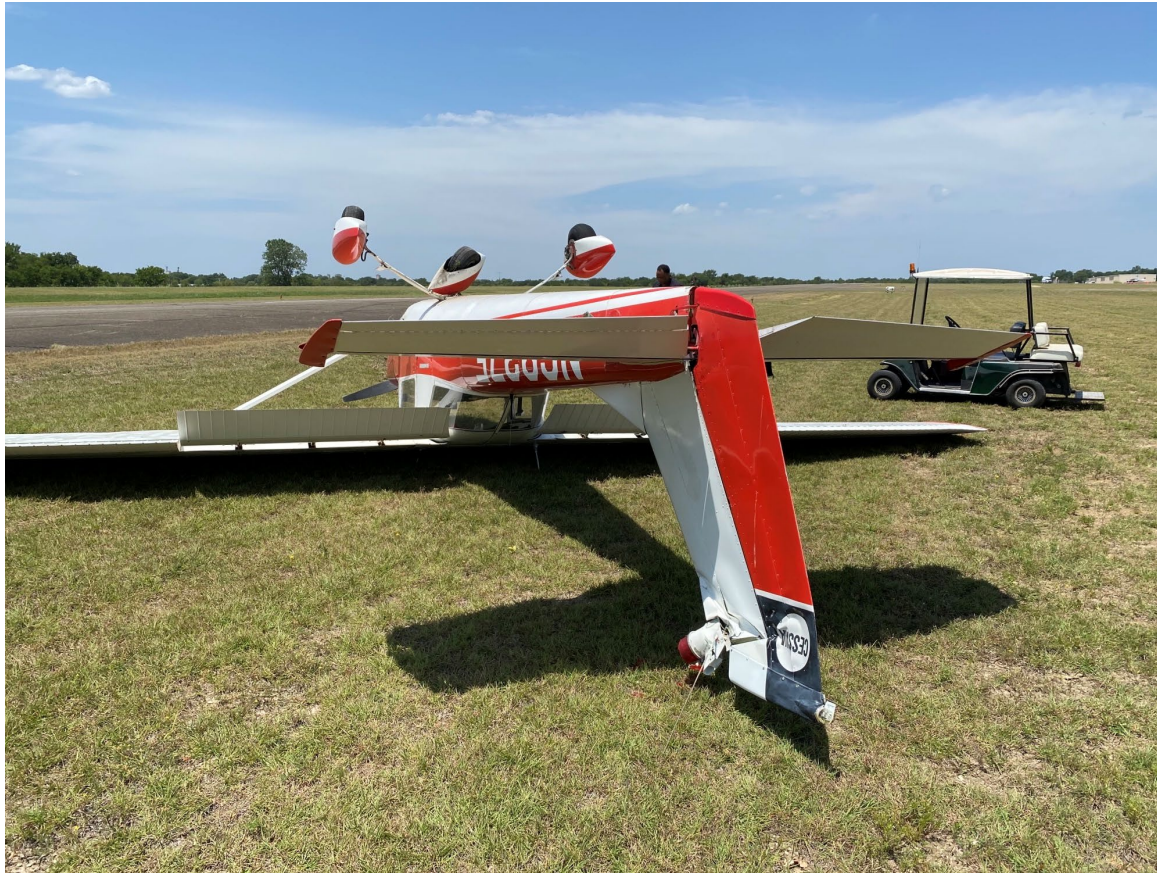
**Photograph 2 - Deformation noted to the rudder and vertical stabilizer (Courtesy of FAA)**

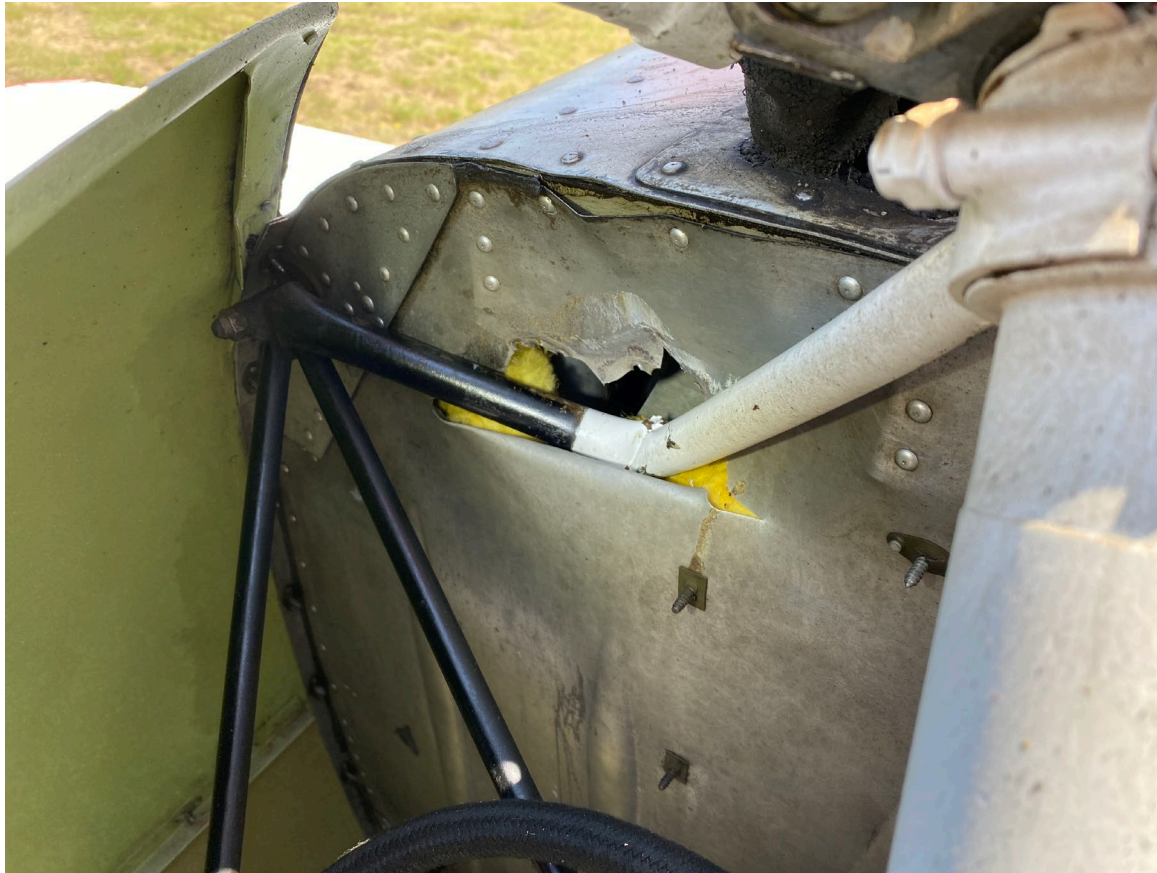
**Photograph 3 - Tears in the firewall and deformation to the engine mount (Courtesy of FAA)**
