# National Transportation Safety Board

CEN23LA344

## EXAMINATION SUMMARY

Location: Oberlin, Kansas  
Date: July 20, 2023  
Time: 1236 central daylight time  
Airplane: Beechcraft Bonanza A36, N36900

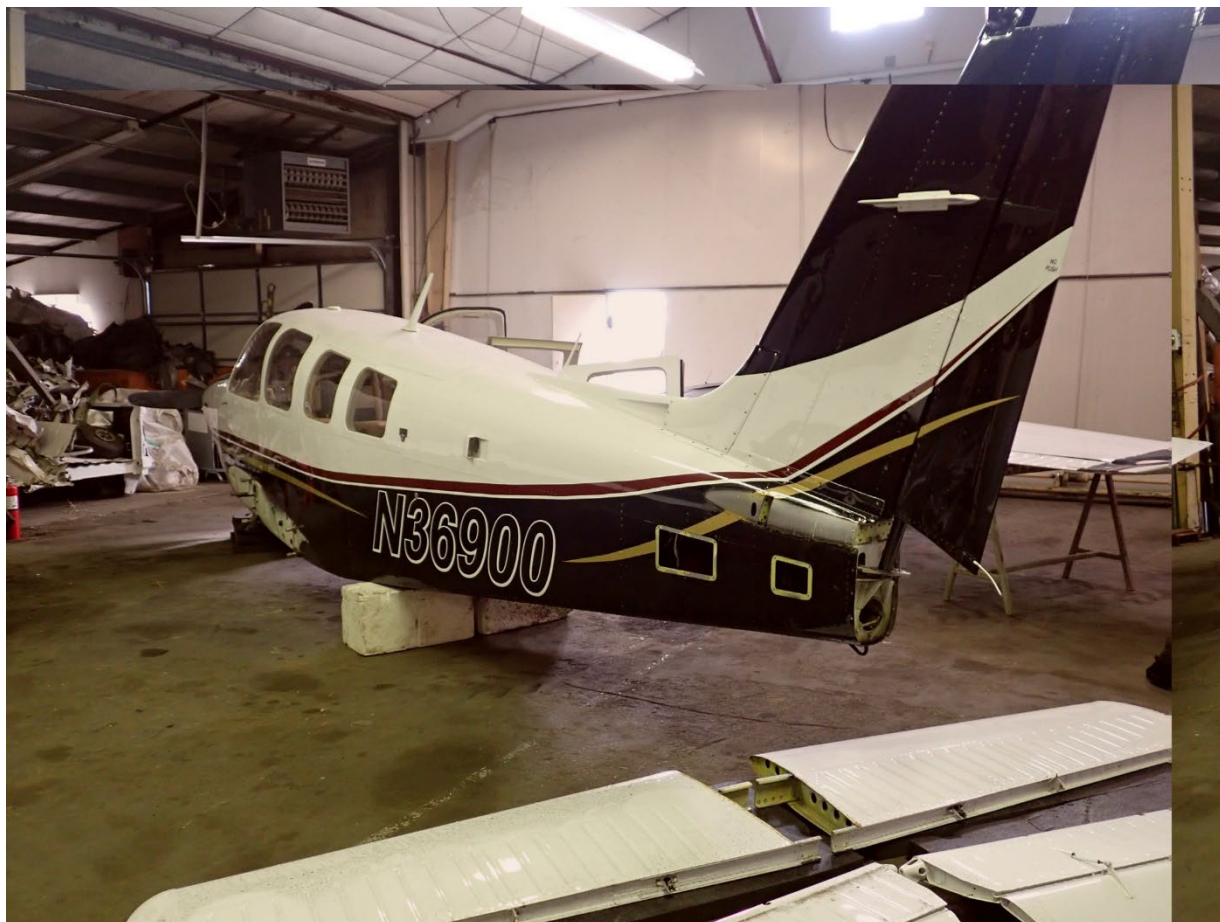
Figure 1: View of fuselage

The wings were separated from the fuselage for recovery (Figure 1). Fuel was collected from the fuel strainer consistent with 100 low lead aviation fuel. The fuel sample was clear and free of debris. Water finding paste was used and no water was found in the fuel sample. The fuel strainer filter was removed. There was an unknown fibrous material on the outside of the filter (Figure 2), however the majority of the filter was clear.

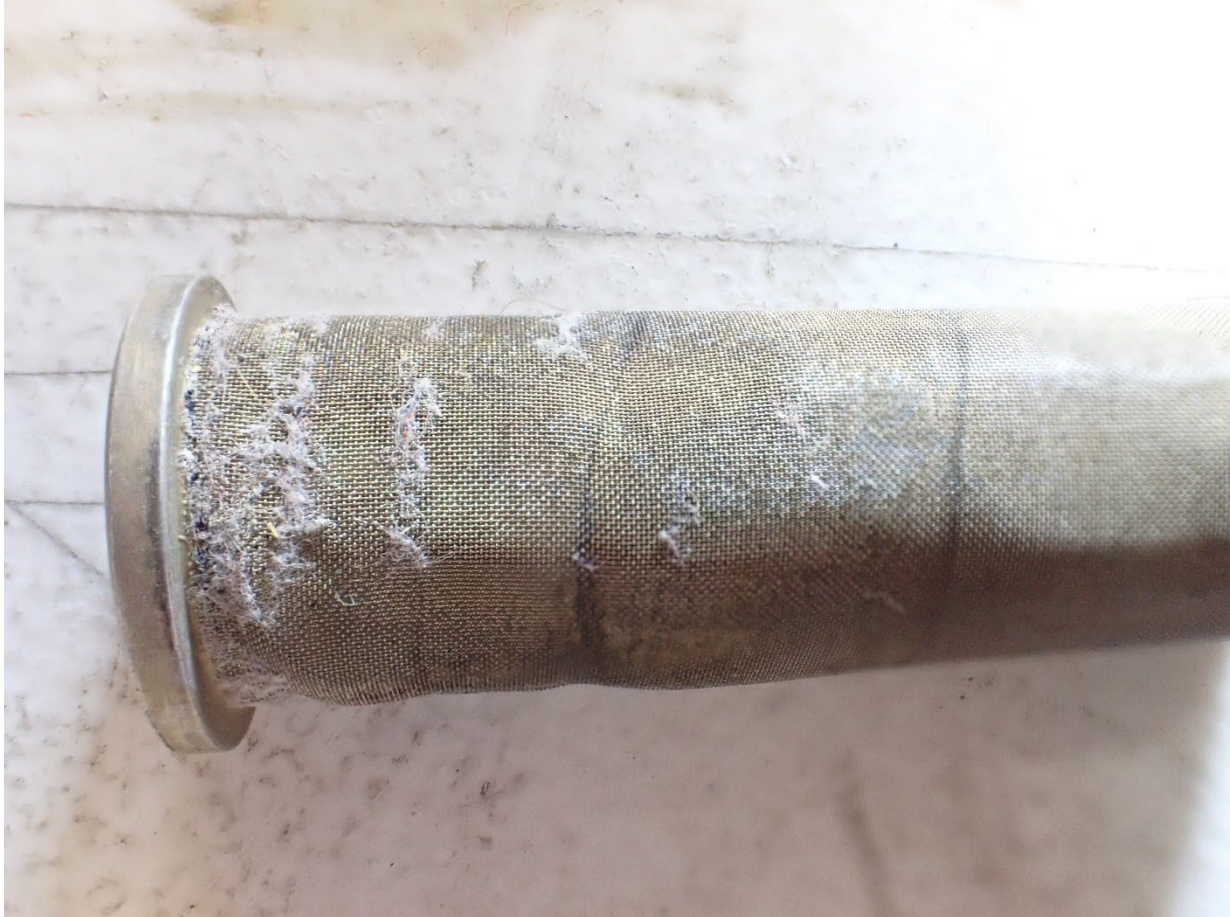
Figure 2: Fuel Strainer Filter

- The fuel strainer filter was removed. There was fibrous material on the filter.
- The fuel distributor screen was removed and was unremarkable.
- The fuel check valve was removed. The screen was clear.

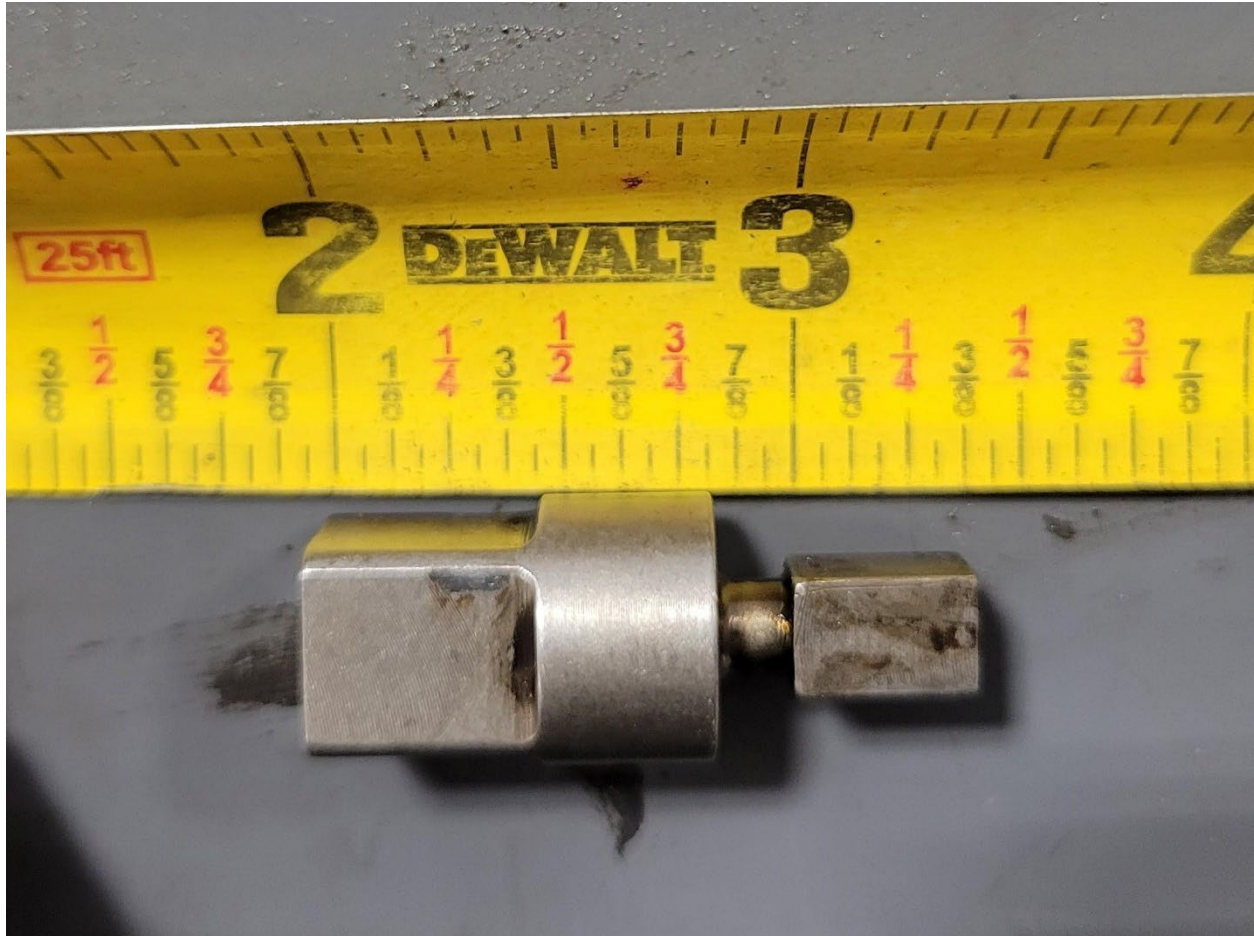
Figure 3: Fuel pump drive coupler

- The fuel pump coupler remained attached to the engine and rotated when the propeller was turned by hand.
- The fuel pump coupler was removed and intact (figure 3).

The engine driven fuel pump was removed at the accident site by a Federal Aviation Administration (FAA) inspector and provided during the examination. The coupler remained attached to the engine and rotated when the propeller was rotated by hand. The fuel pump drive coupler was measured at 1.37 inches, in compliance with Teledyne Continental Aircraft Engine Mandatory Service Bulletin MSB95-6. Pressure was obtained at the fuel pump outlet when the fuel pump drive was manually rotated.

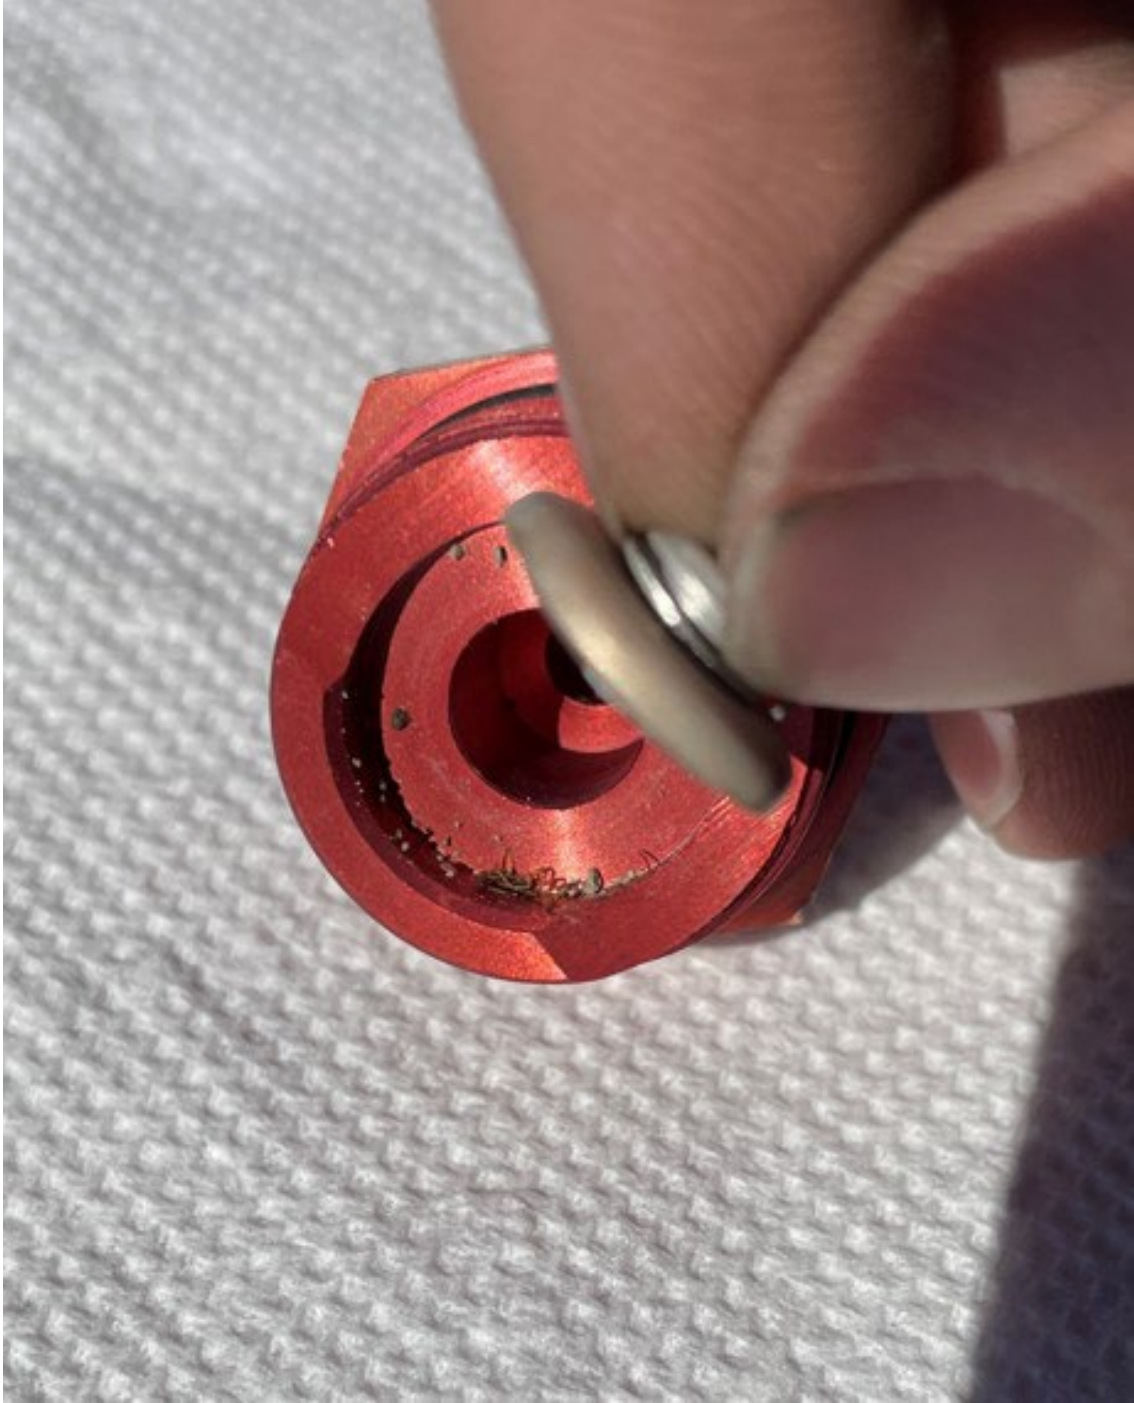
Figure 4: Left wing fuel vent check valve

- Induction alternate air was free and correct.
- The fuel servo was removed and was unremarkable.
- The right-wing fuel vent was unobstructed.
- The left-wing fuel vent was obstructed when pressure tested. Investigators cleared most of the debris when applying pressurized air.

- The left-wing fuel vent check valve was found stuck closed and insect debris were observed inside. (Figure 4)

The fuel system was pressure tested at the left and right wing tanks to the fuel pump inlet. No anomalies were noted. The right-wing fuel tank vents were unobstructed. The left-wing fuel tank vents were obstructed. When pressure tested, debris was removed from the vent lines. The left-wing fuel vent check valve was observed stuck in the closed position. The vent line from the tank was also obstructed. The fuel selector functioned normally.
