CEN23LA348

## INVESTIGATION PHOTOGRAPHS

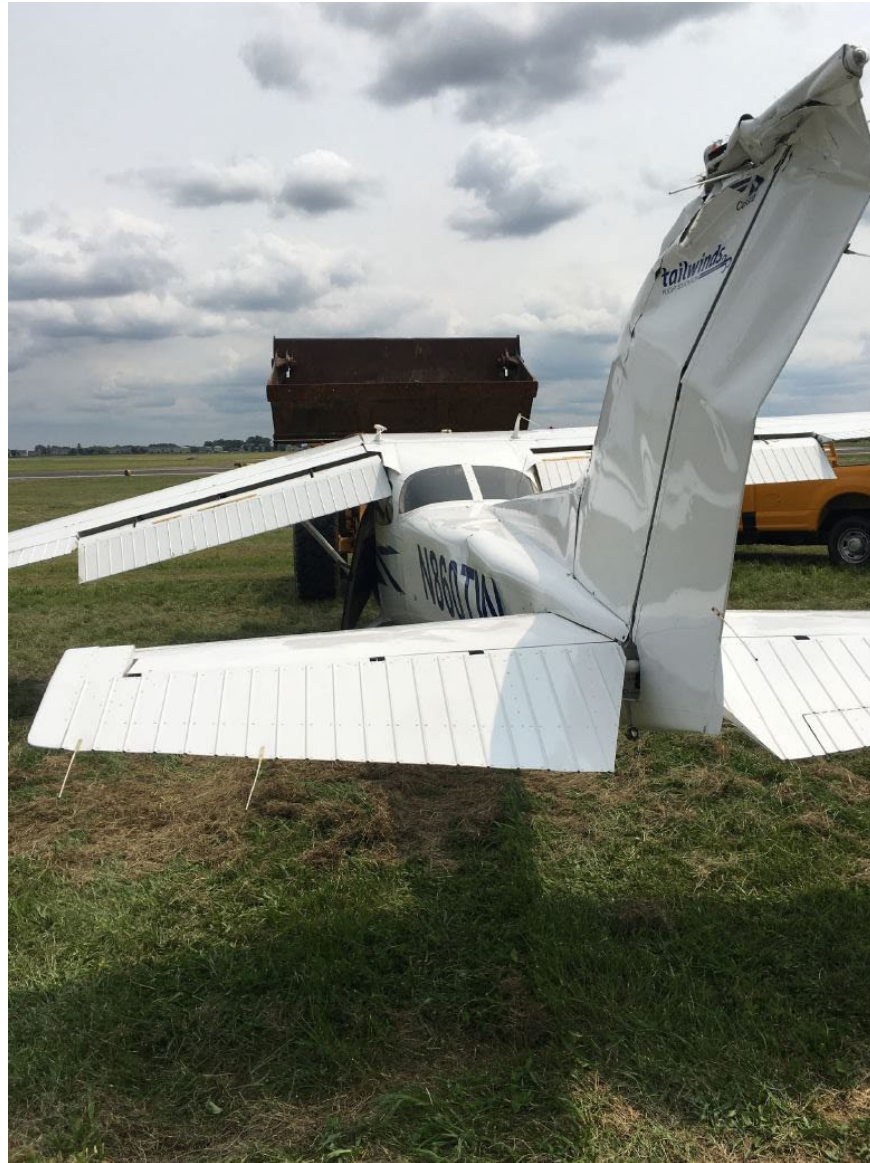
**Photograph 1 -Damaged Empennage (Courtesy of FAA)**

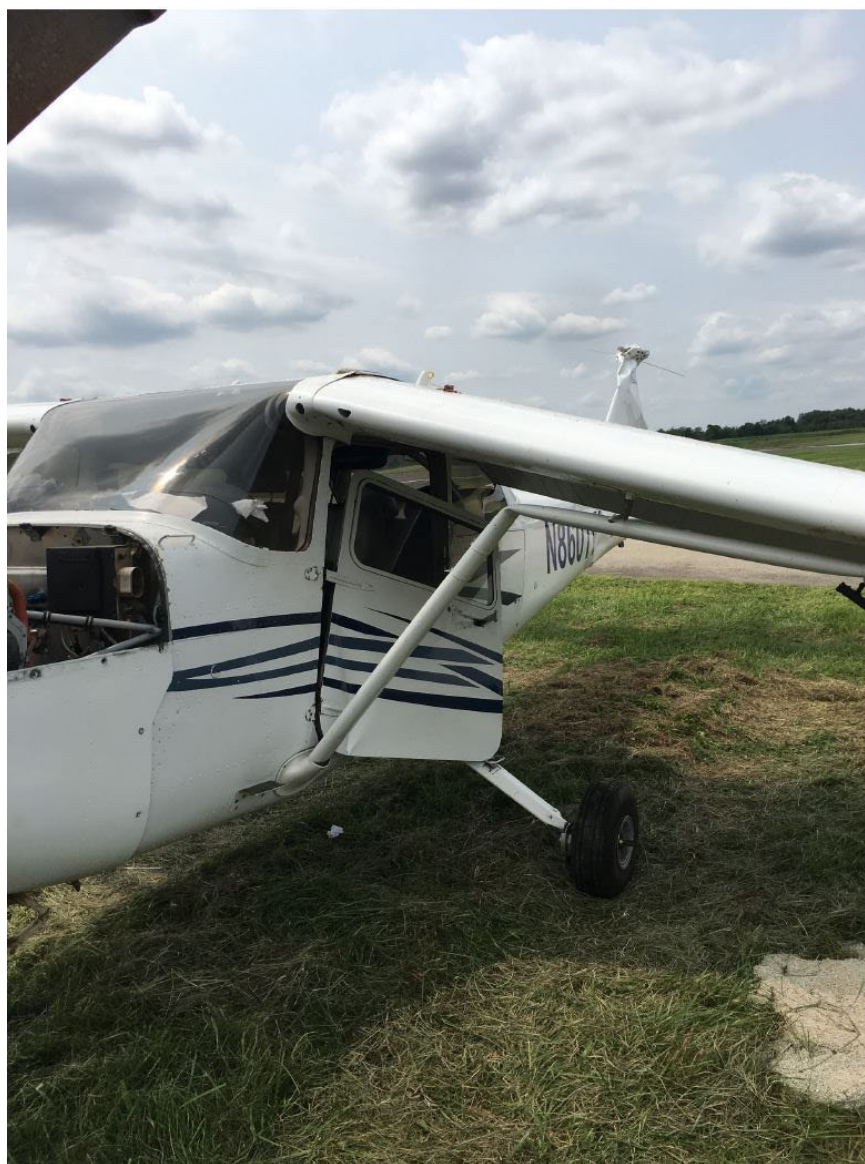
**Photograph 2 - Damaged Left Wing and Lift Strut (Courtesy of FAA)**
