CEN23LA350

## INVESTIGATION PHOTOGRAPHS

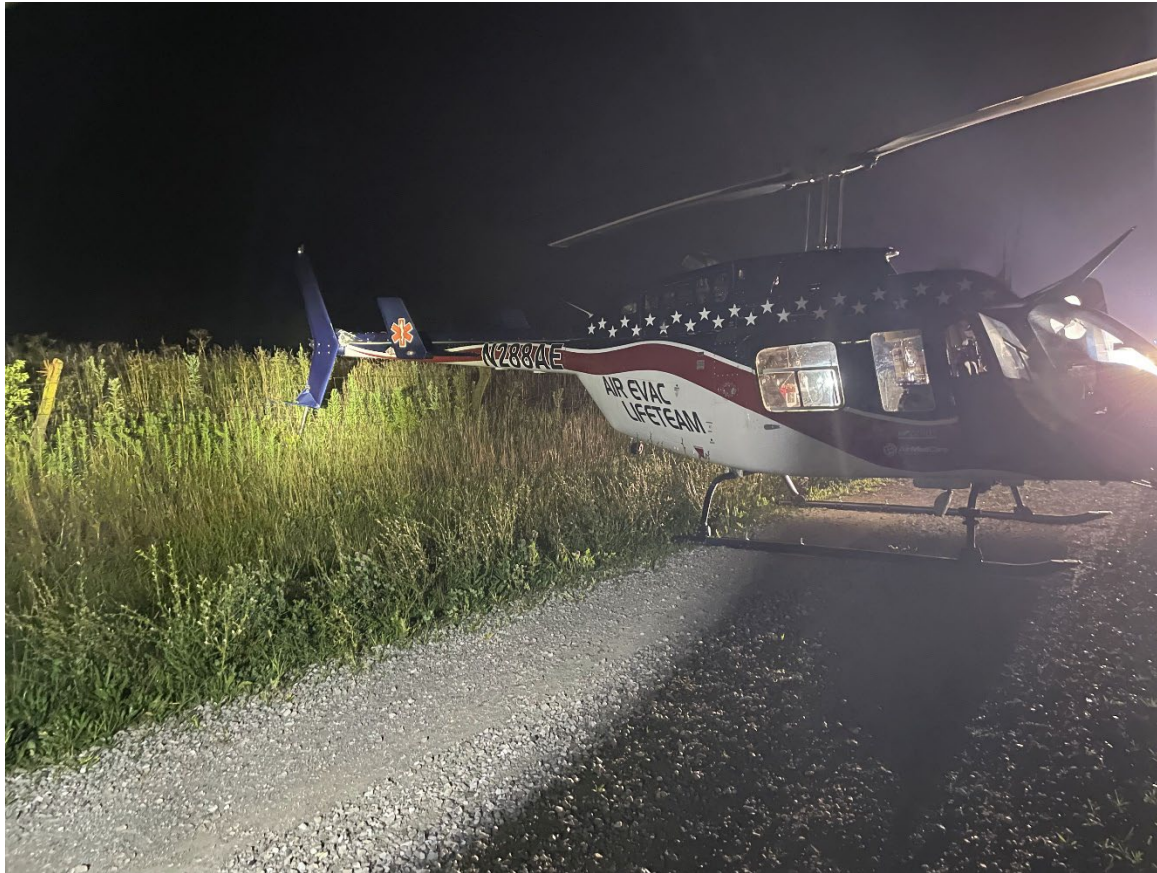
**Photograph 1 - View of the right side of the helicopter at the accident site, during night conditions (Courtesy of Air Evac Lifeteam)**

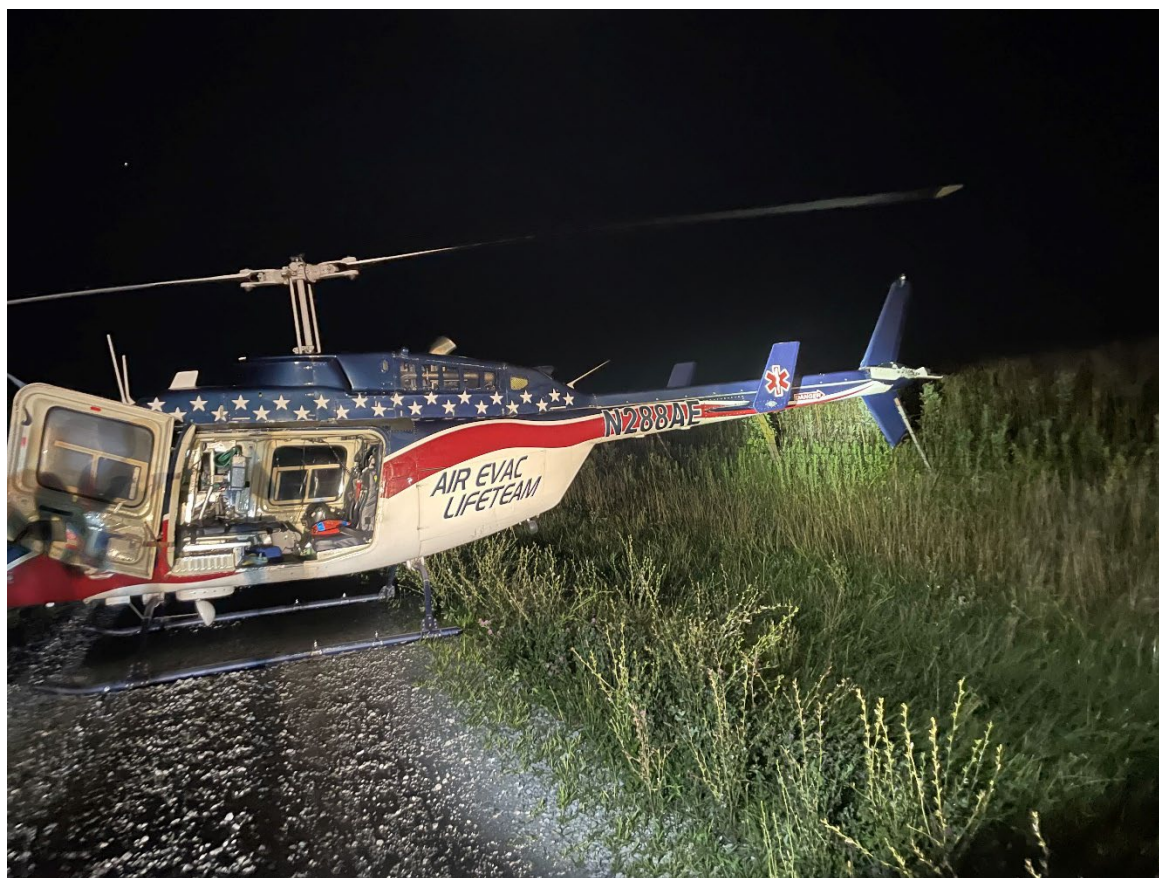
**Photograph 2 - View of the left side of the helicopter at the accident site, during night conditions (Courtesy of Air Evac Lifeteam)**

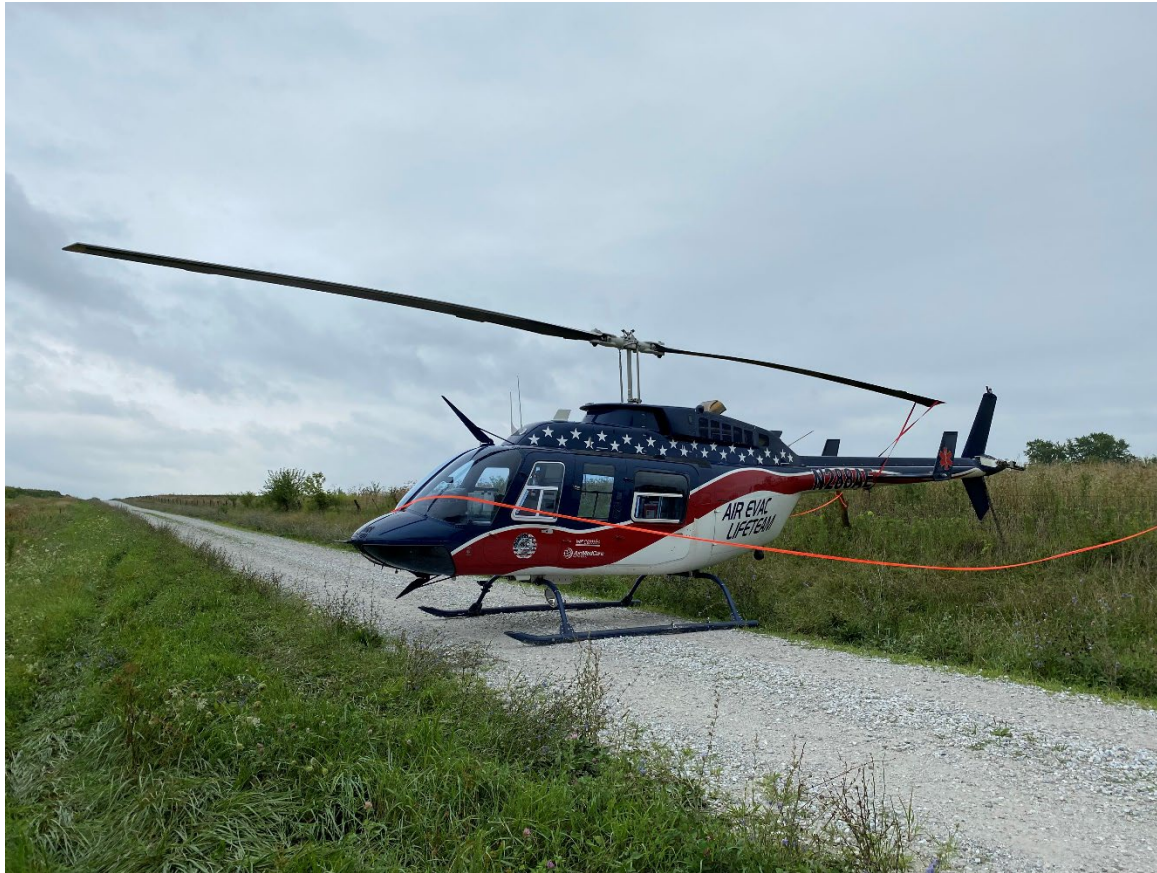
**Photograph 3 - View of the left side of the helicopter at the accident site, during day conditions  
(Courtesy of the Federal Aviation Administration)**

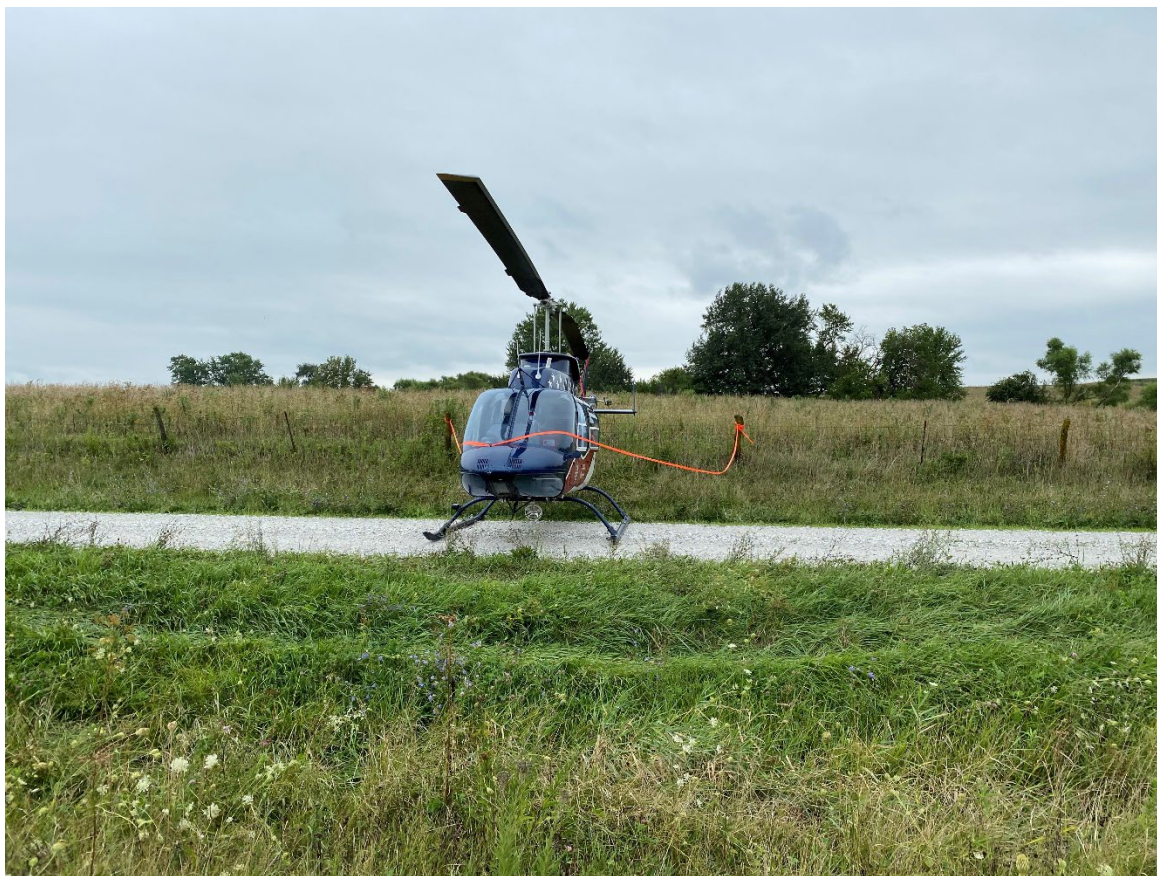
**Photograph 4 - View of the front of the helicopter at the accident site, during day conditions  
(Courtesy of the Federal Aviation Administration)**

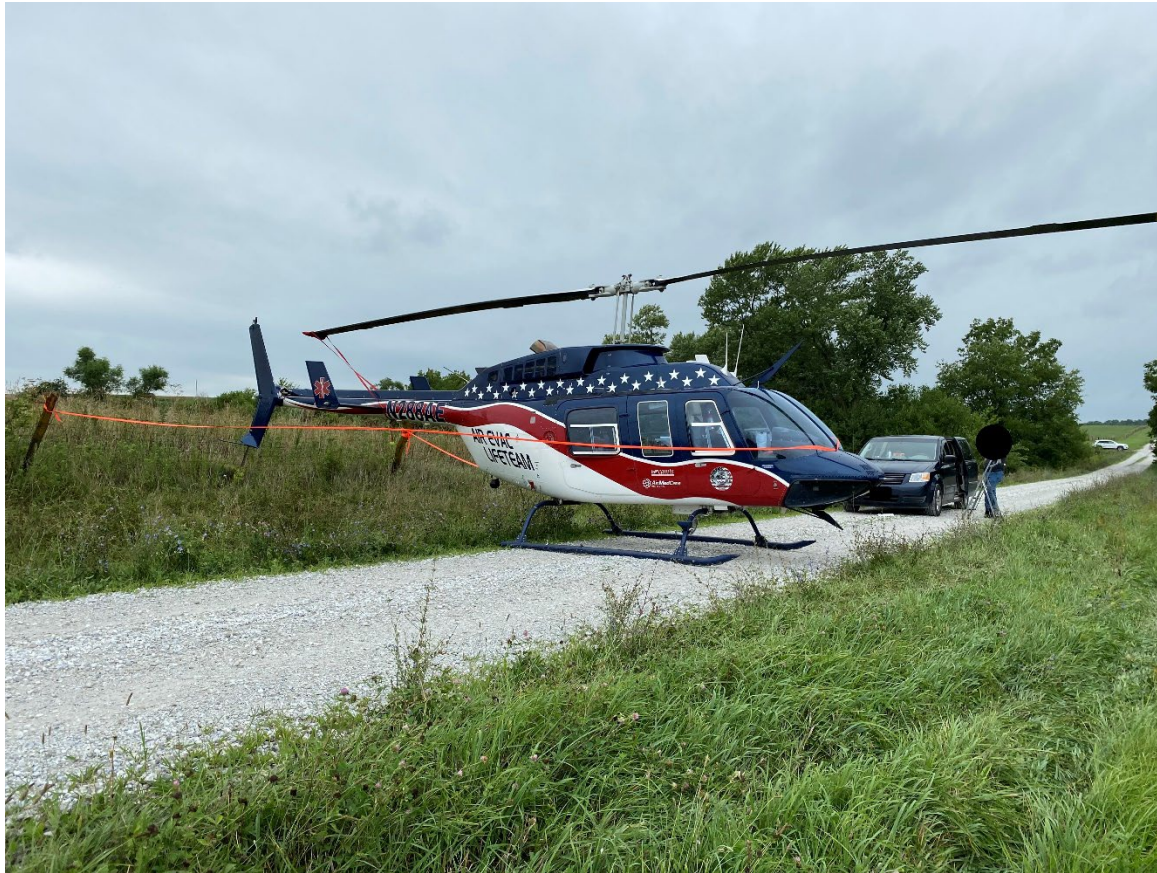
**Photograph 5 - View of the right side of the helicopter at the accident site, during day conditions (Courtesy of the Federal Aviation Administration)**

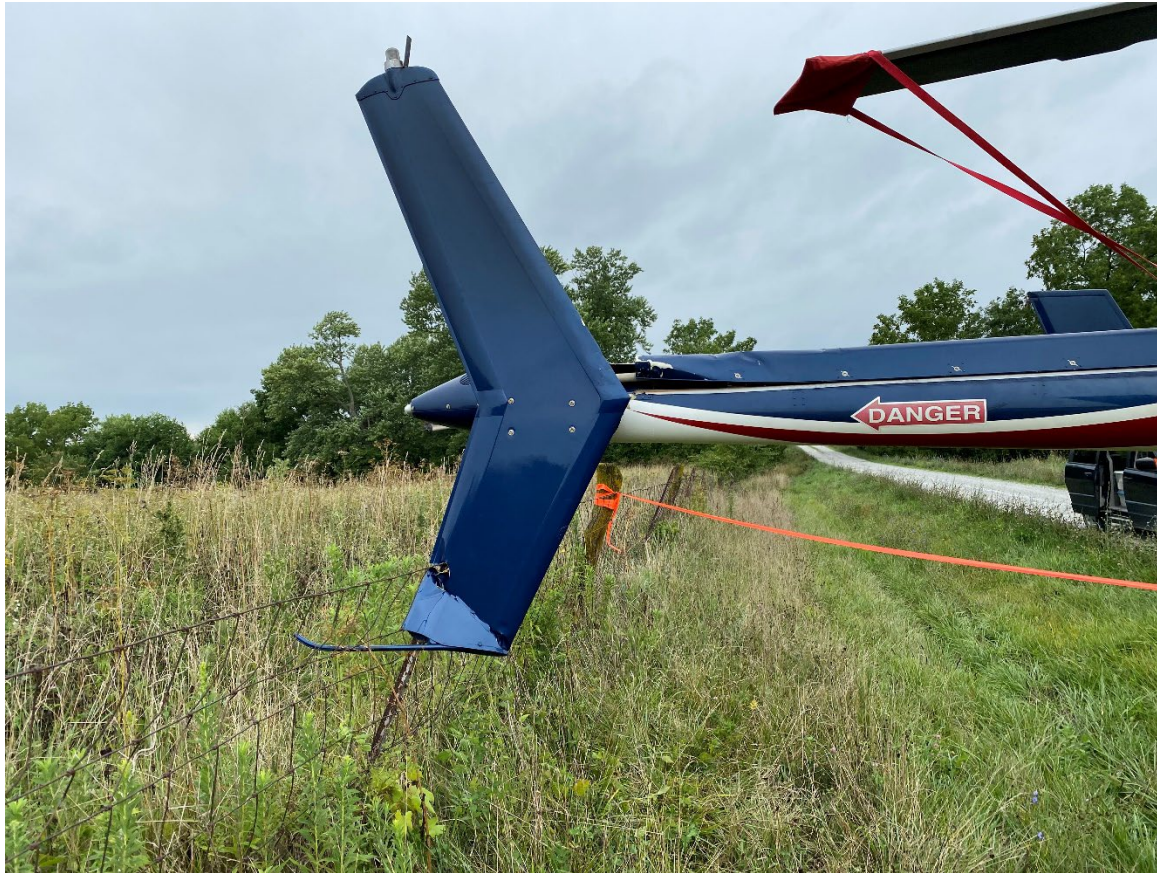
**Photograph 6 - View of the empennage at the accident site, during day conditions (Courtesy of the Federal Aviation Administration)**

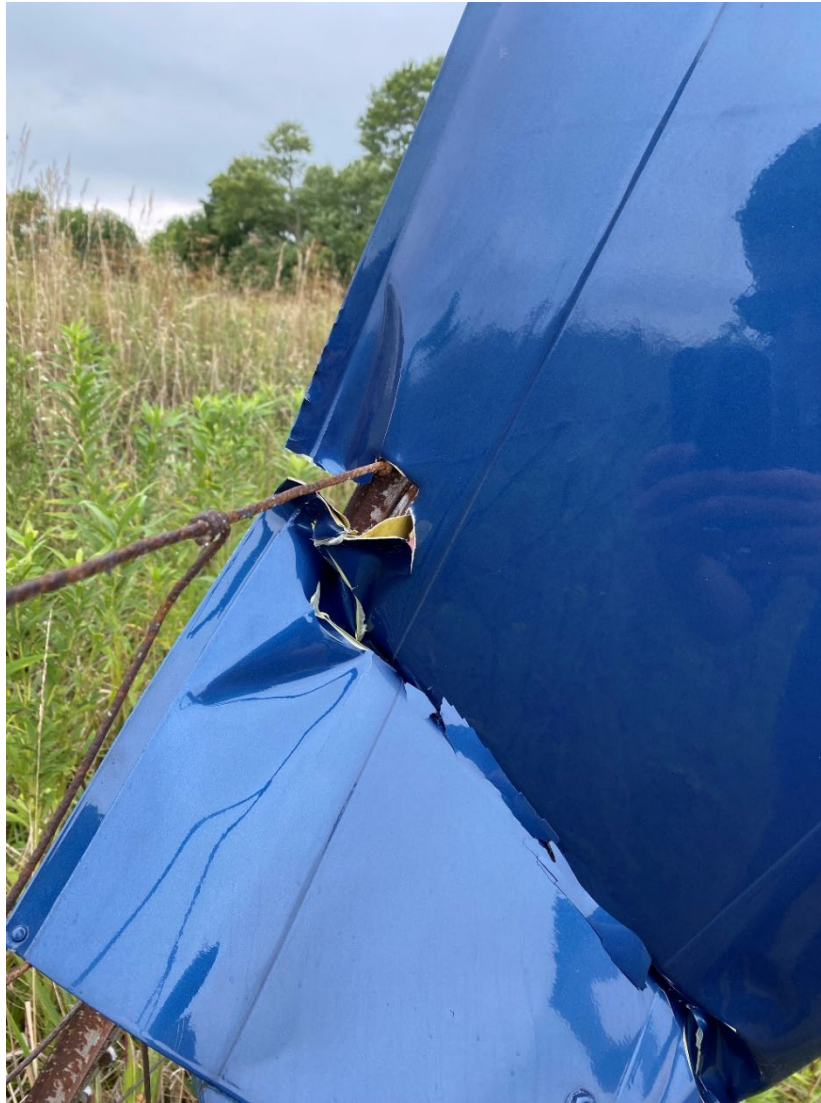
**Photograph 7 - View of the vertical stabilizer and the fence at the accident site, during day conditions (Courtesy of the Federal Aviation Administration)**

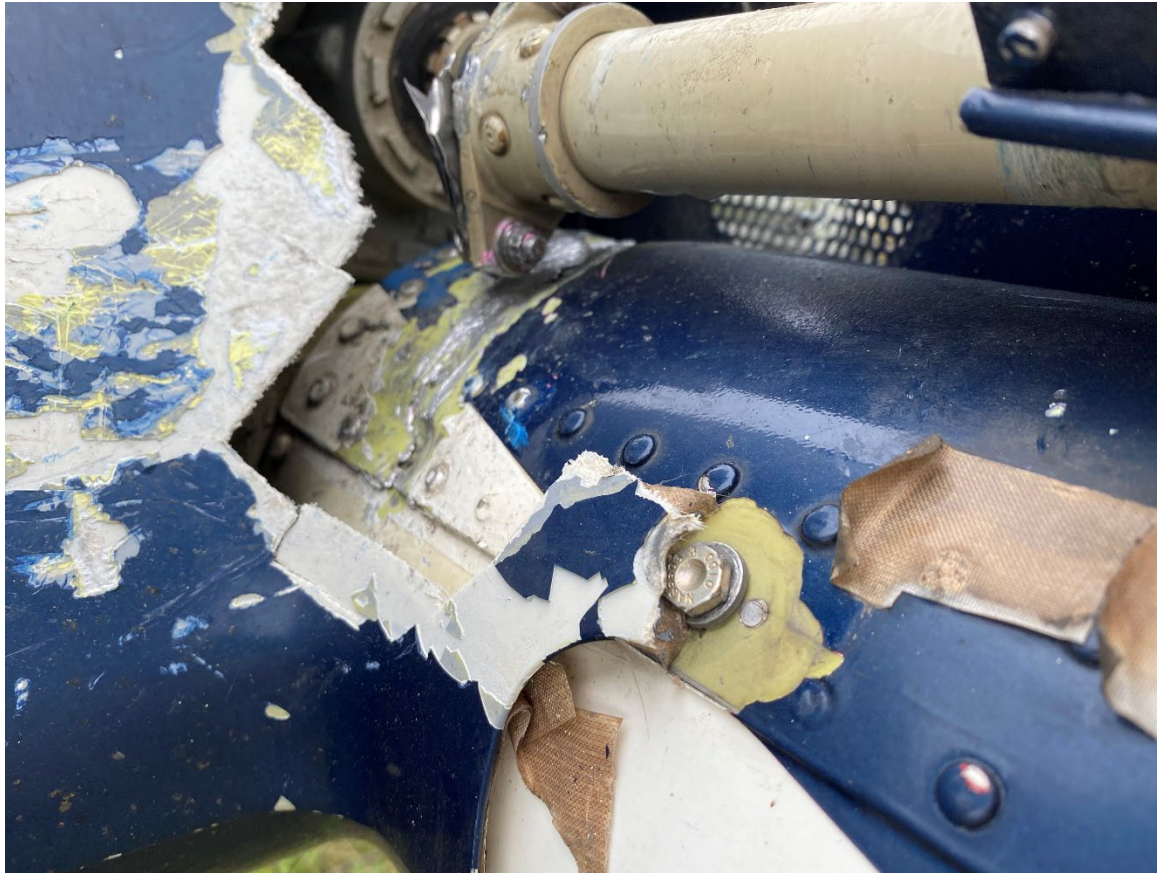
**Photograph 8 - View of the damage sustained to the tail boom and the tail rotor driveshaft.  
(Courtesy of the Federal Aviation Administration)**

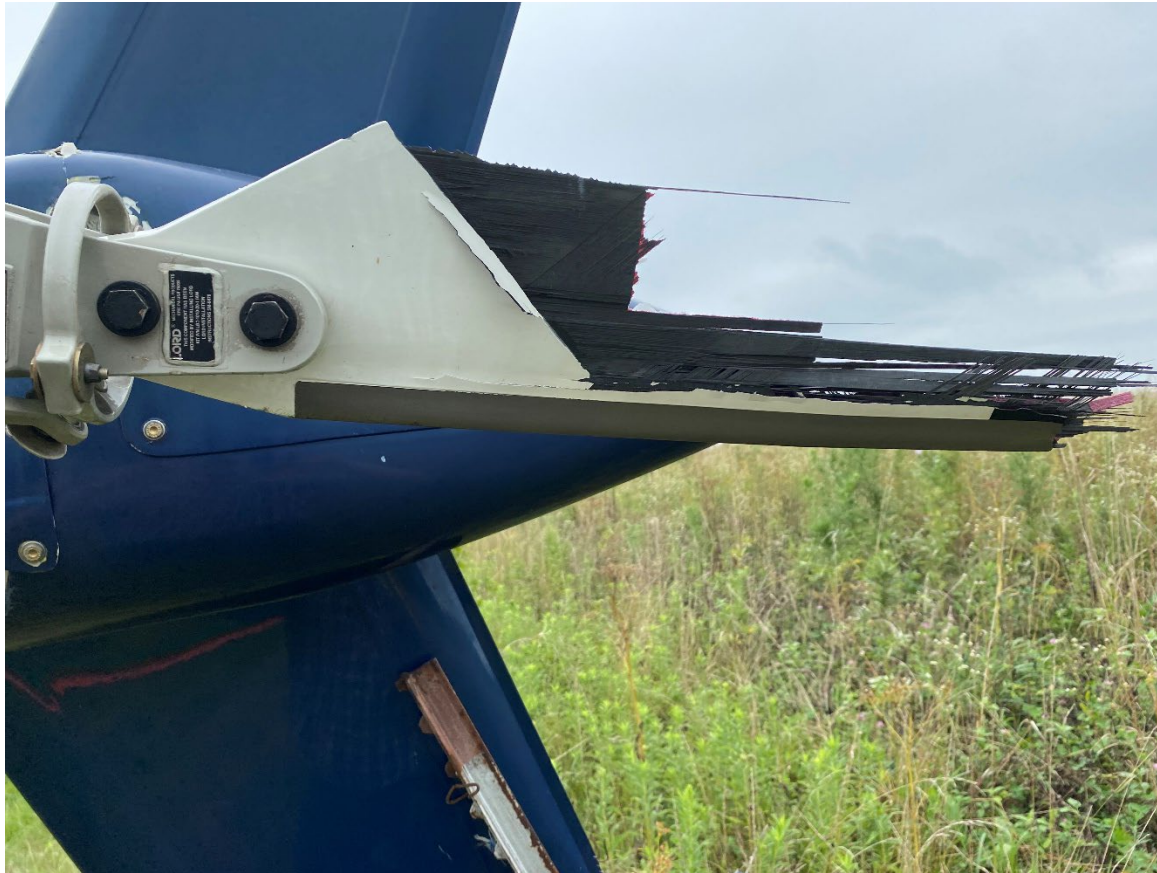
**Photograph 9 - View of the damage sustained to one of the tail rotor blades (Courtesy of the Federal Aviation Administration)**

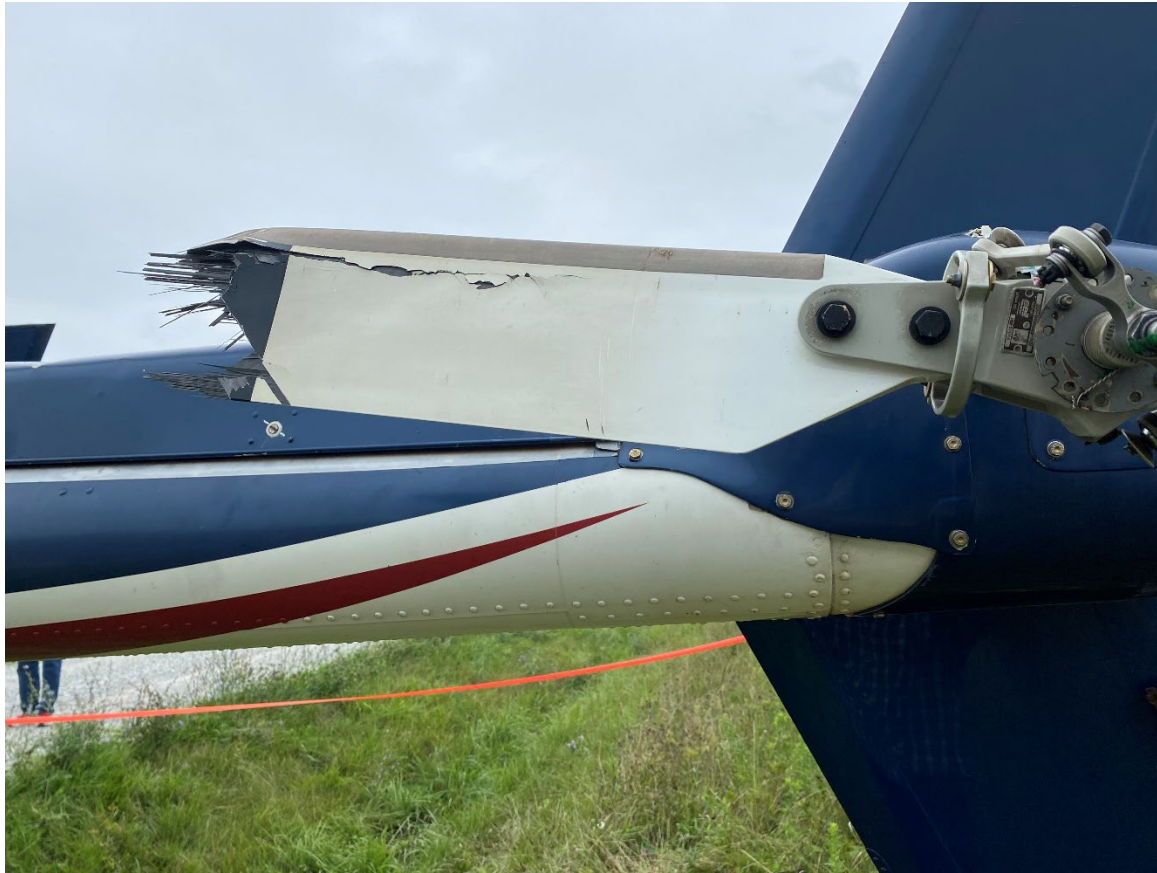
**Photograph 10 - View of the damage sustained to the one of the tail rotor blades (Courtesy of the Federal Aviation Administration)**
