CEN23LA355

## INVESTIGATION PHOTOGRAPH

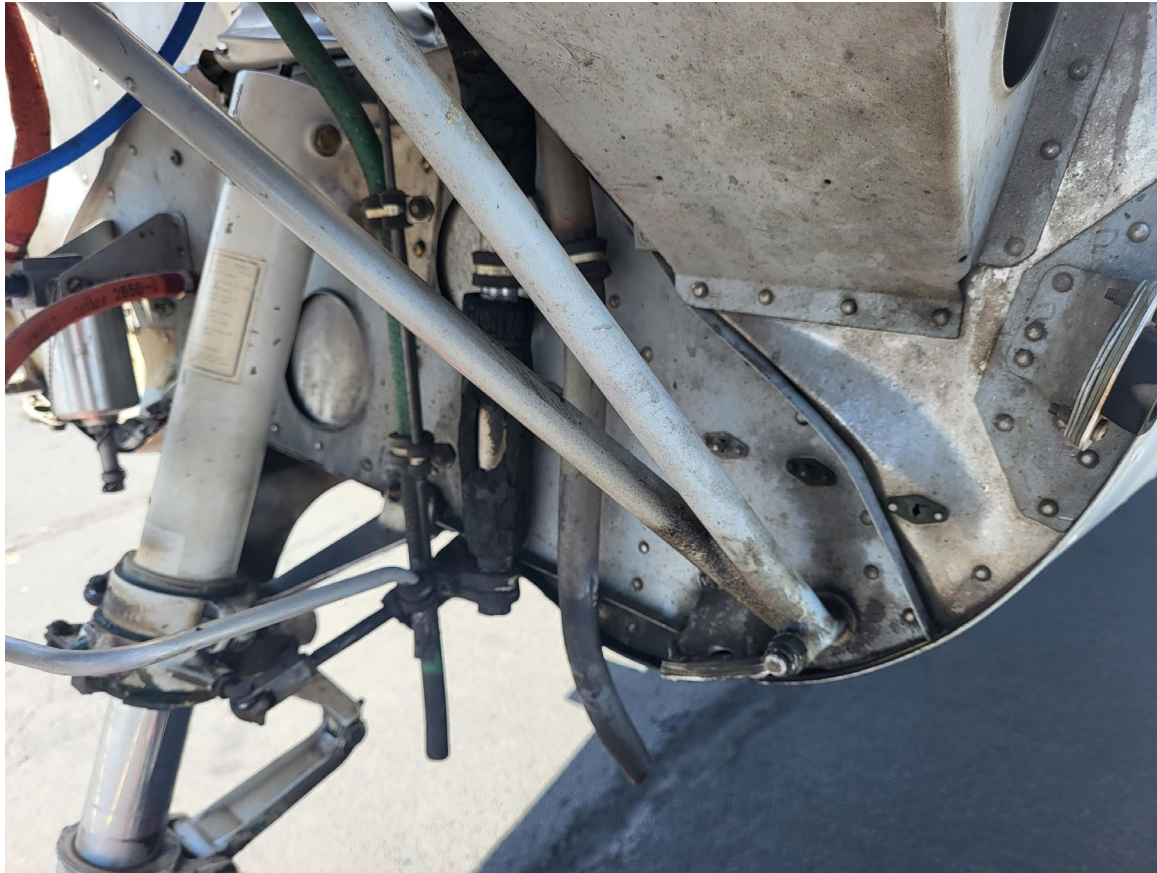
**Photograph 1 - Bent and wrinkled airframe firewall (Courtesy of Operator)**
