CEN23LA357

## INVESTIGATION PHOTOGRAPHS

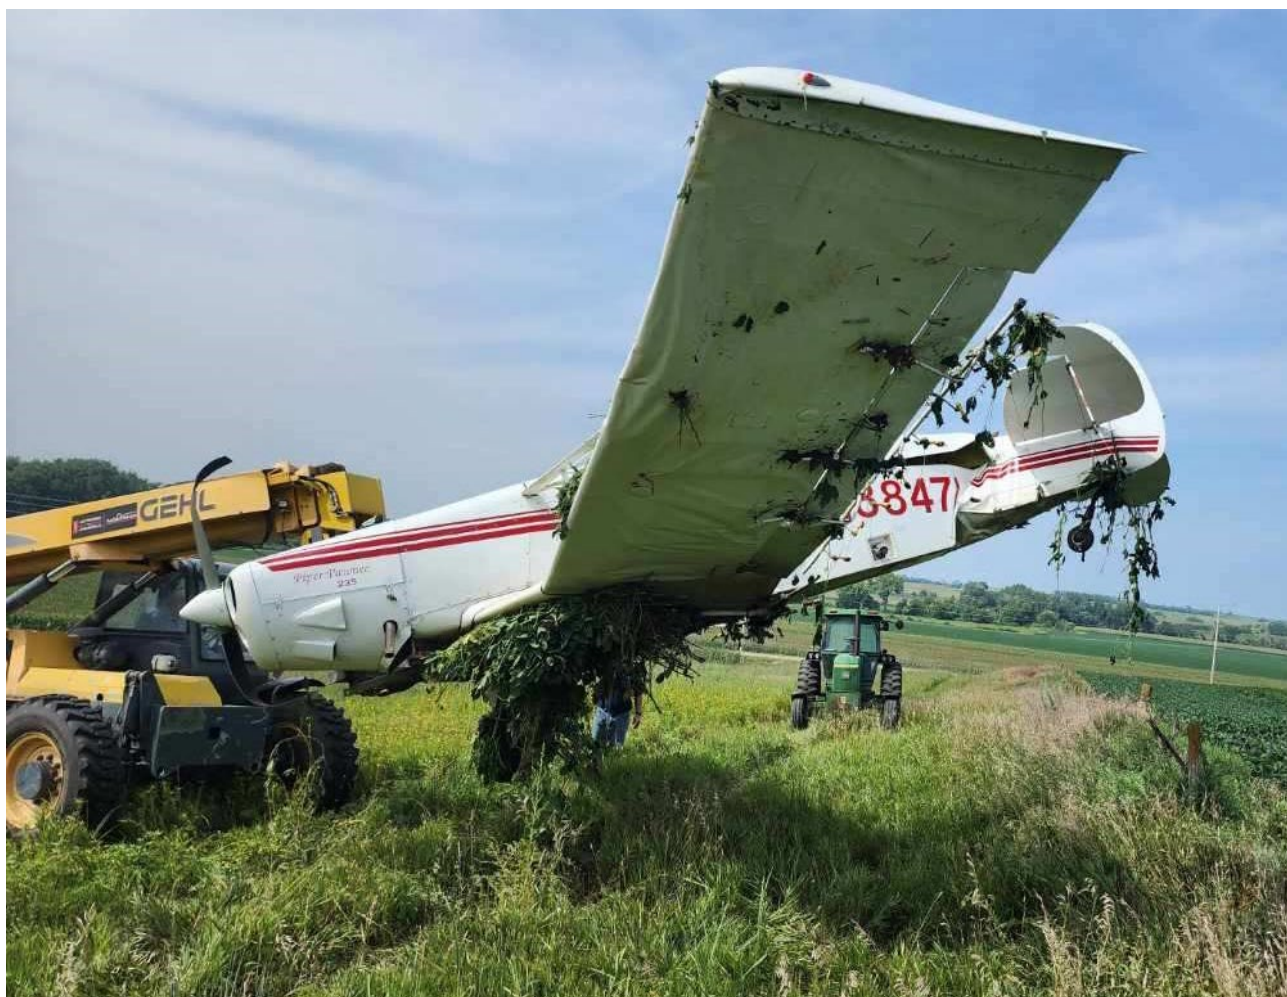
**Photograph 1 - Damage to Left Wing (Courtesy of FAA)**

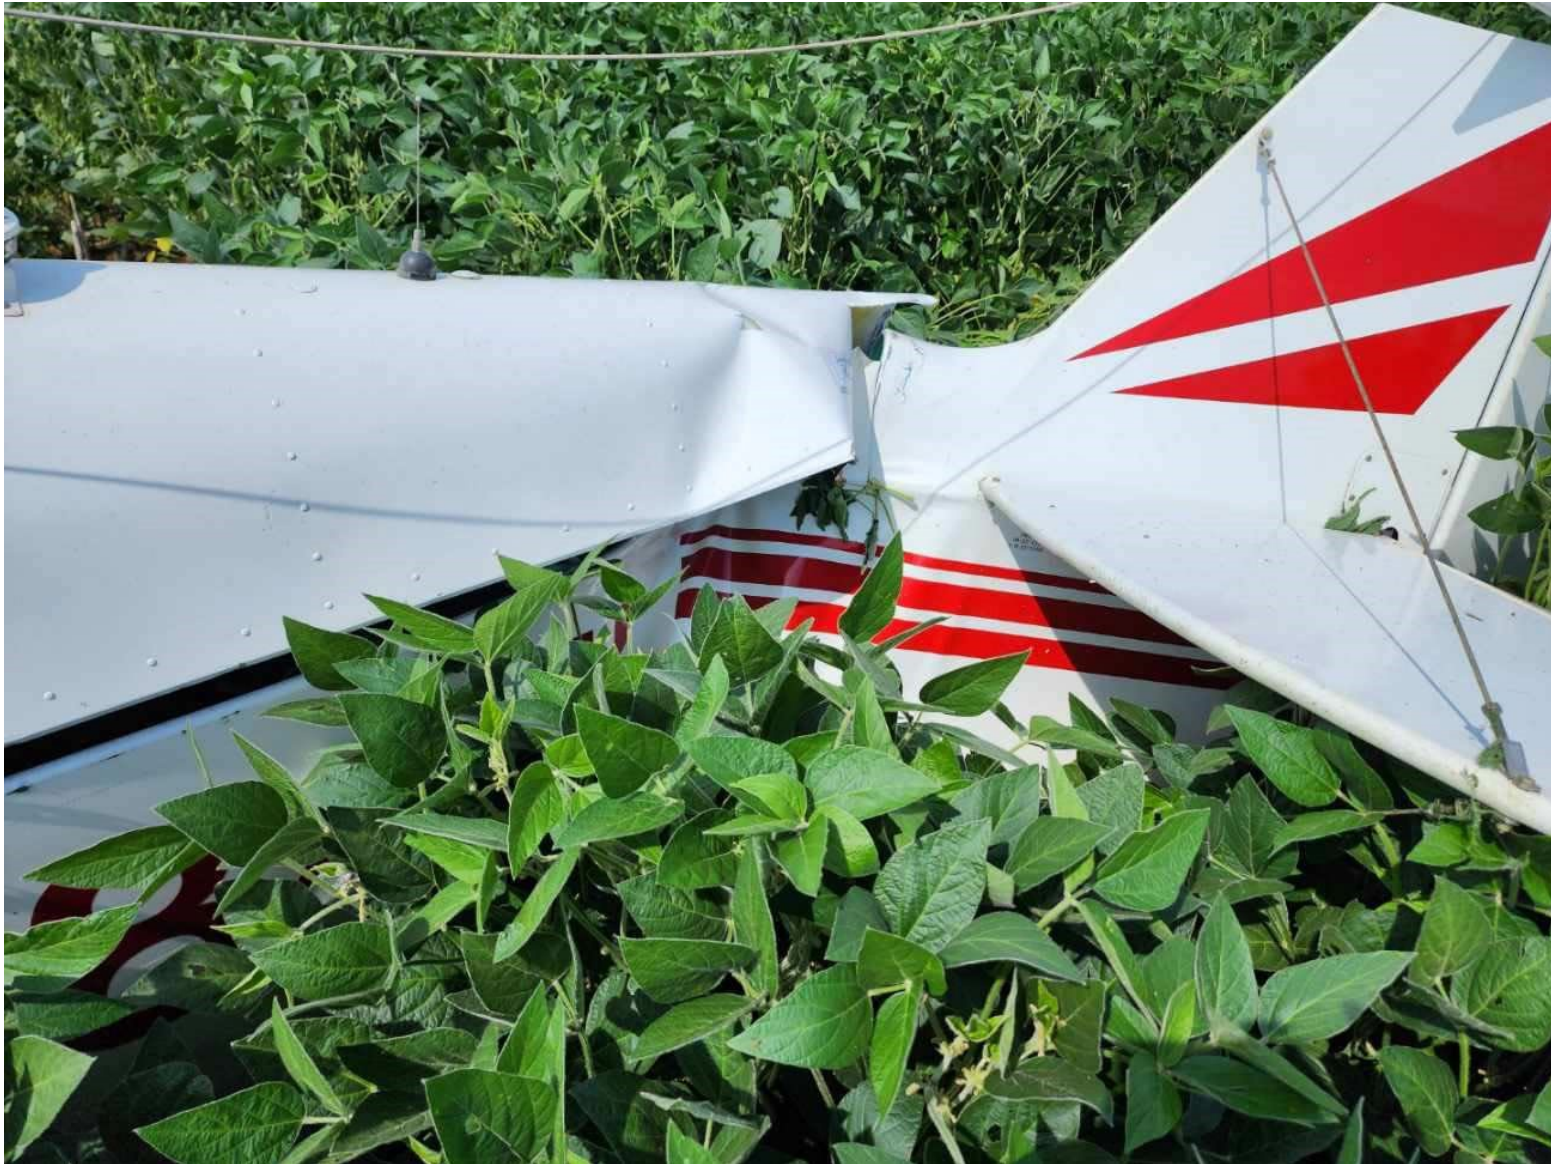
**Photograph 2 - Damage to Empennage (Courtesy of FAA)**
