CEN23LA365

## INVESTIGATION PHOTOGRAPHS

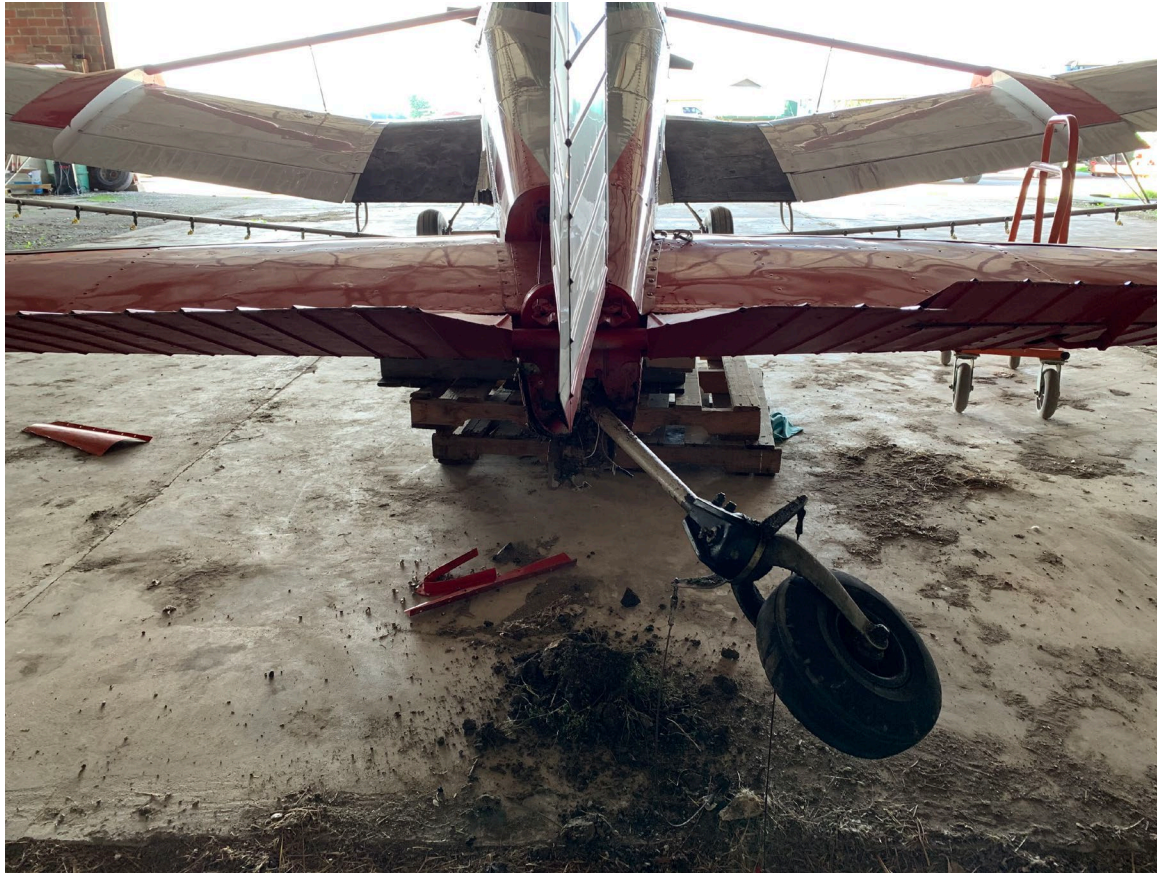
**Photograph 1 -Tailwheel assembly displaced to the right (Courtesy of FAA)**

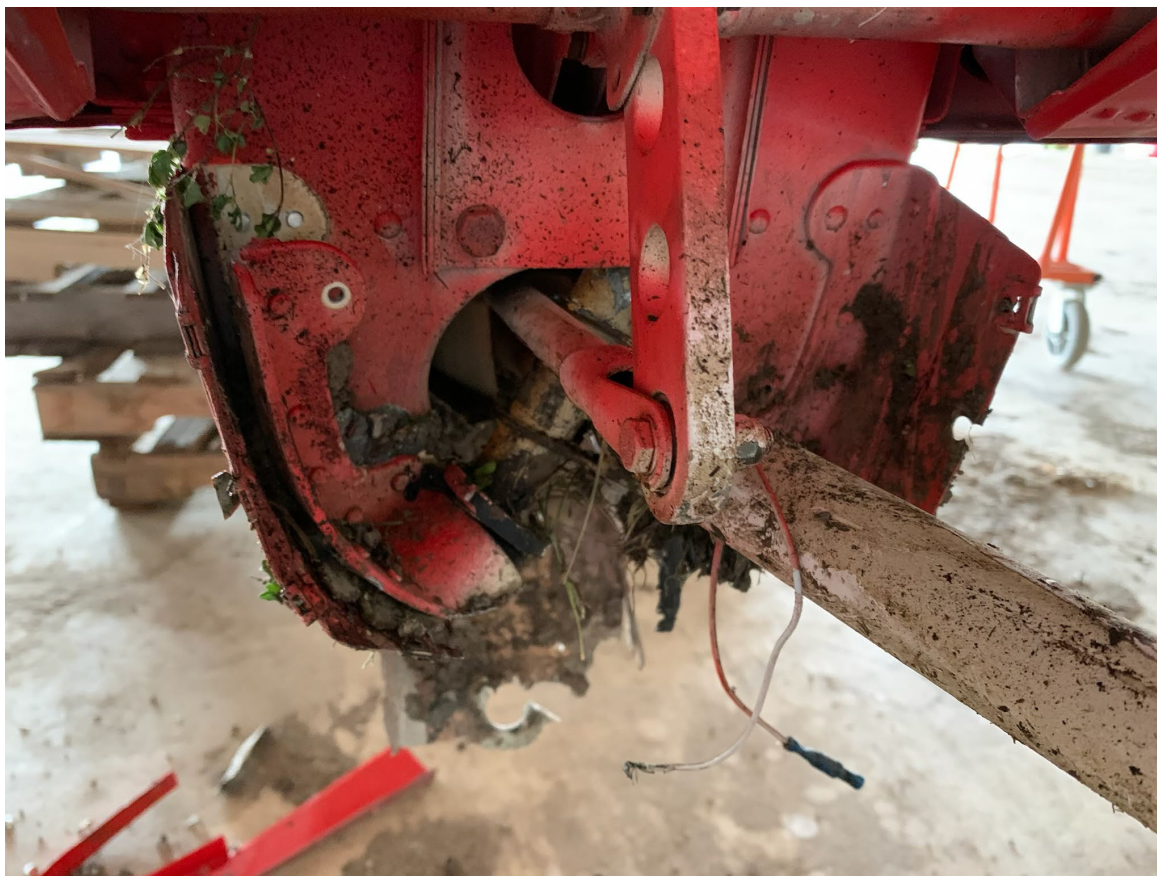
**Photograph 2 - Substantial damage to tailwheel supporting structure (Courtesy of FAA)**
