Mike Folkerts  
NTSB, Central Region  
14291 East 4<sup>th</sup> Avenue, Bldg. 7  
Denver, CO 80011  
Subject: Carburetor Exam

Quality Aircraft Accessories has performed a post incident exam on the following carburetor:

Marvel Schebler  
Model: MA-4-5  
P/N: 10-5034  
S/N: BU-14-1047

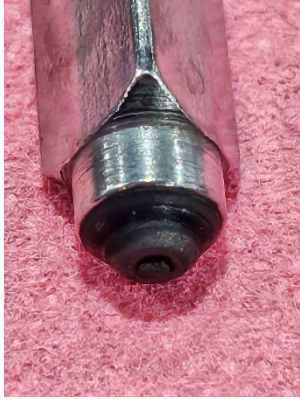
After removing the 6 bolts and separating the two halves, I examined the float assembly. The float setting was not correct. It should be set at 13/64ths between the pontoon and the parting surface. I could not get a 13/64ths drill shank in between the pontoon and the parting surface. Indicating that the float was set too rich. The float was a brass float indicating that Service Bulletin SB-2 Revision 3 was never complied with. No foreign debris was found inside the carb bowl. There was significant wear of the tip of the float needle which would cause the needle to not seat properly when the proper fuel level was reached.

Worn Float Needle

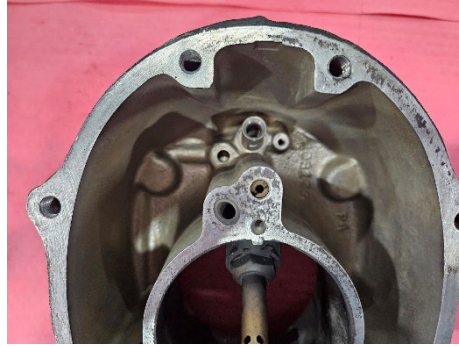
No debris in fuel bowl.

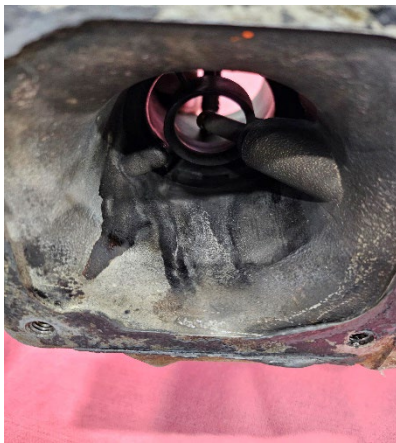
On initial exam of the outside of the carb, there were obvious fuel stains around the outside of the fuel bowl at and below the parting surface. There was also fuel staining in the throat of the bowl below the main fuel nozzle. After normal overhaul/repair, the 6 bolts that hold the throttle body to the bowl, are secured using a lock washer with tabs that are bent up to hold the bolt secure. This carburetor had one bolt where the lock tabs were not bent up. Also, all 6 bolts were loose enough to move with my fingers. Also noted externally, was the economizer screw was not safety wired as per the manual.

Fuel Staining

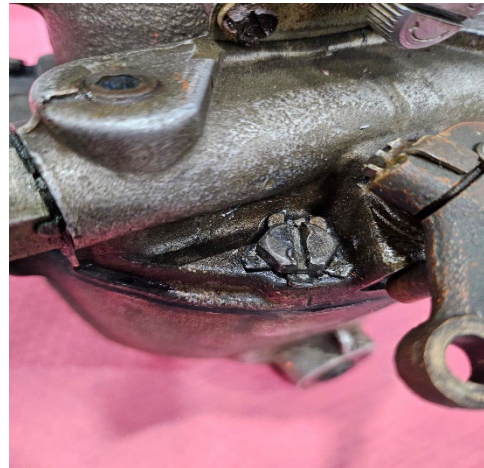
Lock tabs not bent and bolts loose.

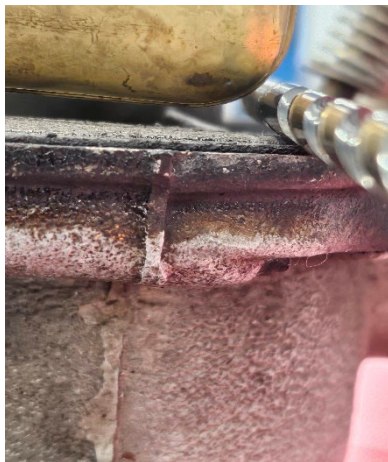
Float level set rich.
