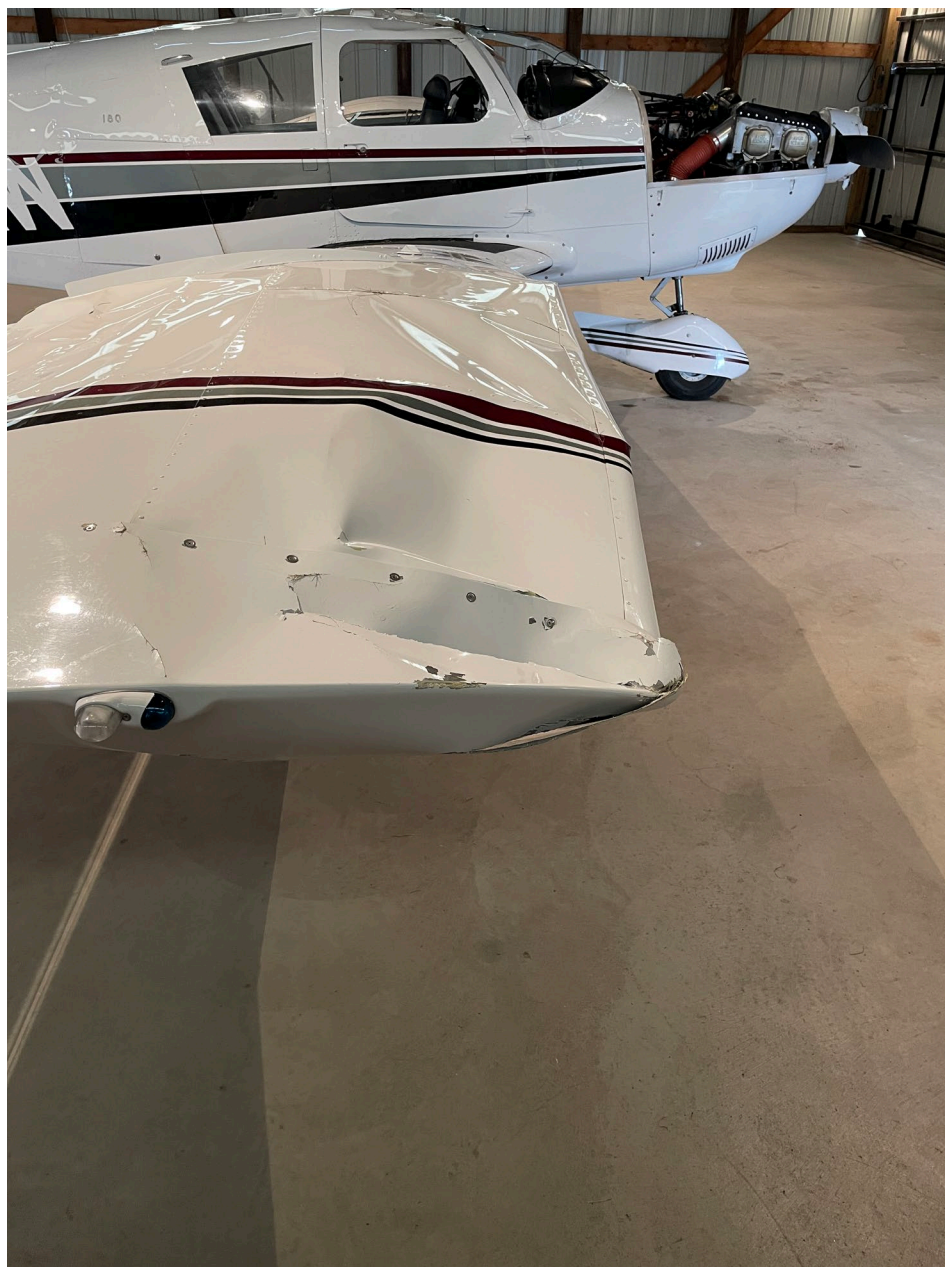
**Photo 1 – Right wing damage (Source: FAA)**

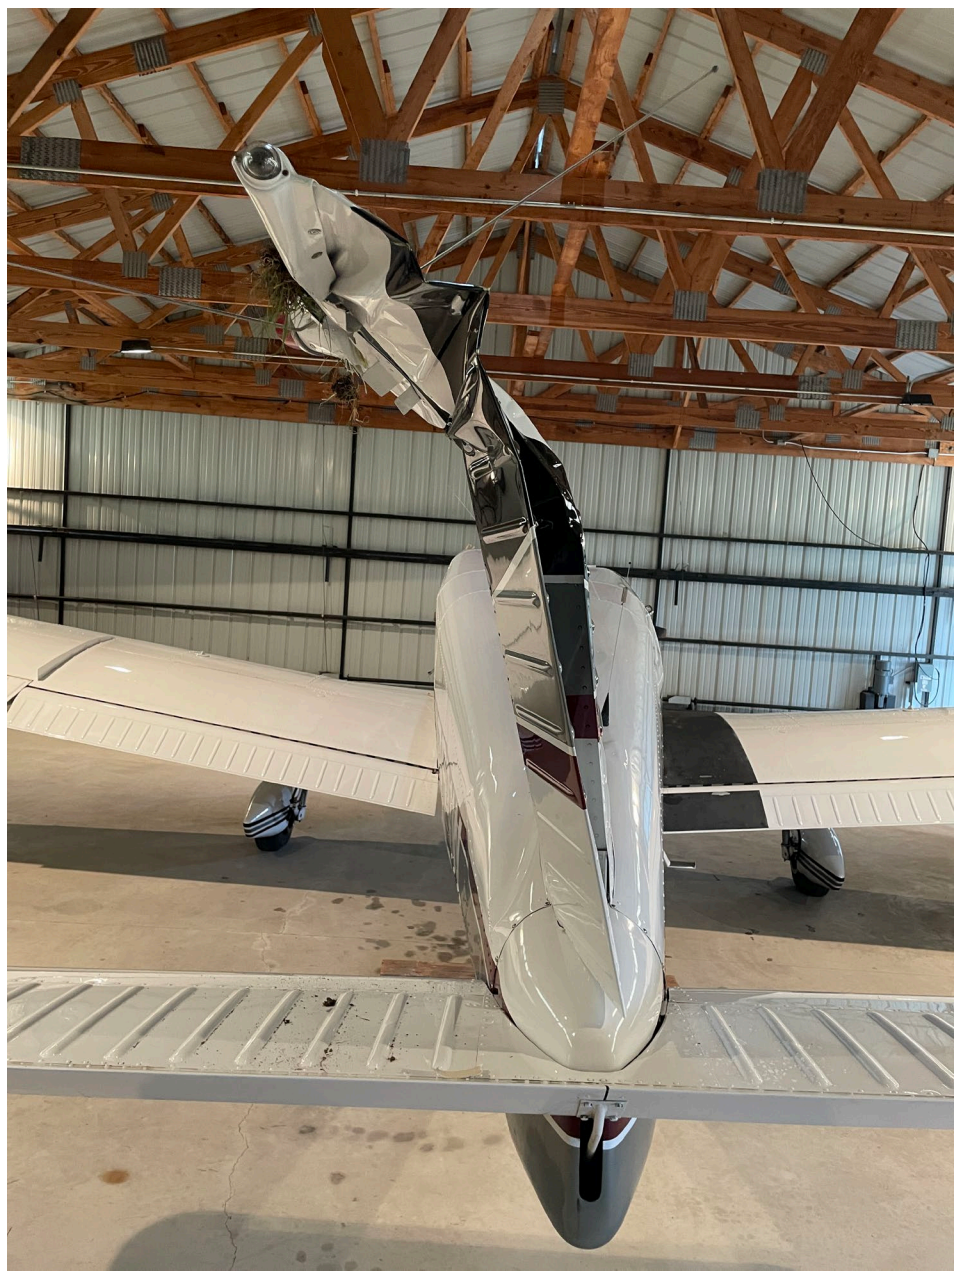
**Photo 2 – Vertical stabilizer and rudder damage (Source: FAA)**

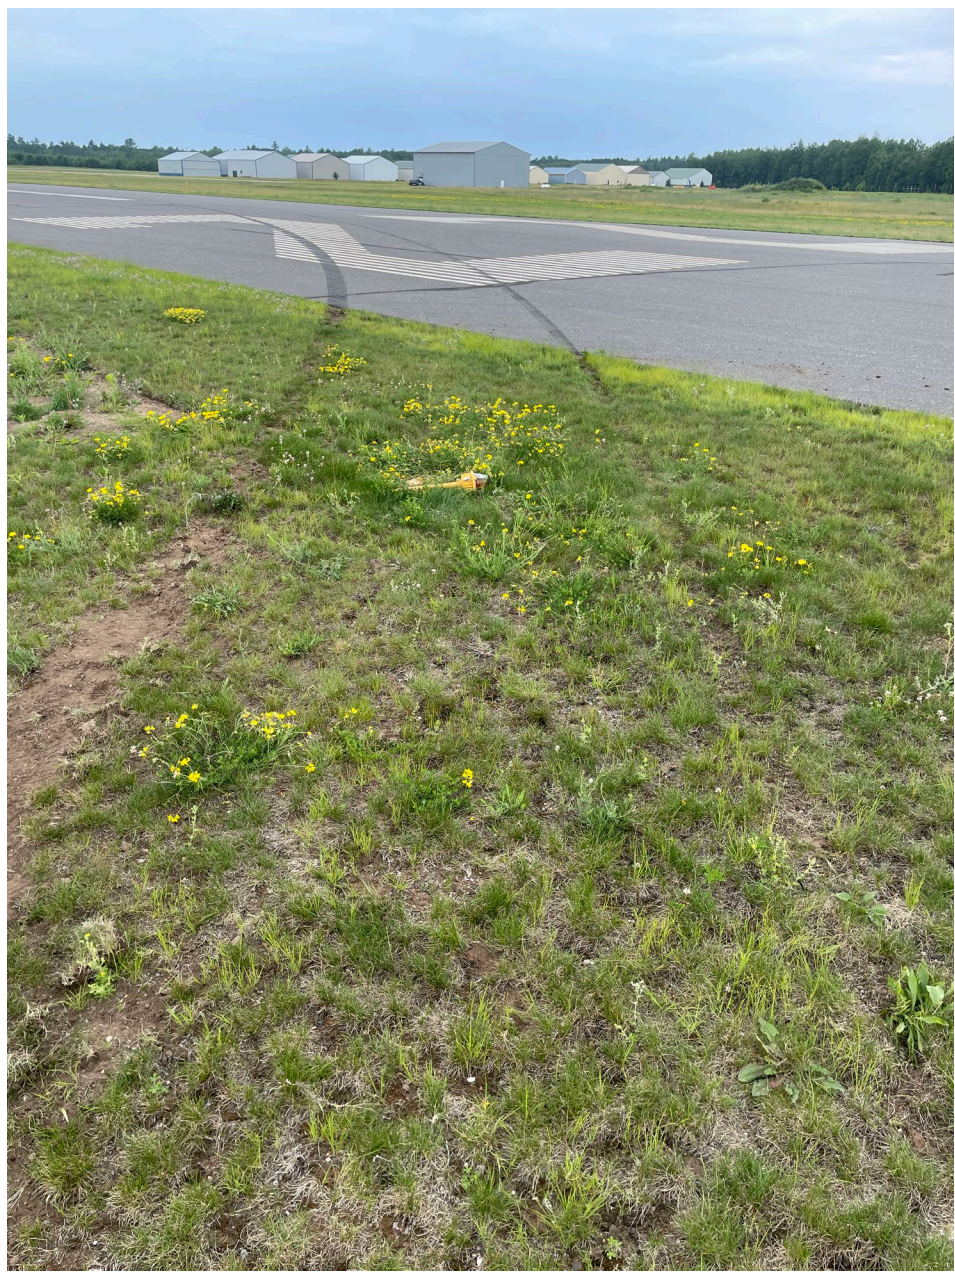
**Photo 3 – Runway excursion tire marks (Source: FAA)**
