CEN23LA370

## INVESTIGATION PHOTOGRAPHS

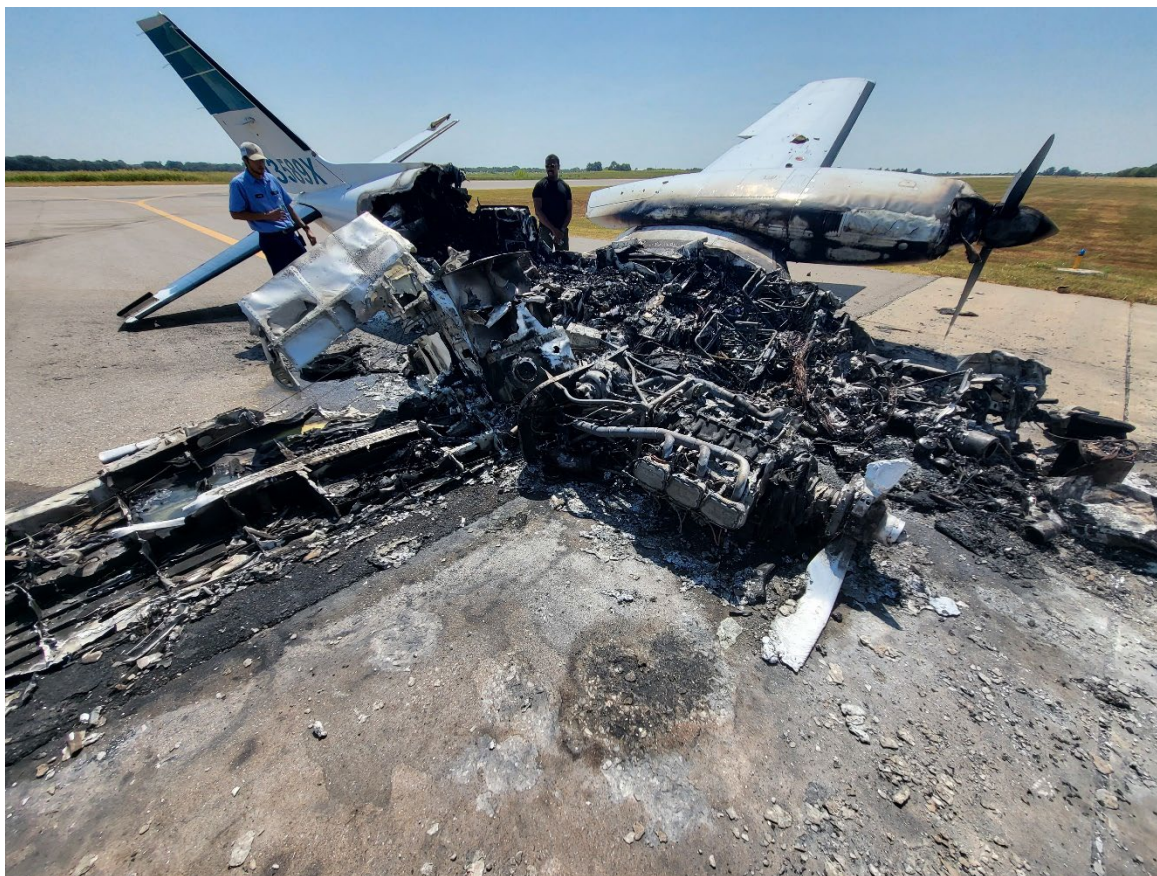
**Photograph 1 - Accident Overview (Courtesy of Durant Airport Director)**

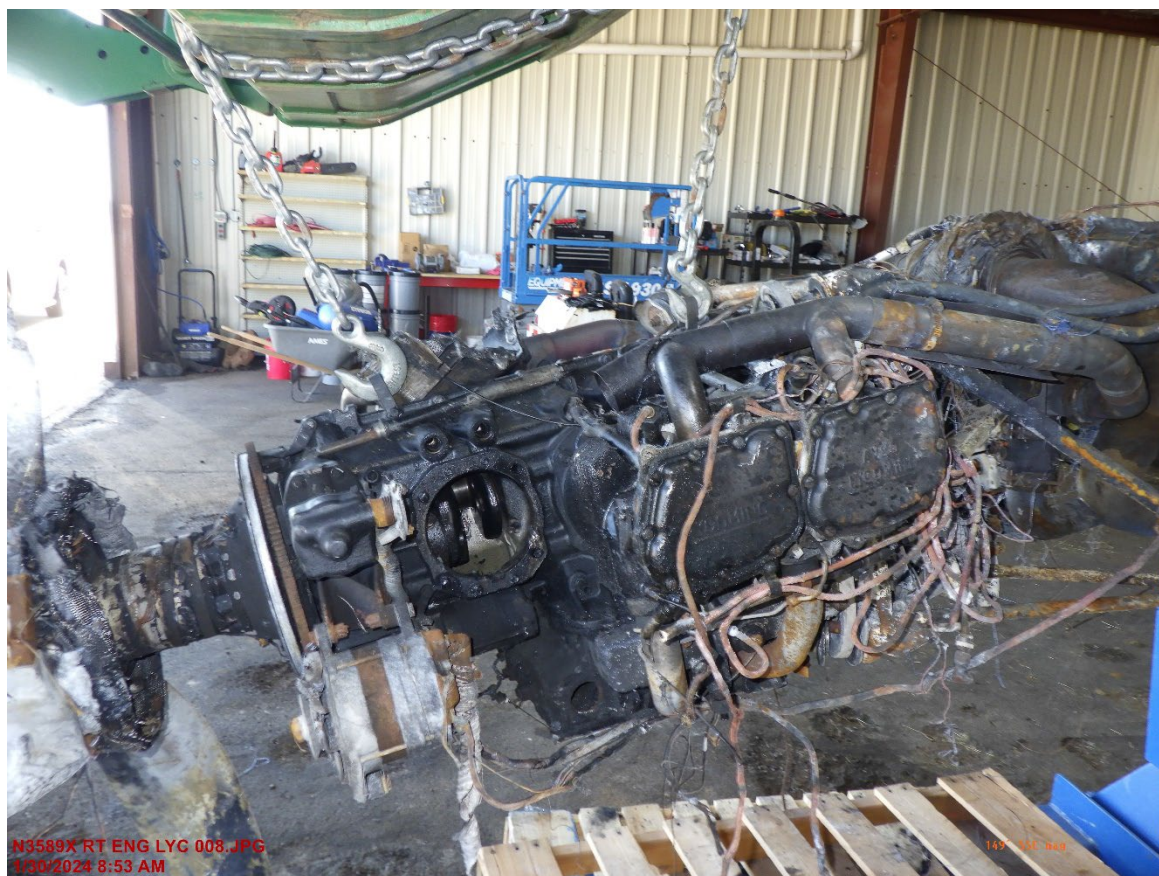
**Photograph 2 - Right Engine (Courtesy of Lycoming Engines)**

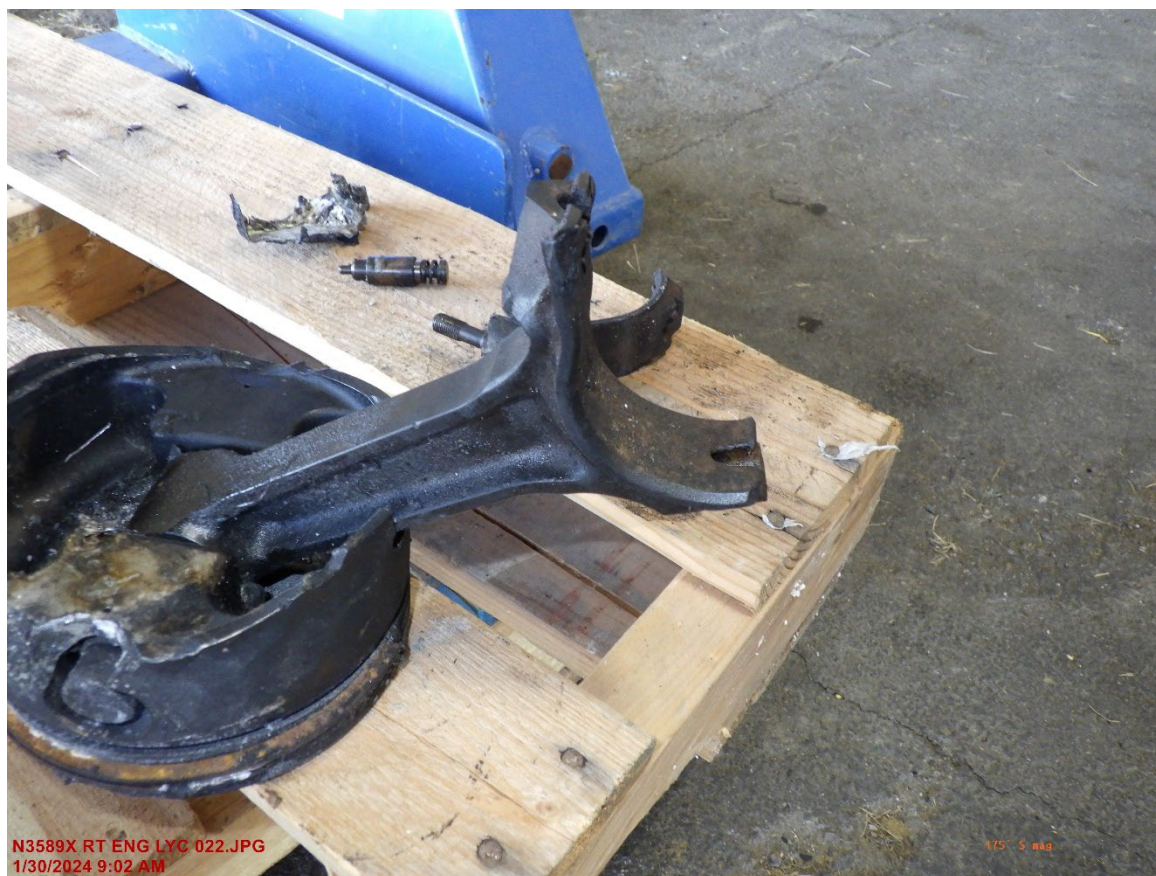
**Photograph 3 - No. 2 Piston and Connecting Rod (Courtesy of Lycoming Engines)**

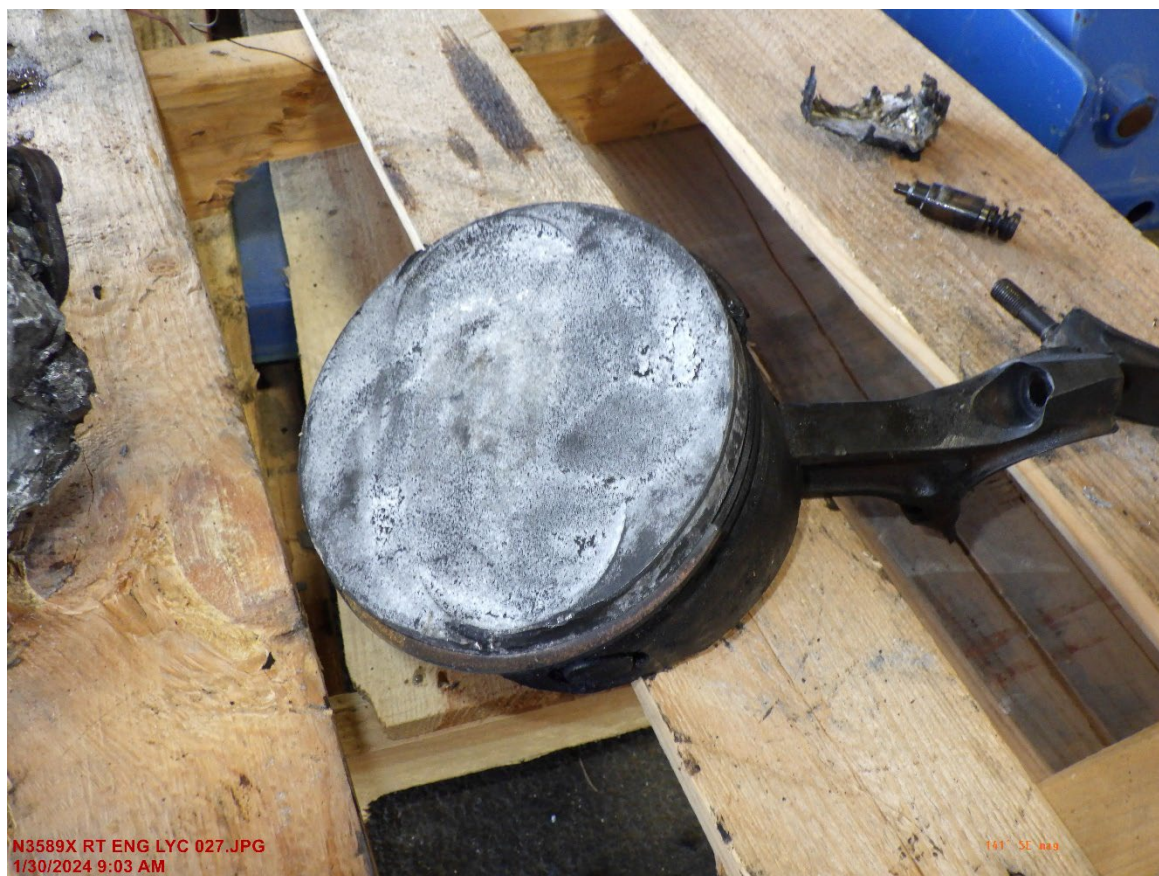
**Photograph 4 - No. 2 Piston Head (Courtesy of Lycoming Engines)**

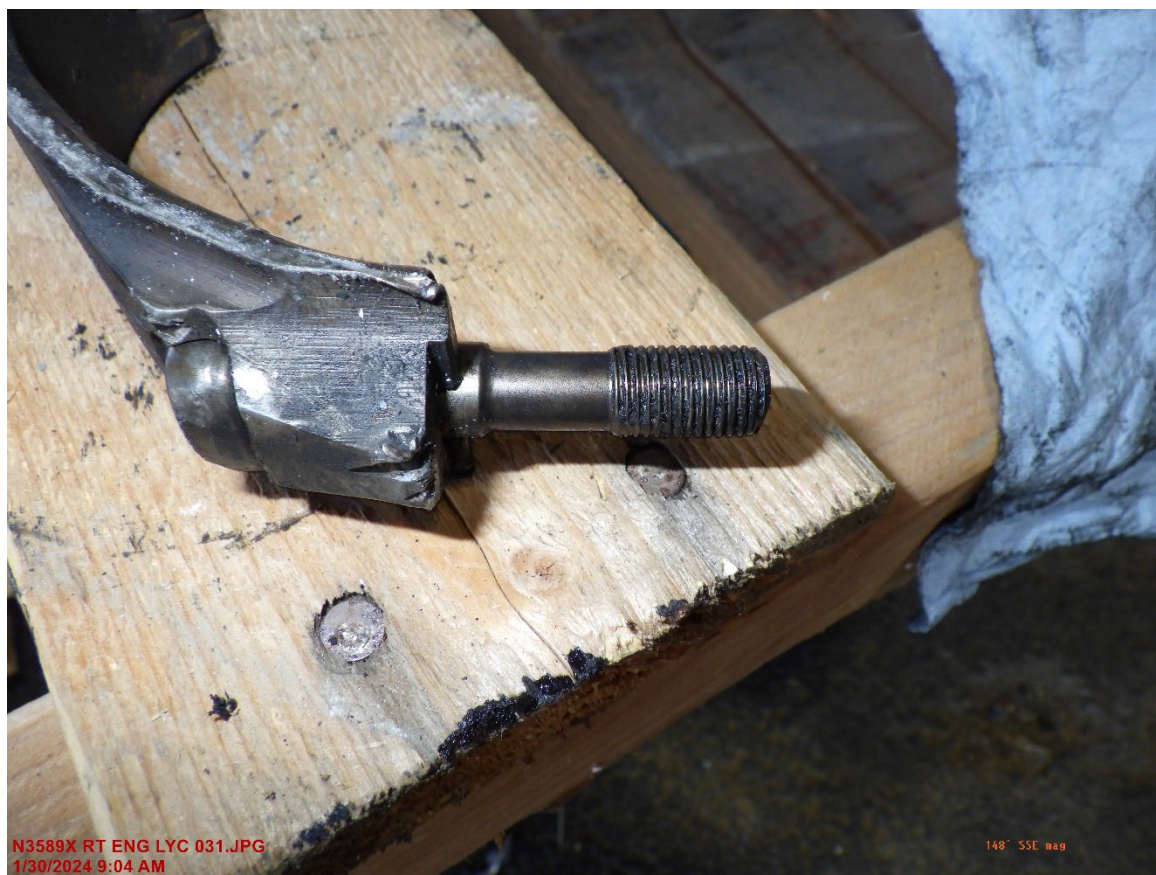
**Photograph 5 - No. 2 Connecting Rod Cap (Courtesy of Lycoming Engines)**
