# National Transportation Safety Board

CEN23LA388

## **COMPONENT EXAMINATION**

Location: Wichita, Kansas  
Date: August 30, 2023  
Time: 1314 Local  
Airplane: N9663X - Cessna 210B

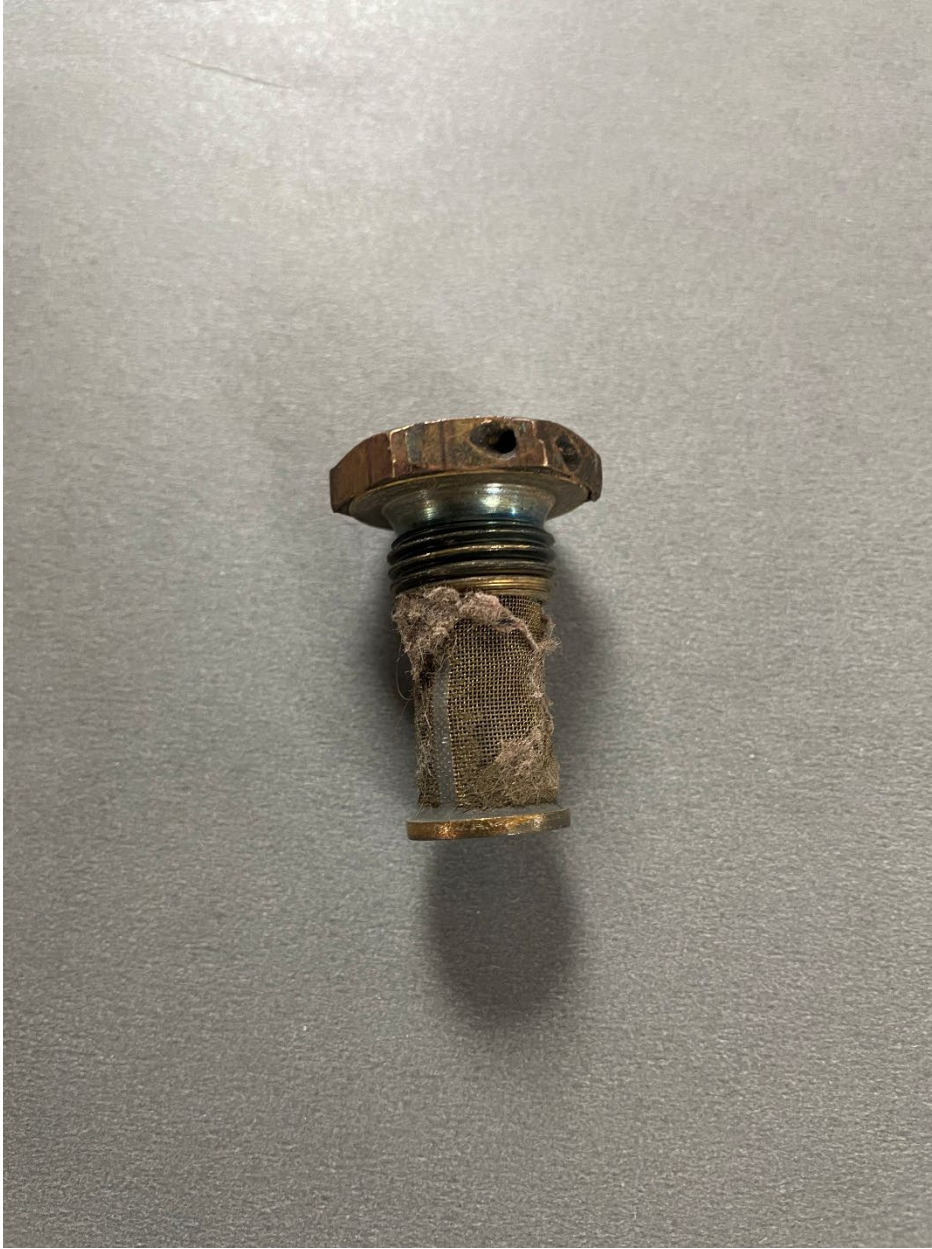
The fuel control unit and throttle body were examined and the fuel mixture screen removed. There was a substantial amount of debris on the screen. The screen was reinstalled and the unit connected to a calibrated flow bench for functional testing. The functional testing of the fuel control unit did not reveal any discrepancies.

Figure 1 Debris as found on fuel control unit screen.

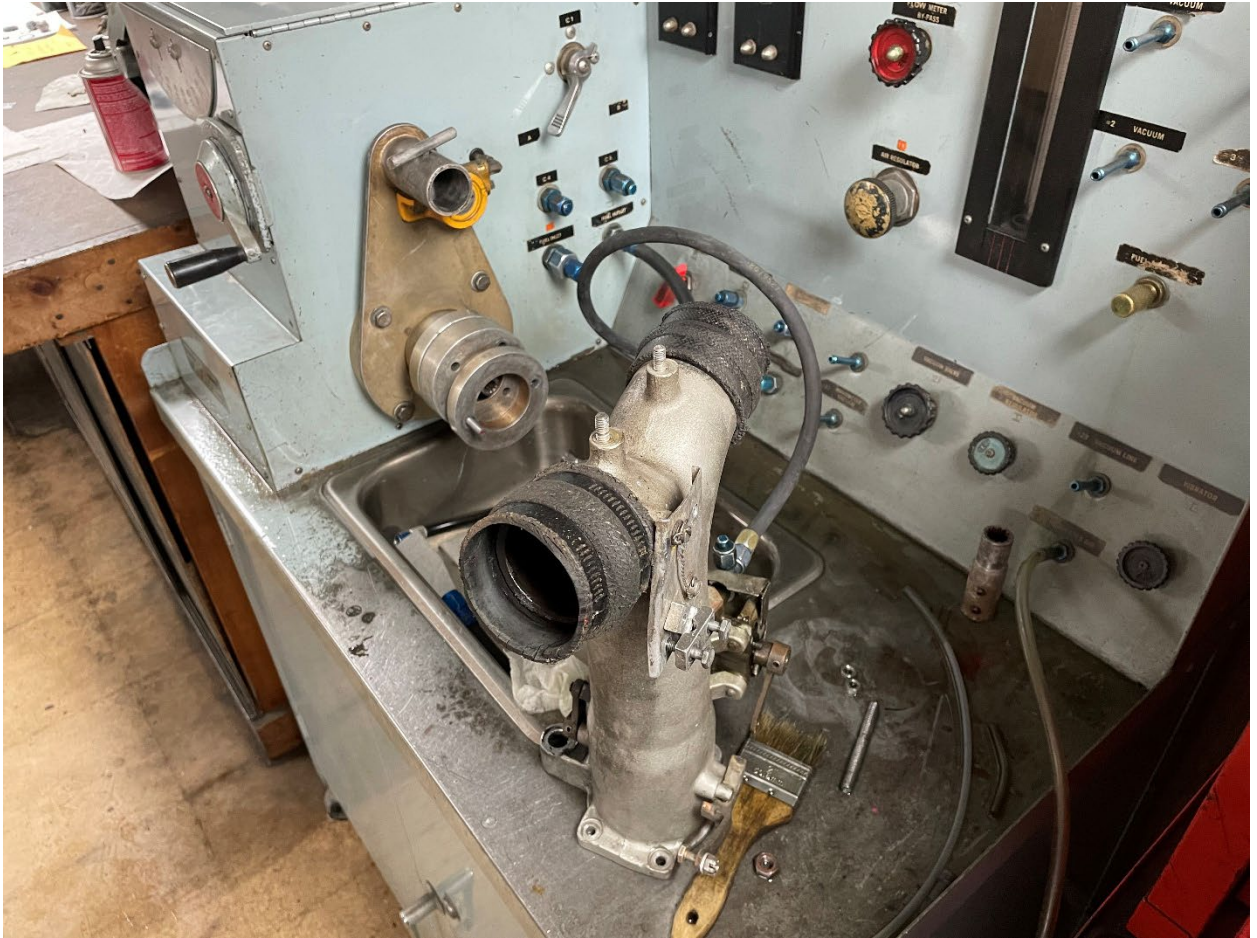
Figure 2. Fuel control unit/throttle body connected to flow bench.

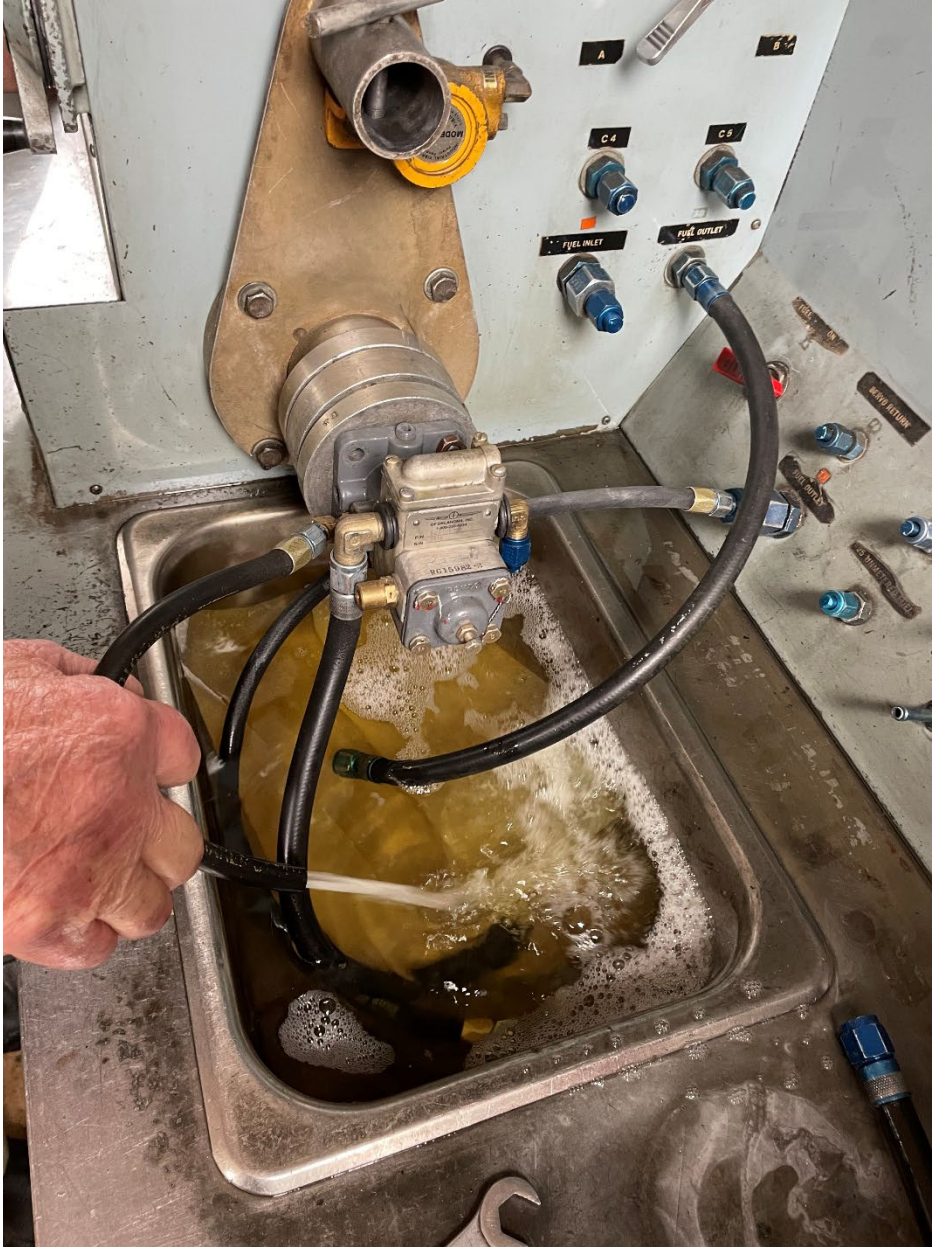
The fuel pump was placed on the fuel test bench and functionally tested. No discrepancies were noted.

Figure 3. Fuel pump connected to test bench.

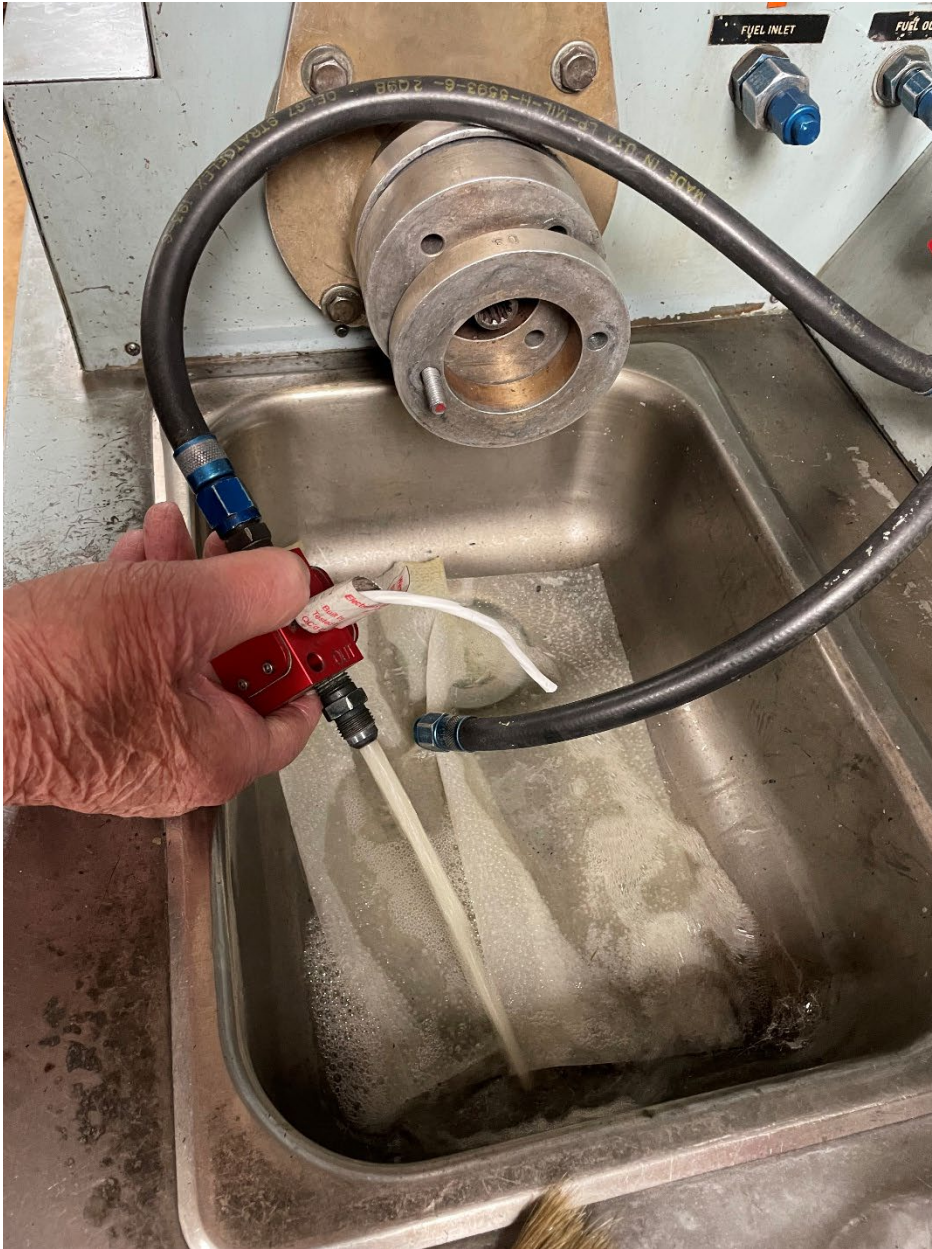
The fuel flow sensor was examined, and no obstruction was noted when blown through by mouth. The turbine could be heard spinning while blowing by mouth. The unit was then connected to the flow bench and test fluid pumped through it. No blockage was noted.

Figure 4. Fuel flow sensor connected to test bench.
