CEN23LA393

**INVESTIGATION PHOTOGRAPH**

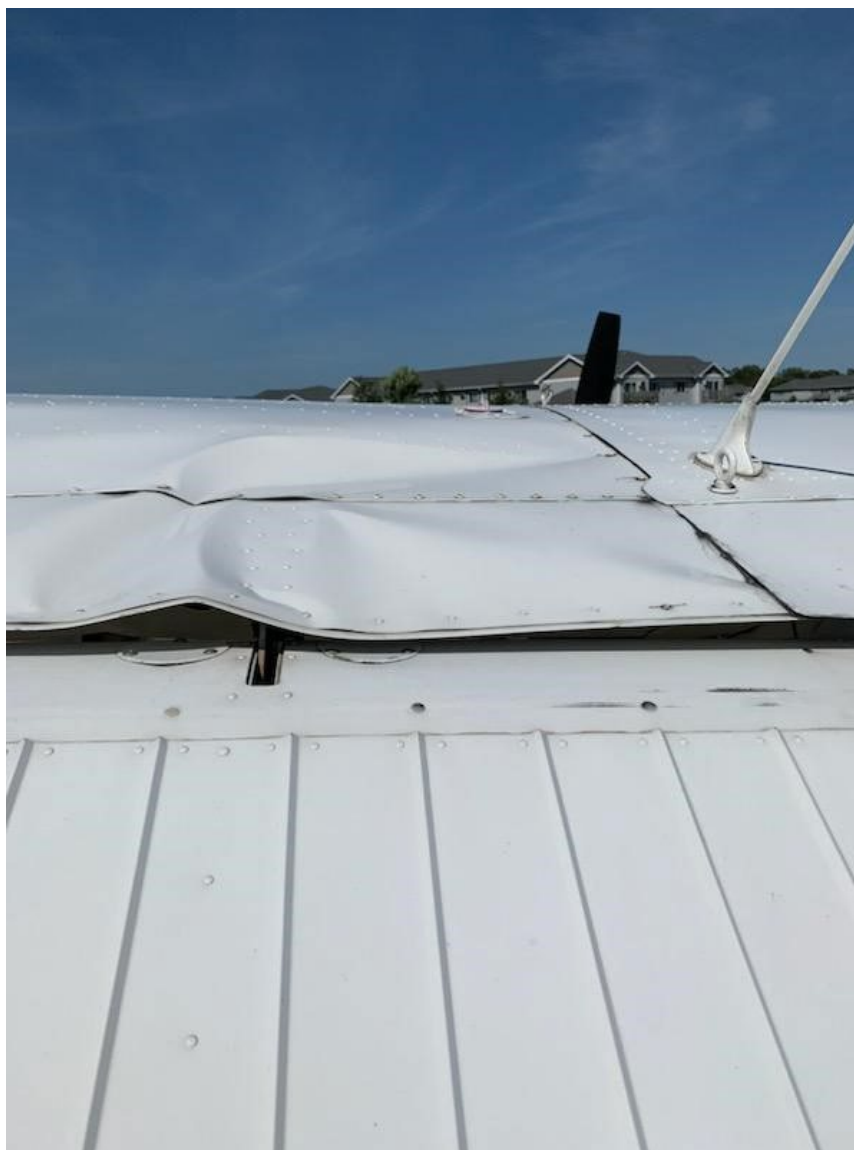
**Photograph 1 - Left wing rear spar is bent and buckled (Courtesy of Wisconsin State Patrol)**
