**From:** [REDACTED]  
**To:** [REDACTED]  
**Subject:** CEN23LA398 - Crystal, Minnesota - Materials Laboratory Examination Report  
**Date:** Friday, October 20, 2023 12:56:14  
**Attachments:** [IMG\\_0030.JPG](#)  
[IMG\\_0039.JPG](#)  
[image003.png](#)

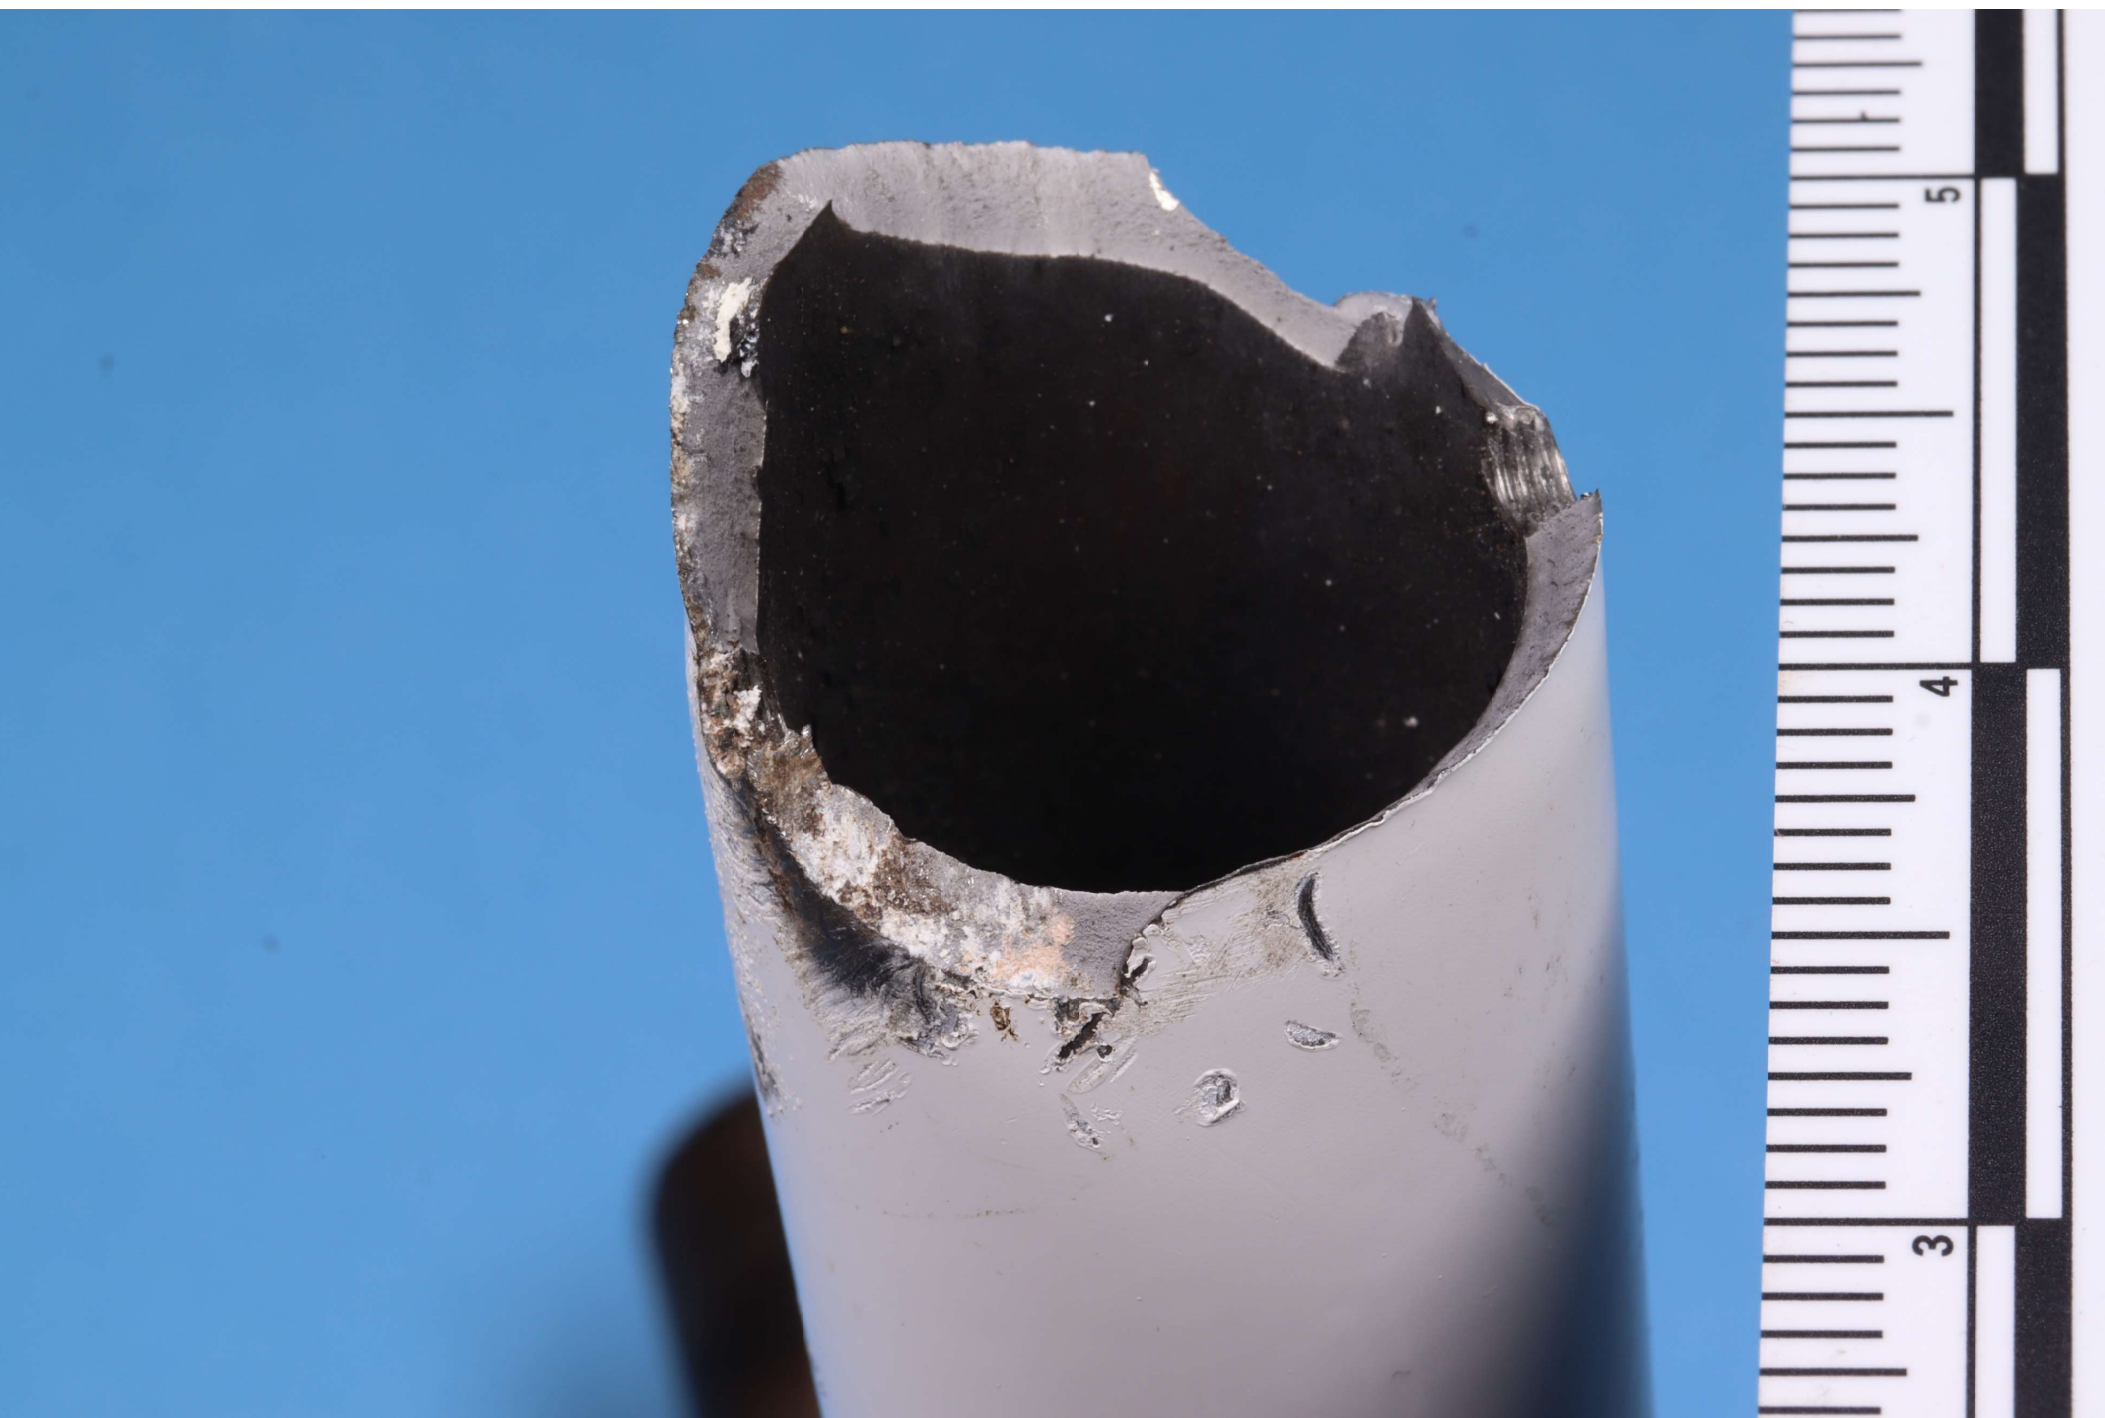
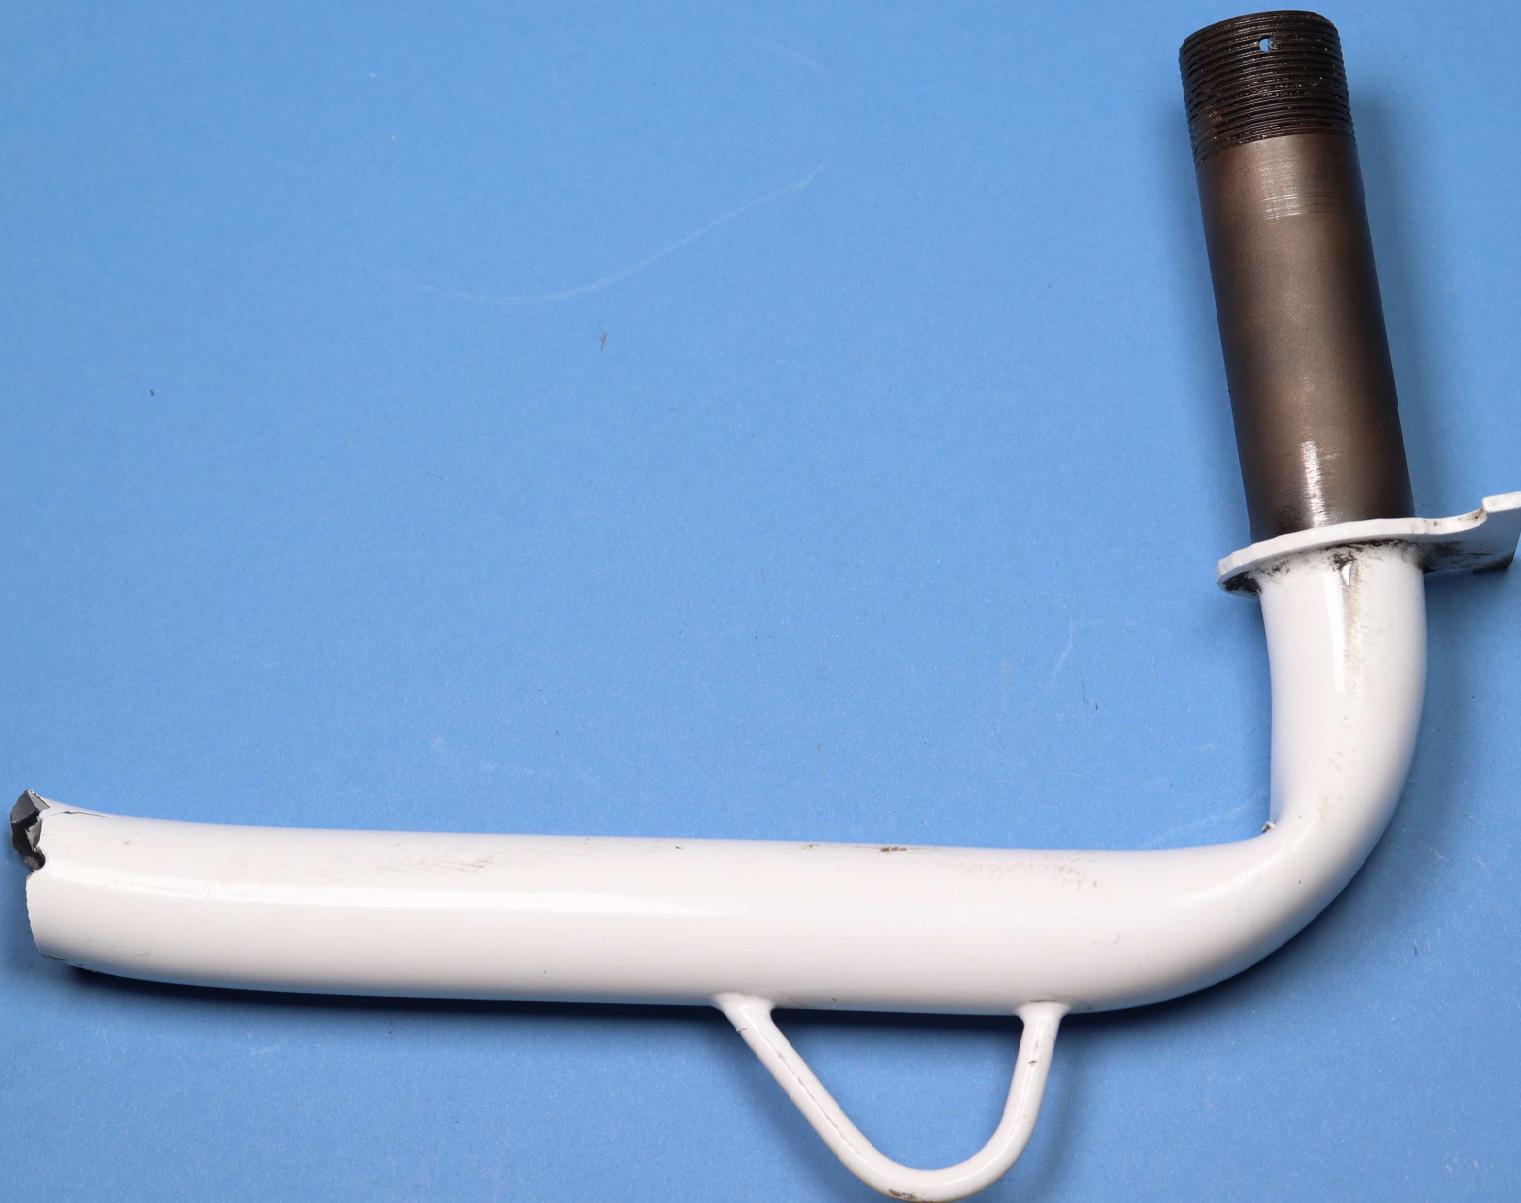
The submitted nose landing gear strut from the subject investigation was examined visually and under optical magnification using stereo microscope. An overall view of the nose gear strut and a closer view of the fracture at the upper end of the strut are shown in the attached images. The lower end of the strut was bent aft relative to the rest of the leg piece forming an acute angle between the vertical segment and the upper segment of the strut. The fracture surface at the upper end of the strut was formed on slant angles and had matte gray features consistent with ductile overstress fracture. Portions of the fracture were obscured by post-fracture sliding contact damage. However, no evidence of preexisting damage was observed.
