# National Transportation Safety Board

CEN23LA399

## **MATERIALS LABORATORY**

Factual Report 24-053

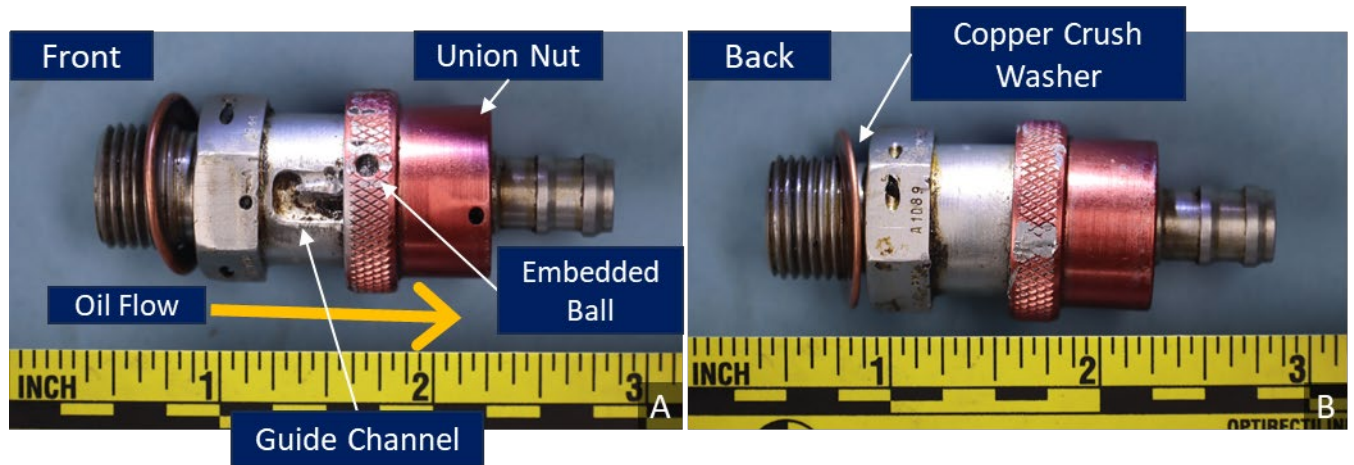
The sump valve was received by the Materials Lab in the fully 'closed' position, as shown in **Figure 1**. Per instructions available from Eaton, the valve can be opened by turning the union nut (copper in color) counterclockwise, pushing the nut up along the body of the valve, and then turning it clockwise. This action pushes up an internal stem, moving a metal plate and O-ring out of the sealed position and allowing oil to flow through the stem. A ball embedded into the union nut follows a 'C'-shaped guide channel machined into the surface of the valve, and the valve is held open when the ball rests at the upper end of the C. When closed, the union nut is held in place by an internal spring that inhibits its rotational and axial motion.

**Figure 1.** A) Front and B) back of the valve as received.

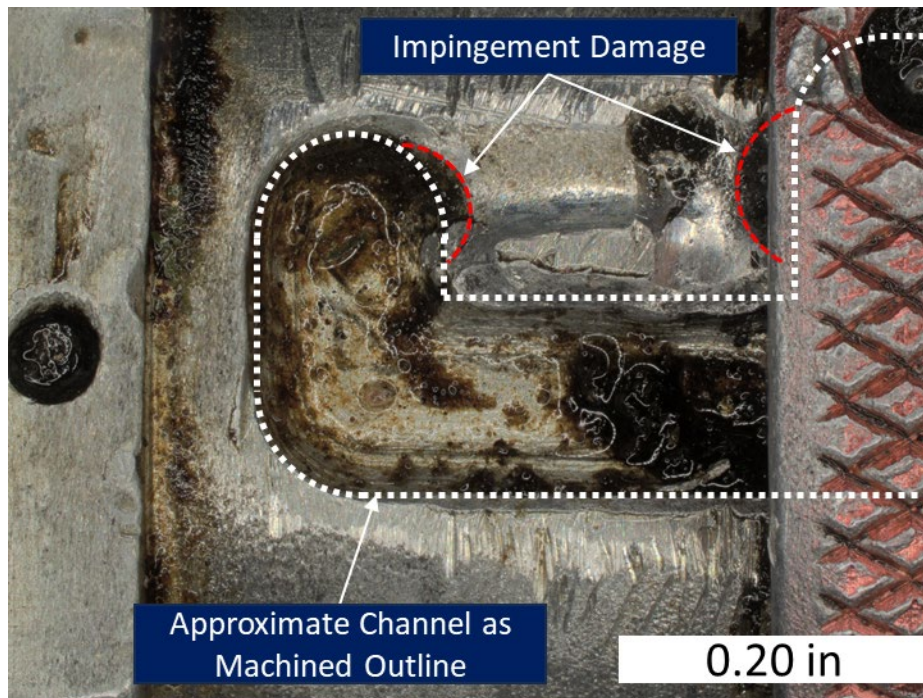
Closer examination of the guide channel on the accident valve showed damage to the surfaces around the channel. As machined, the guide channel is expected to have straight edges along the inside walls of the C. This can be seen in the image of a similar valve taken from Eaton marketing materials (**Figure 2**). However, the walls at the top and bottom of the C showed damage consistent with impingement by the ball in the union nut. These damages are highlighted in **Figure 3**.

**Figure 3.** Guide channel with impingement damage illustrated. The white line shows the approximate edges of the guide channel as it would have been machined. The red lines show the distortion of that channel due to impingement.

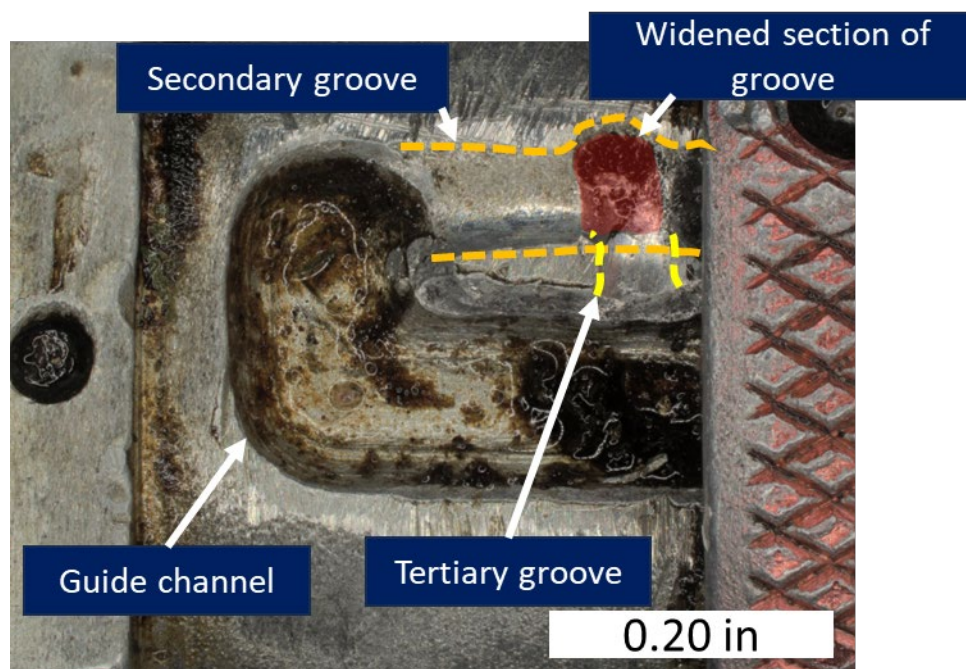
A secondary groove - hereafter referred to as a 'false channel' - was imprinted into the surface next to the guide channel, extending between the two impingement areas. The channel was approximately 0.02 inch deep and 0.06 inch wide at the center. Towards the lower end of the channel, just above the edge of the union nut, the channel widened to 0.08 inch. At this widening point, a tertiary groove (perpendicular to the guide channel and false channel) appeared to connect the two channels. This groove was approximately 0.06 inch wide. These damages are highlighted in **Figure 4**. These damages are consistent with the union nut being

**Figure 4.** Secondary (orange) and tertiary (yellow) grooves outlined.

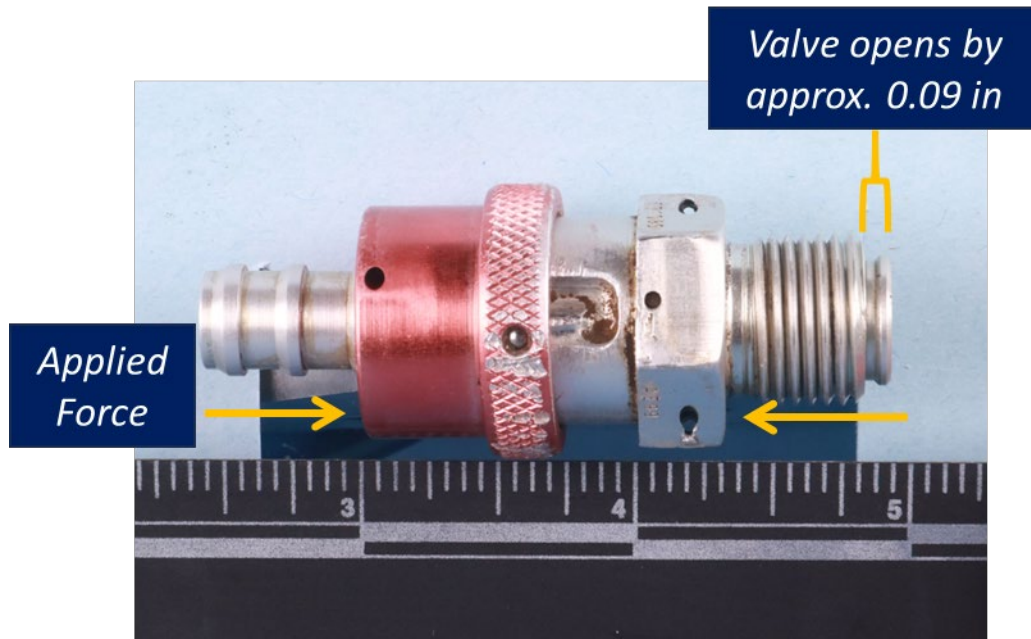
forced across the body of the valve, causing the ball to impinge on the surface and creating the groove. When the union nut was pushed up such that the ball engaged with the impingement at the lower end of the C, the inner stem would move up by approximately 0.09 inch (**Figure 5**). In this configuration, the O-ring was visible but still inside the body of the valve. When released from this position, the valve would return to its 'closed' configuration.

**Figure 5.** Partial opening of valve when an axial force is applied to the union nut. Valve held open by clamp. When the clamp was removed, the valve returned to the fully-closed position.

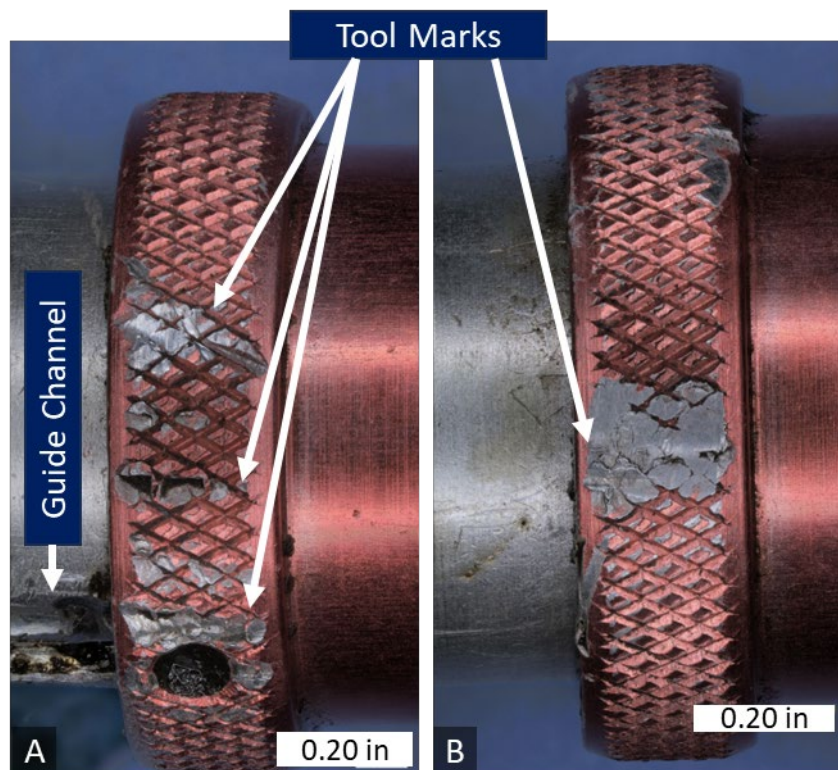
Mechanical damage was also visible on other surfaces. **Figure 6** shows tool marks on opposite sides of the knurled portion of the union nut, consistent with pliers, channel locks, or similar equipment. Finally, damage was noted on the safety wire guides at the top end of the valve (**Figure 7**), consistent with a small-gauge wire impinging on the outside edge of the guides.

**Figure 6.** Tool marks on the knurled ring of the union nut A) near the guide channel and B) approximately opposite from the first set of marks.

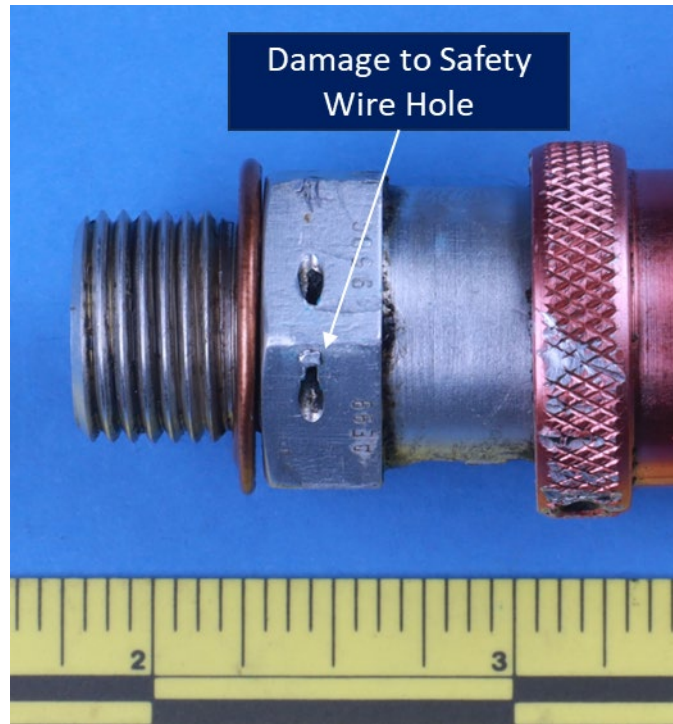
**Figure 7.** Damage on one of the safety wire holes.

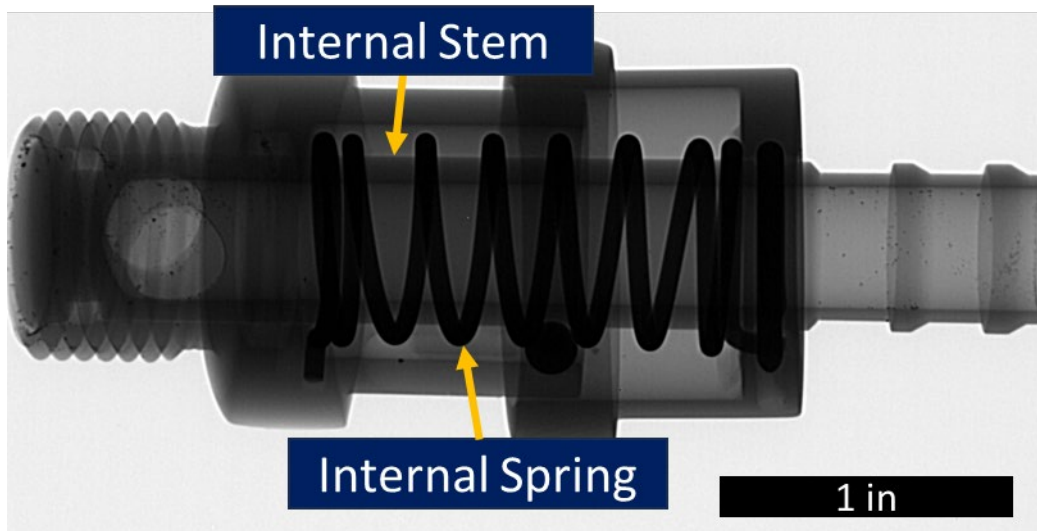
The valve still appeared to operate as normal. The union nut could be turned and pushed up along the guide channel. X-ray imaging with computed tomography (X-ray CT) (**Figure 8**) revealed that the spring and other internal structures were intact.

**Figure 8.** X-ray CT of the valve showed no damage to internal structures.

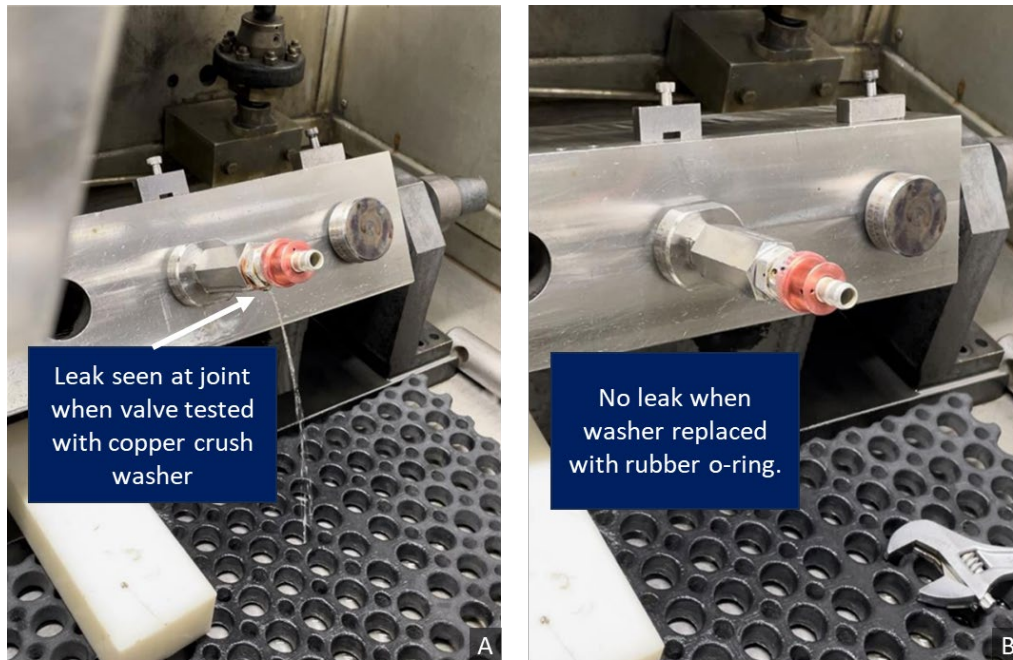
The valve was submitted to Eaton Aerospace in Jackson, MI, for leak tests on their specialized testing equipment. Eaton verified the calibration of the equipment prior to testing and further verified that liquid could flow through the valve when it was open. The leak tests were conducted according to standard Eaton procedures, first at 5-10 psi for minimum 30 s and then 300 psi -0 psi/+30 psi for minimum 30 s. The valve was initially tested with the copper crush washer that was submitted along with the valve. In this configuration, a leak was observed at the threaded joint at both low and high pressures (**Figure 9**). In a second round of testing, Eaton replaced the crush washer with a rubber O-ring, as this is the standard configuration in which the valves are sold. No leaks were observed when the valve was tested in this configuration.

**Figure 9.** Leak tests on the accident valve conducted at Eaton A) with the copper crush washer and B) after replacing the washer with an O-ring.
