CEN23LA399

## INVESTIGATION PHOTOGRAPHS

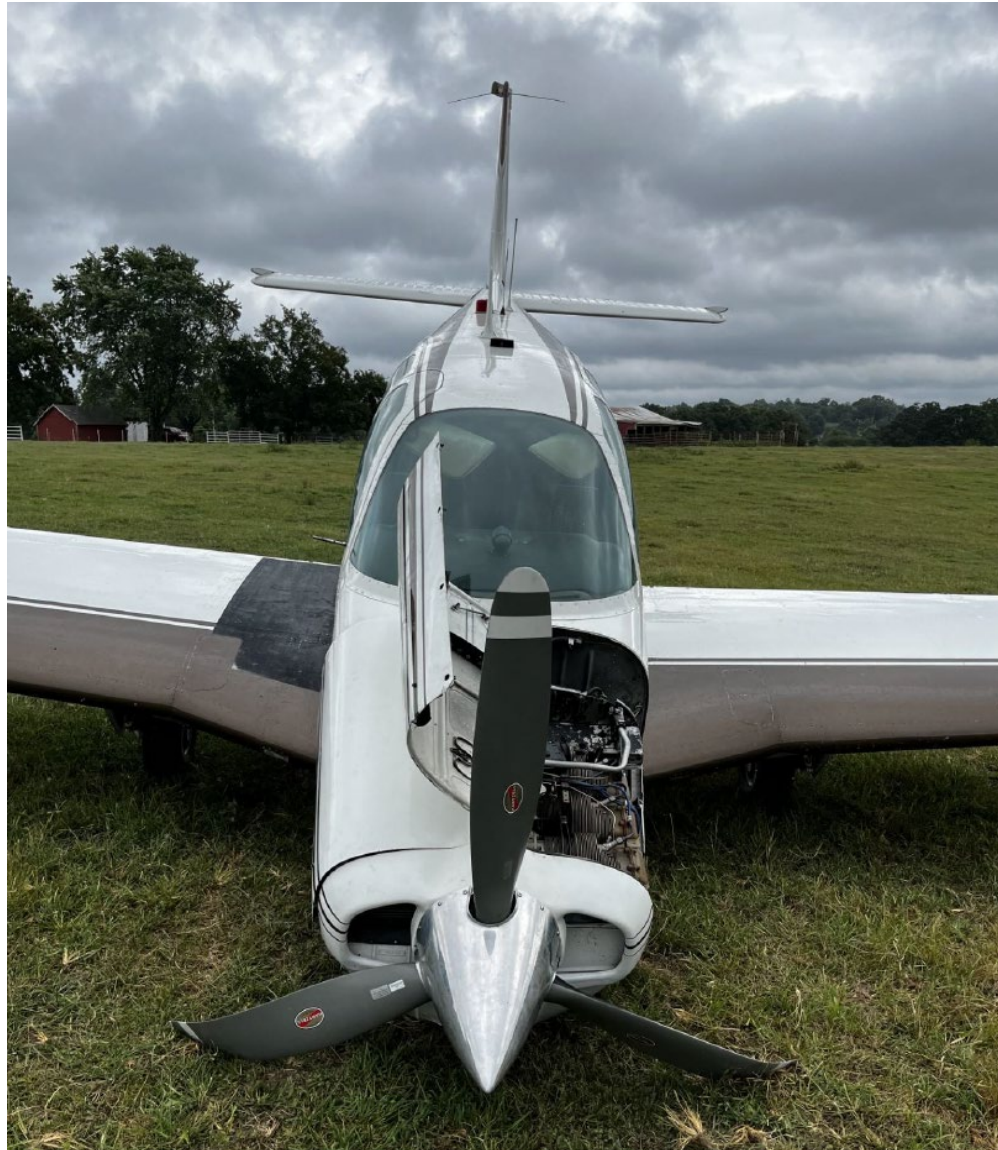
**Photograph 1 - View of the front of the airplane at the accident site (courtesy of the Federal Aviation Administration)**

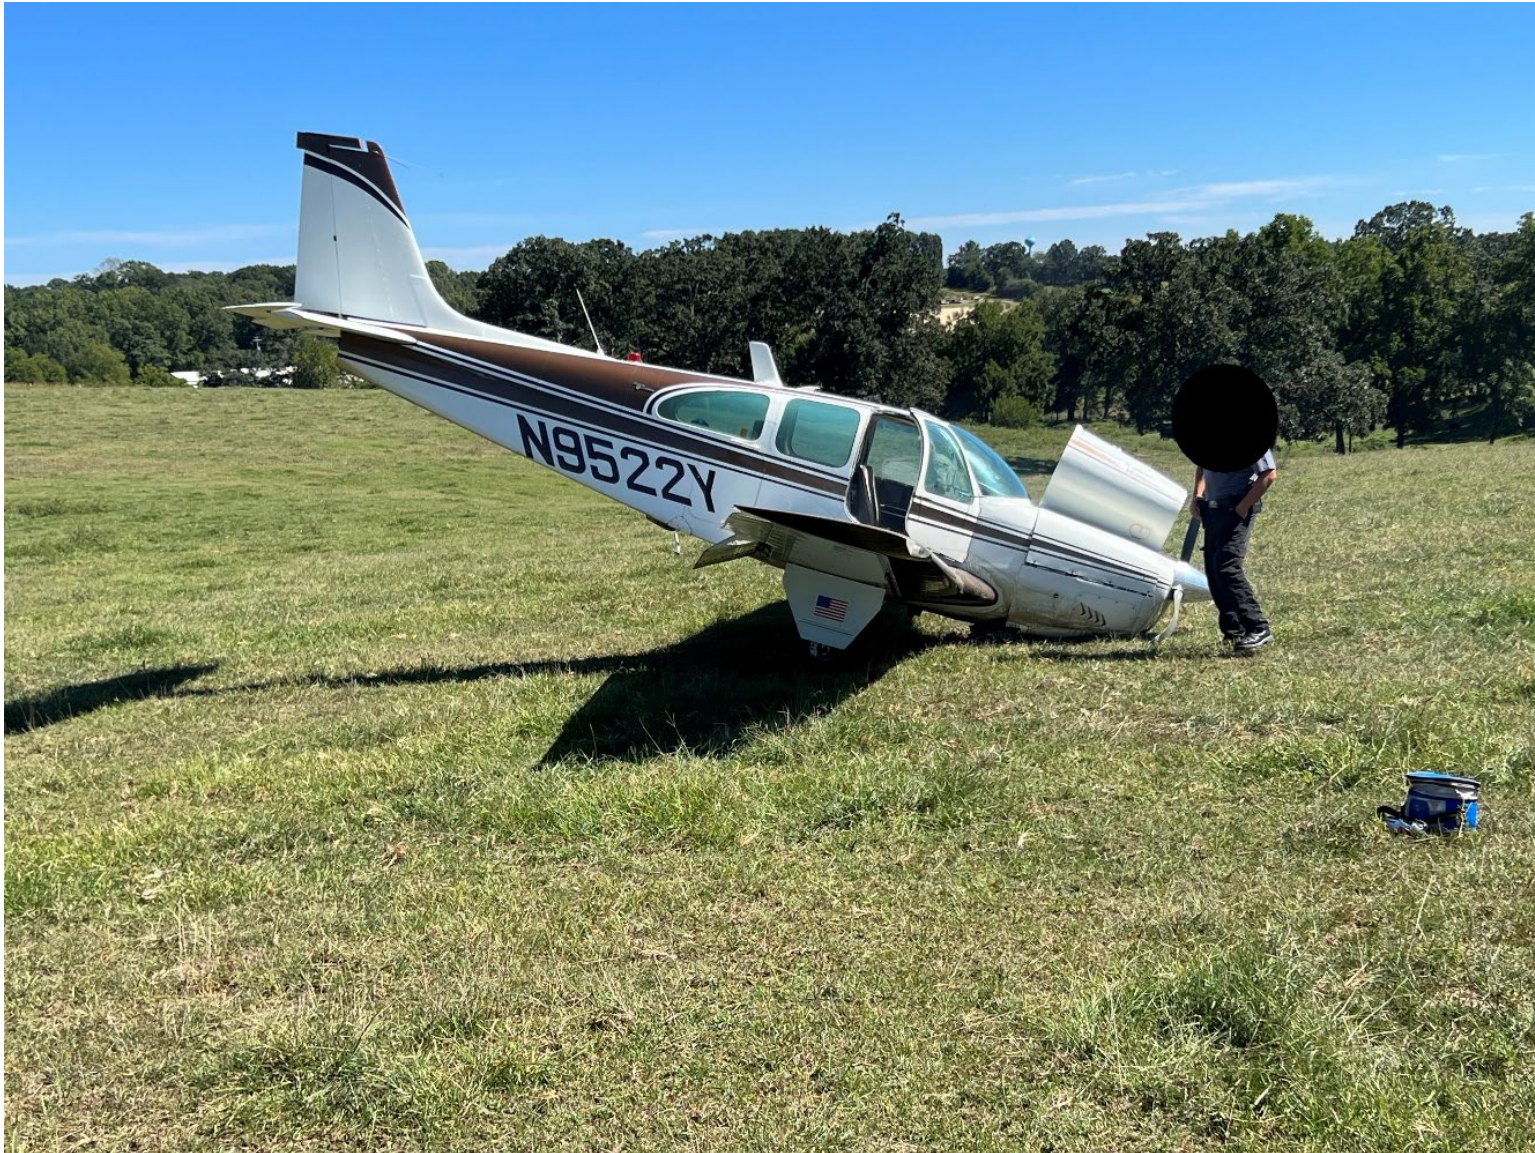
**Photograph 2 - View of the right side of the airplane at the accident site (courtesy of the Federal Aviation Administration)**

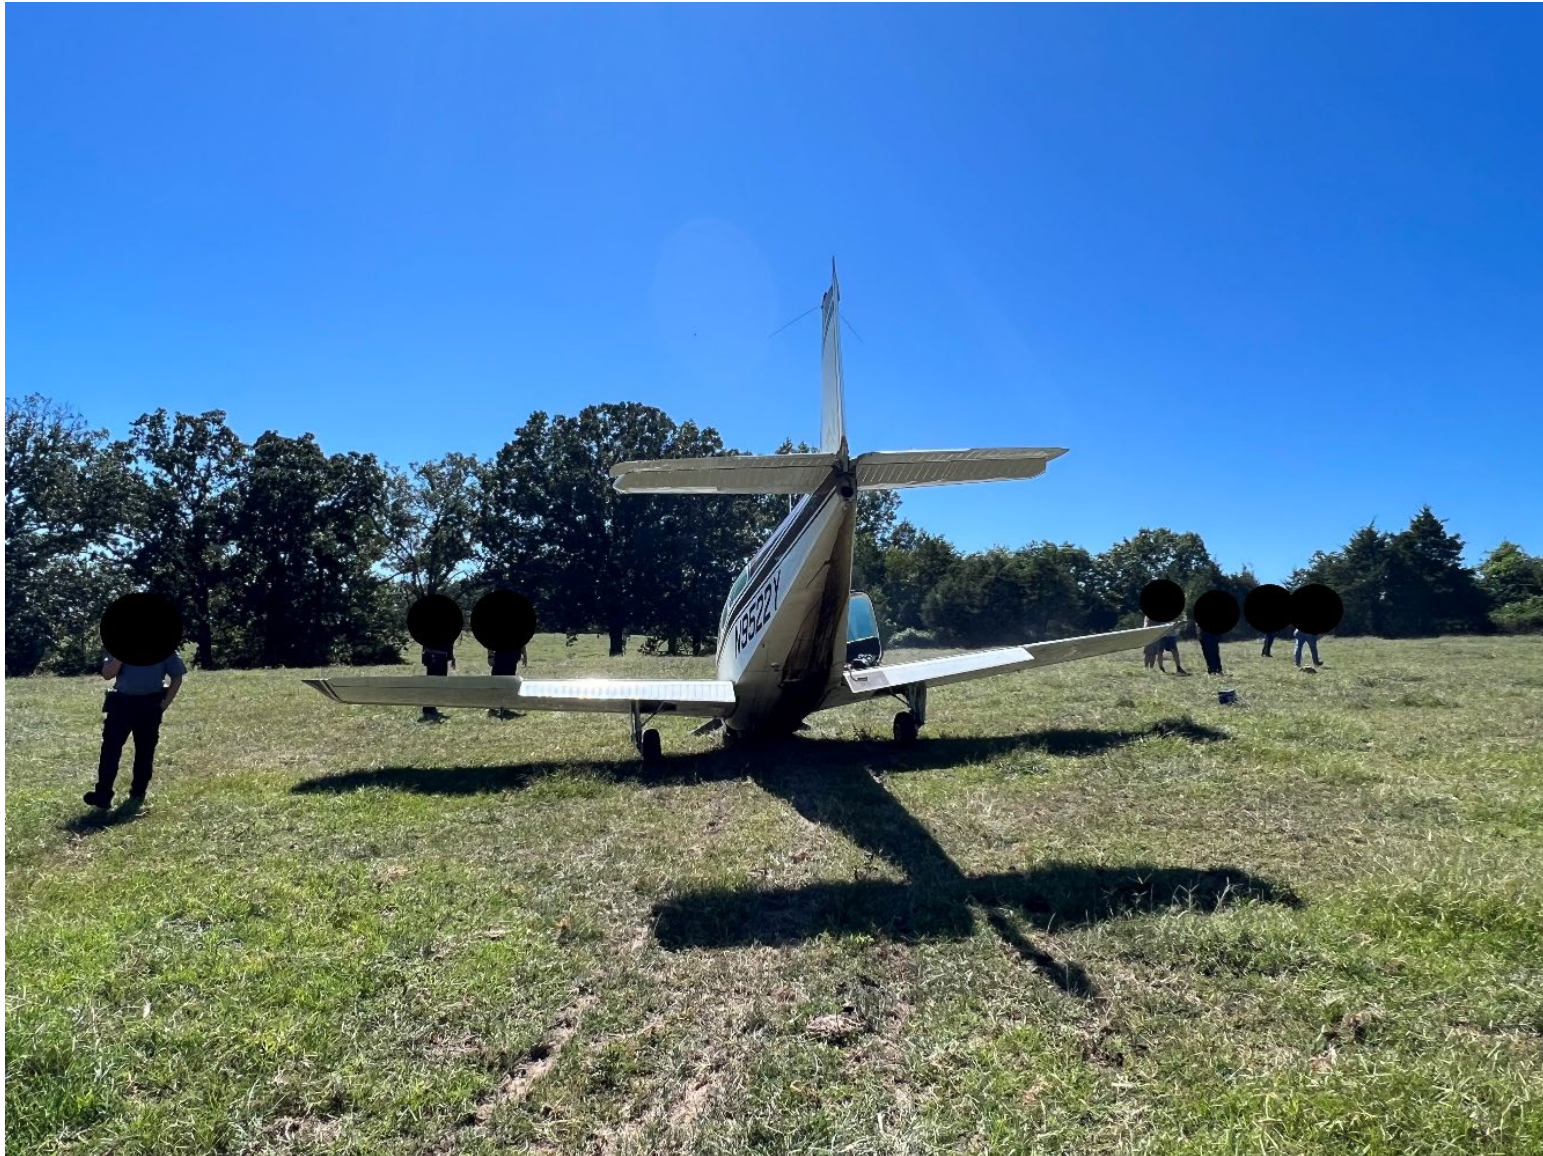
**Photograph 3 - View of the rear of the airplane at the accident site (courtesy of the Federal Aviation Administration)**

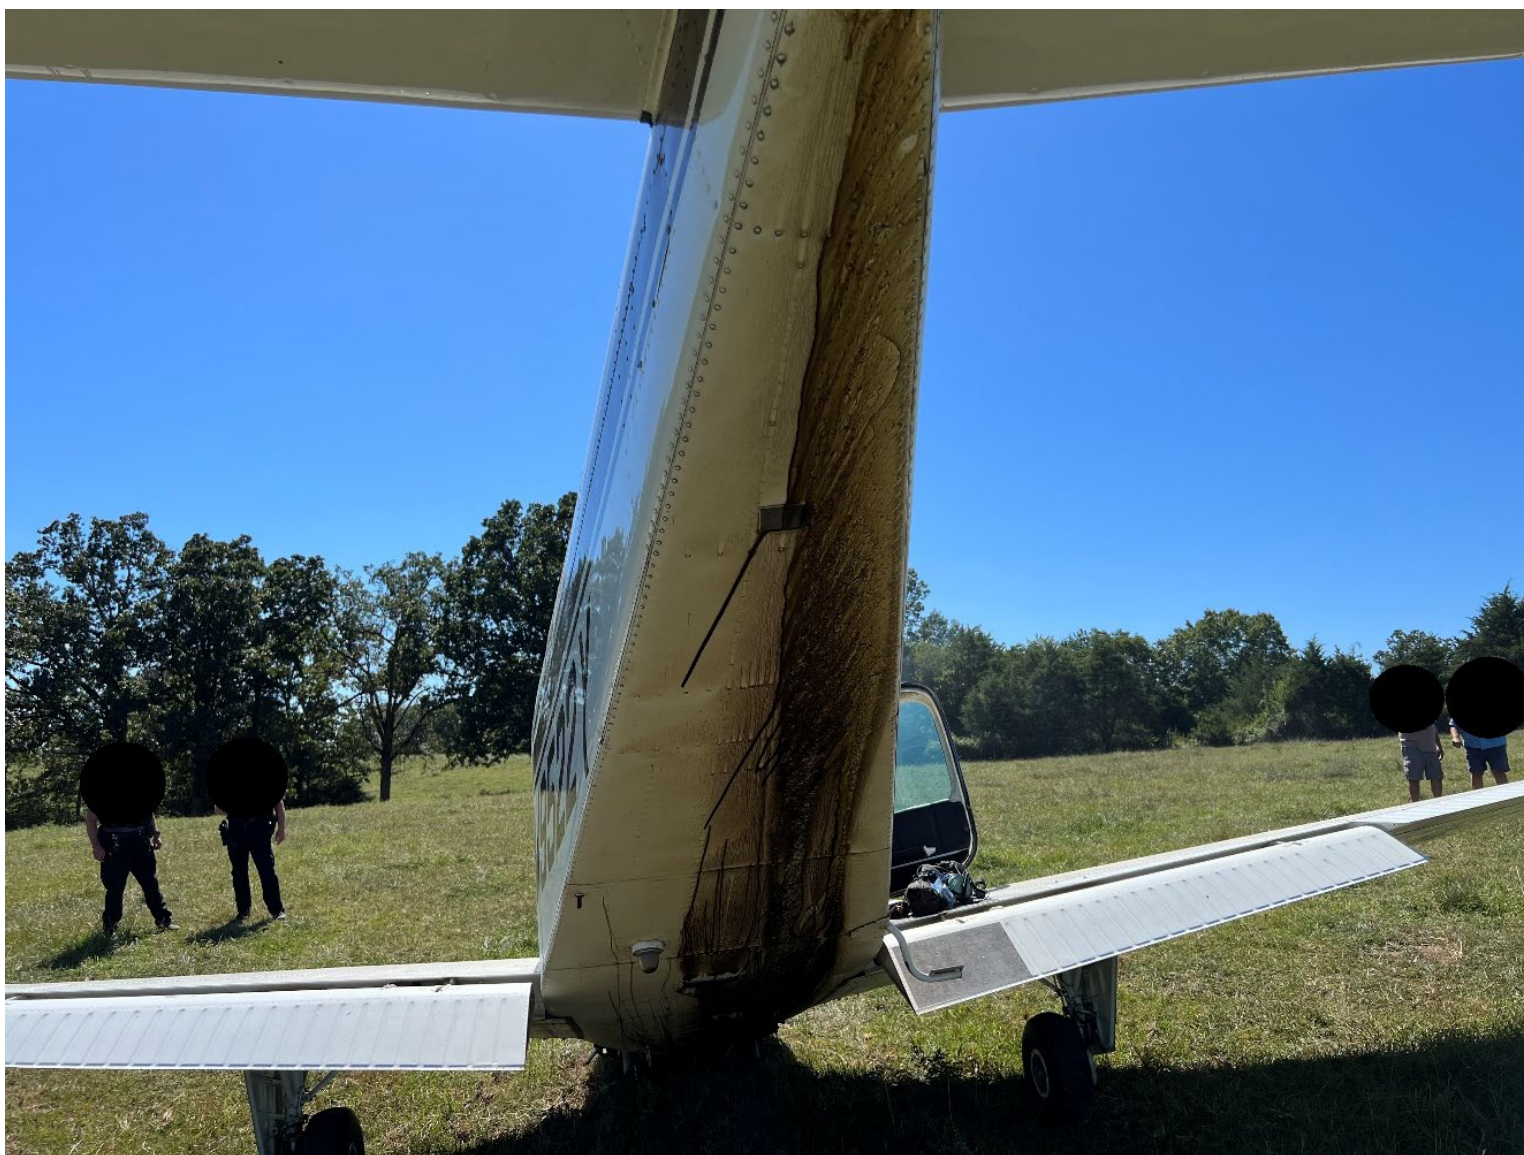
**Photograph 4 - View of the rear of the airplane at the accident site (courtesy of the Federal Aviation Administration)**

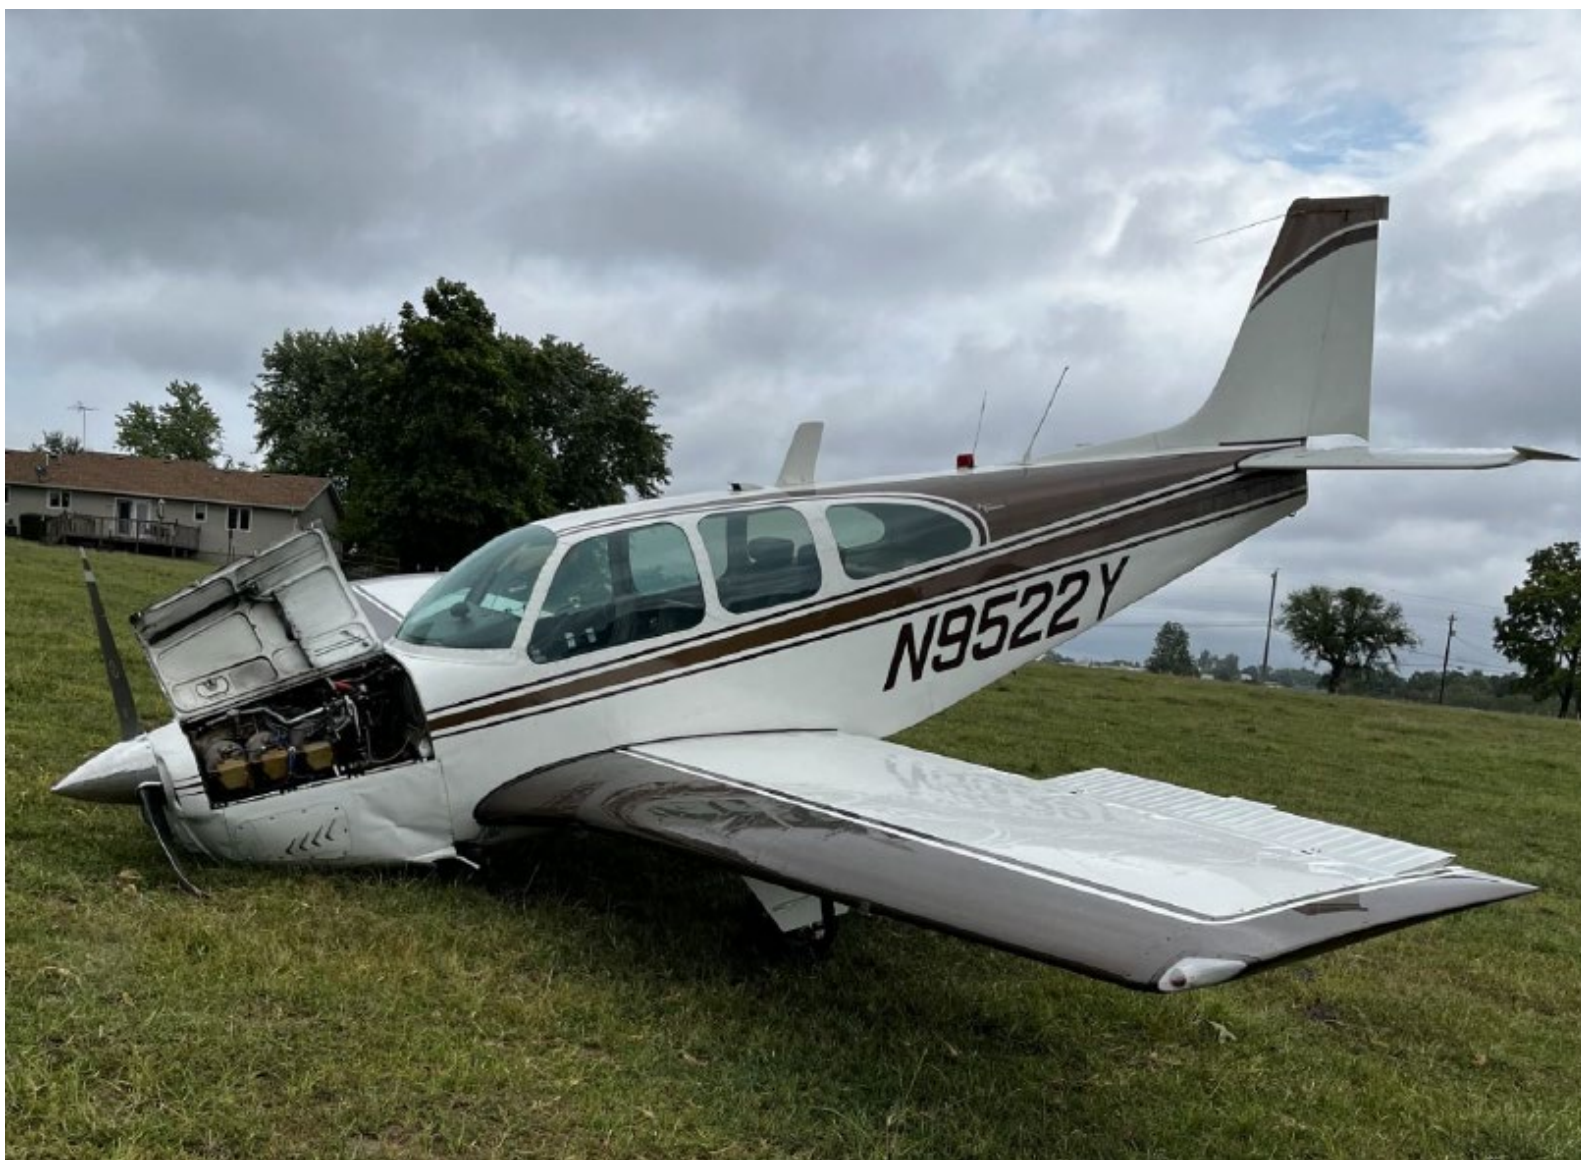
**Photograph 5 - View of the left side of the airplane at the accident site (courtesy of the Federal Aviation Administration)**

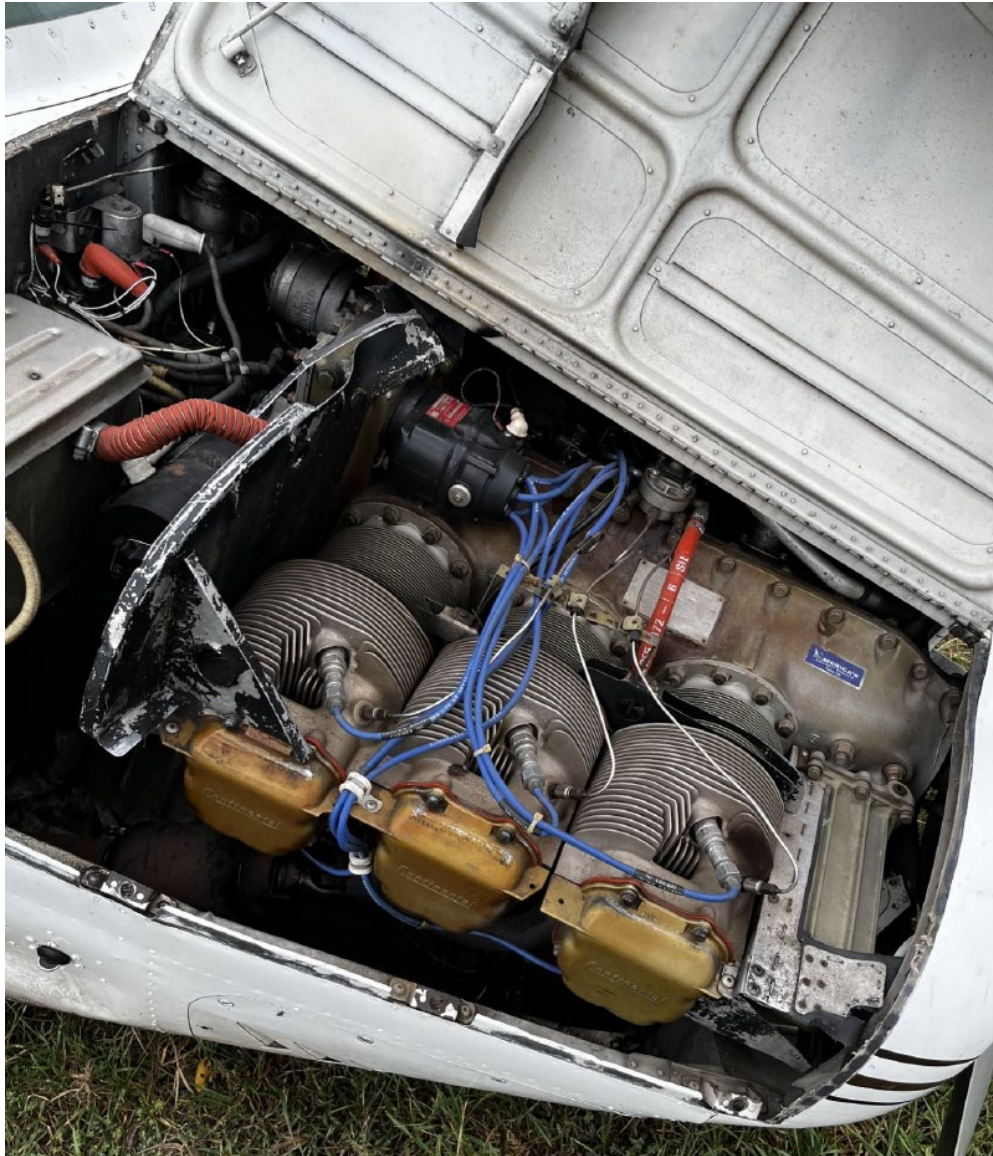
**Photograph 6 - View of the right side of the engine at the accident site (courtesy of the Federal Aviation Administration)**

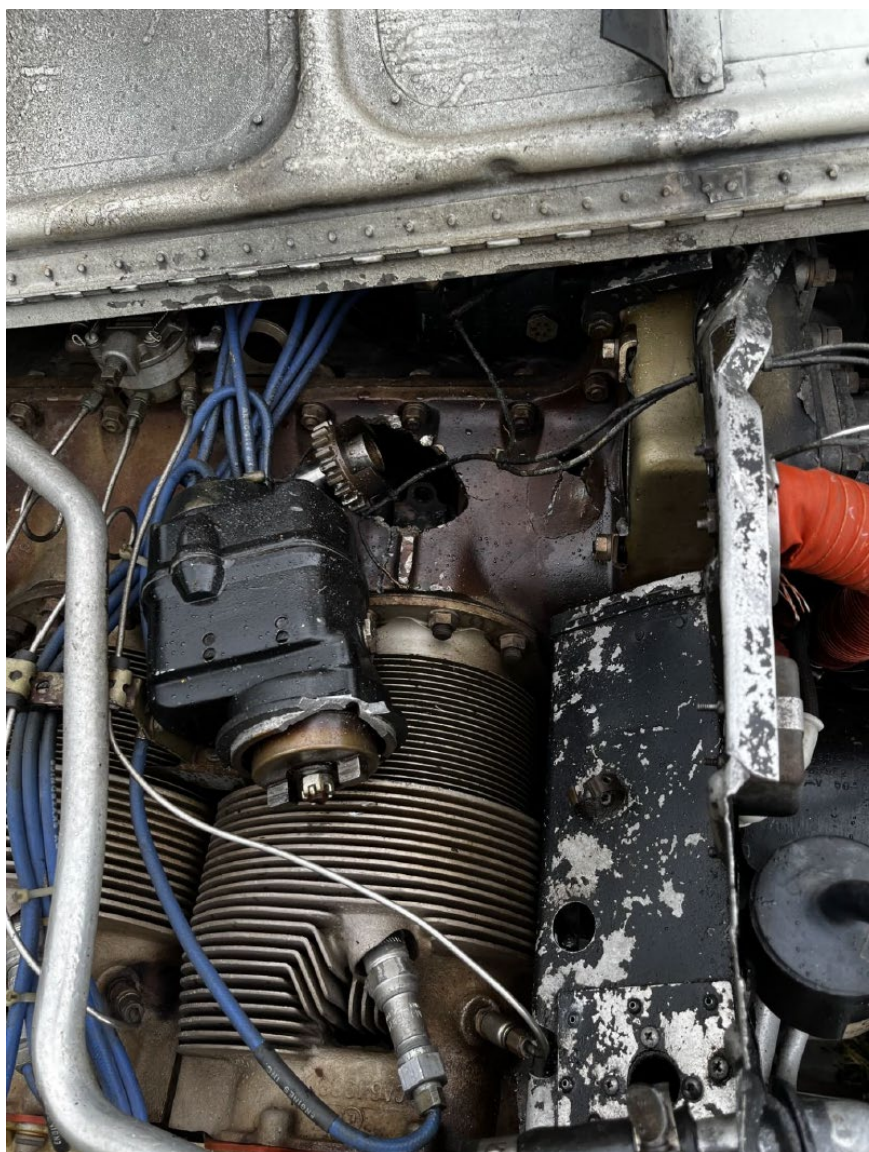
**Photograph 7 - View of the left side of the engine at the accident site (courtesy of the Federal Aviation Administration)**

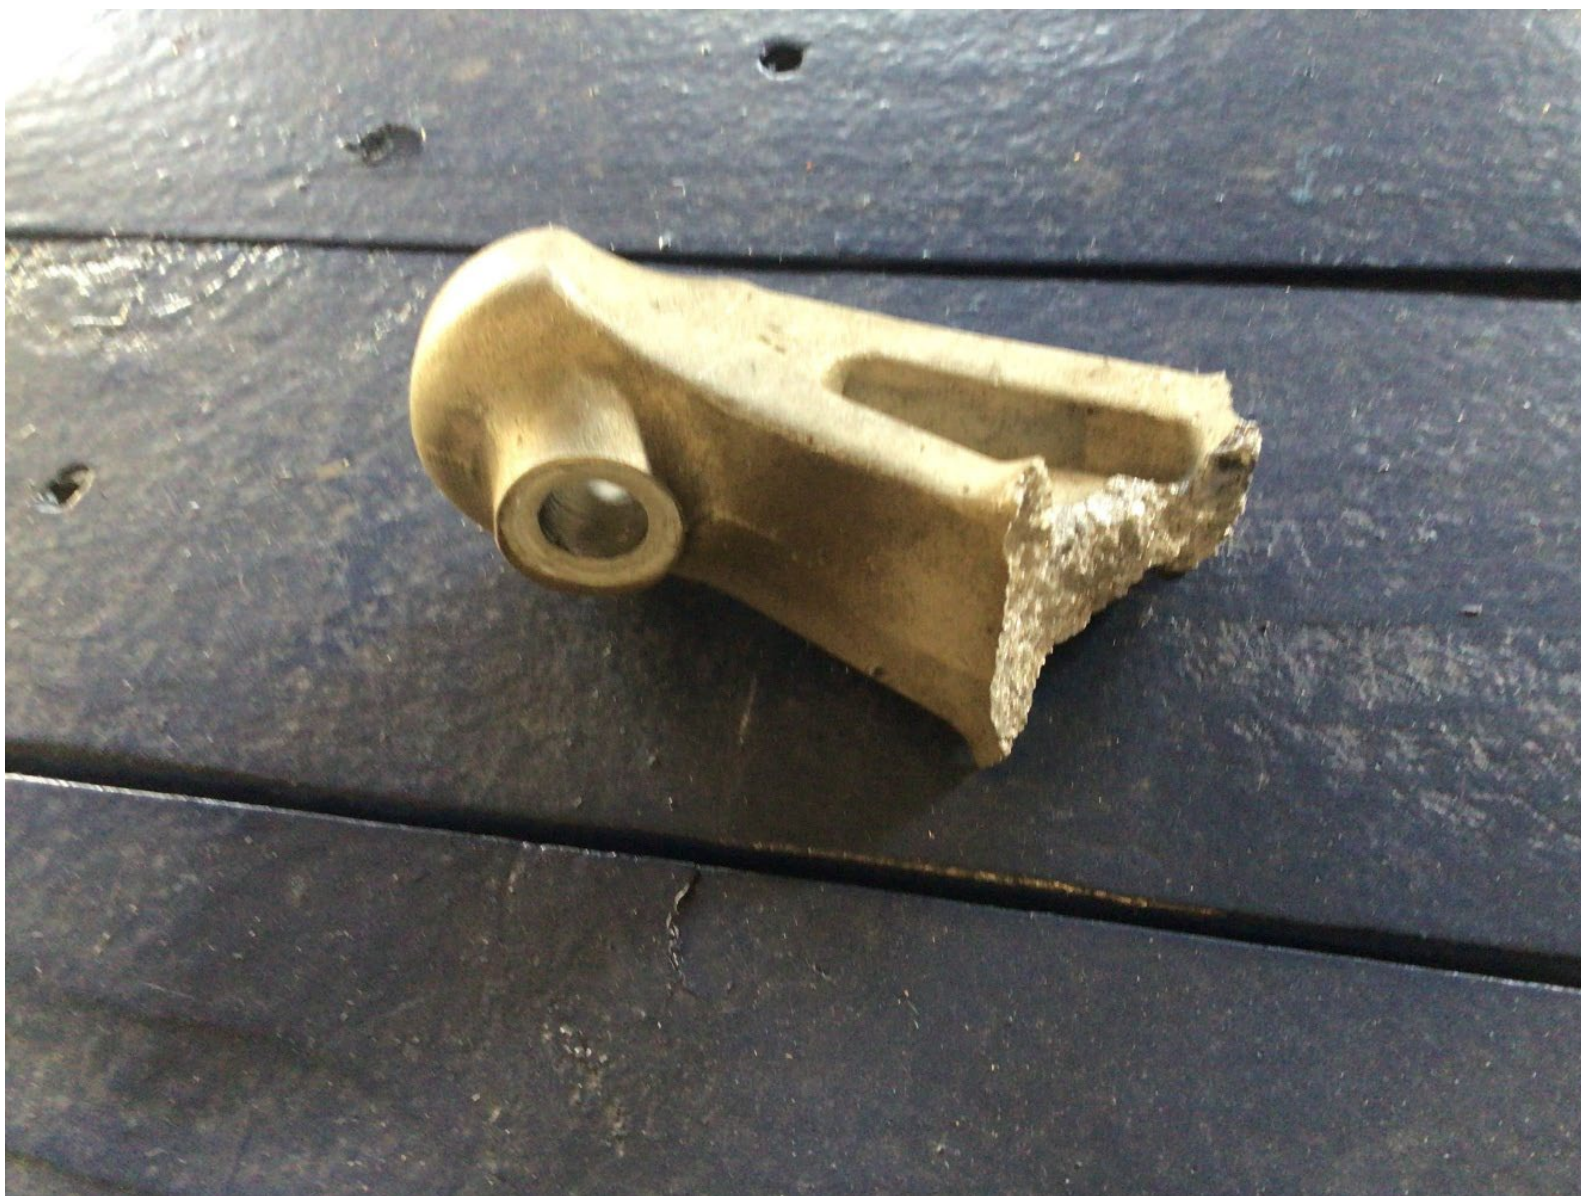
**Photograph 8 - View of the fractured engine mount (courtesy of Missouri Aviation, Inc.)**

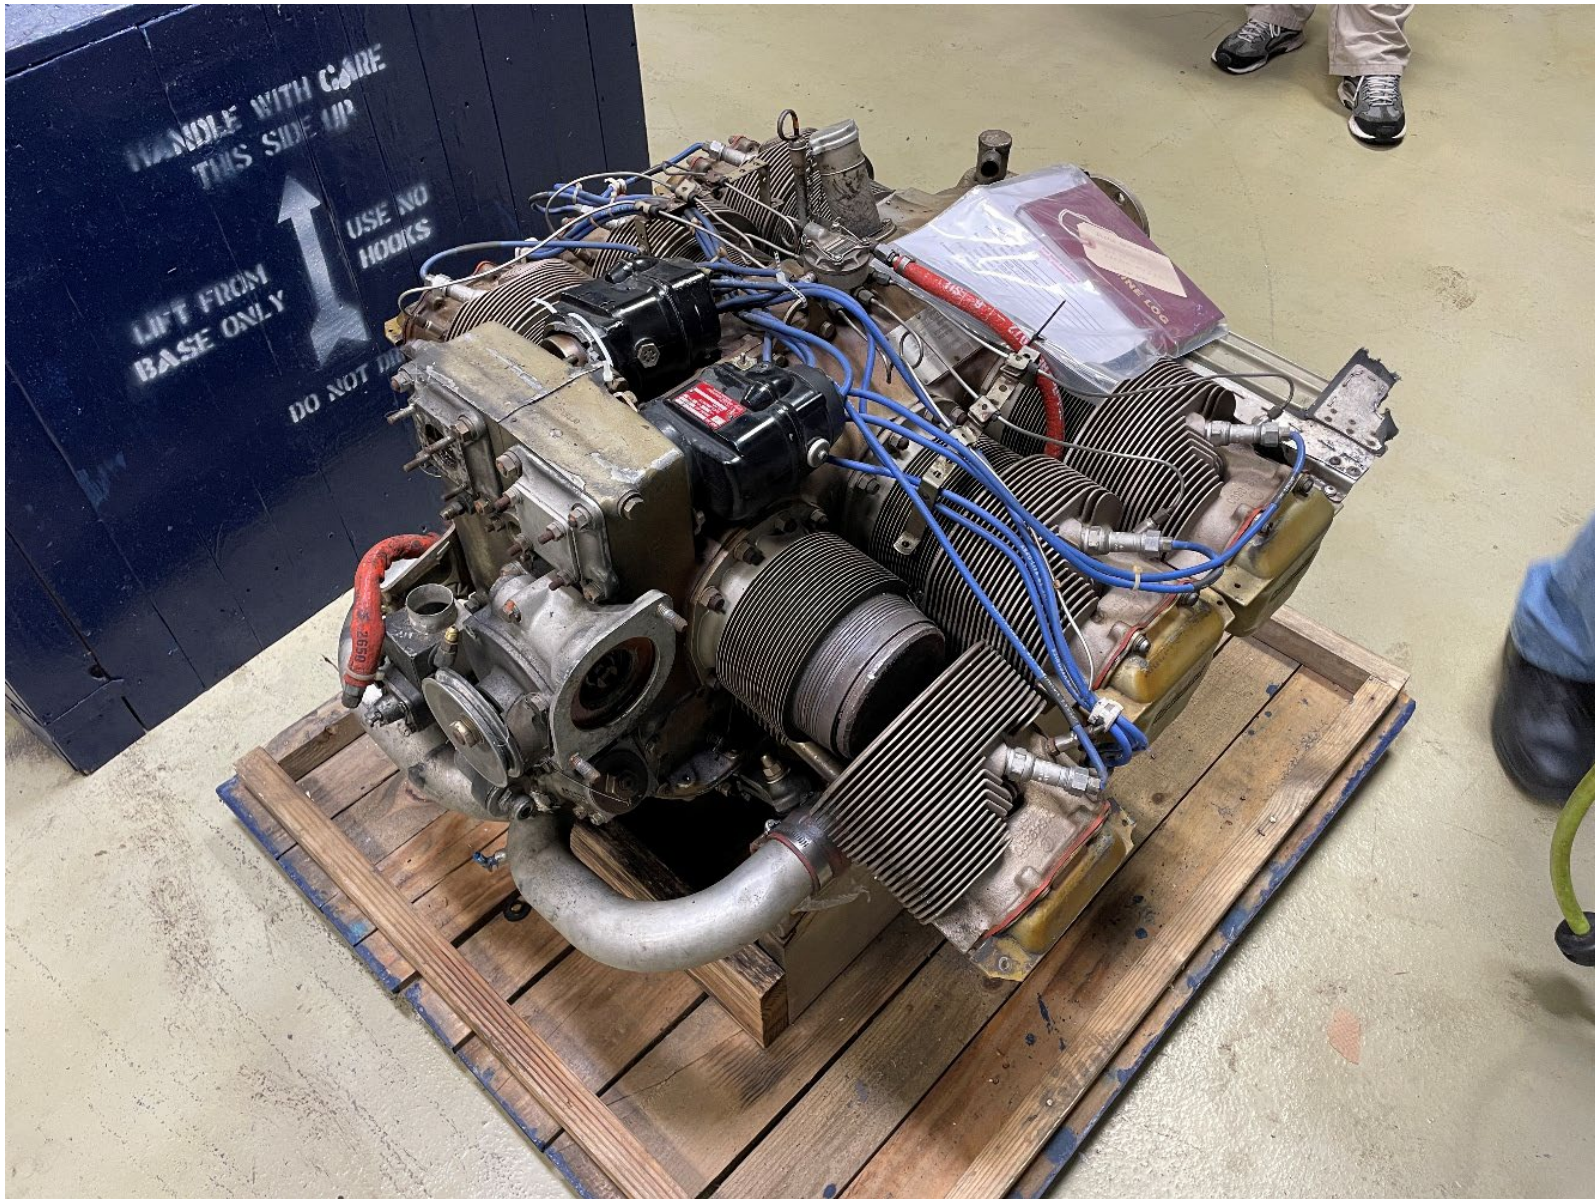
**Photograph 9 - View of the rear of the engine during the engine examination**

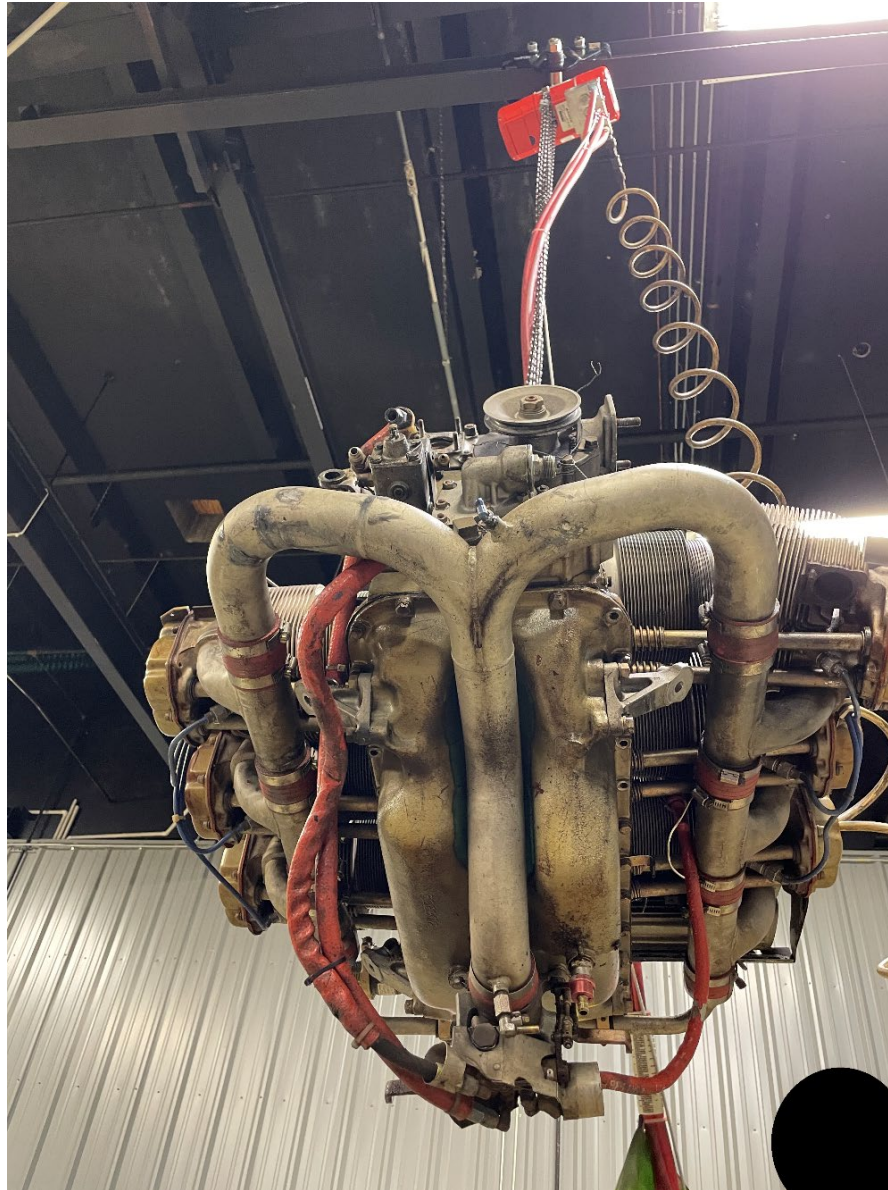
**Photograph 10 - View of the bottom of the engine during the engine examination**

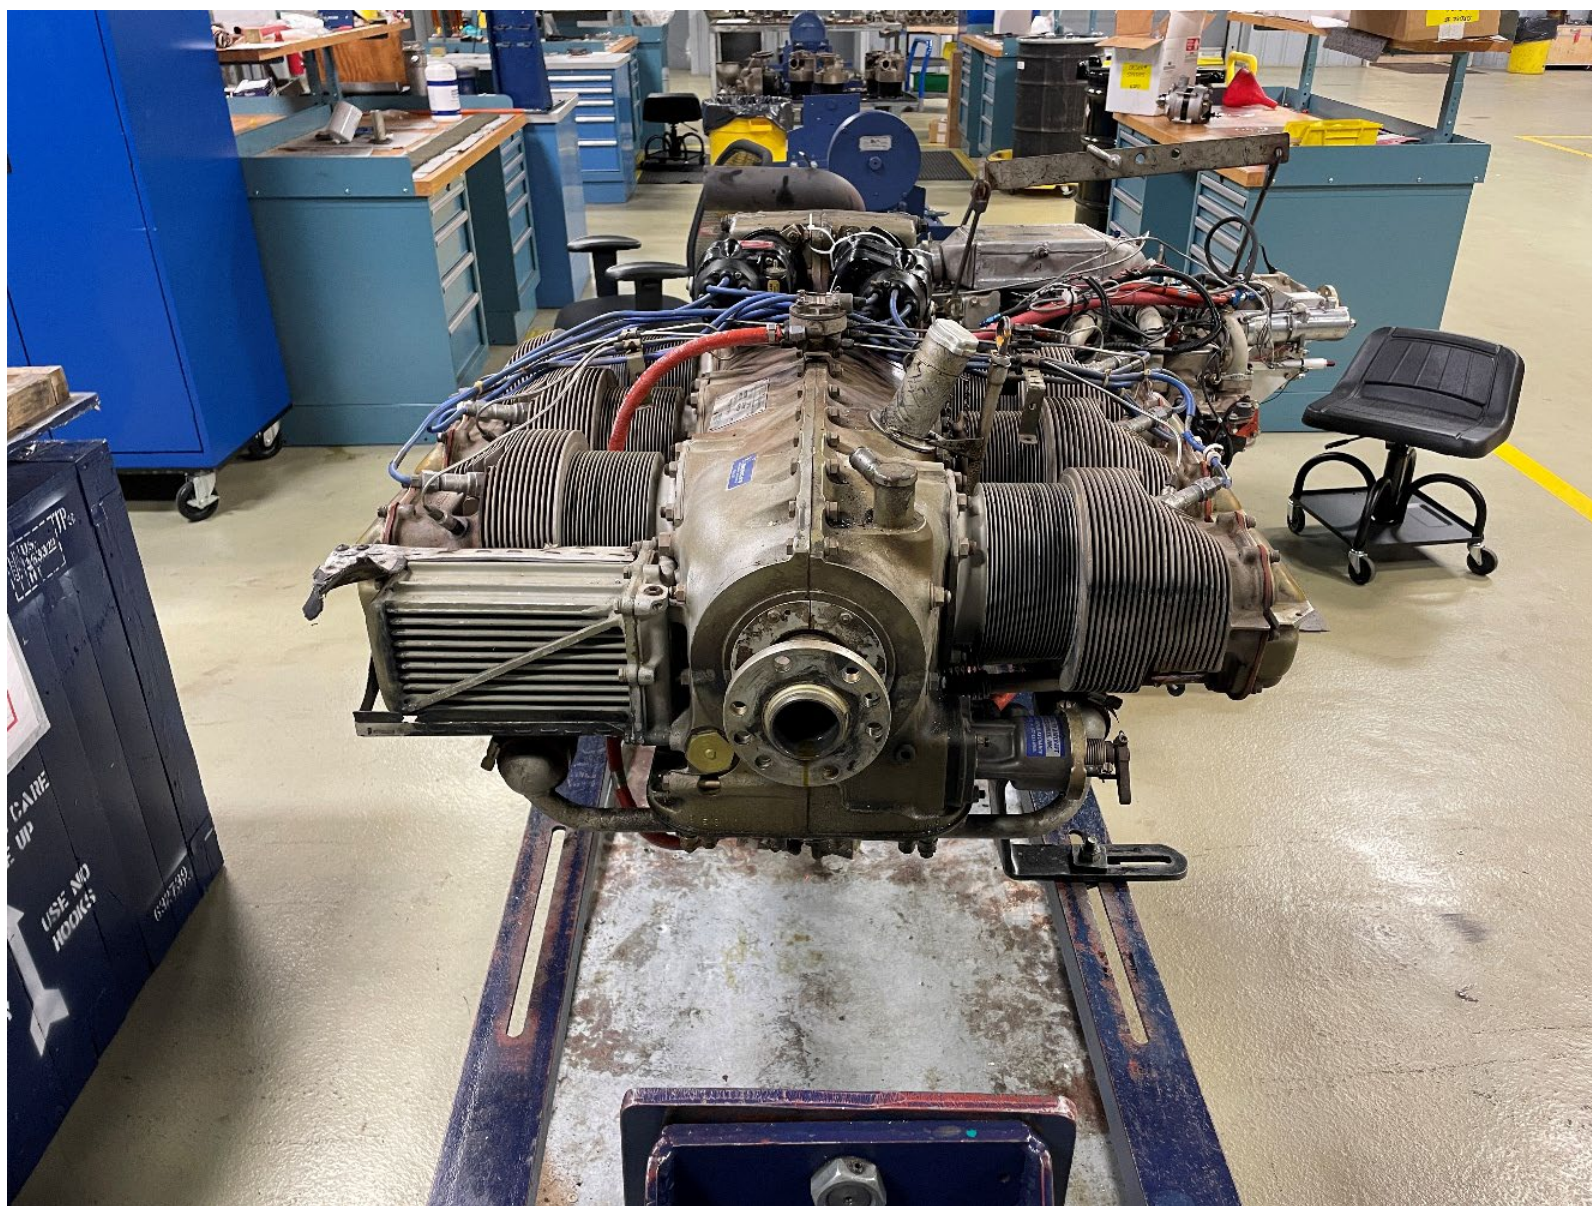
**Photograph 11 - View of the front of the engine during the engine examination**

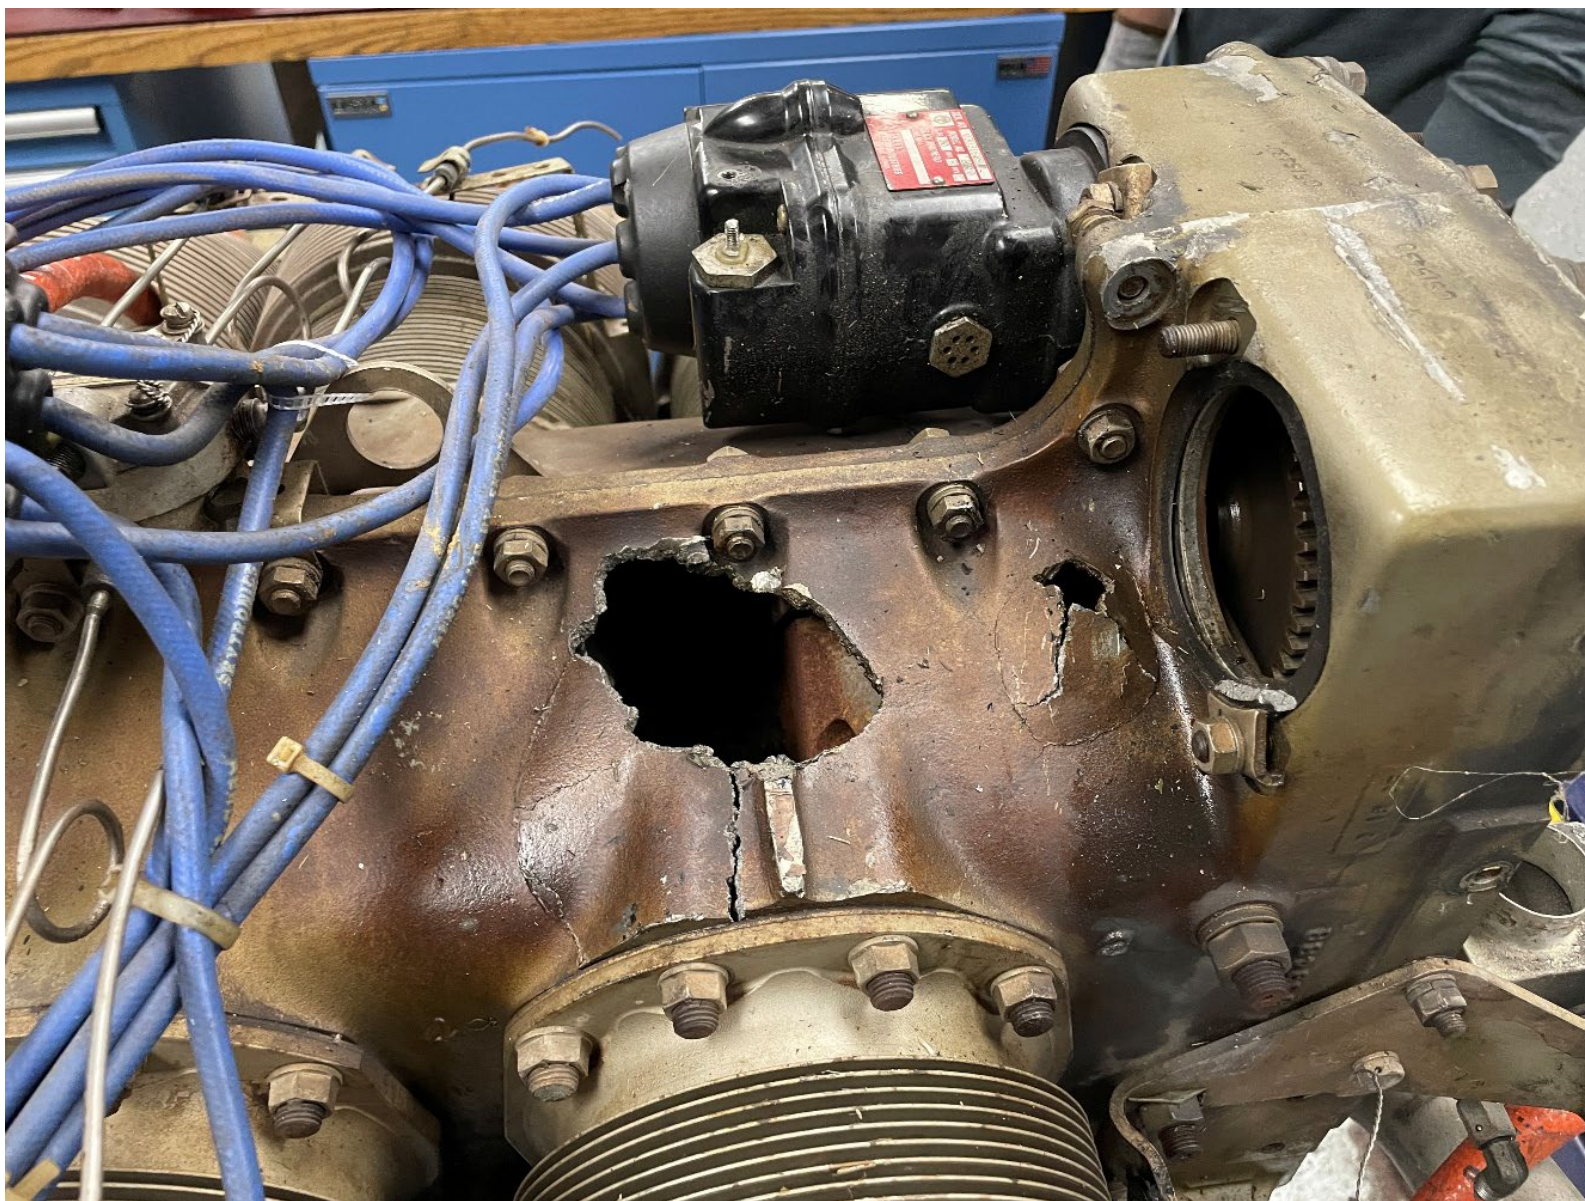
**Photograph 12 - View of the left side of the engine during the engine examination**
