CEN23LA400

## INVESTIGATION PHOTOGRAPHS

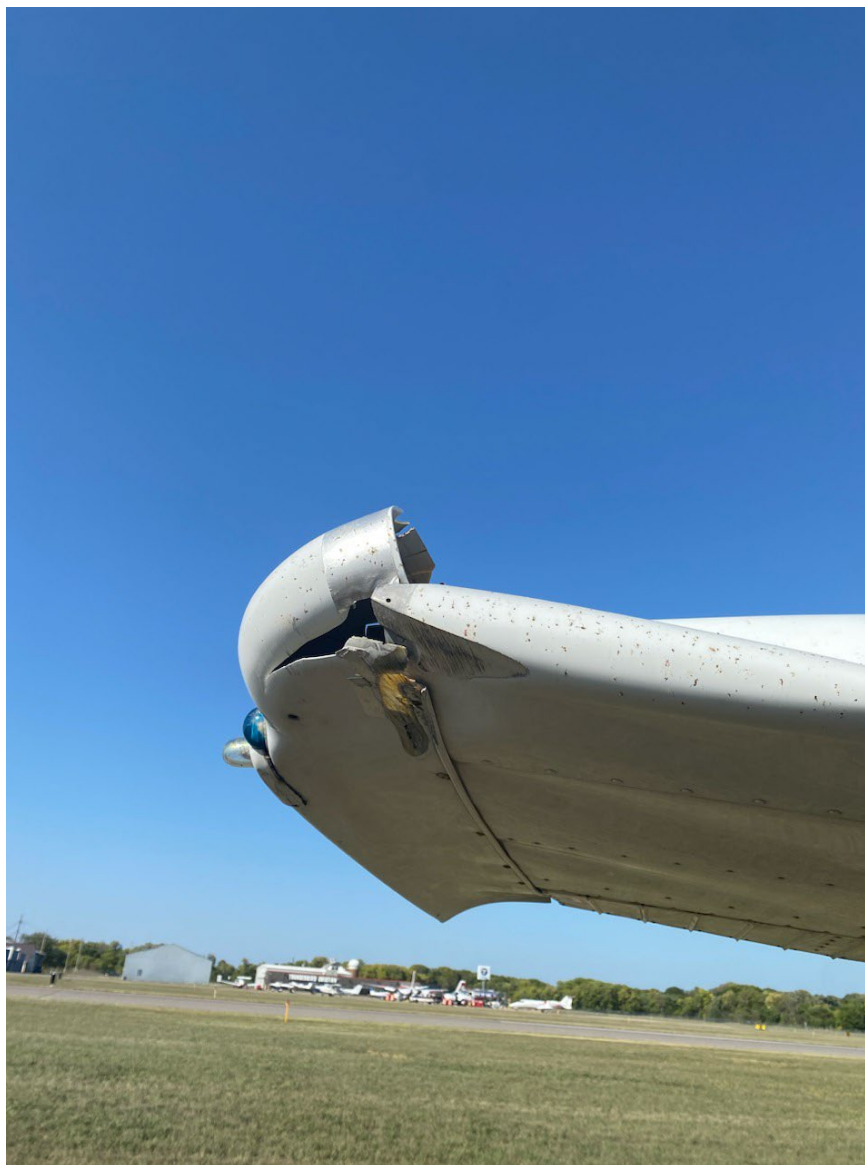
**Photograph 1 - Substantially Damaged Right Wing (Courtesy of FAA)**
