CEN23LA402

## INVESTIGATION PHOTOGRAPHS

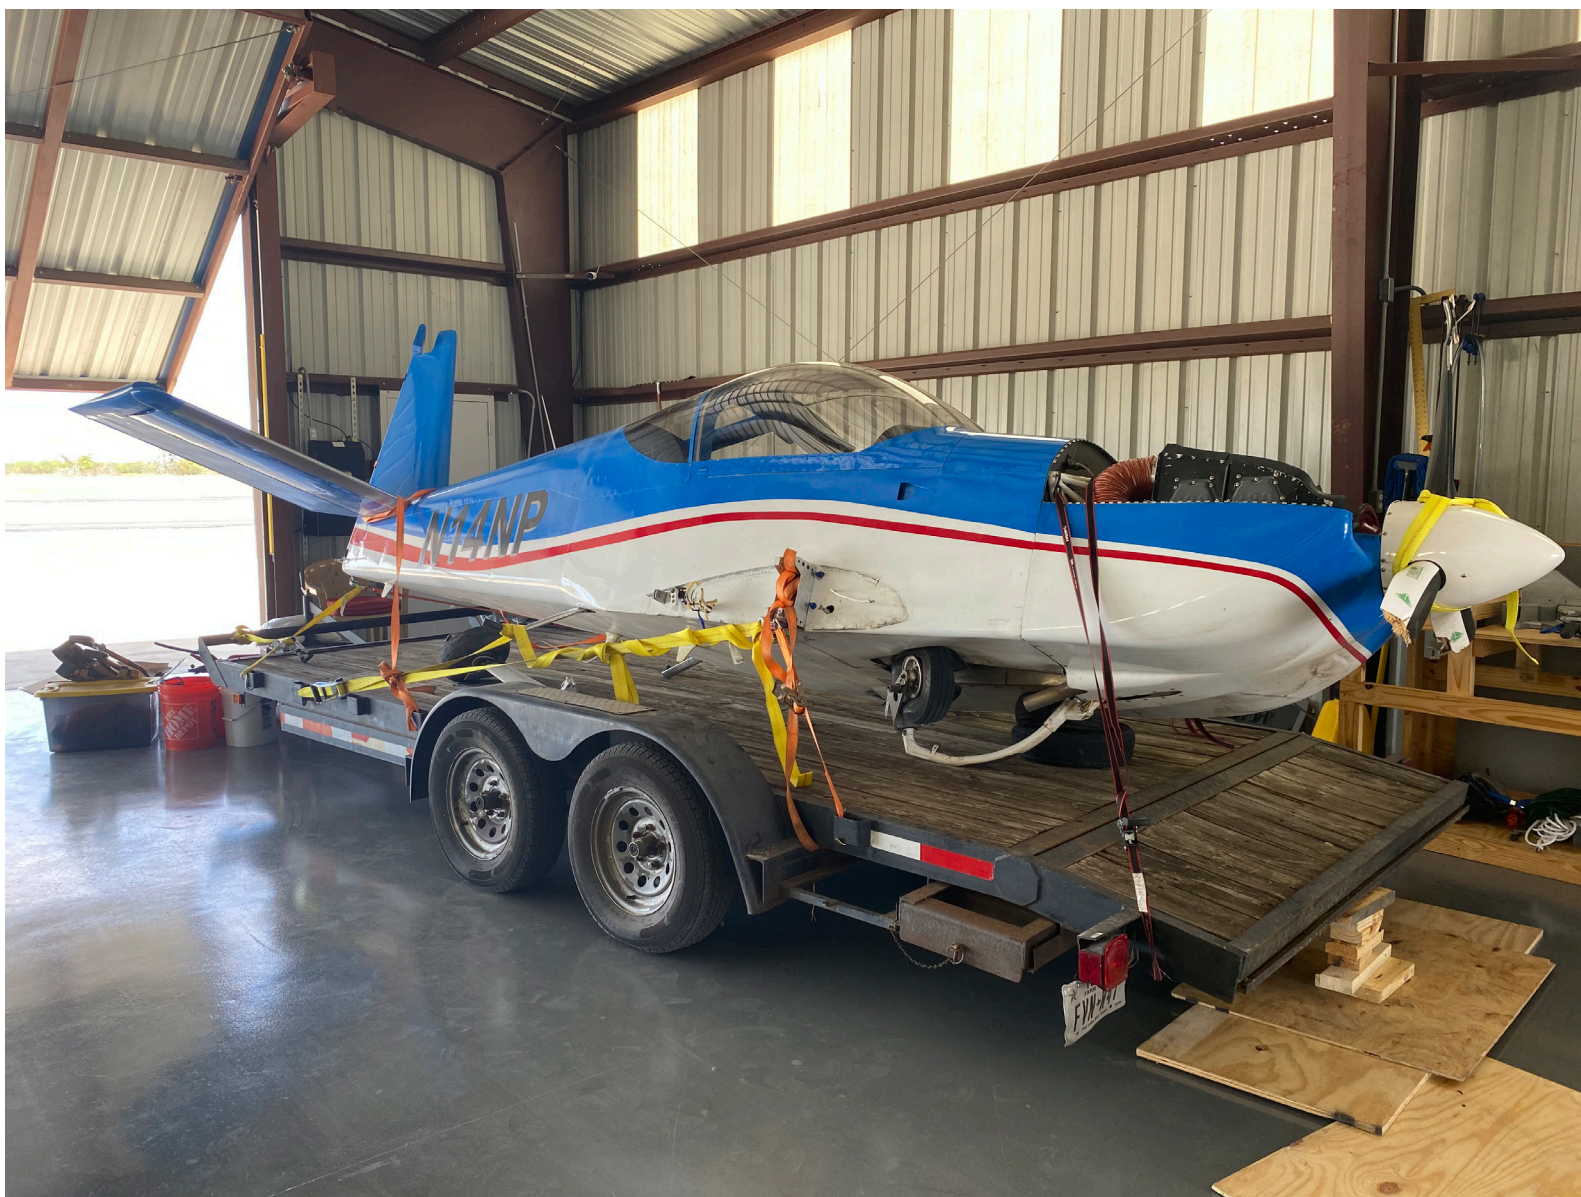
**Photograph 1 - Airplane, right side (Courtesy of FAA)**

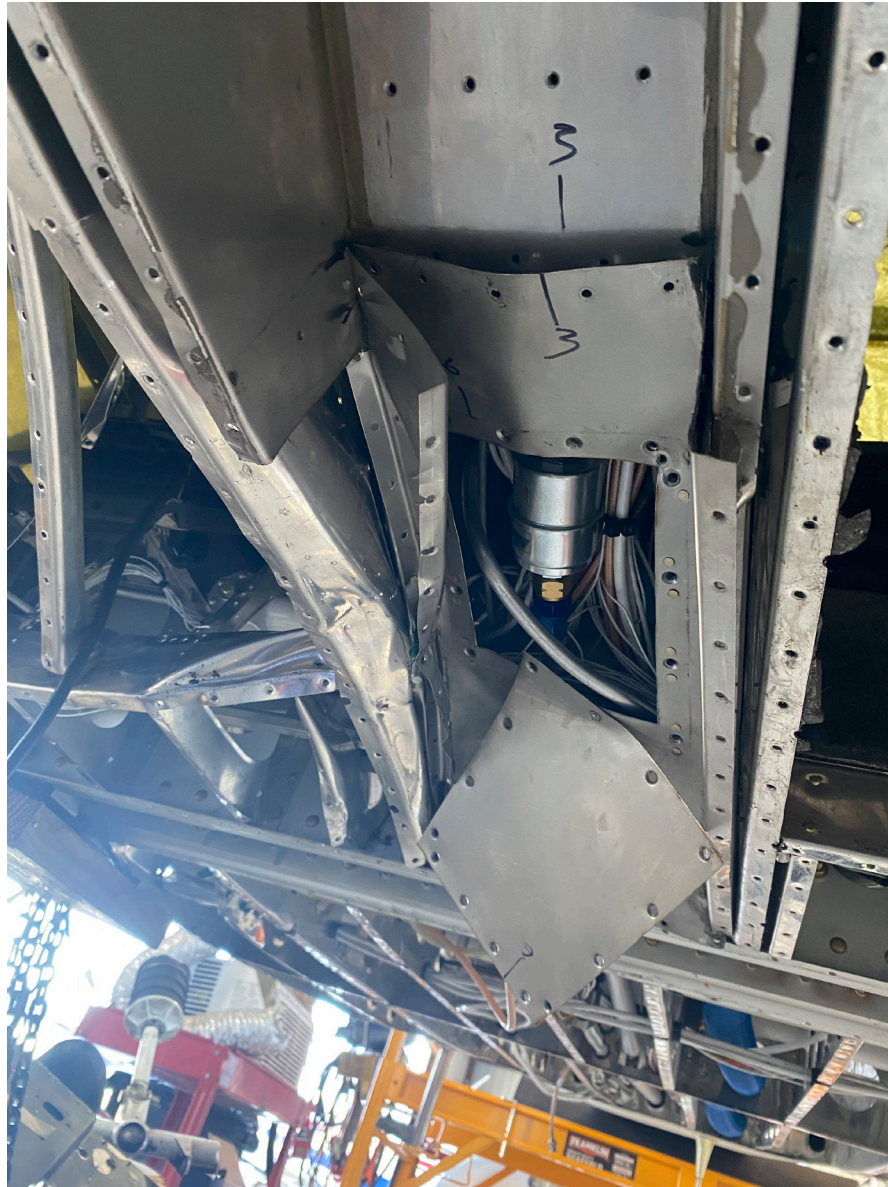
**Photograph 2 - Structural damage (Courtesy of FAA)**

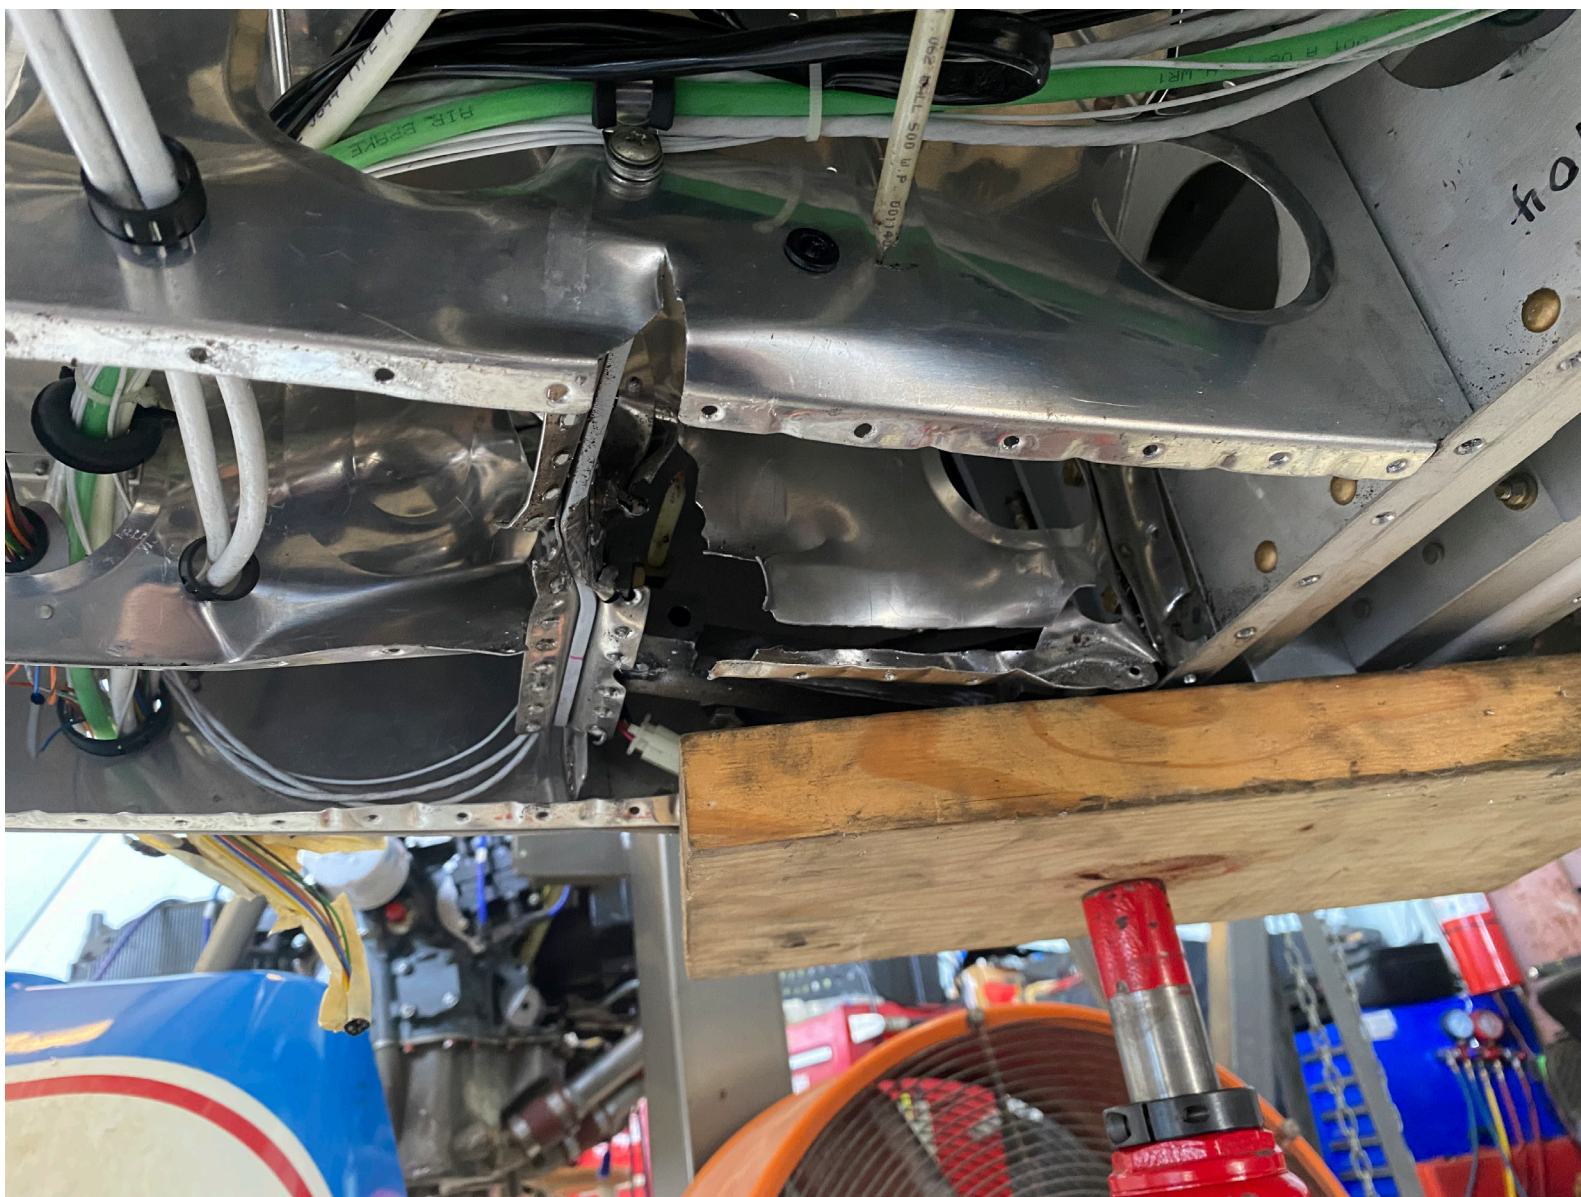
**Photograph 3 - Structural damage (Courtesy of FAA)**

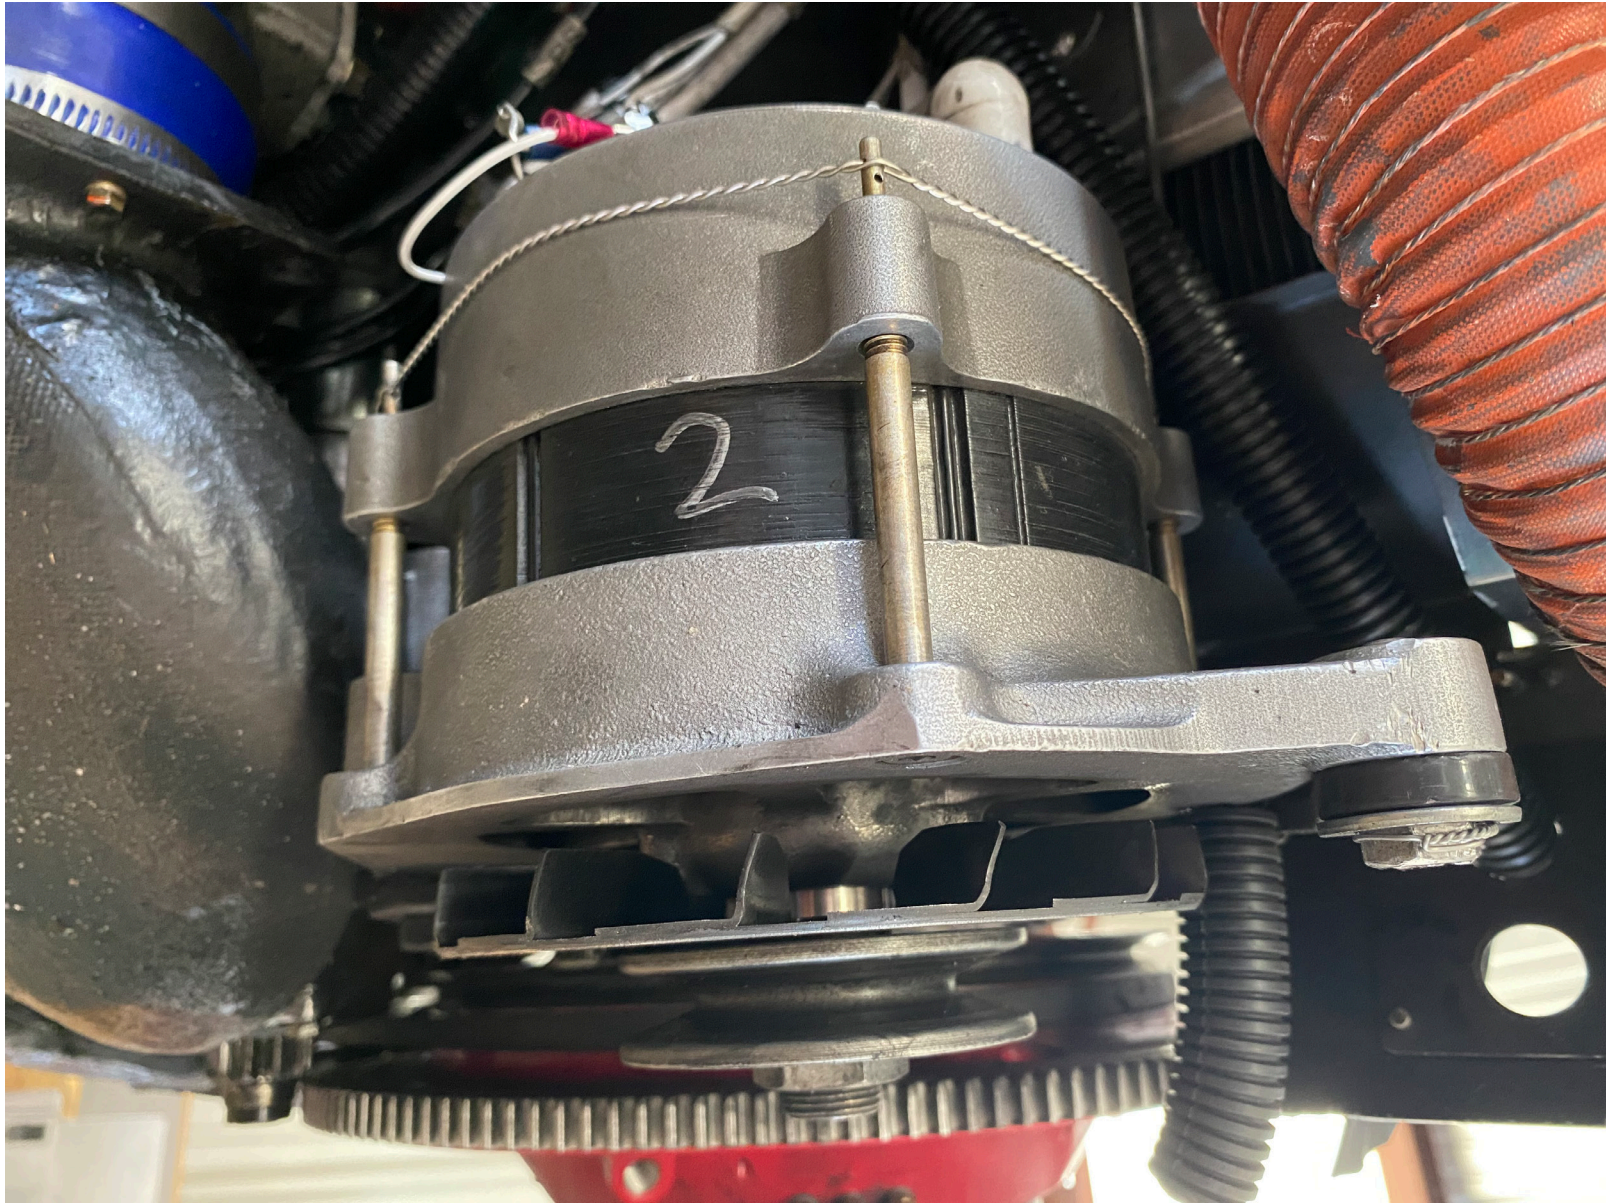
**Photograph 4 - Alternator No. 2, belt missing (Courtesy of FAA)**

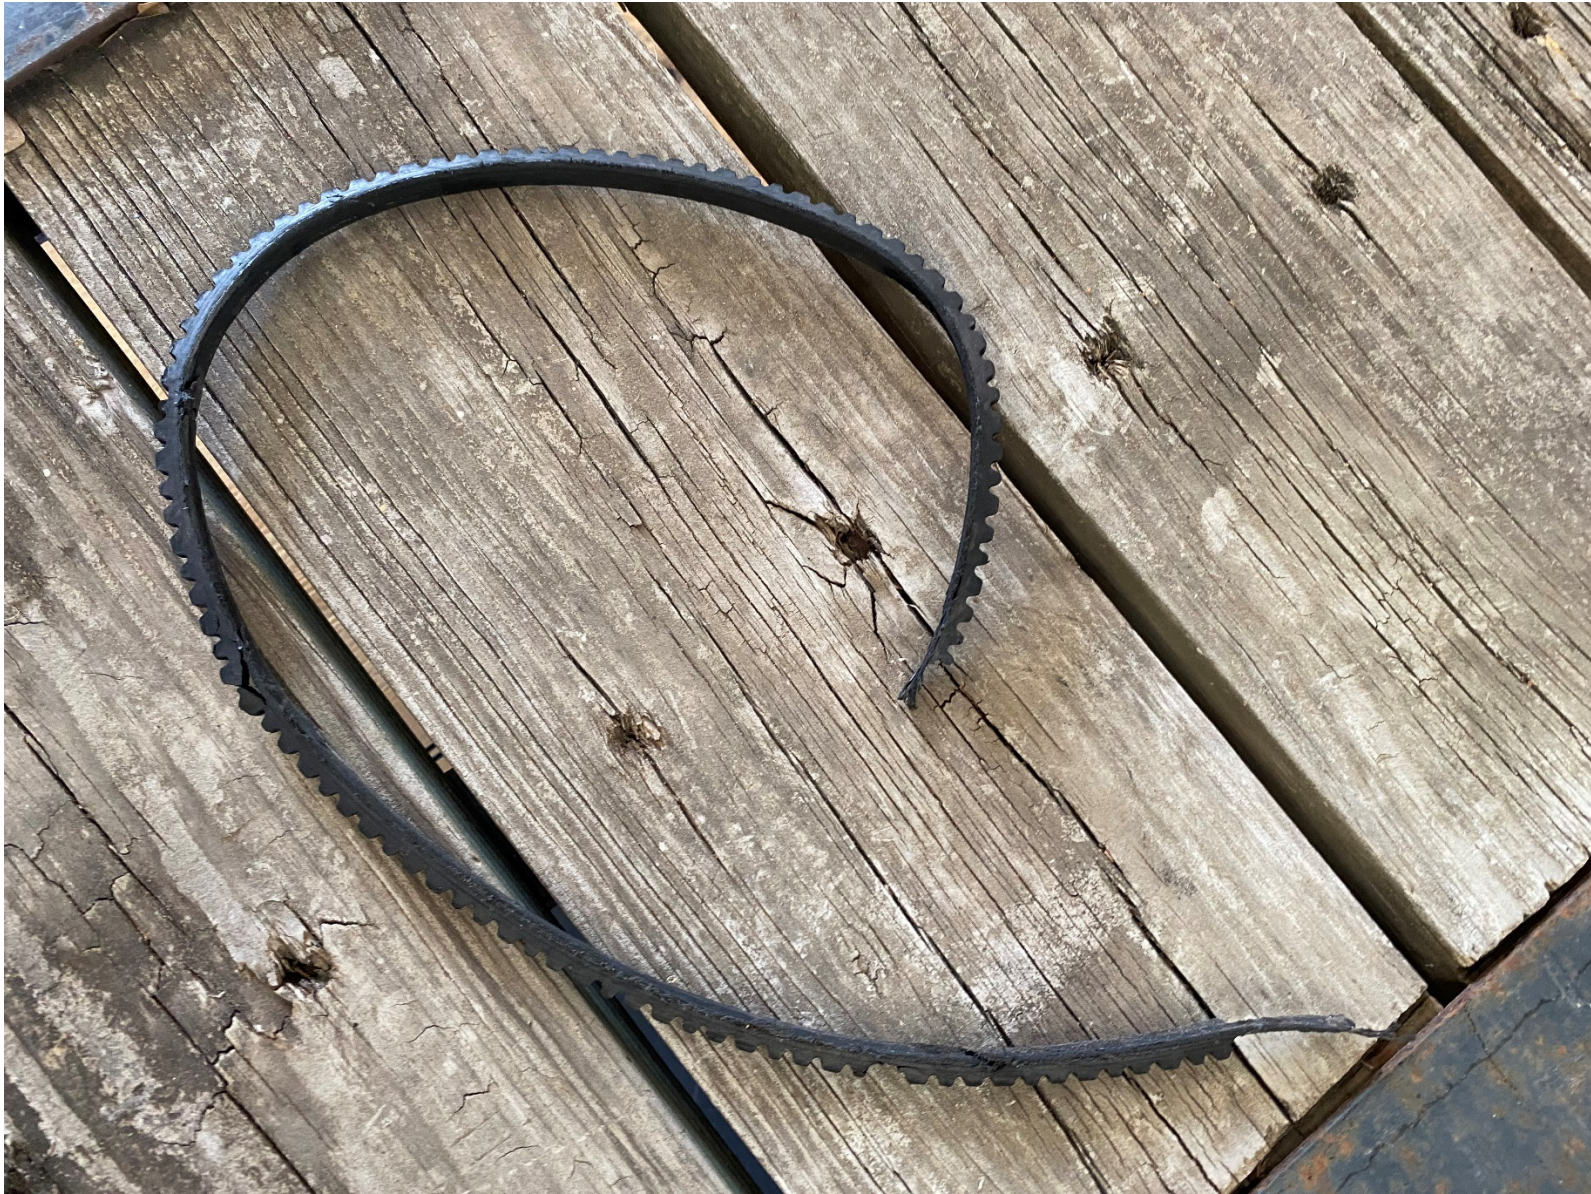
**Photograph 5 - Broken belt from alternator No. 2 (Courtesy of FAA)**

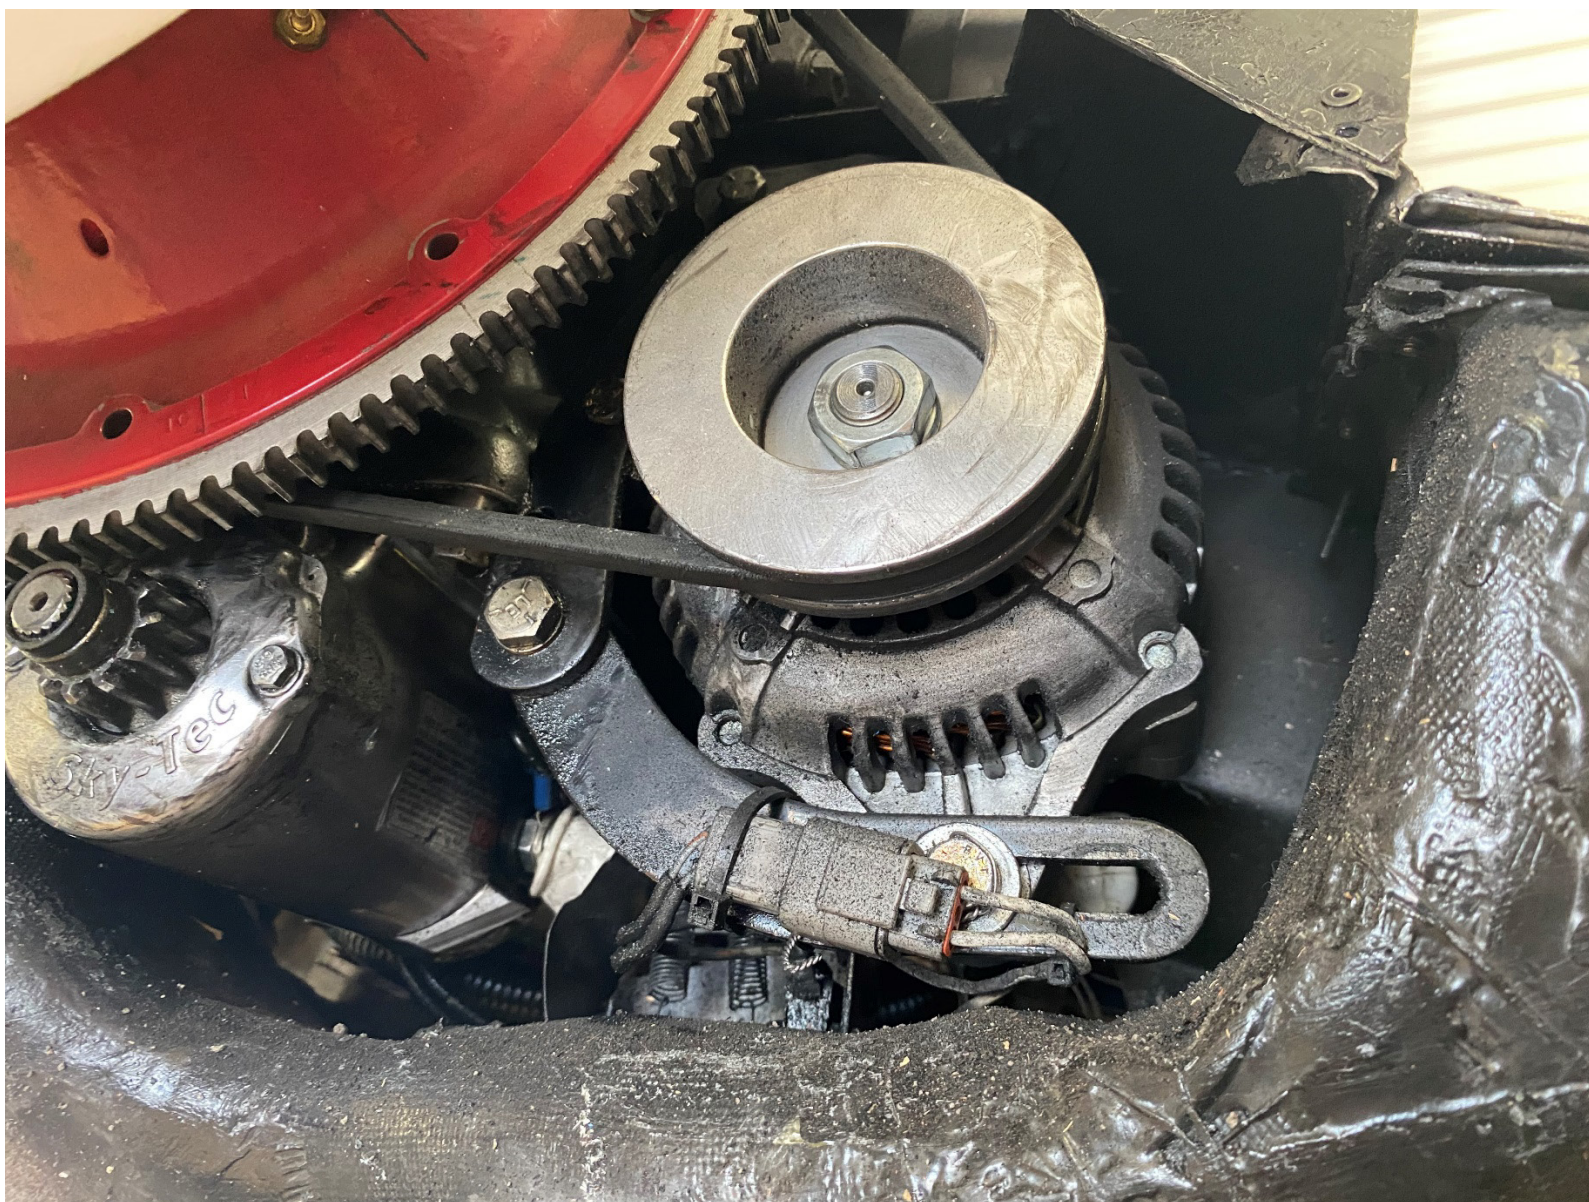
**Photograph 6 - Alternator No. 1 (Courtesy of FAA)**

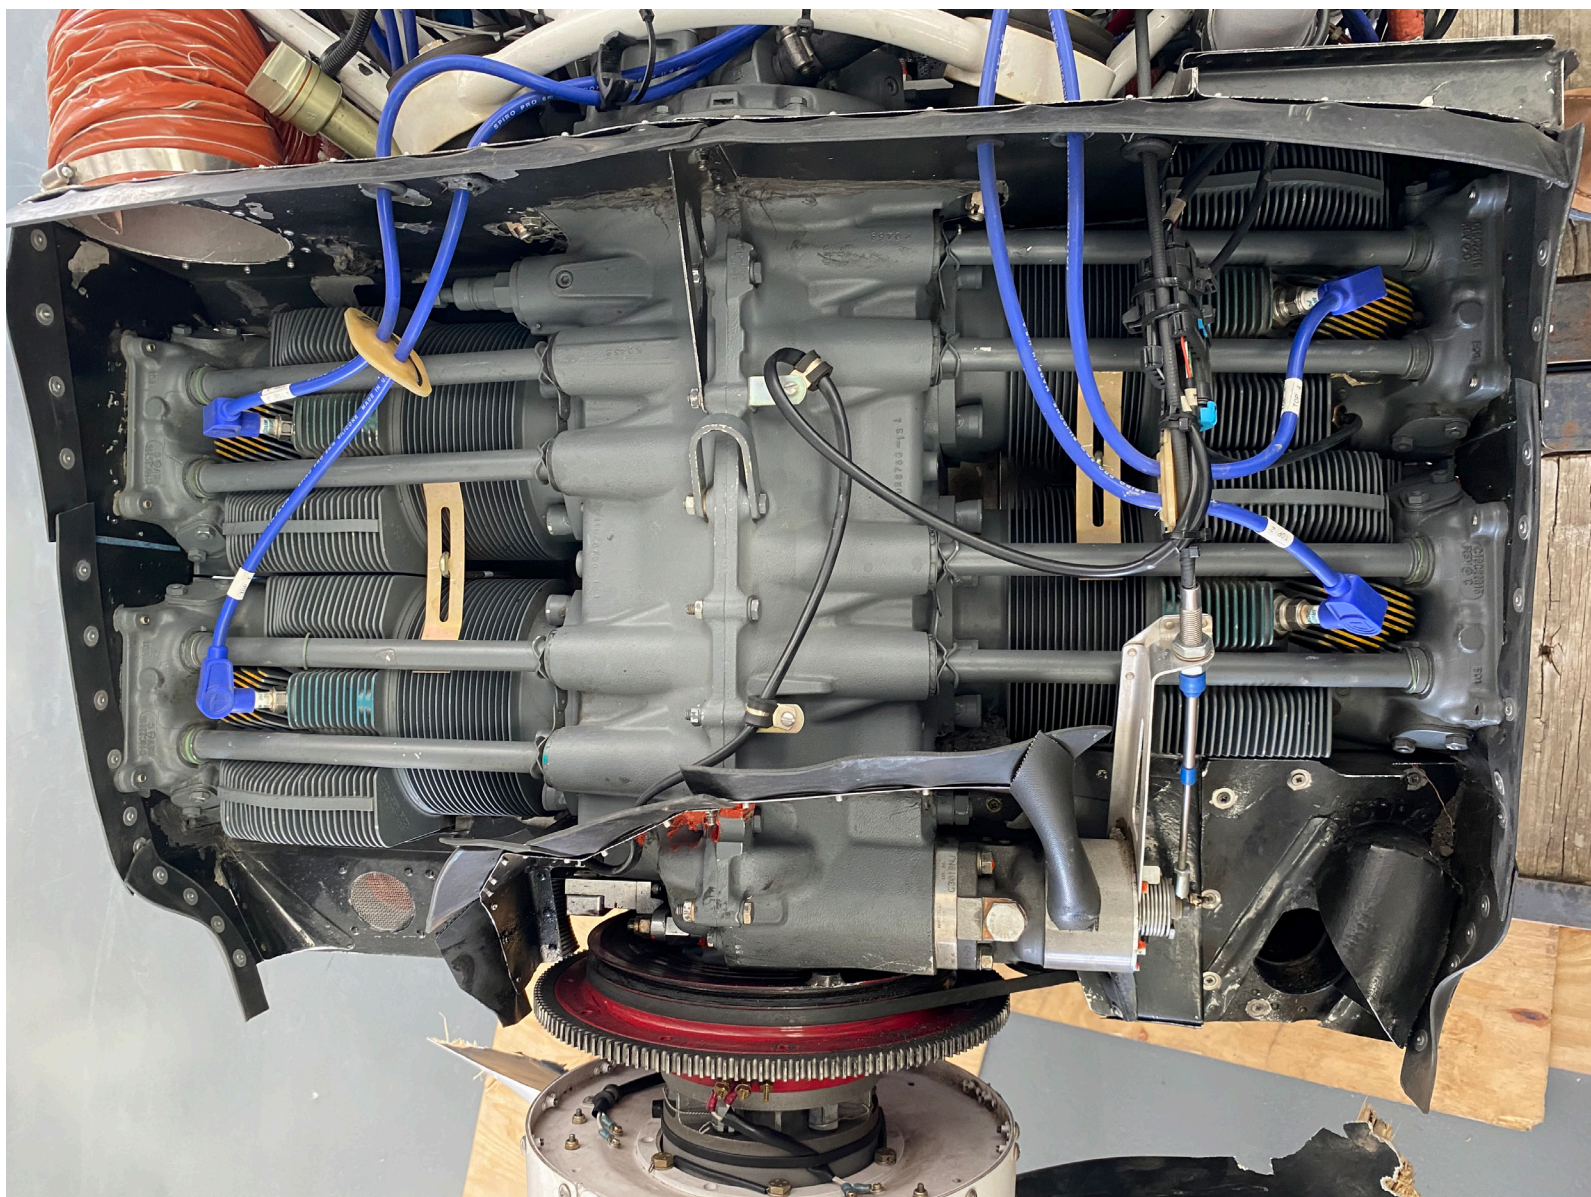
**Photograph 7 - Top view of engine (Courtesy of FAA)**
