# National Transportation Safety Board

CEN23LA405

## **MATERIALS LABORATORY**

Factual Report 24-050

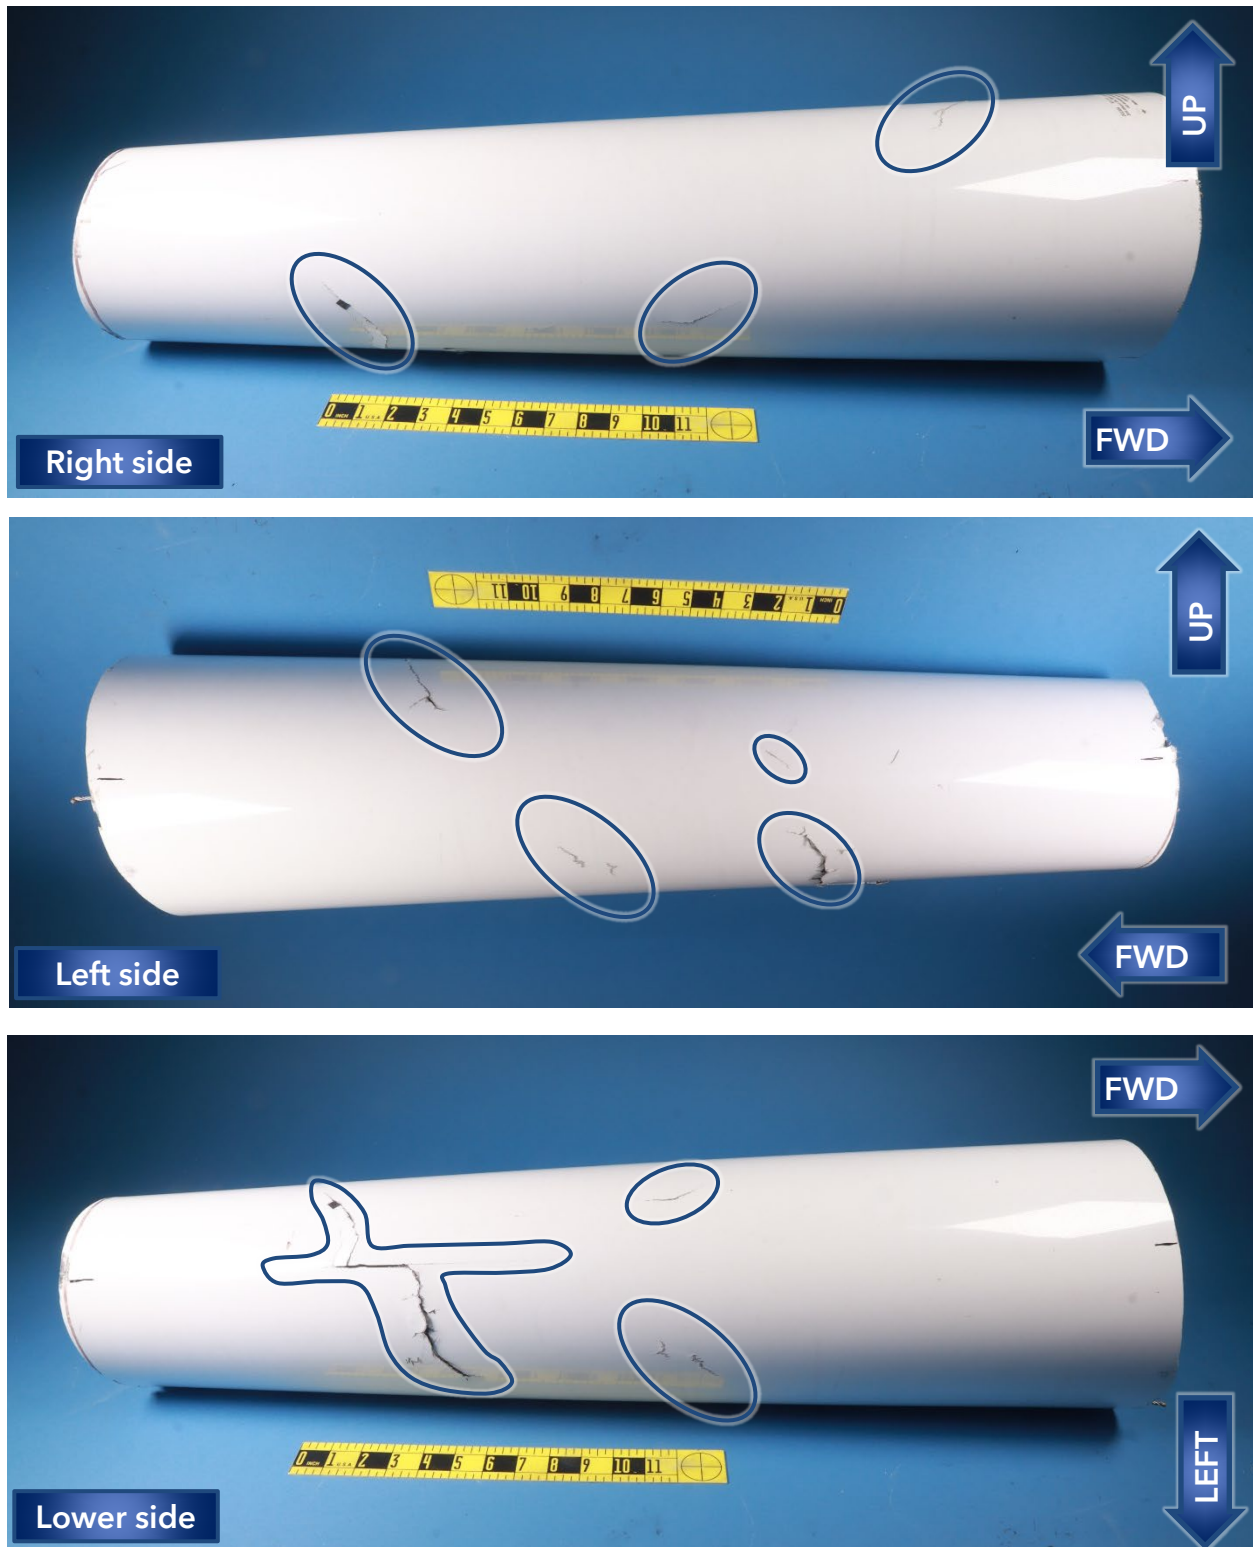
Skin cracks observed on the sectioned piece are shown circled in figures 1 and 2. As shown in the side views in figure 1, the skin cracks were oriented approximately 45° relative to the transverse plane on both the left and right side. Additionally, longitudinal cracks were observed on the upper and lower sides of the fuselage. The 45° cracks intersected the longitudinal crack at the lower side of the skin as indicated by the continuous boundary around the cracked areas. On the upper side of the fuselage, the cracks oriented at 45° were separate from the longitudinal crack as indicated with separate circled areas shown in figure 2. The longitudinal crack on the upper side of the fuselage was located between 7 and 11 inches away from the cut end and was difficult to see visually. To aid in detection and photography, a fine black powder was rubbed over the surface to help reveal the cracks in the white paint for the photograph shown in the lower image in figure 2.

**Figure 1.** Overall views of the submitted fuselage section showing the right side (upper image), left side (middle image), and lower side (lower image). Locations of cracks are outlined.

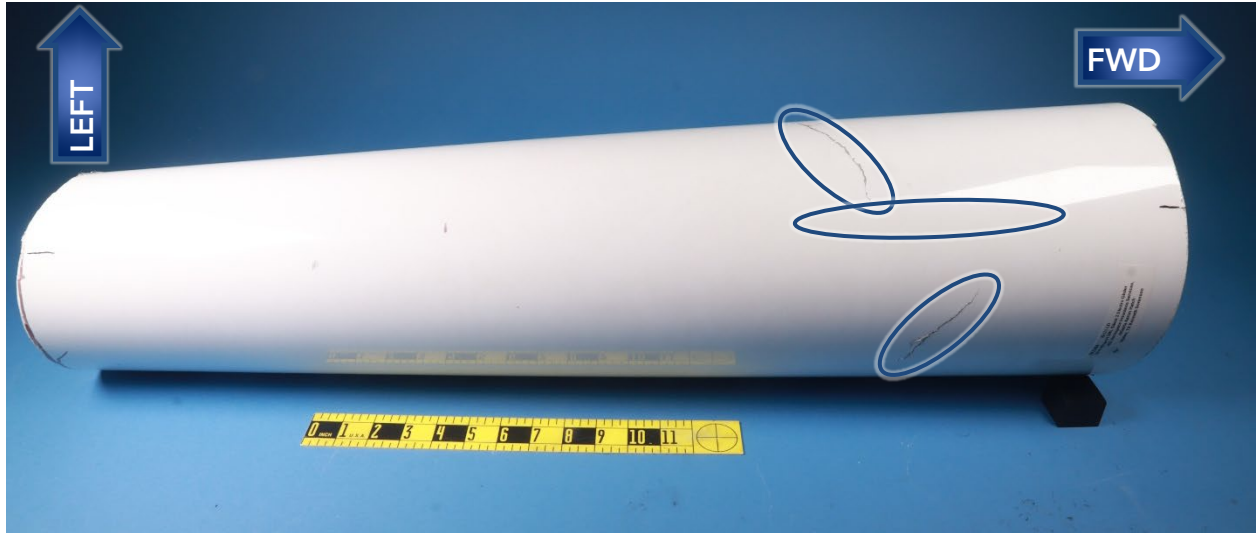
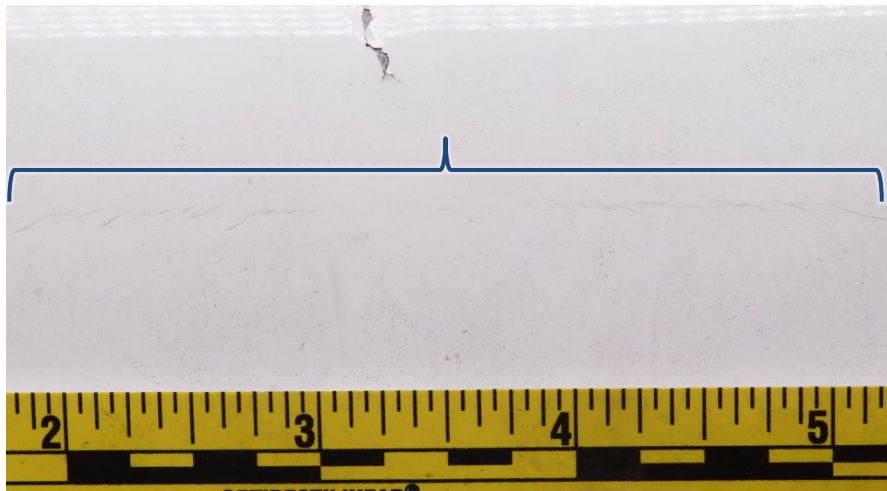
**Figure 2.** Overall view of the upper side of the submitted fuselage section (upper image), where locations of cracks are outlined. The lower image shows a closer view of the longitudinal crack as indicated with an unlabeled bracket after the surface was rubbed with a fine black powder to help reveal the crack in the white paint.

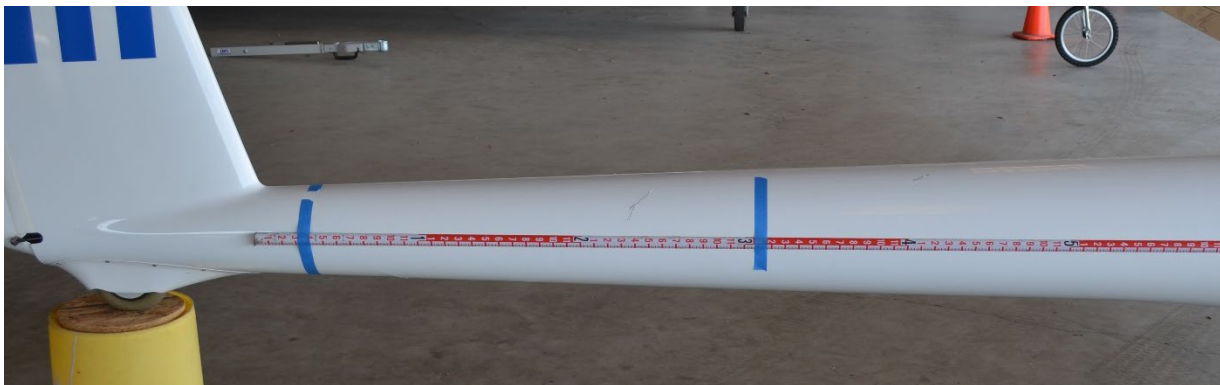
Overall views of the submitted fuselage piece are shown in figures 1 and 2. The 33.5-inch long piece was from the aft end of the fuselage forward of the empennage. The damaged area of the fuselage is shown in figure 3 before it was sectioned from the aircraft. As shown in the image, cracks on the upper side of the fuselage were located up to approximately 30 inches forward of the vertical stabilizer.

**Figure 3.** View of the damaged fuselage before it was sectioned from the aircraft. (Image provided by the aircraft owner)

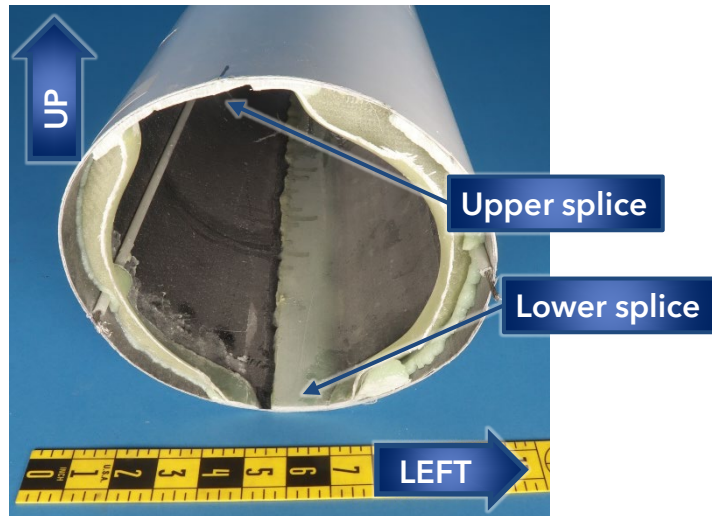
The fuselage skin was made from fiber reinforced polymer composite materials with both glass fiber and carbon fiber fabric reinforcement. The fuselage skin was constructed of two halves (left half and right half) that were spliced together at the upper and lower sides as indicated in figure 4. At each splice location, the skin layers butted together, and strips of glass-fiber reinforced fabric were bonded to the interior surfaces to form single strap butt joints.

**Figure 4.** End view of the fuselage section showing longitudinal splice locations for the fuselage skin halves.

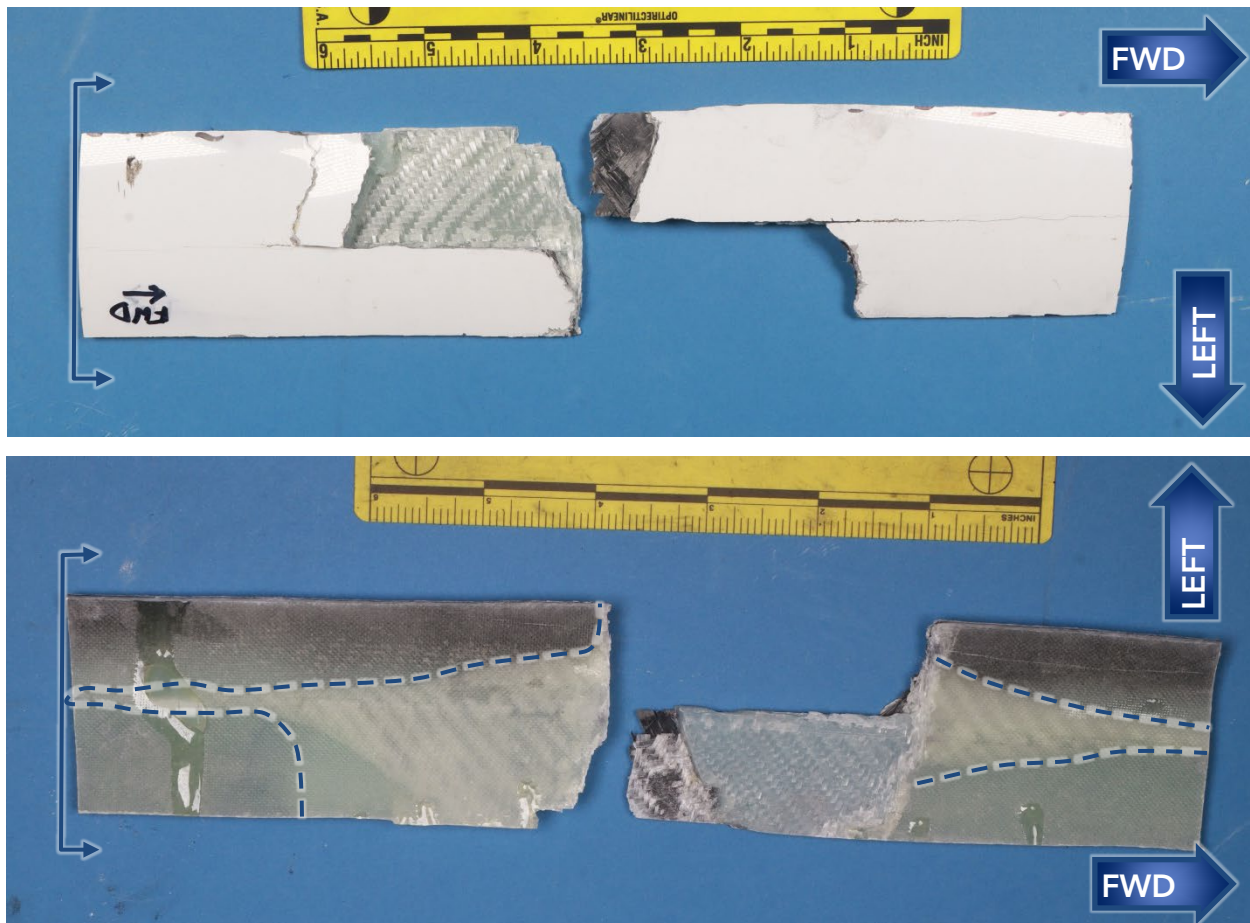
A portion of the upper skin containing the longitudinal crack and a section of the upper splice was cut from the remainder of the fuselage skin using a hand-held cutting tool with an oscillating diamond-coated blade. Views of the exterior and interior surfaces of the sectioned piece are shown in figure 5. On the interior side, a portion of the strap had a lighter appearance within the region shown bounded by dashed lines in the lower image in figure 5. The change in color was consistent with a disbond between the strap and the skin.

**Figure 5.** Piece of fuselage skin removed from the cracked lower splice. Arrowed lines indicate the location of a transverse materialographic section at the aft end of the aft piece. Dashed lines in the lower image indicate a lighter region likely associated with strap disbonding.

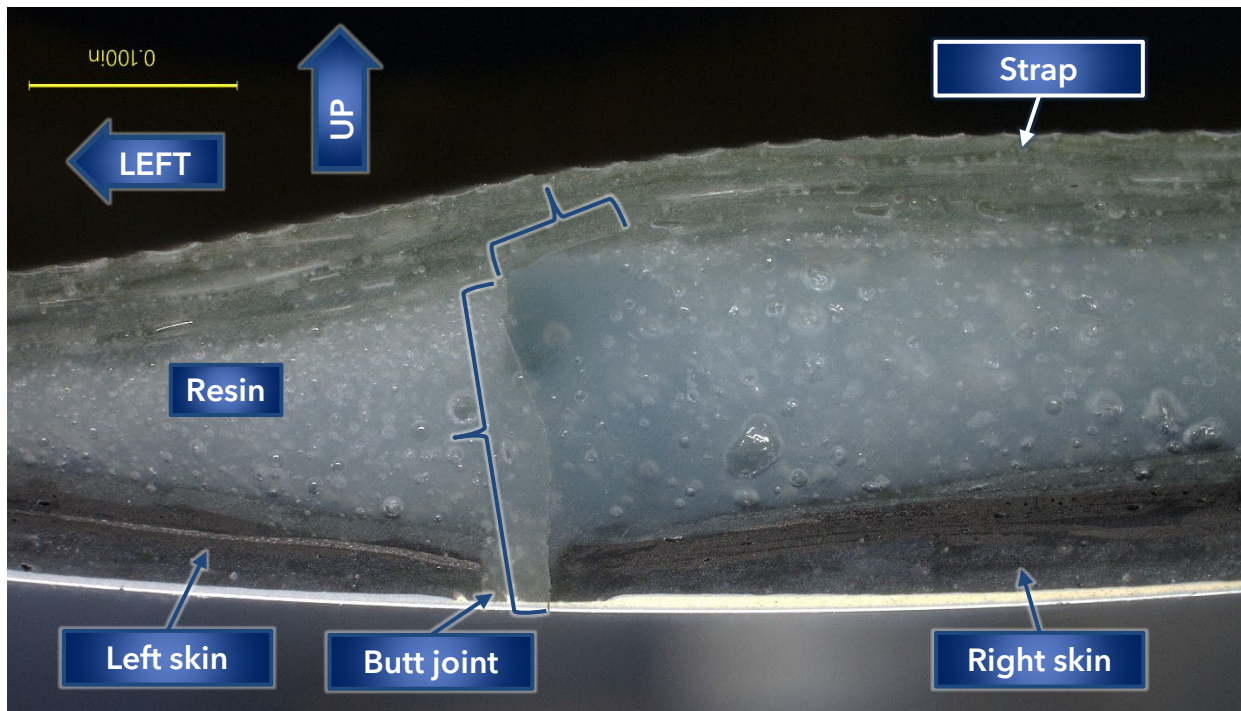
The middle of the splice between the left and right skin halves is shown in figure 6. Resin filled the gap between the butt ends of the left and right skin layers and the area between the strap and the skins. The resin layer was approximately 0.10 inch thick on the right side of the splice and became thinner toward the left side as shown in figure 7. The skin and strap layers were closely bonded to each other at the left side of the splice. A vertical crack was observed at the butt joint as indicated with an unlabeled bracket in figure 6. The upper end of the vertical crack intersected a smaller transverse crack at the lower side of the strap.

**Figure 6.** Materiallographic section showing the middle of the single strap splice where the butt ends of the fuselage skin halves were joined. Unlabeled brackets indicate the location of a vertical crack through the butt joint intersecting a smaller transverse crack at the lower side of the strap.

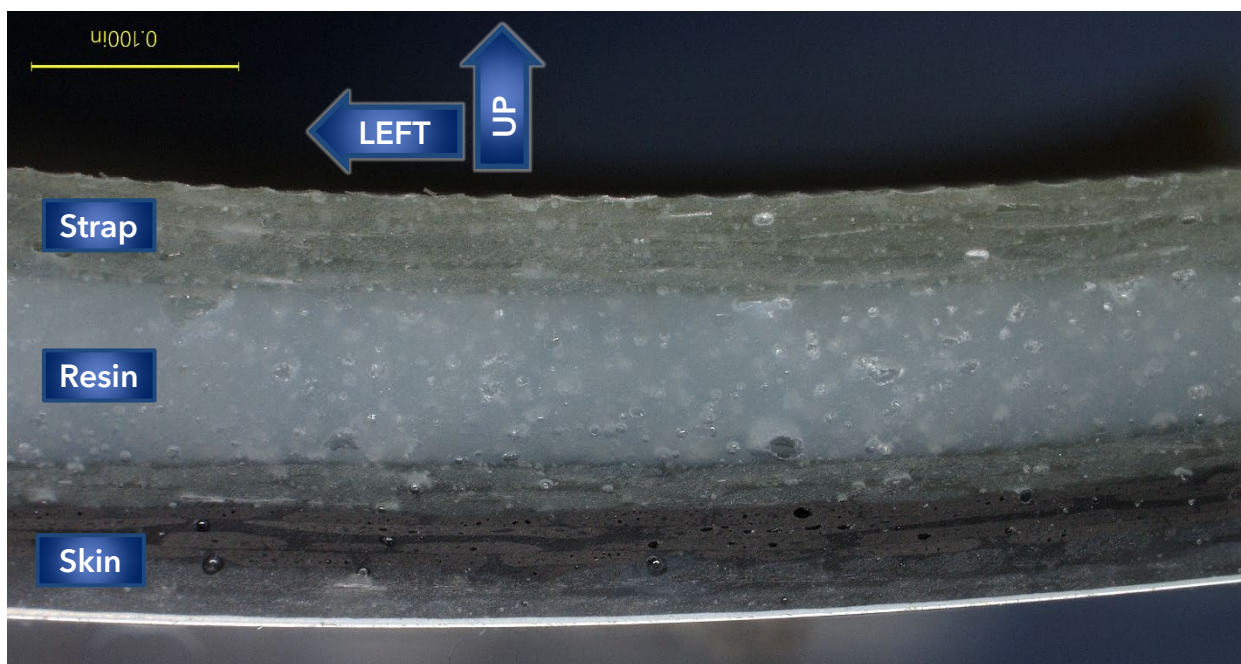
**Figure 7.** Materiallographic section of the splice to the right of the butt joint showing the 0.1-inch thick resin layer between the strap and the skin.

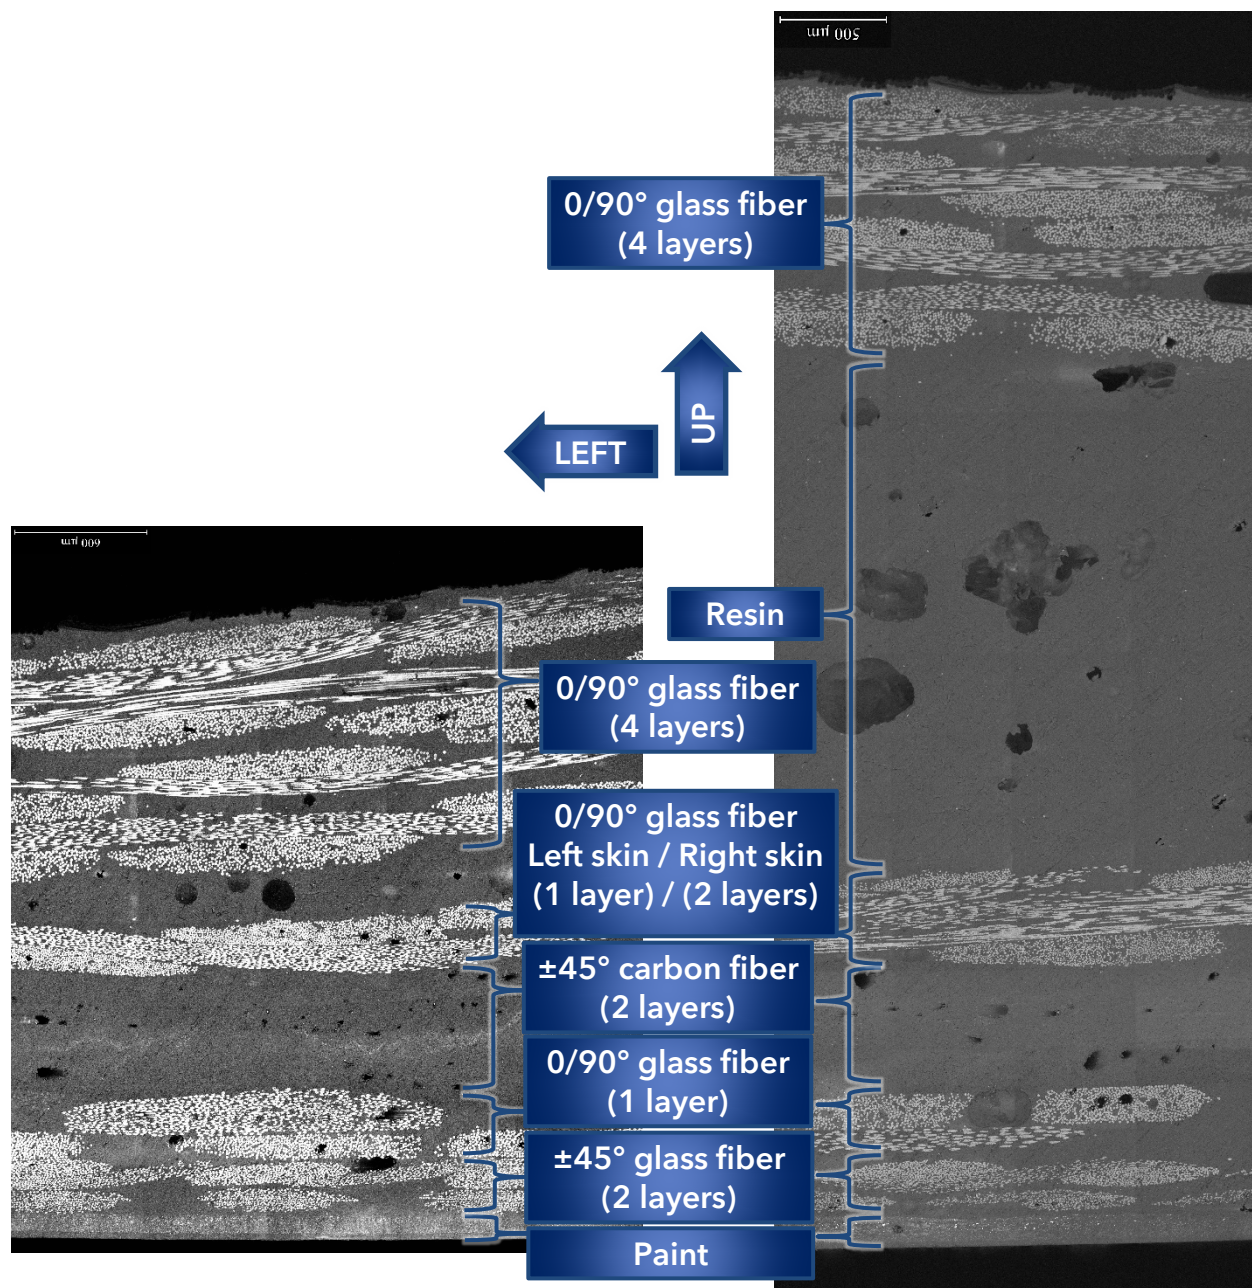
The SEM images of the cross-section shown in figure 8 were obtained using a backscatter detector in composition mode.<sup>1</sup> The displayed images are collections of individual SEM images that were stitched together to show overall views of the layup in the single strap splice to the left and right of the butt joint. Glass fibers appear lighter gray relative to the carbon fibers and resin, and voids appear relatively dark. Fiber orientations were determined by relative elongation of fibers ends where they intersected the transverse plane with little or no elongation to 0-degree fibers, intermediate elongation to  $\pm 45$ -degree fibers, and relatively high elongation associated with 90-degree fibers. All fibers were observed in bundles consistent with fabric construction. No evidence of glass fiber roving was observed, including in the resin pocket between the strap and the skin.

**Figure 8.** SEM images stitched together to show the cross-section on the left side (left image) and right side (right image) of the single strap splice.

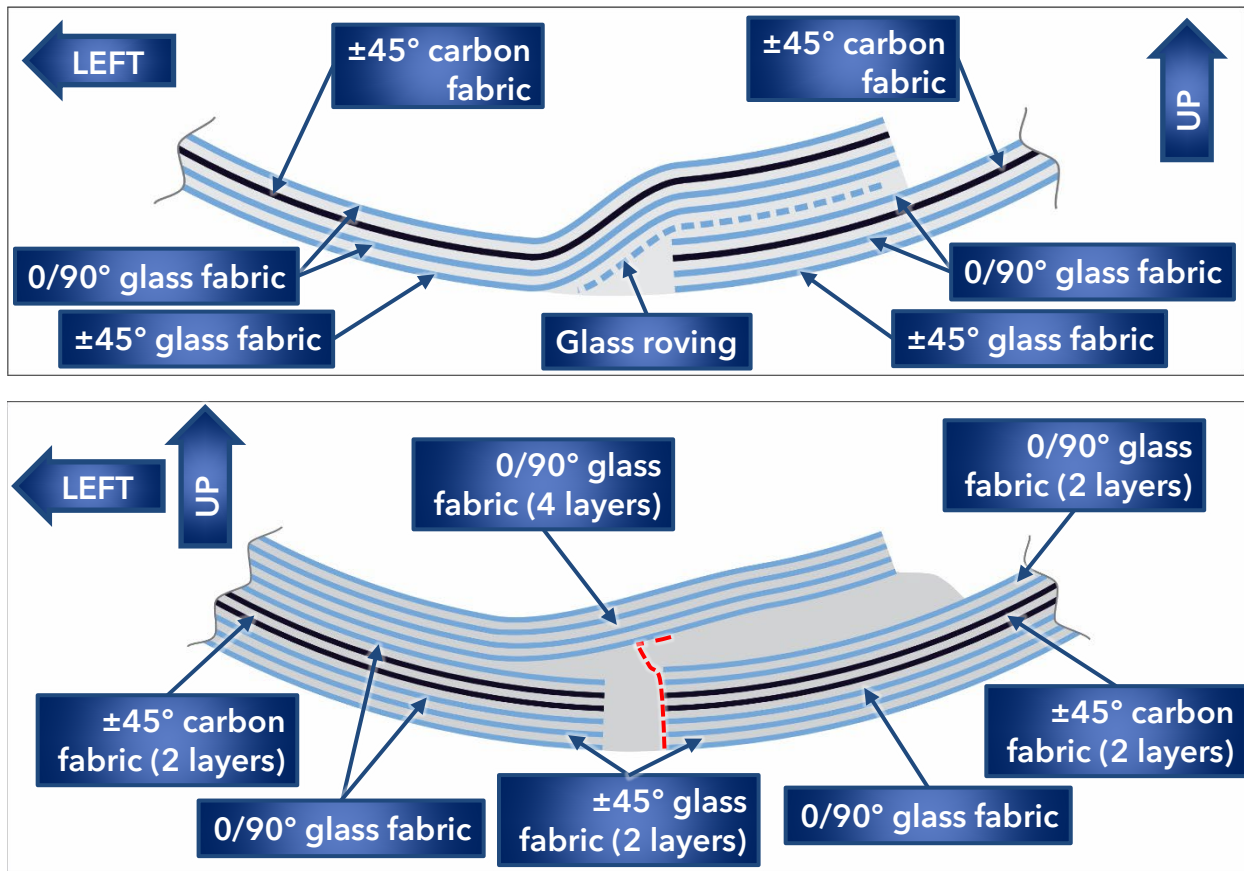
reviewed. The drawing indicated each half of the fuselage skin at the damaged location forward of the empennage would consist of 1 layer  $\pm 45^\circ$  glass fiber, 1 layer  $0/90^\circ$  glass fabric, 1 layer  $\pm 45^\circ$  carbon fiber, and 1 layer  $0/90^\circ$  glass fiber starting from the outside surface as shown in the upper image in figure 9. The longitudinal joint between the halves was shown as an overlap joint with 6 threads of glass roving (represented by a blue dashed line in figure 9) in the dished portion of the joint. Details of how the fuselage halves were to be bonded together were not included in the available information.

The accident aircraft was serial number 2077 manufactured in 2016. The as-built construction at the location of the materialographic section as illustrated in the lower image in figure 9 showed skins with one additional  $\pm 45^\circ$  glass fabric layer on the exterior, one additional  $\pm 45^\circ$  carbon fabric layer in the middle, and one additional  $0/90^\circ$  layer on the inner surface of the skin on the right side only, relative to the reference build drawing. Additionally, the joint between the two halves was a single strap butt joint instead of the overlap splice shown in the reference drawing. The strap consisted of four layers at the centerline and to the right of the butt joint. To the left of the joint, the layers of the strap tapered to one layer ending approximately 4 inches from the butt splice. No evidence of  $0^\circ$  glass roving was observed in the as-built splice. Although the skin layers had a mix of fabric orientations with some layers in the  $0/90^\circ$  orientation and others in the  $\pm 45^\circ$  orientation, all four layers of the strap were oriented in the  $0/90^\circ$  orientation. A red dashed line in the lower image in figure 9 illustrates the approximate crack locations in the splice as observed in the cross-section shown in figure 6.

**Figure 9.** Diagrams of the layup for the skin at the lower splice between the two fuselage halves showing a comparison between the skin layup schedule as presented in an Alisport engineering drawing from 2004 (upper image) and the as-built structure, manufactured in 2016, observed in a cross-section of the accident aircraft fuselage (lower image). Glass fiber reinforcement layers are shown in blue, and carbon fiber reinforcement layers are shown in black. The dashed red line in the lower image indicates the approximate crack path observed in the materialographic cross-section through the single strap splice.

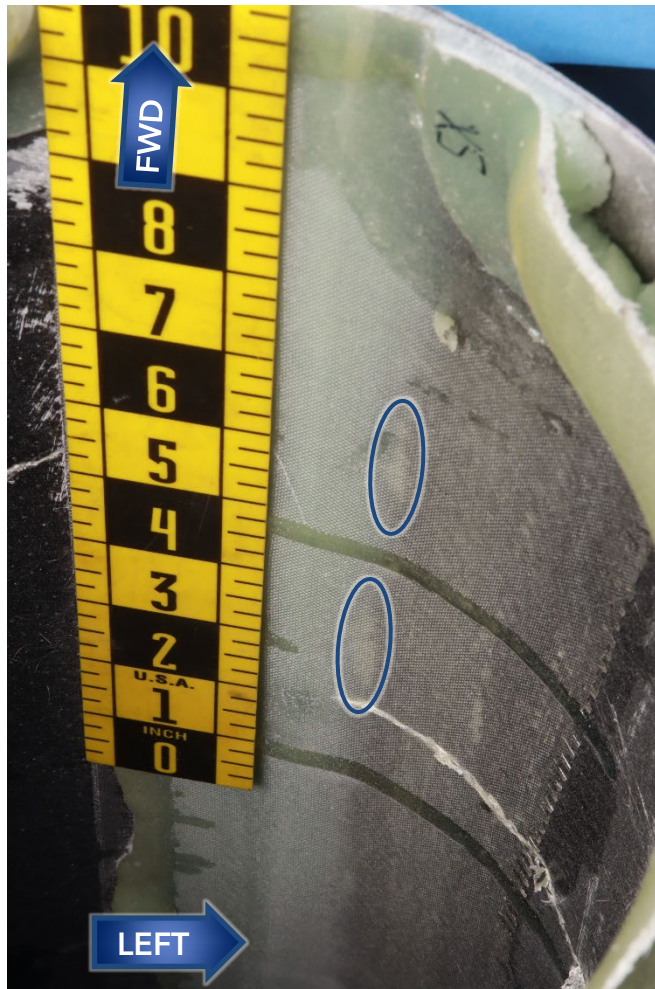
The interior surface of the fuselage near the forward cut end is shown in figure 10, where two areas of the upper splice area are shown circled. These areas had a distinctly lighter appearance relative to the surrounding areas, consistent with areas of voids or disbonds. The longitudinal crack on the upper side of the fuselage (see figure 2) was located in this area of the fuselage at a location corresponding to the 0 to 4-inch marks on the ruler shown in figure 10.

**Figure 10.** Interior surface of the fuselage at the upper splice location. Areas circled had a lighter appearance consistent with a disbond or void. The longitudinal crack shown in figure 2 was between 7 and 11 inches away from the cut end, which corresponds to the 0 to 4-inch marks on the ruler shown in this image.
