CEN23LA407

## INVESTIGATION PHOTOGRAPHS

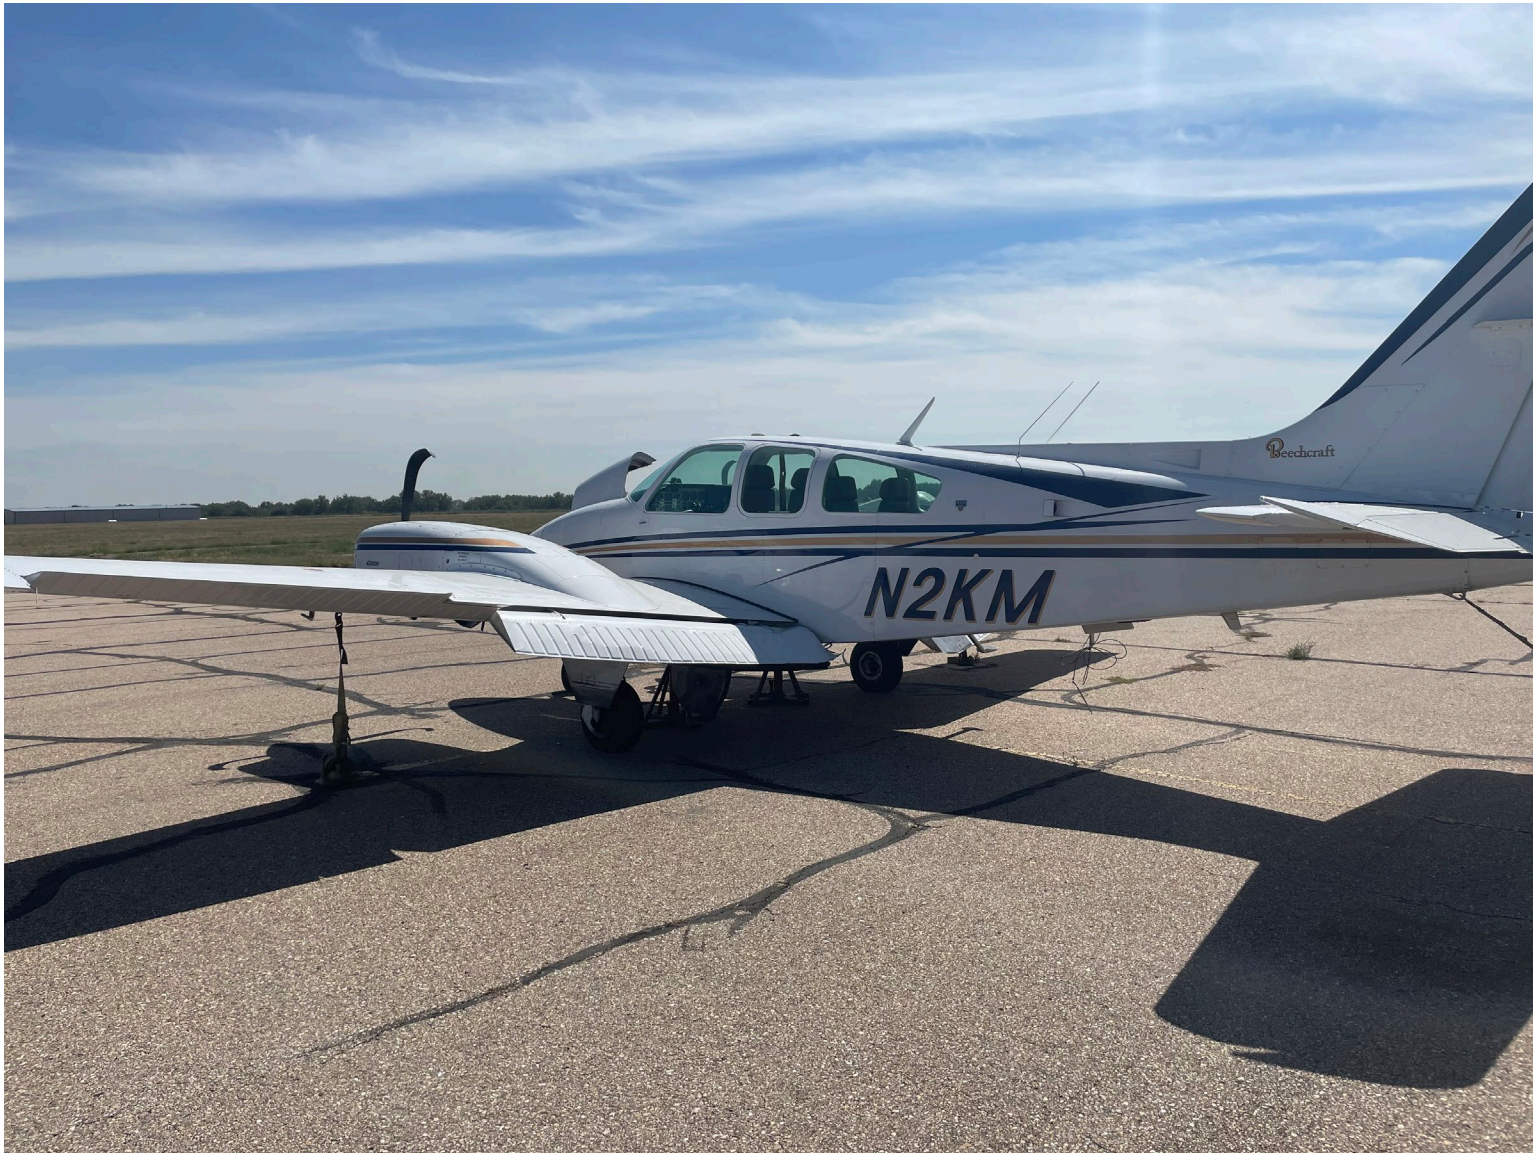
**Photograph 1 - Accident Airplane Overview**

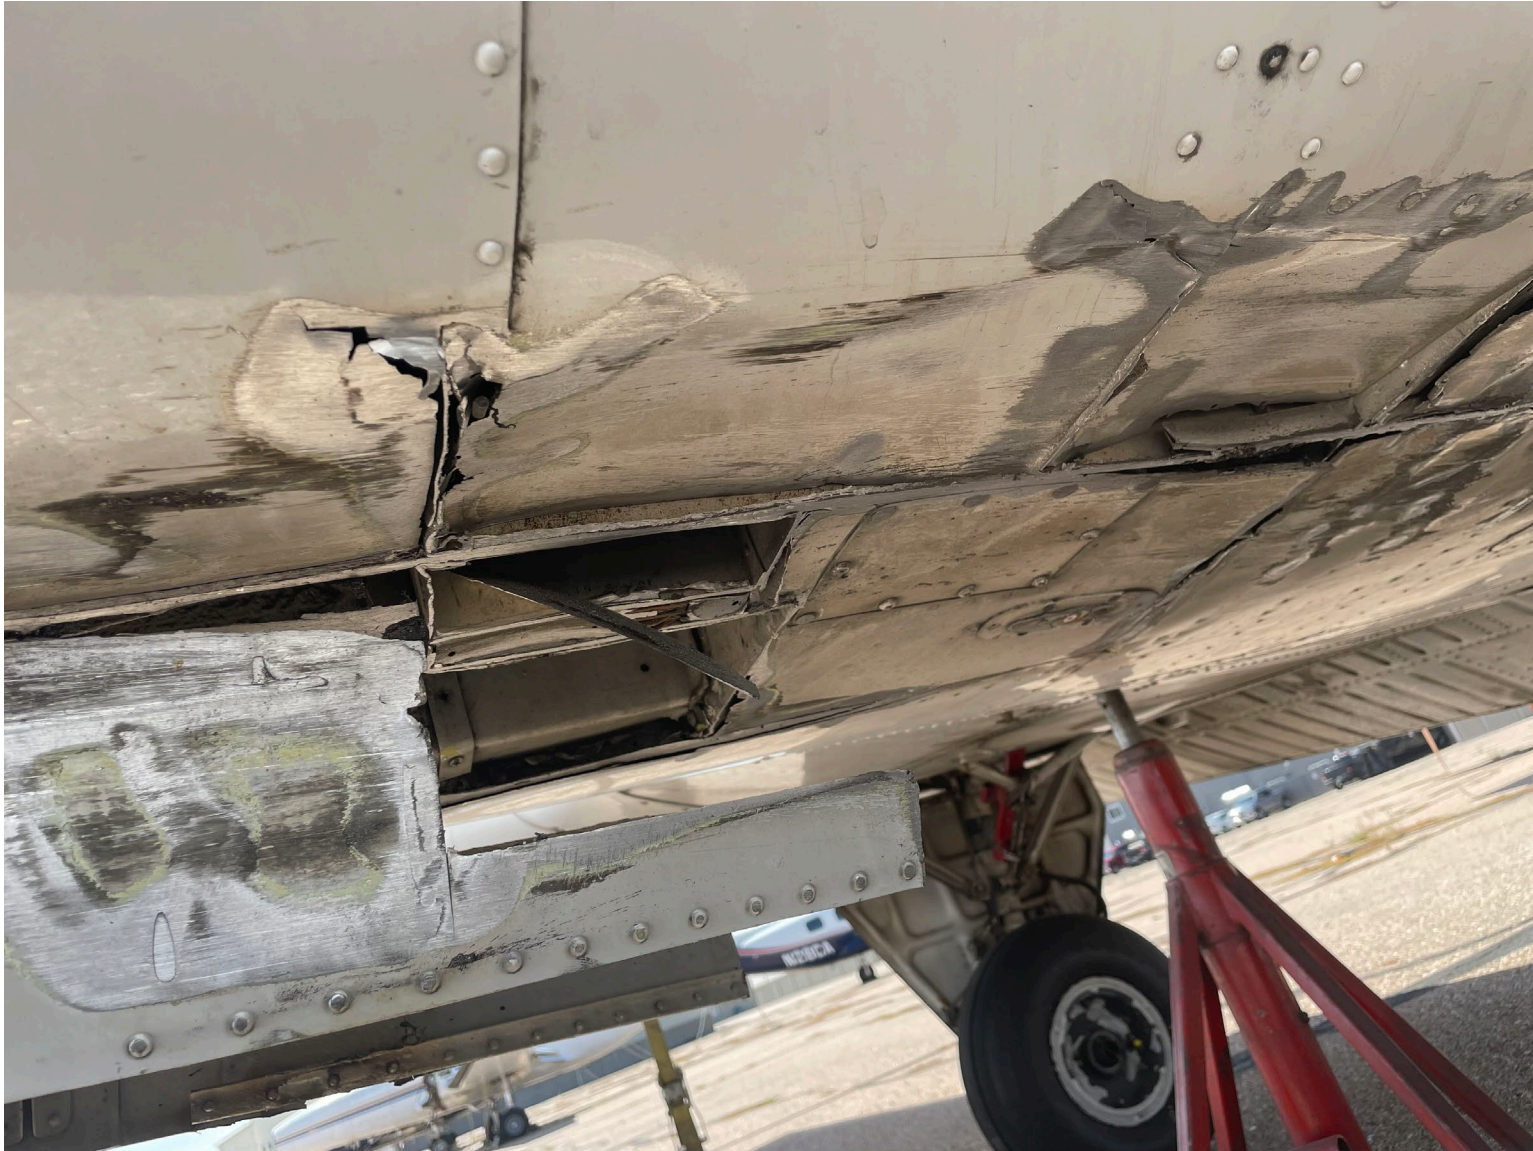
**Photograph 2 - Lower Fuselage Damage**

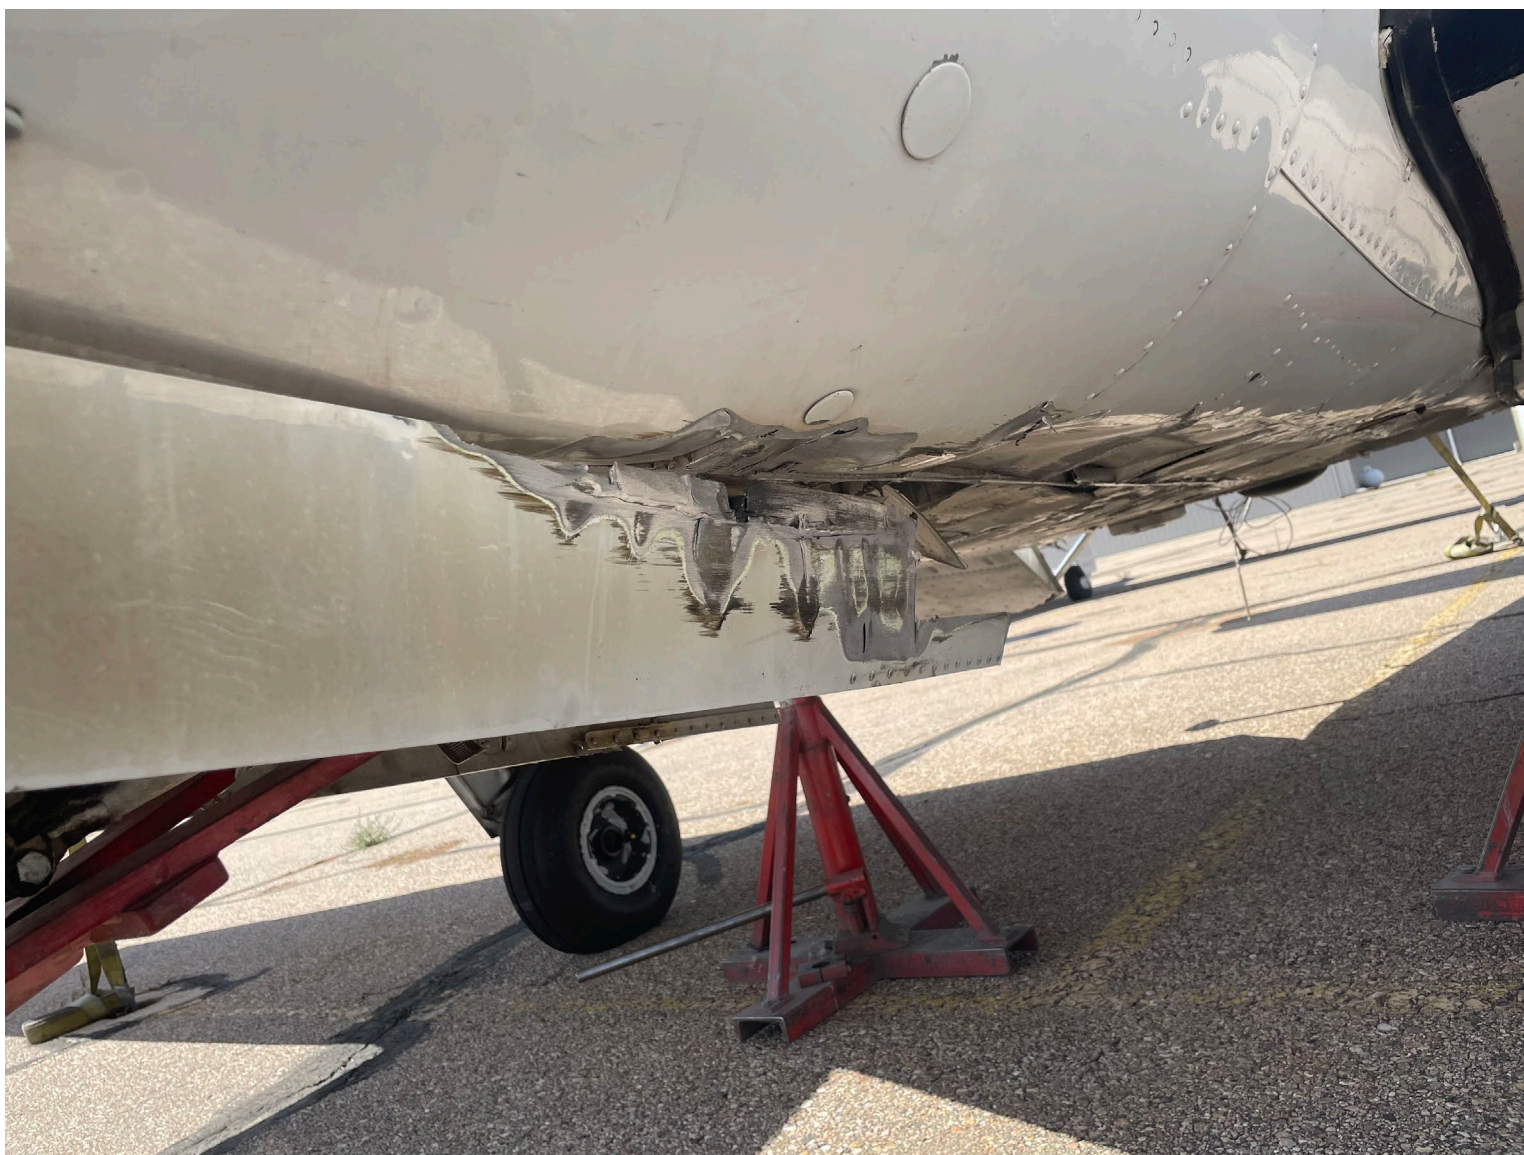
**Photograph 3 - Nose Landing Gear Door Damage**

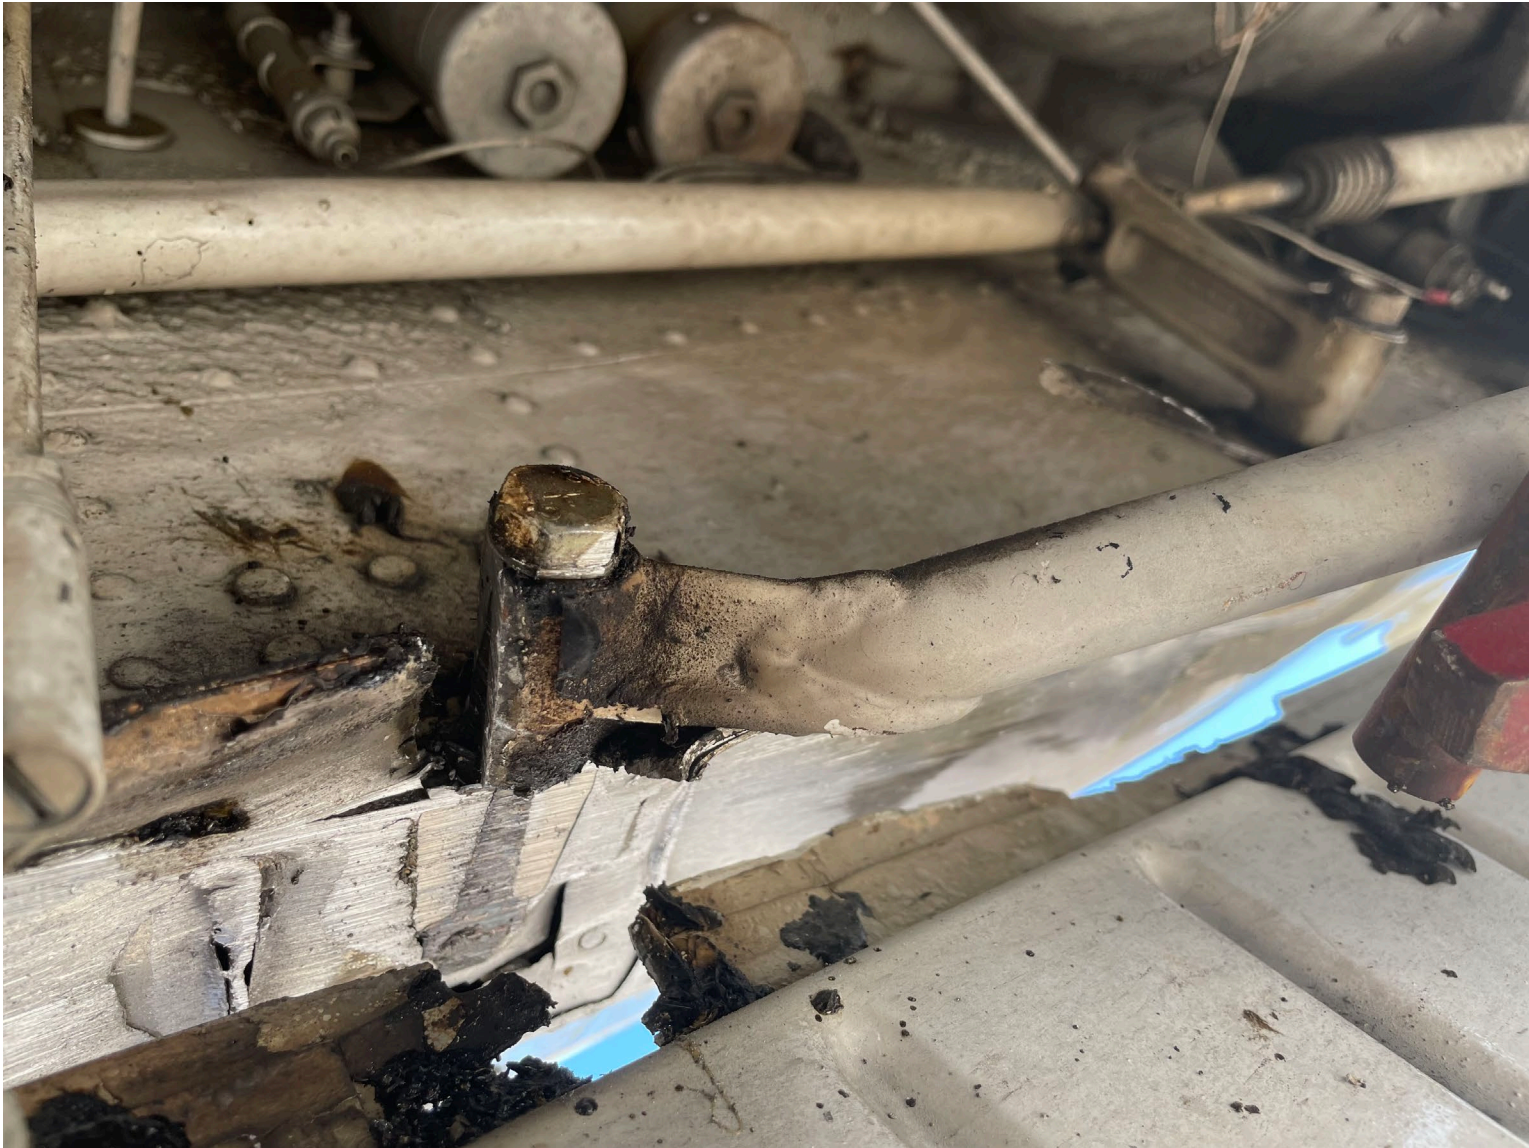
**Photograph 4 - Main Landing Gear Actuator**

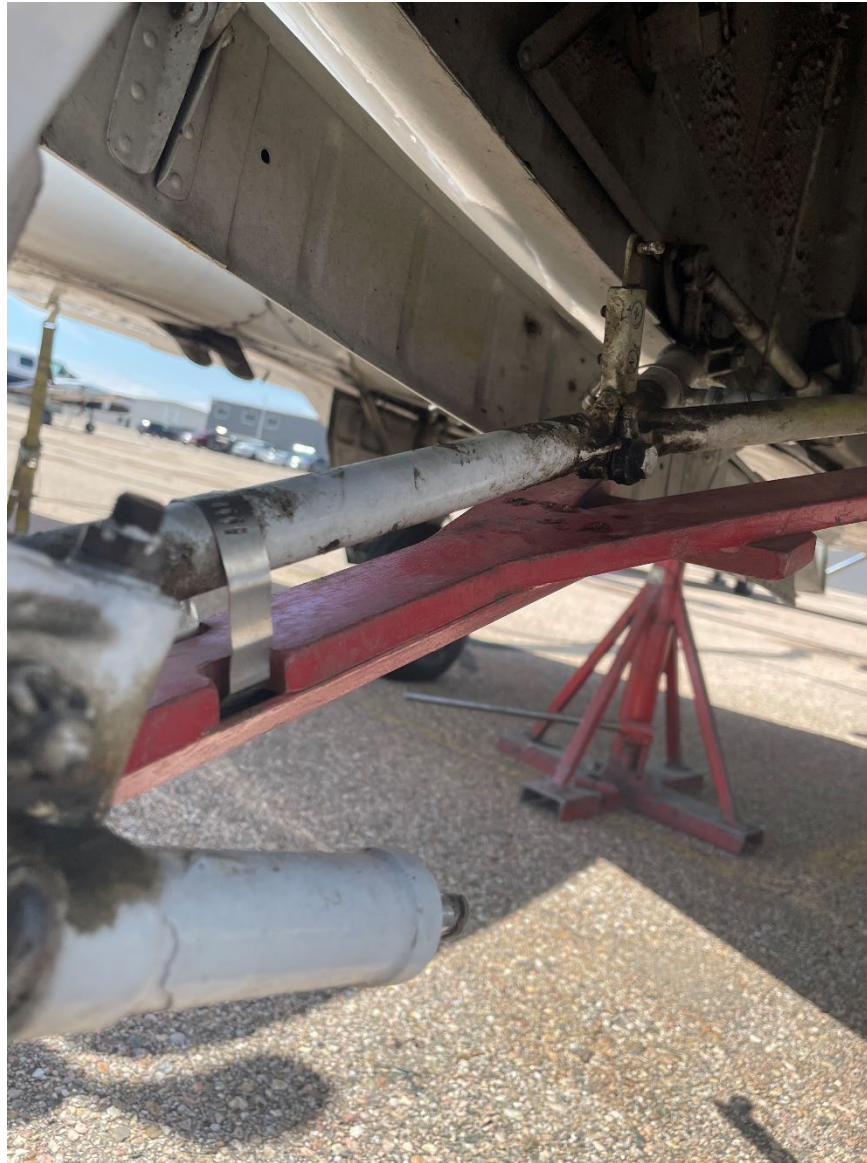
**Photograph 5 - Nose Landing Gear Actuator**
