CEN23LA416

**INVESTIGATION PHOTOGRAPH**

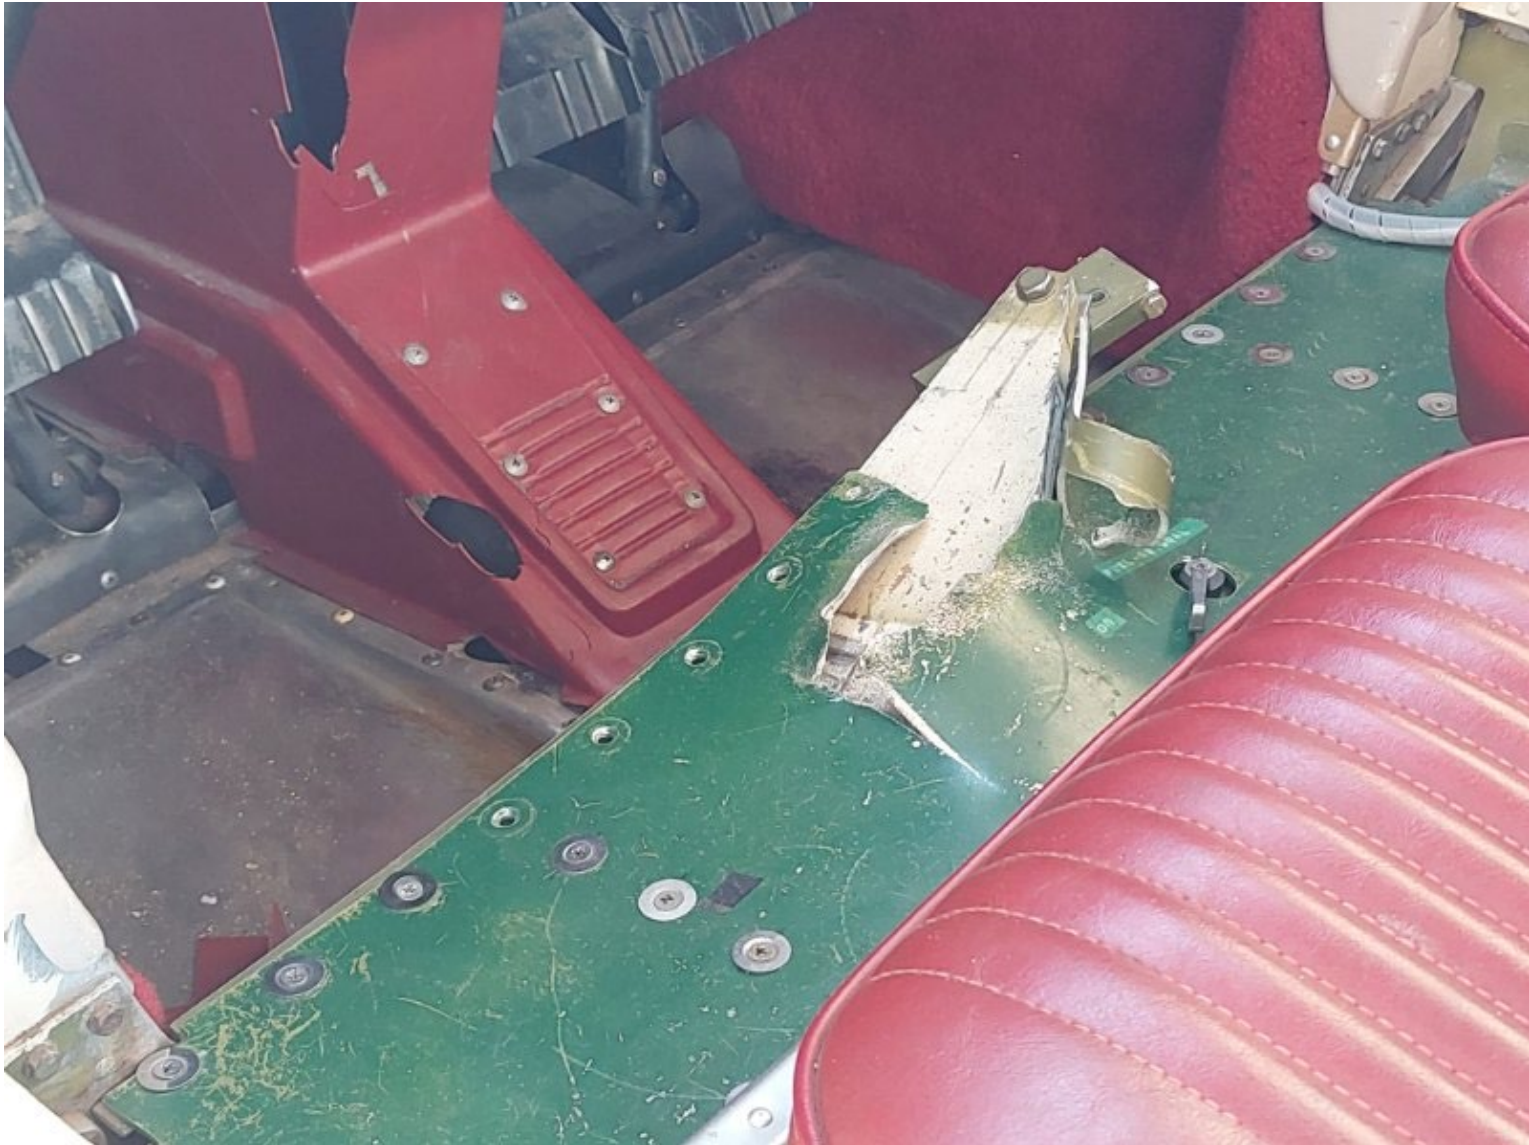
**Photograph 1 - Left main landing gear strut punctured forward fuselage (Courtesy of Airport Operations)**
