CEN23LA417

## INVESTIGATION PHOTOGRAPHS

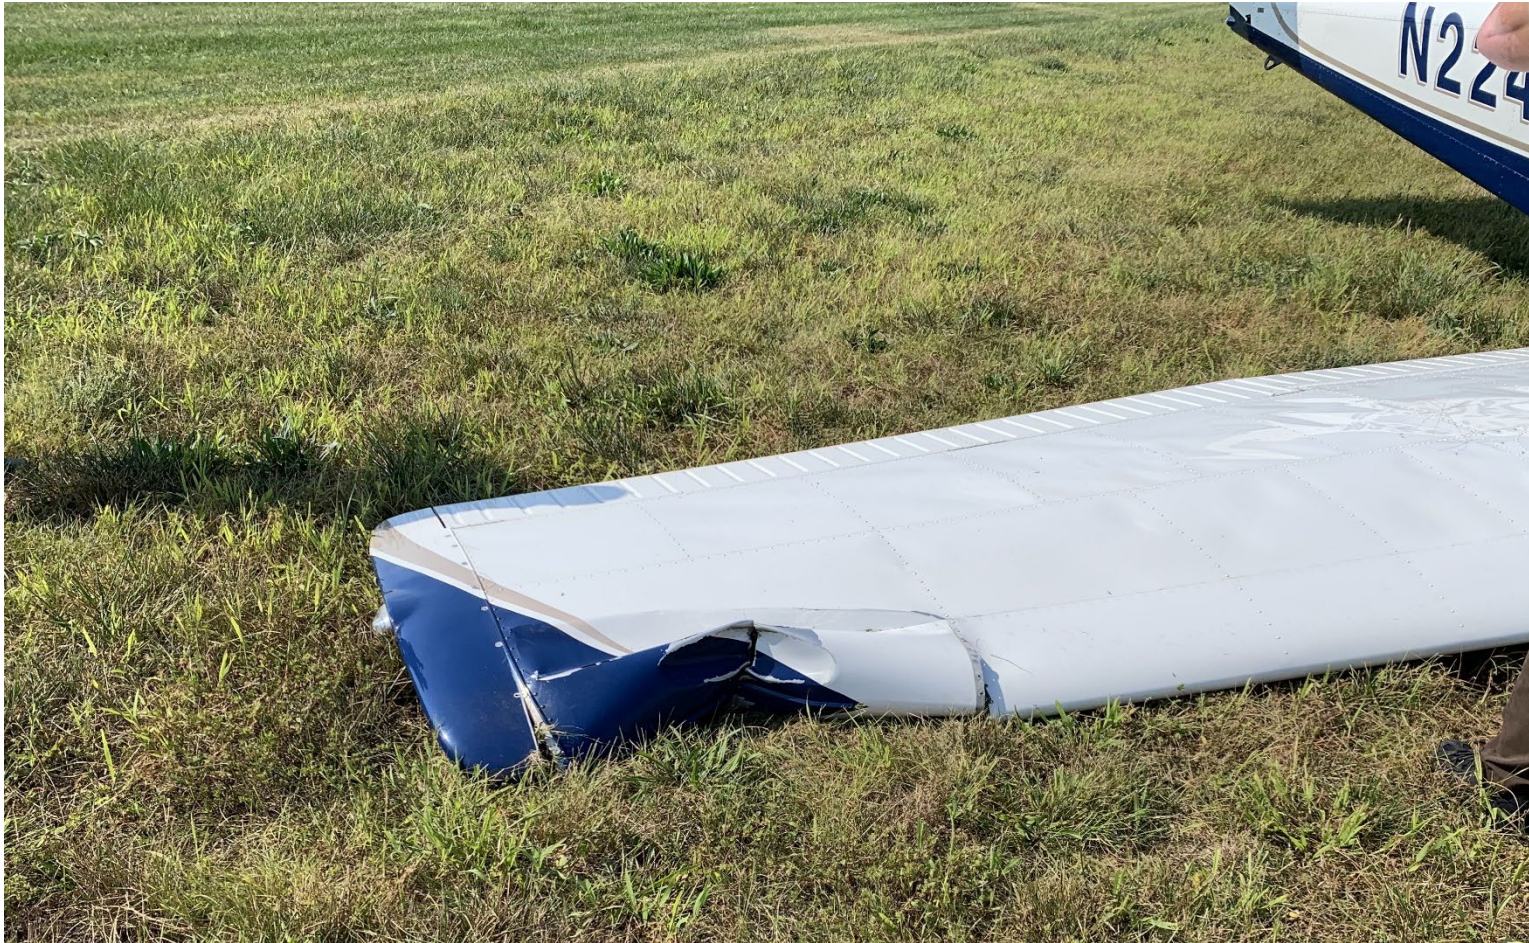
**Photograph 1 - Outboard right wing damage (Courtesy of Federal Aviation Administration)**

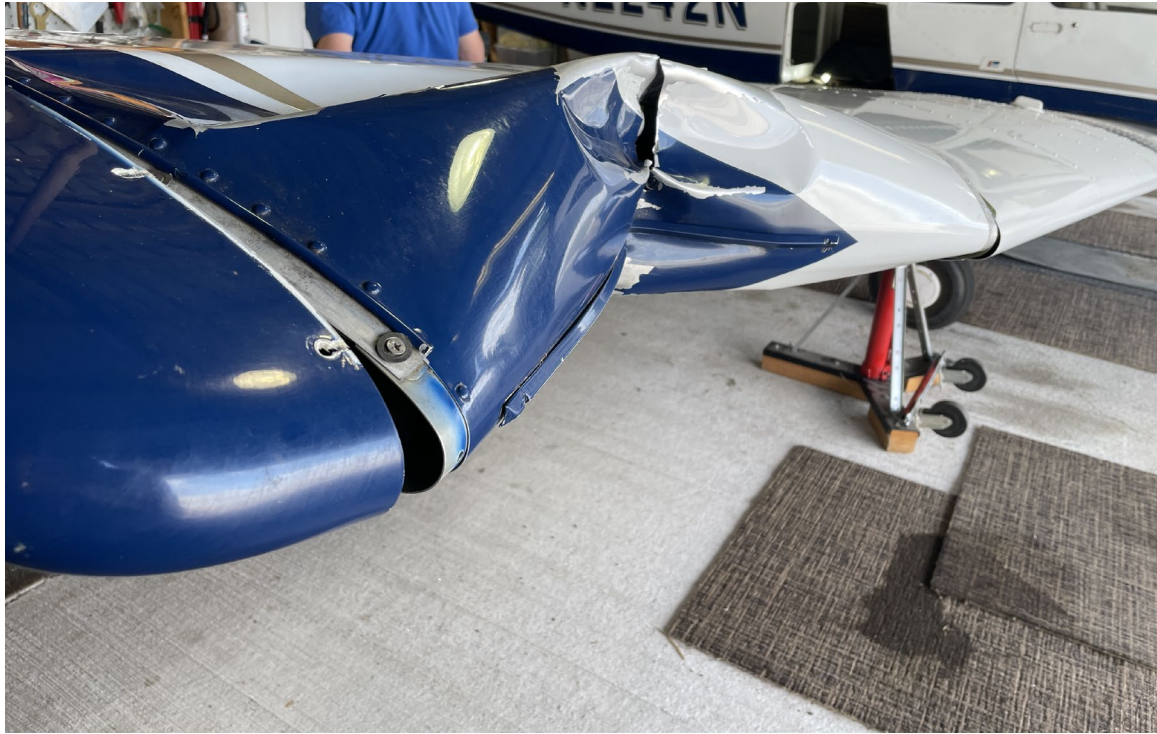
**Photograph 2 - Outboard right wing damage (Courtesy of Federal Aviation Administration)**
