# INSPECTION & MAINTENANCE RECORD

Model Sundowner

ENG. Lyc 0360 N# 18994 S/N M-1998

Beecolcraft M 1988 N 18 994  
ENGINE DESCRIPTION

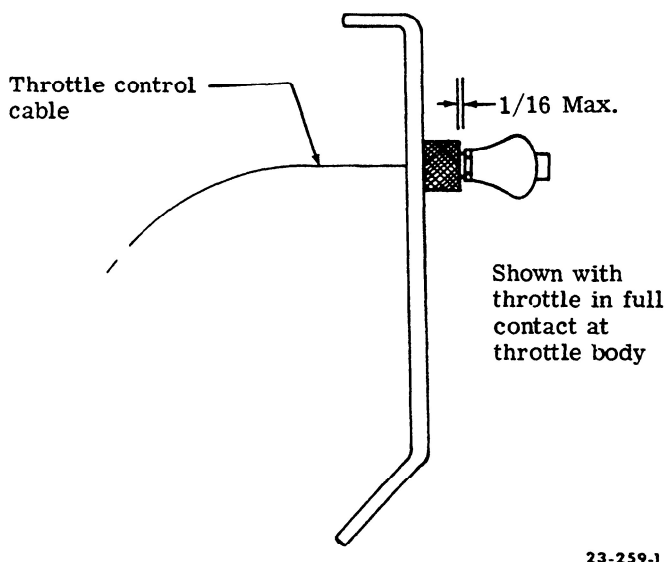
Figure 3-32. Throttle Rigging

control should be so rigged that, when the control is making full throttle contact at the throttle body, a maximum gap of 1/16 inch remains at the instrument panel (see Figure 3-32).
