## Air Safety Investigations Aircraft Incident/Accident Technical Report

| Aircraft Incident/<br>Accident Information | Year: 1977 | Make: Beechcraft | Model: C23 |
| | Serial number: M-1998 | | Registration: N18994 |
| Senior Air Safety Investigator: Casey J. Love | | Report #: ASI-23-CU-T | Report date: 04-01-24 |

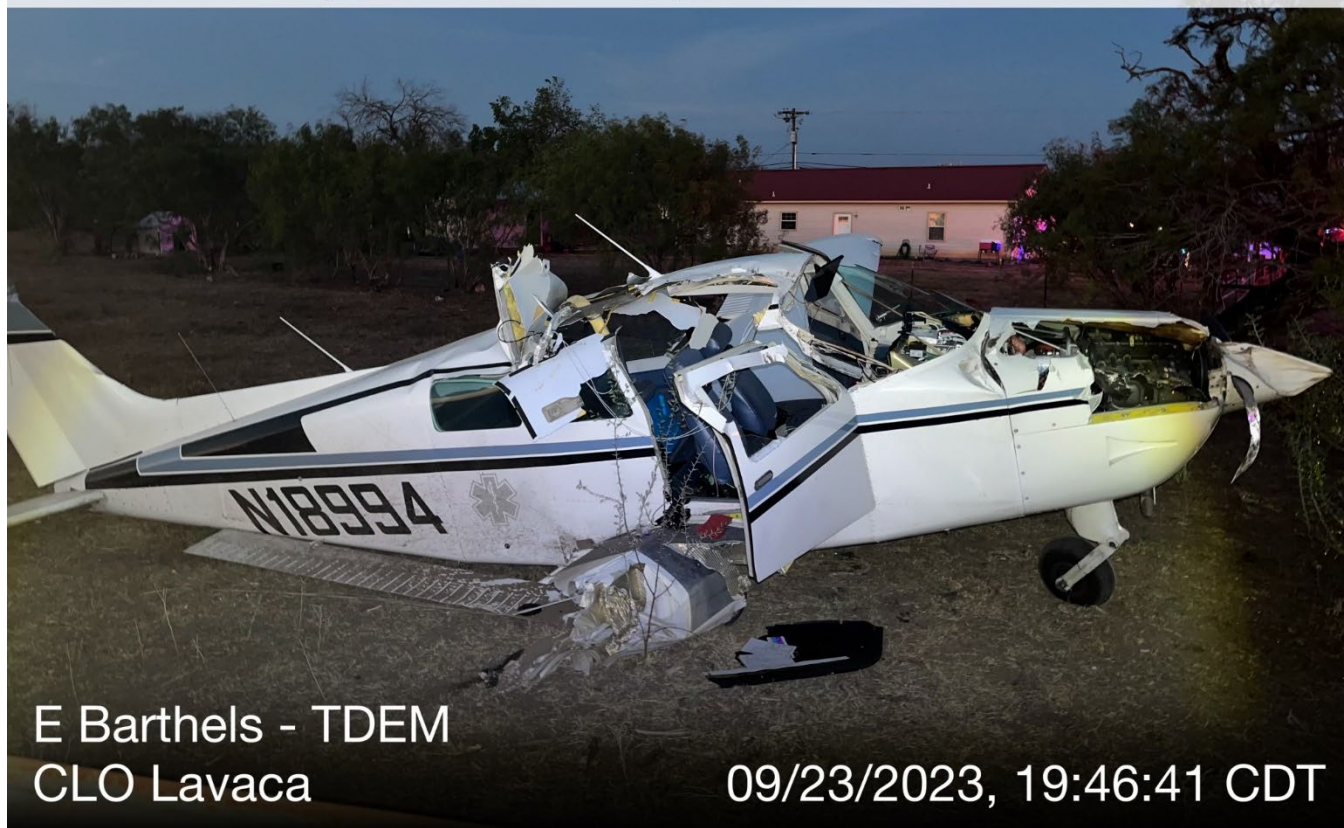
During the impact sequence the right wing was fracture separated at the wing root approximately two feet outboard of the wing attach fittings. The wing remained near the tree impact. The flap remained with the main wreckage. The right side of the cockpit and cowling sustained impact damage separating the upper cabin skin and deforming the cabin door and door post. The left wing was cut near the root by the recovery crew to facilitate transportation. The horizontal stabilator was removed for transportation.

Texas Department of Emergency Management Photograph (Wreckage Overview)

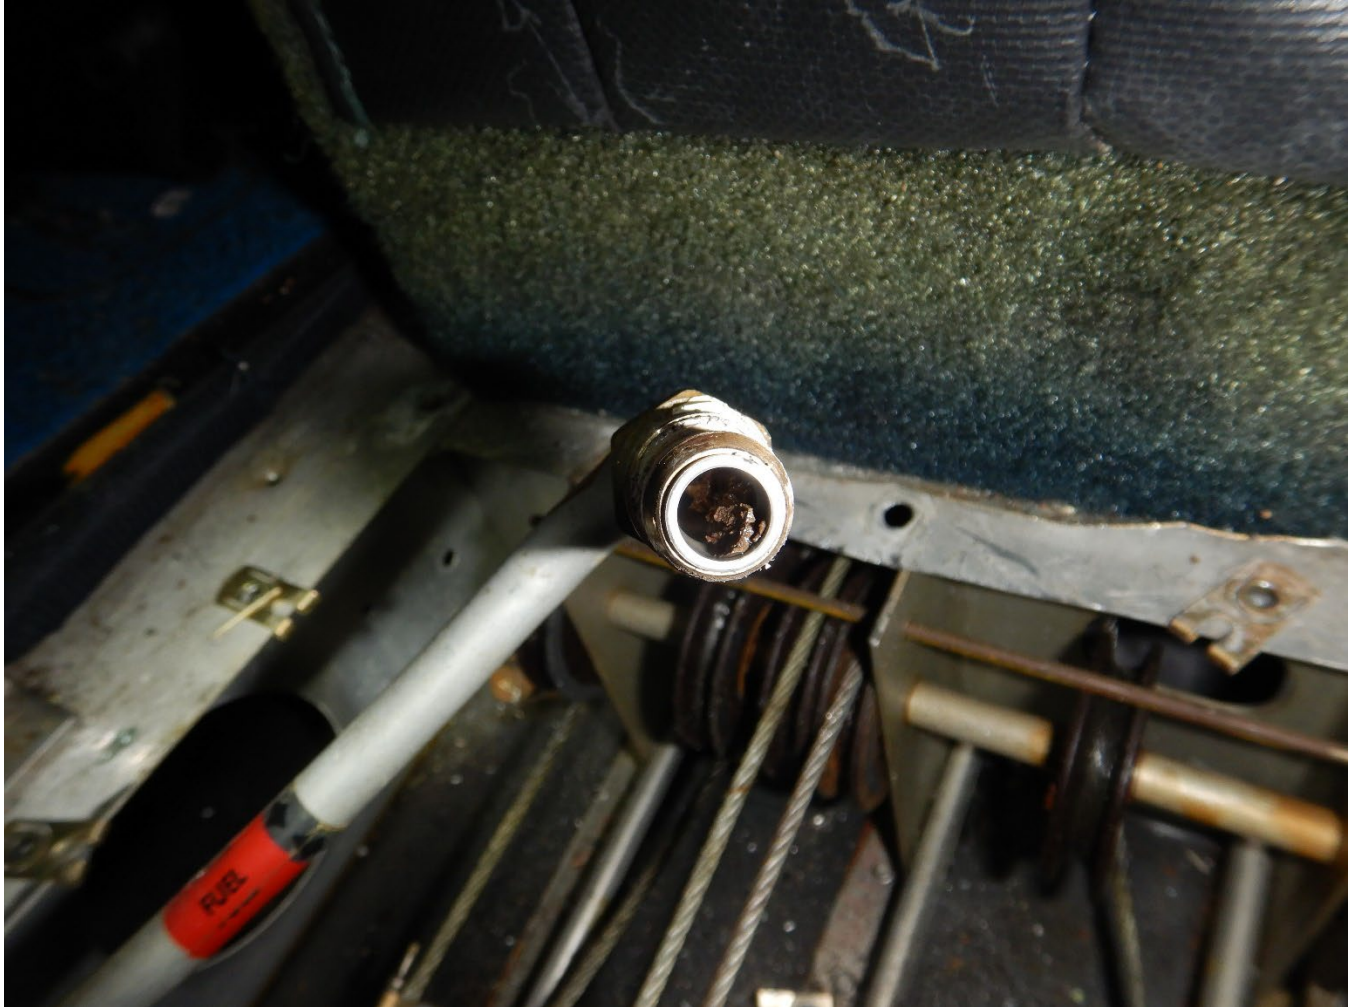
In the accident video provided by the pilot, the fuel quantity system read 40 gallons at the time of the accident. The right-wing fuel tank was breached during the accident sequence when the wing was impact separated. The left tank was breached along the leading edge a few inches inboard of the fuel cap location. In photographs taken by first responders, fuel can be seen in the left-wing tank. During the examination, the fuel strainer bowl was removed and found to contain slight debris and was reassembled for testing. The wing tank finger screens were free from obstructions. The fuel vent lines were examined by passing air and/or a flexible plastic cable through the lines. The right-wing fuel vent plumbing was fracture separated near the outboard rib. The vent system was determined to be free of obstructions. A fuel container with a hose attached was plumbed into each wing fuel outlet fitting at the wing root, one at a time. Fuel was then passed from each wing fitting through the fuel selector and fuel plumbing to the engine driven fuel pump and to the carburetor. The aircraft battery was connected to the airframe terminals and power was supplied to the main bus. The boost pump was satisfactorily tested for operation. There were no restrictions to fuel flow or leaks. The carburetor screen, the fuel strainer screen, and boost pump screen were all free of obstruction or contamination. The pilot reported turning the selector to OFF before exiting the aircraft. The fuel selector was removed and disassembled for examination and found to be in normal operating condition. The fuel lines from the fuel selector to the fuel strainer were all removed to inspect for obstructions. Slight debris was found in the left fuel line at the selector connection but did not obstruct flow during testing.

TAI Examination ASI-23-CU-050 (Left Fuel Line Debris)

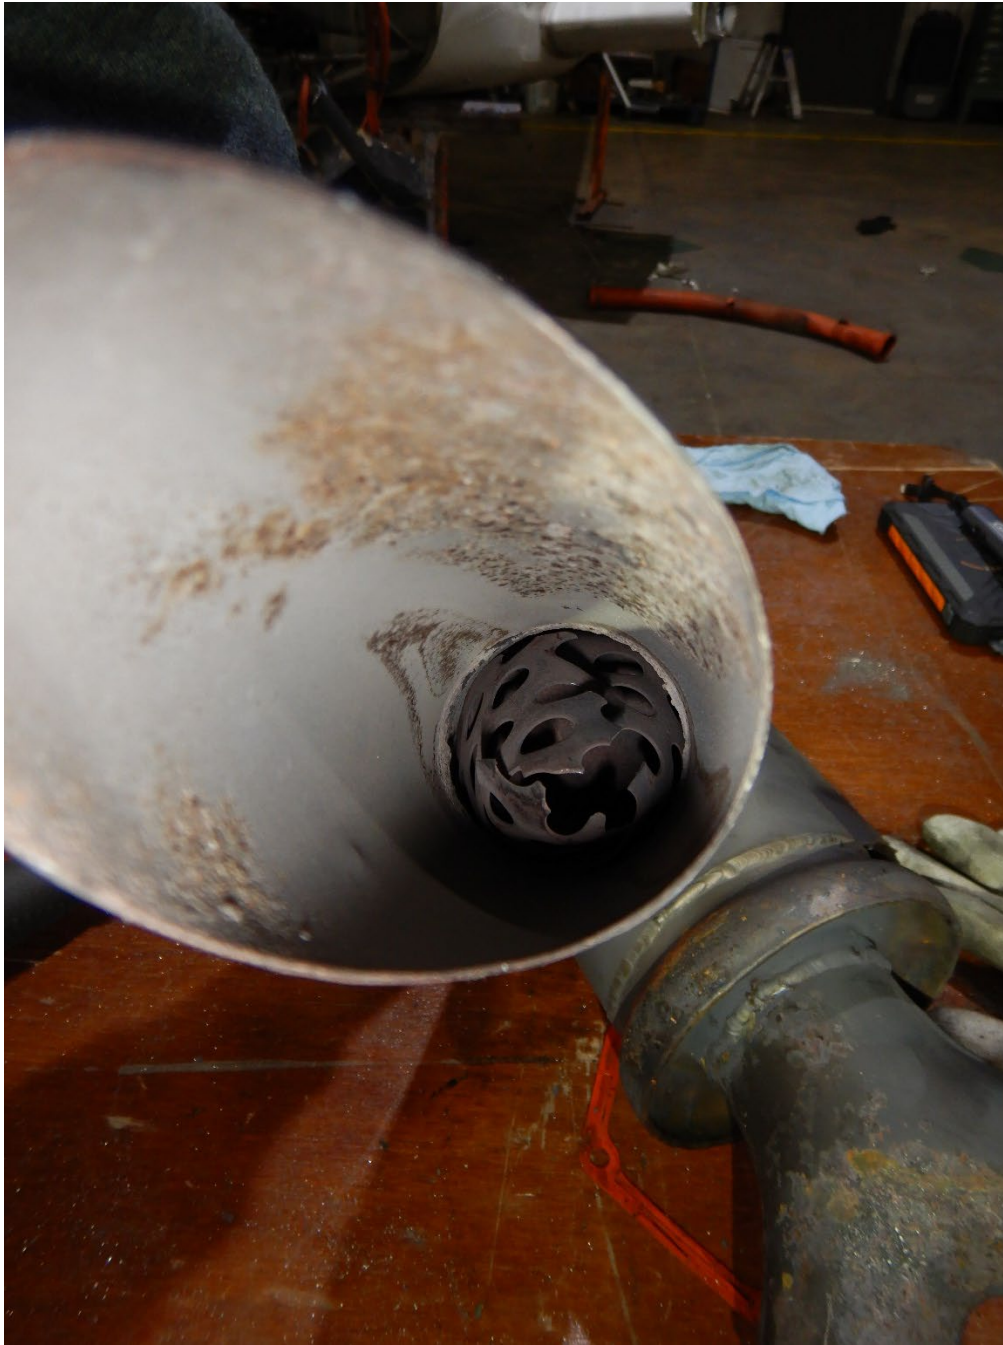
The left magneto had been replaced with a SureFly electronic magneto. Engine control continuity was established for throttle, mixture, and carburetor heat. The flame cone inside the muffler, adjacent to the left exhaust stack, was found lodged inside the tailpipe with the solid end portion of the cone facing upward, mostly obstructing the muffler tailpipe. The muffler was cut open for examination. The fracture surfaces of the cone were thin and rusted. The engine was examined by a Lycoming Engines investigator. He did not report any pre impact abnormalities other than the muffler that would prevent normal operation of the engine.

TAI Examination ASI-23-CU-059 (Exhaust Baffle Obstructing Exhaust Exit)

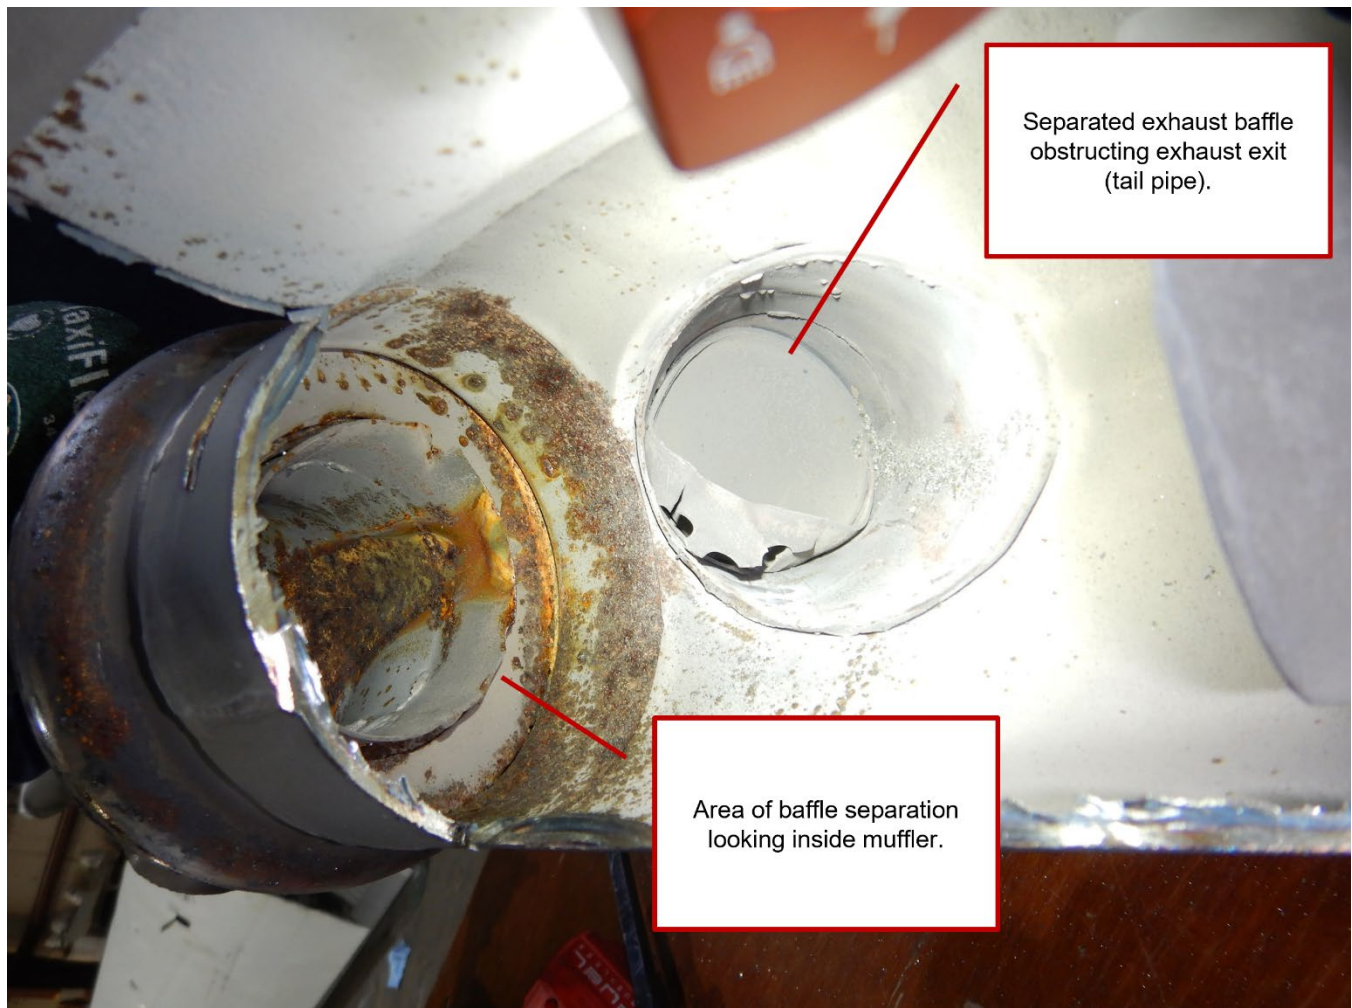
According to the NTSB, the muffler had been installed on the airplane for 504.84 hours. On March 21, 2000, the airplane's muffler was repaired and inspected by an exhaust system repair station. The work order for this muffler repair revealed that the muffler was to be inspected and repaired. The items replaced included: 3 tabs, the outer shell, 2 caps, 2 flame tubes, 2 elbows, 2 beaded ends, 2 end plates, and the tailpipe.

TAI Examination ASI-23-CU-057 (Rotated and Cropped) (Muffler Cut Open for Examination)

The exhaust muffler was retained by the NTSB for further examination. At the time this report was completed, further examination of the muffler was not completed.
