**Air Tractor, Inc.**  
Accident Investigation

**EXAMINATION NOTES**

**CEN23LA425**

**9/28/23**  
**Herington, KS**

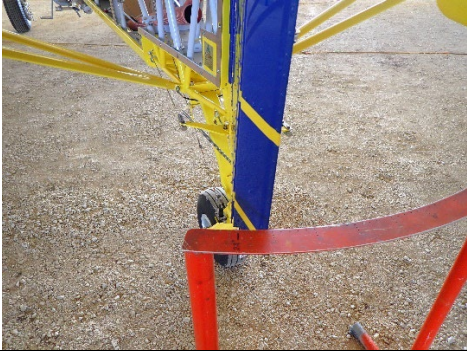
| A photograph showing the rudder of an airplane on a tarmac. A red curved line is drawn over the rudder to indicate its deflection angle to the left. | <p>Full rudder deflection to the left = <math>24^{\circ}</math></p> |

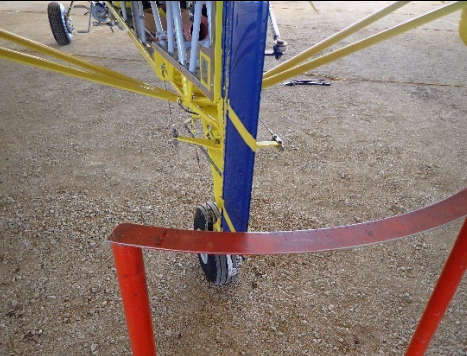
The main gear spring mounted brake lines were found separated at the fuselage fitting so that the brake system was open, and no pressure was developed when the brakes were depressed. The aft rudder pedals were found in the forward adjustment position. While keeping the brake pedals in the neutral position, the rudder pedals were found to move through the full range of motion. While keeping the rudder pedals in the neutral position, the brakes were found to move through the full range of motion. While holding full left rudder deflection, the left brake pedal motion was found to be restricted by the upper spray valve pushrod.

| A photograph showing the rudder of an airplane on a tarmac. A red curved line is drawn over the rudder to indicate its deflection angle to the left. | <p>With brake fully depressed, rudder deflection = <math>17^{\circ}</math></p> |

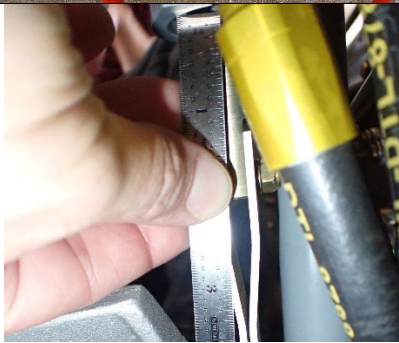
| A close-up photograph of a hand holding a ruler to measure the distance between a master cylinder and a pedal attach plate. The measurement is approximately 1 1/4 inches. | <p>Without input, the measurement between the master cylinder and the pedal attach plates was found to be <math>1 \frac{1}{4}''</math></p> |

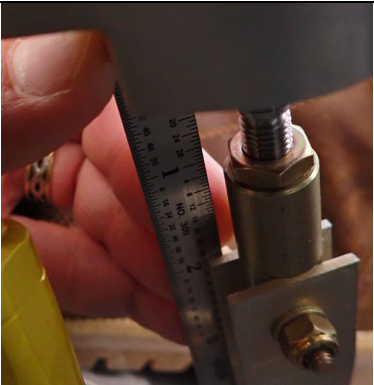
| A close-up photograph of a hand holding a ruler to measure the distance between a master cylinder and a pedal attach plate. The measurement is approximately 1 31/32 inches. | <p>With rudder in near neutral position and brake pedal fully depressed, the distance between the master cylinder and pedal attach plates was measured to be <math>1 \frac{31}{32}''</math></p> |

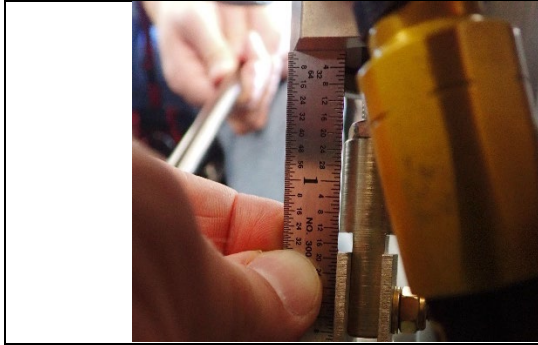
With the rudder fully depressed, and the pedal against the spray valve pushrod, the distance between the master cylinder and pedal attach plates measured  $1 \frac{9}{16}$
