CEN23LA425

## INVESTIGATION PHOTOGRAPHS

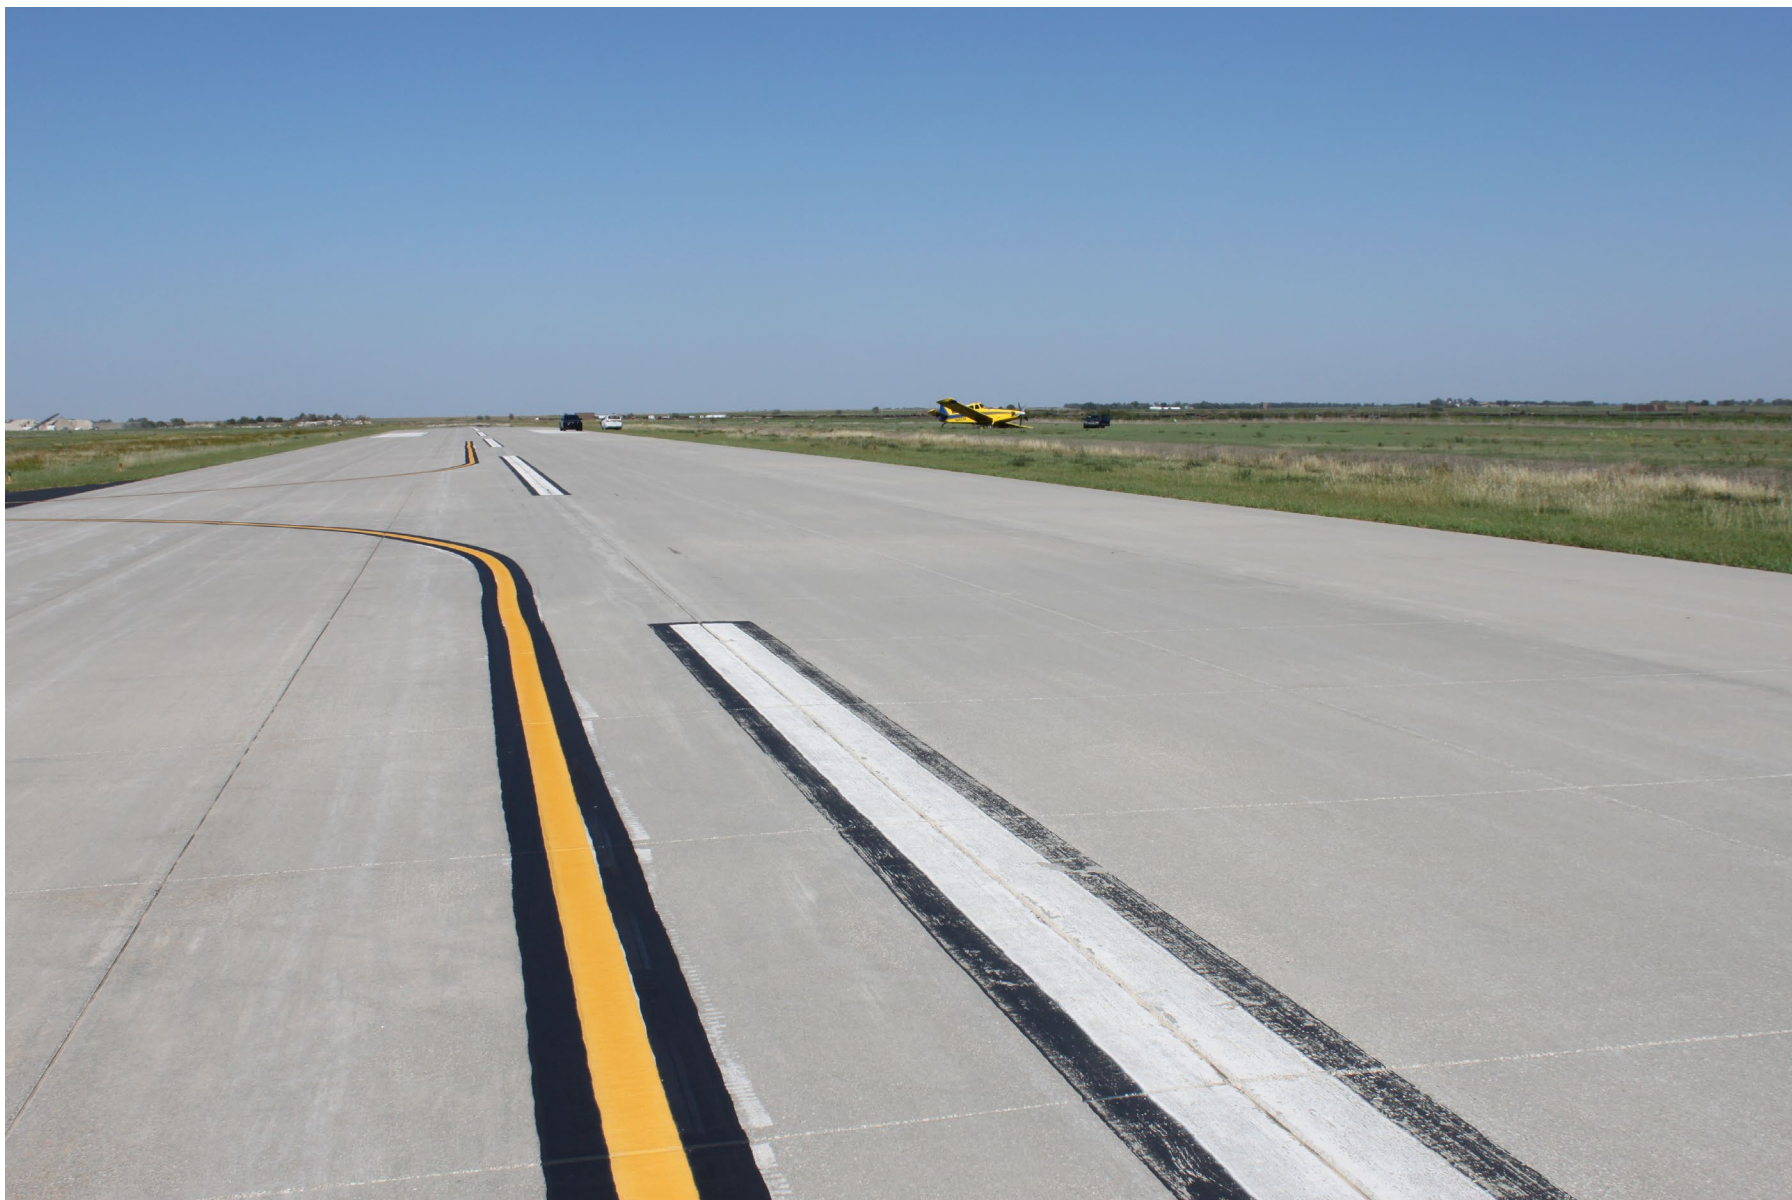
**Photograph 1 - Accident site viewed from runway (Courtesy of FAA)**

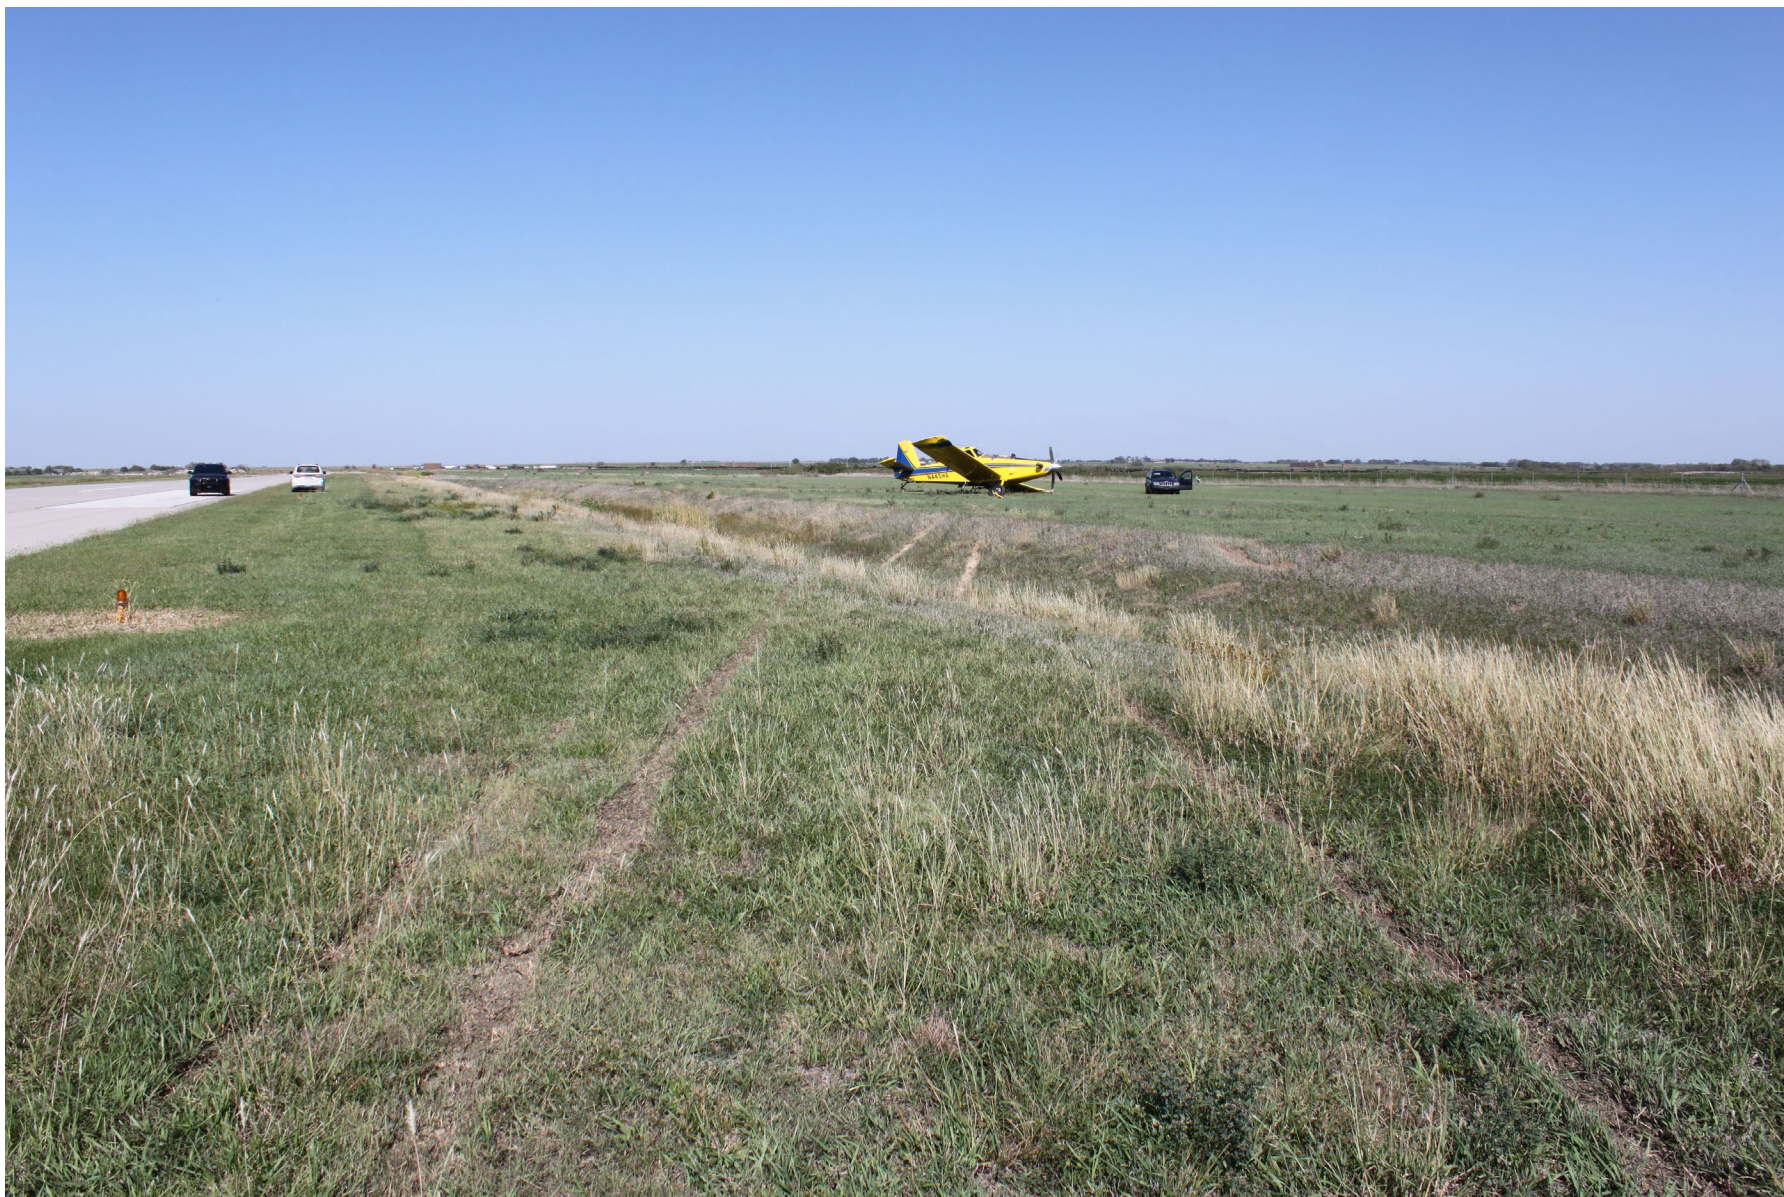
**Photograph 2 - Tire track leading to airplane (Courtesy of FAA)**

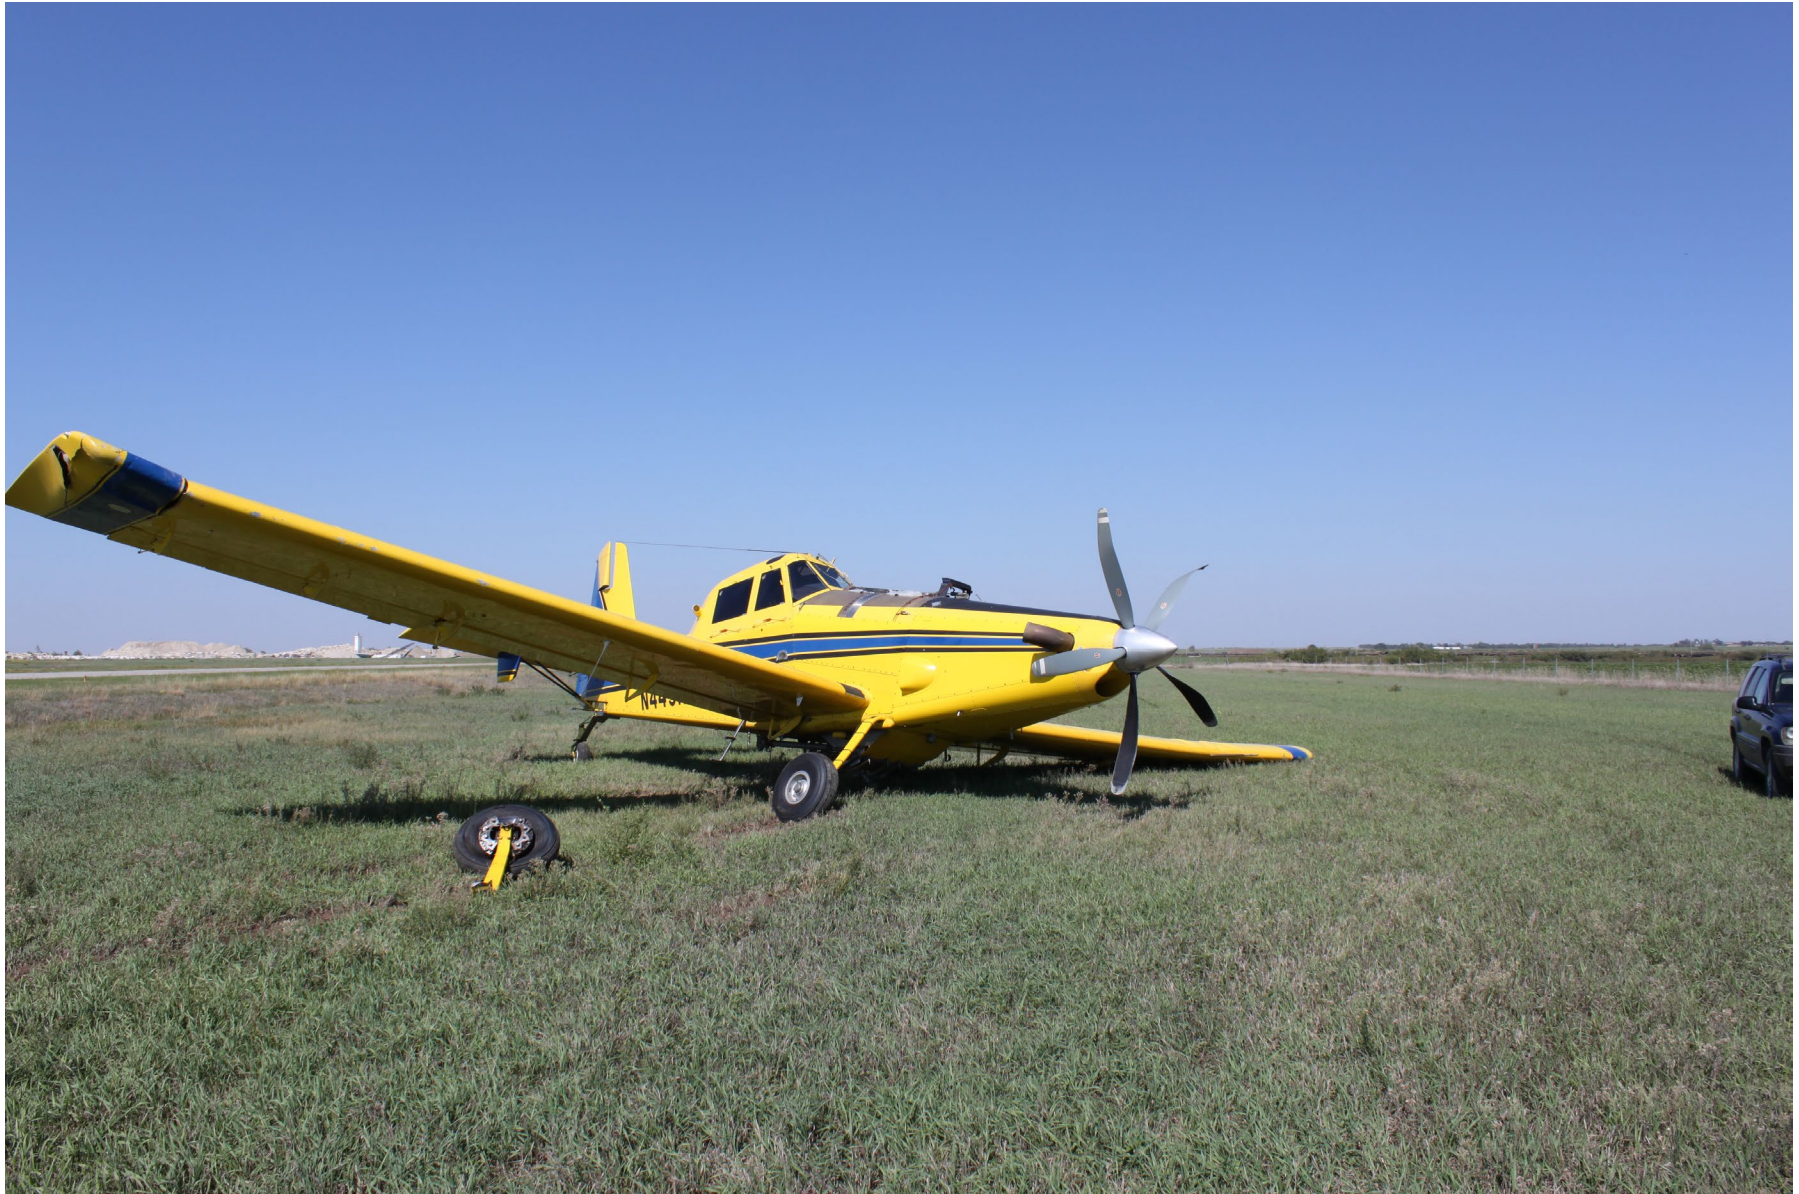
**Photograph 3 - Accident airplane, right side (Courtesy of FAA)**

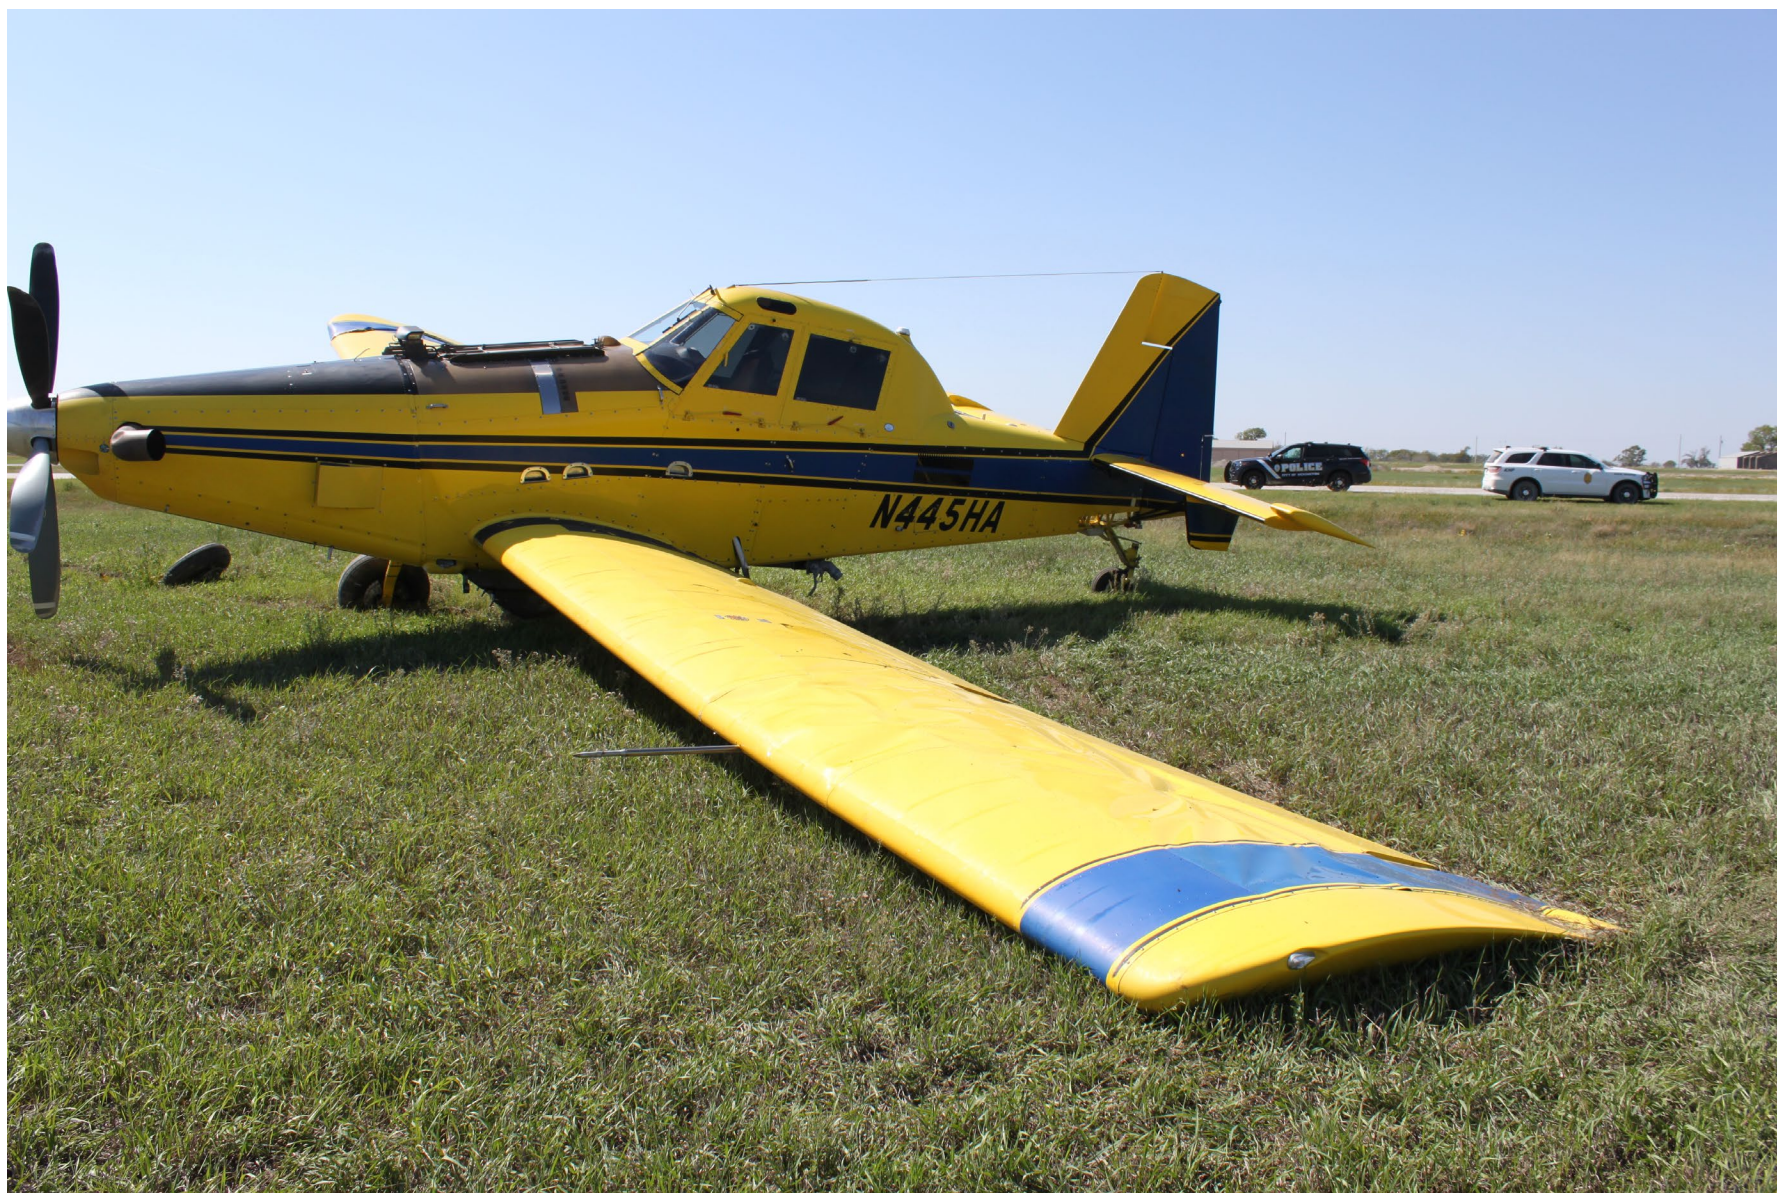
**Photograph 4 - Accident airplane, left side (Courtesy of FAA)**

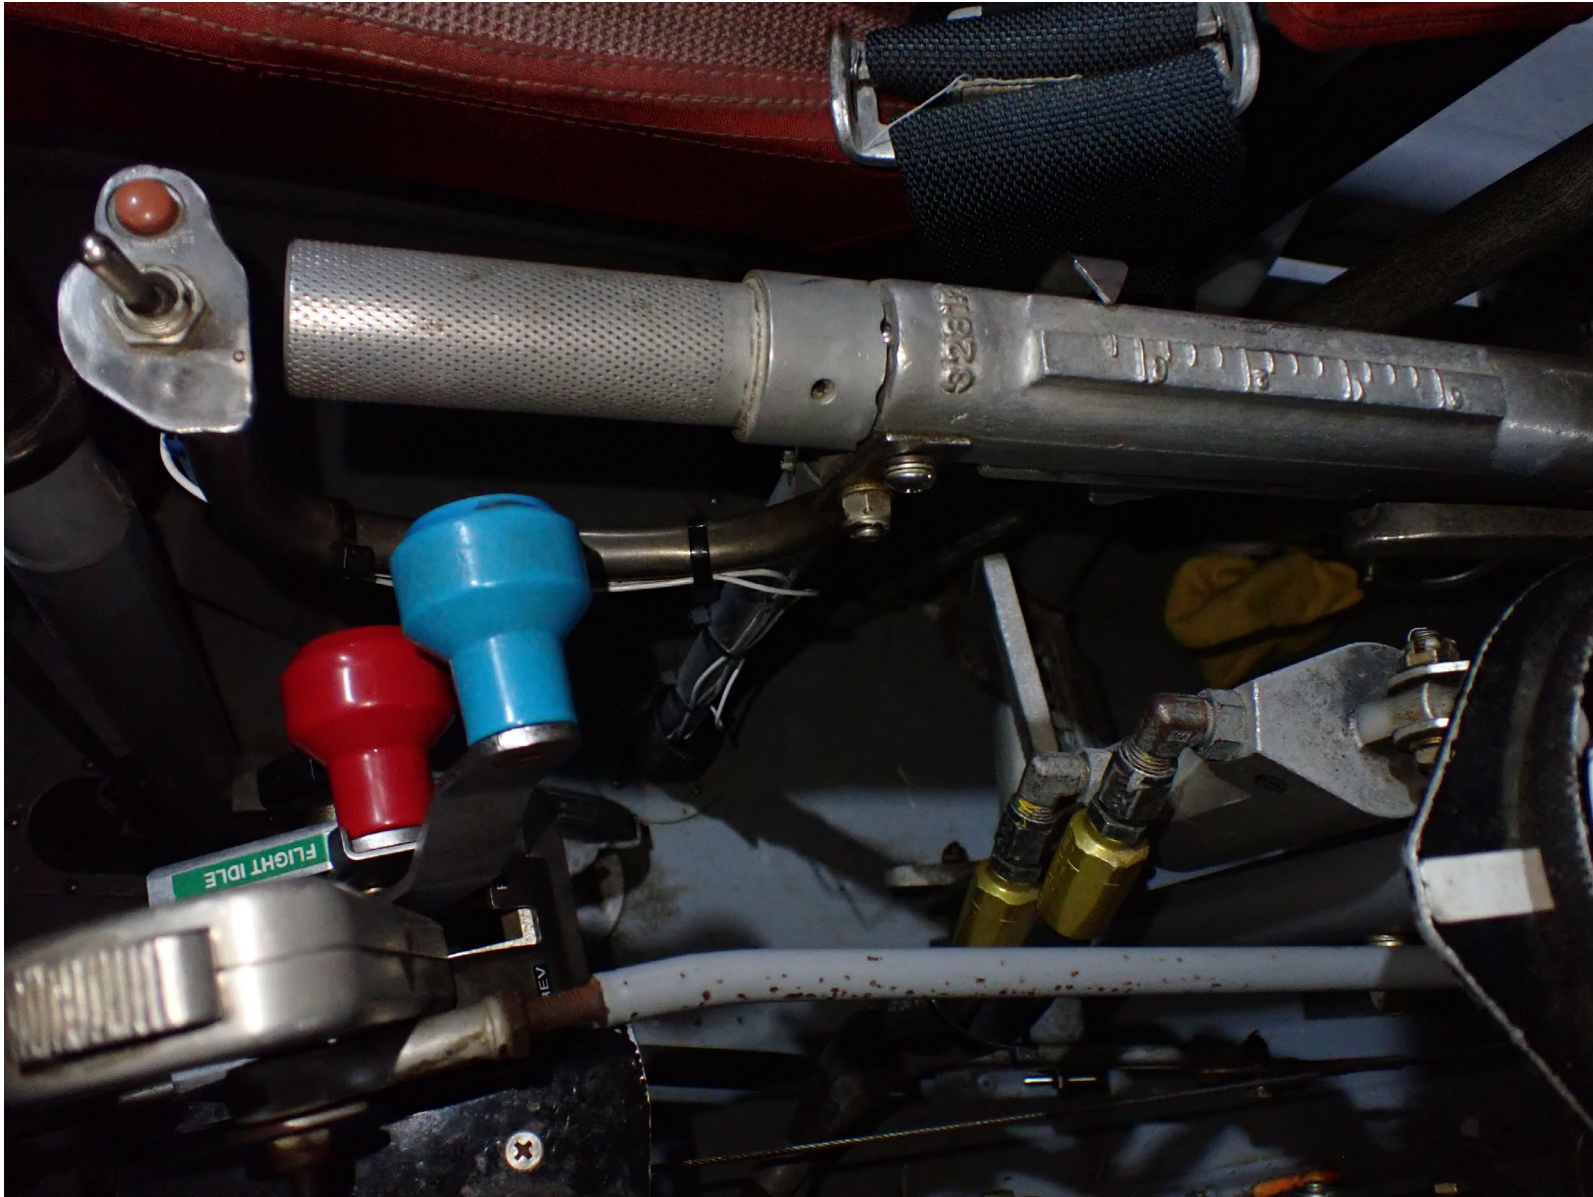
**Photograph 5 - Spray valve control lever (Courtesy of Air Tractor)**

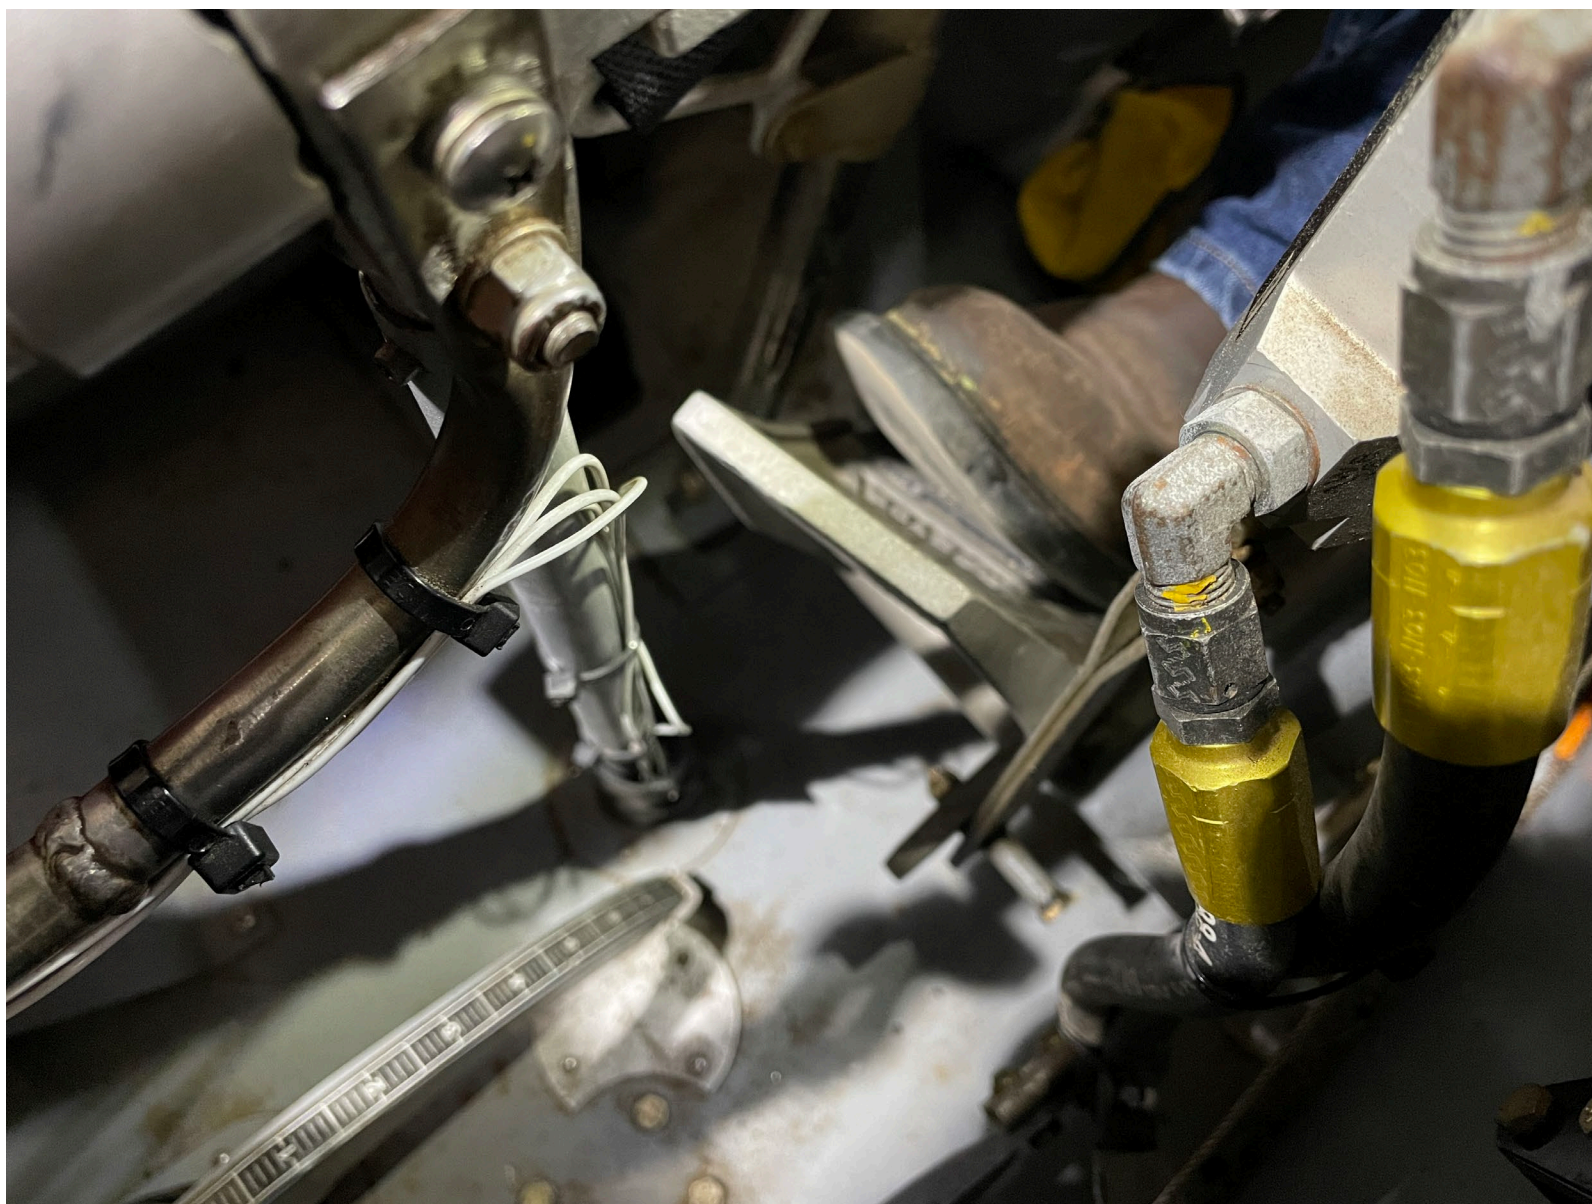
**Photograph 6 - Spray valve lever and rudder pedal (Courtesy of NTSB)**

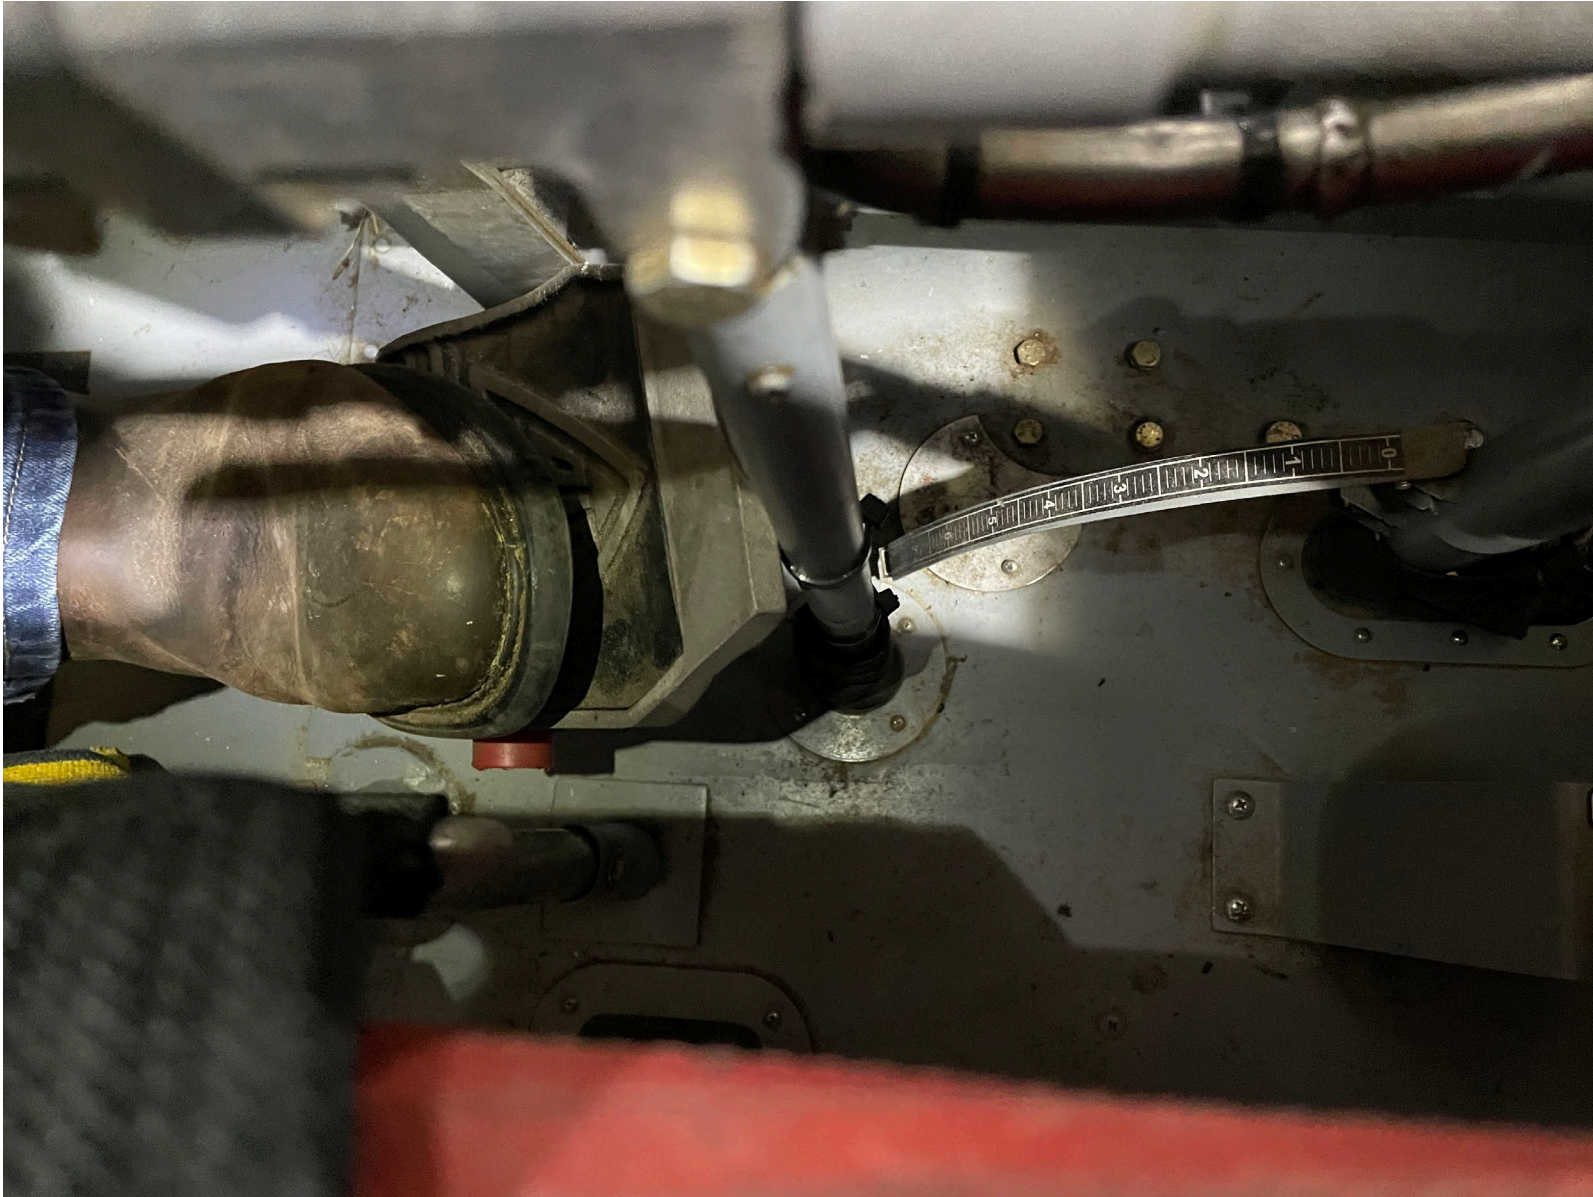
**Photograph 7 - Spray valve pushrod and rudder pedal (Courtesy of NTSB)**

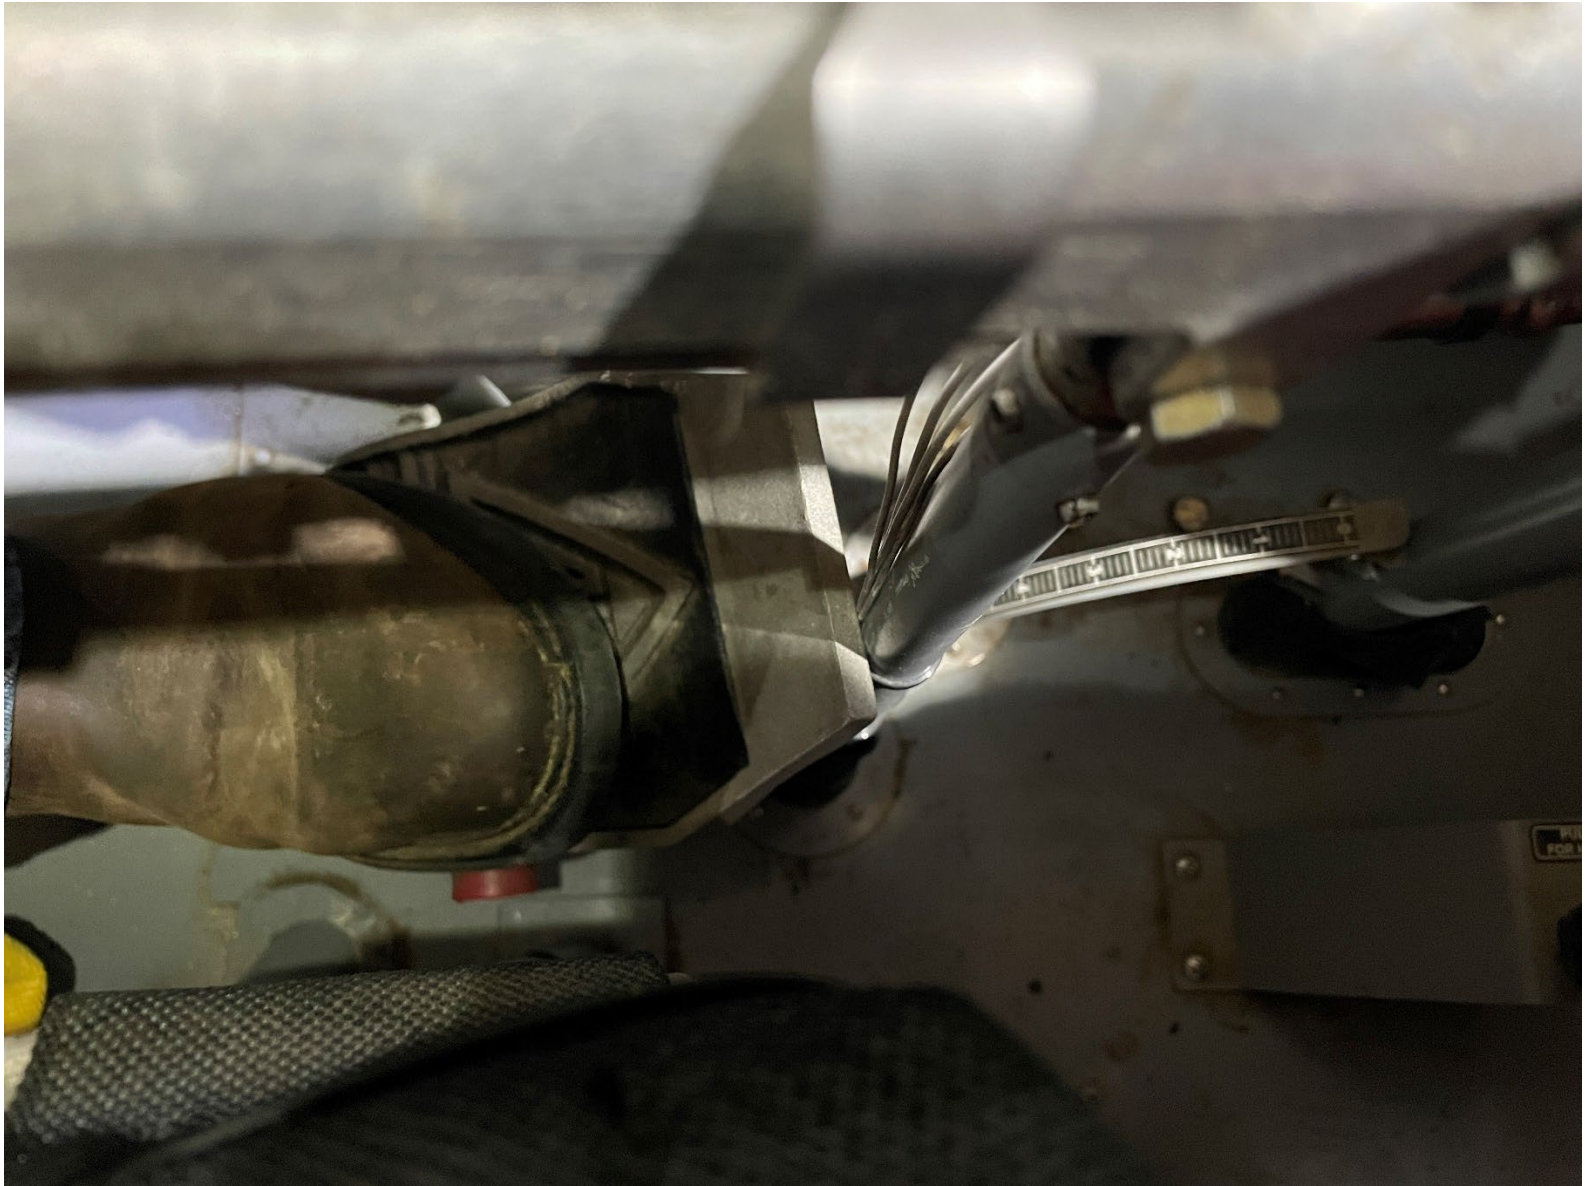
**Photograph 8 - Spray valve pushrod and rudder pedal (Courtesy of NTSB)**

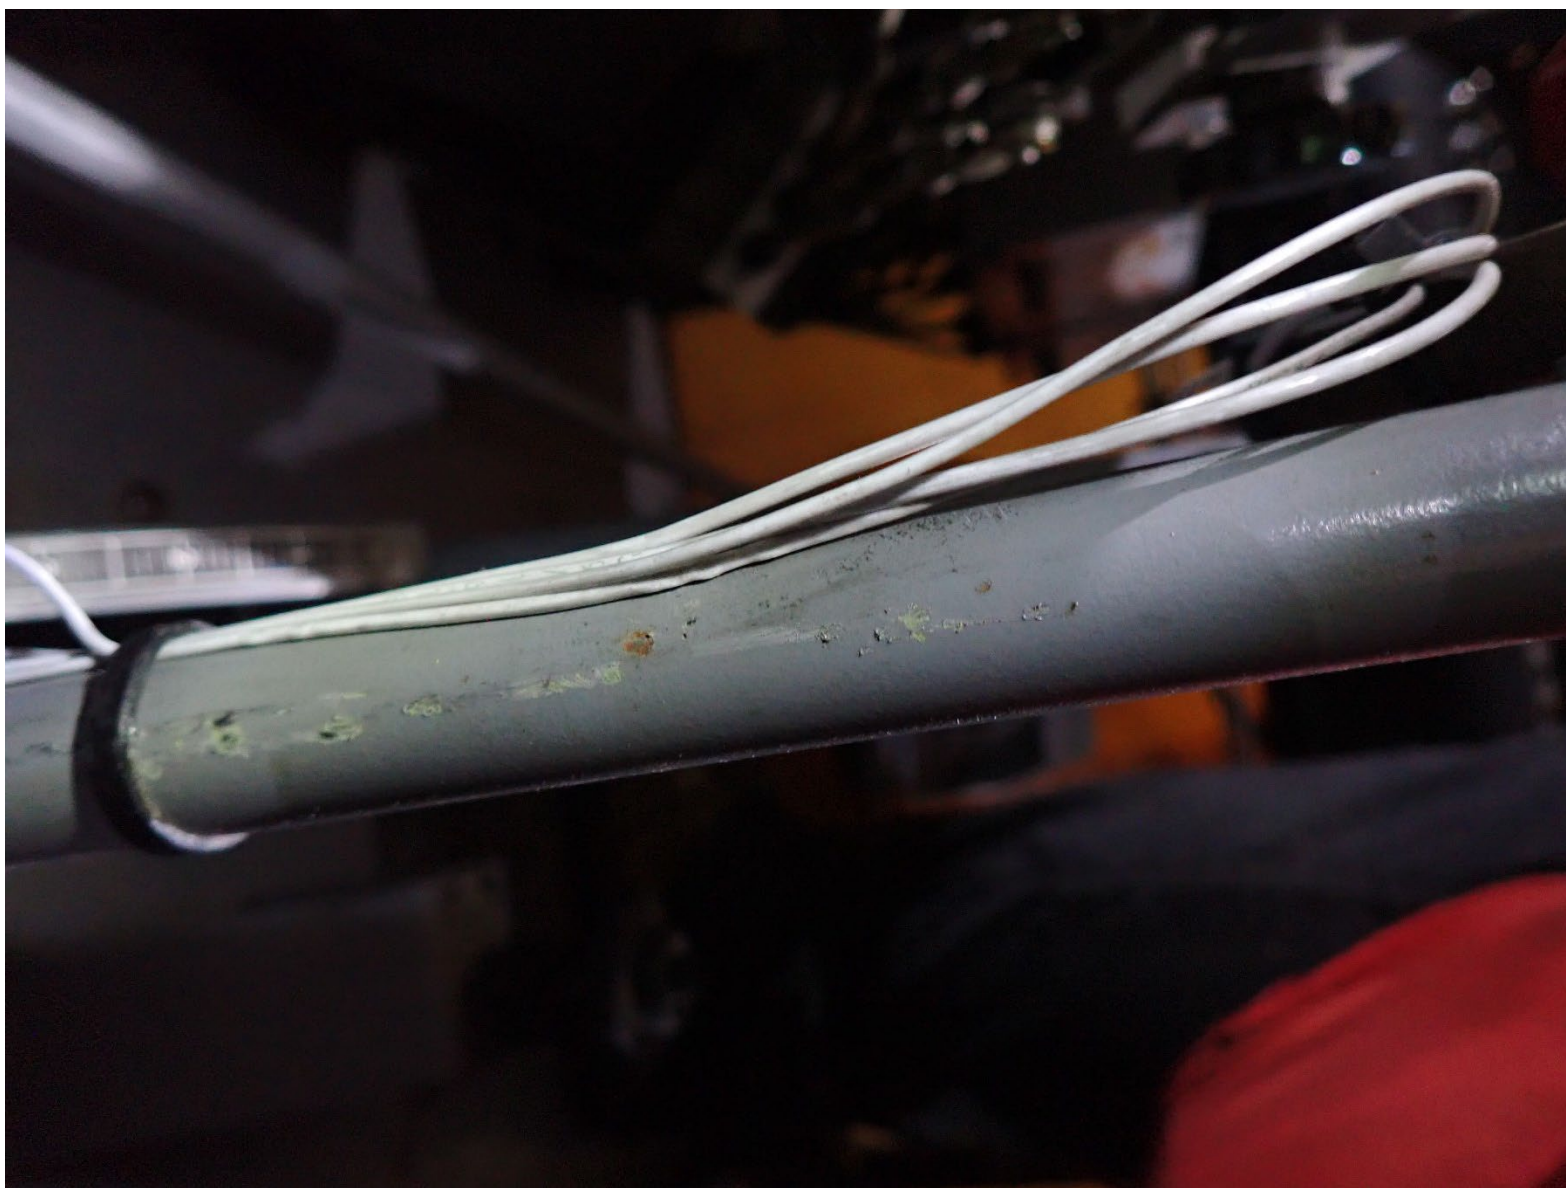
**Photograph 9 - Spray valve pushrod scrapes (Courtesy of Air Tractor)**
