# National Transportation Safety Board

CEN22MA034

## **AIRWORTHINESS**

Group Chair's Factual Report

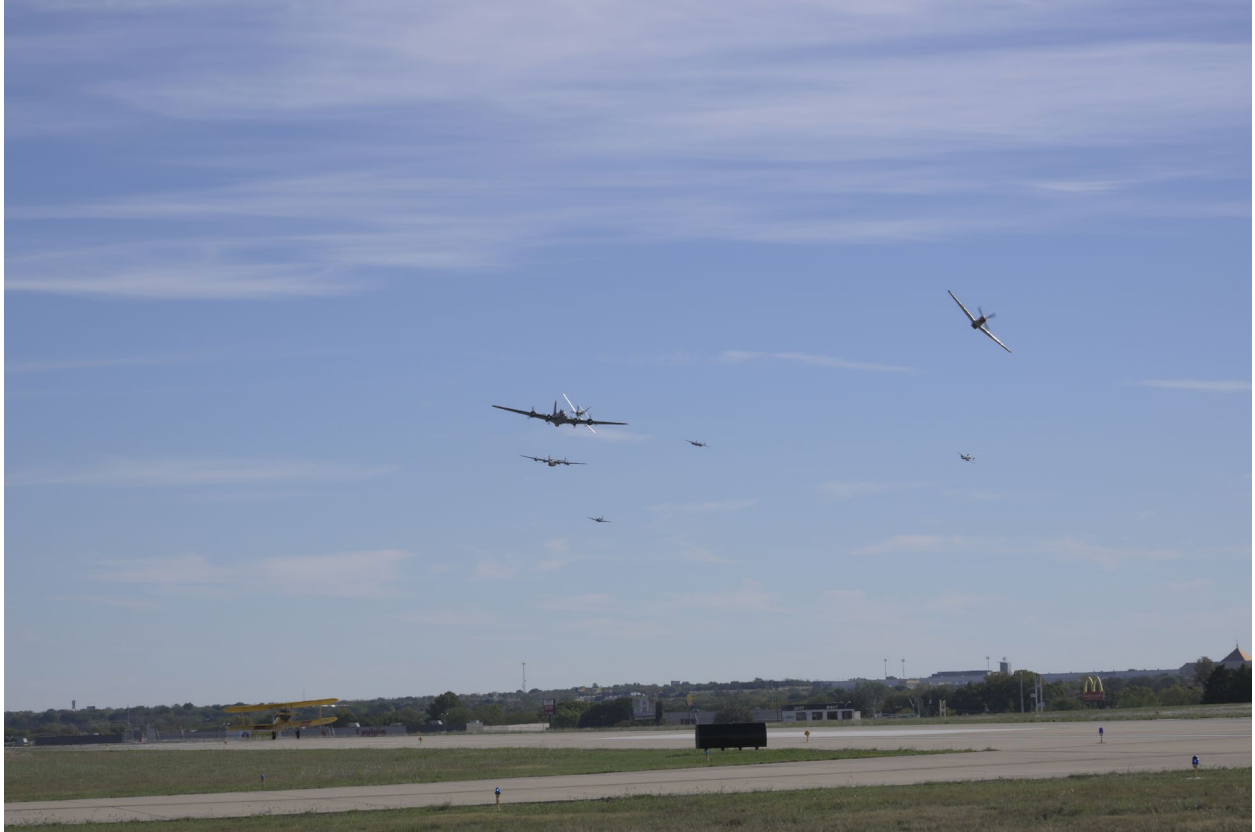
Photographic and video evidence provided showed that the P-63F airplane impacted the aft fuselage of the B-17G airplane from the aft, left side near the trailing edge of the left wing (Figures 3, 4, and 5). The B-17G was in a left bank about 10° and the P-63F was in a left bank about 53° immediately before the collision. Following the collision, both airplanes broke up in-flight and impacted the ground. See the Airworthiness Image Review in the public docket for additional pre- and post-collision photos.

**Figure 3.** Airplanes prior to collision showing bank angles (photo from CAF-David Walsh)

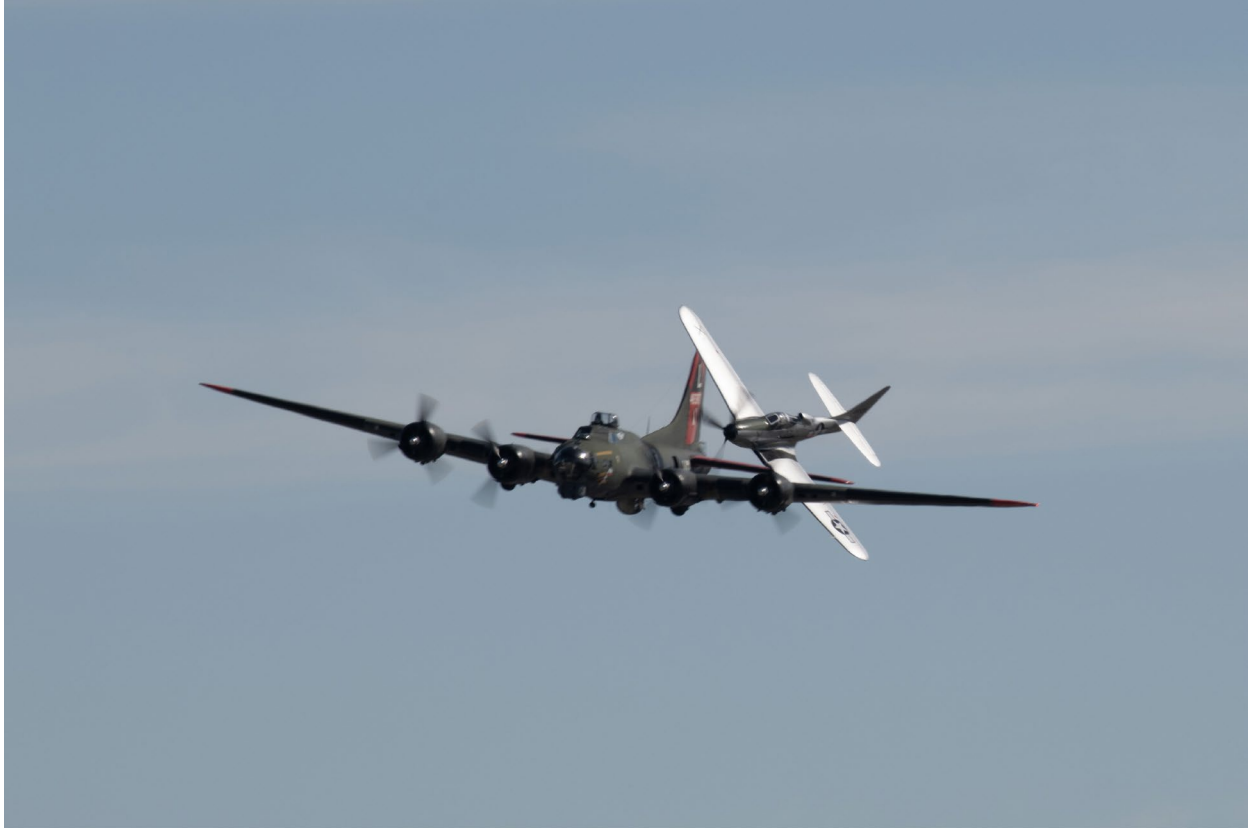
**Figure 4.** Airplanes prior to collision from front left (photo from CAF-Dylan Phelps)

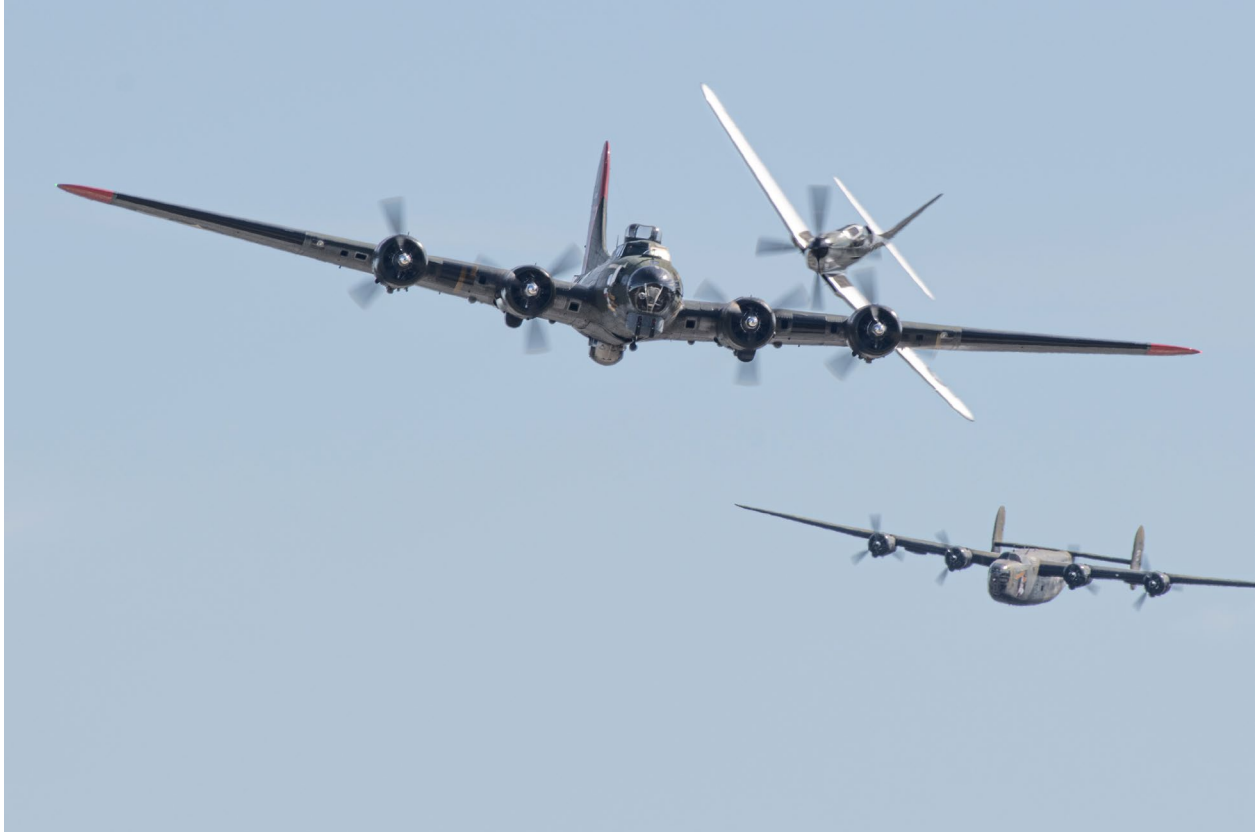
**Figure 5.** Airplanes prior to collision from front right (photo from CAF-Gary Daniels)
