# National Transportation Safety Board

CEN24FA024

## **AIRPLANE EXAMINATION**

Location: Manitowoc, WI  
Date: 10/25/2023  
Time: 1829:29 CDT  
2329:29 UTC  
Airplane: Amateur-Built Lancair 320, N320P

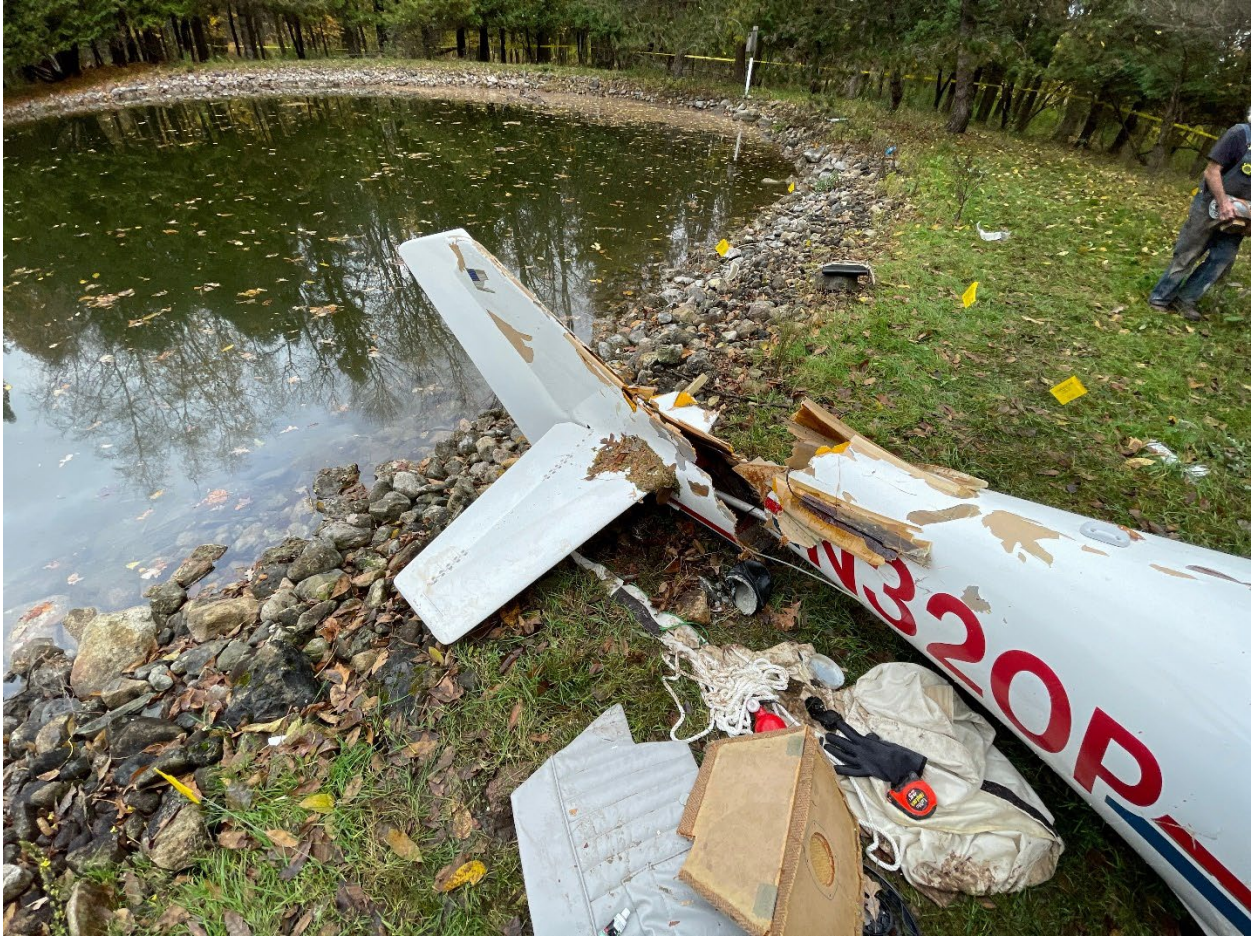
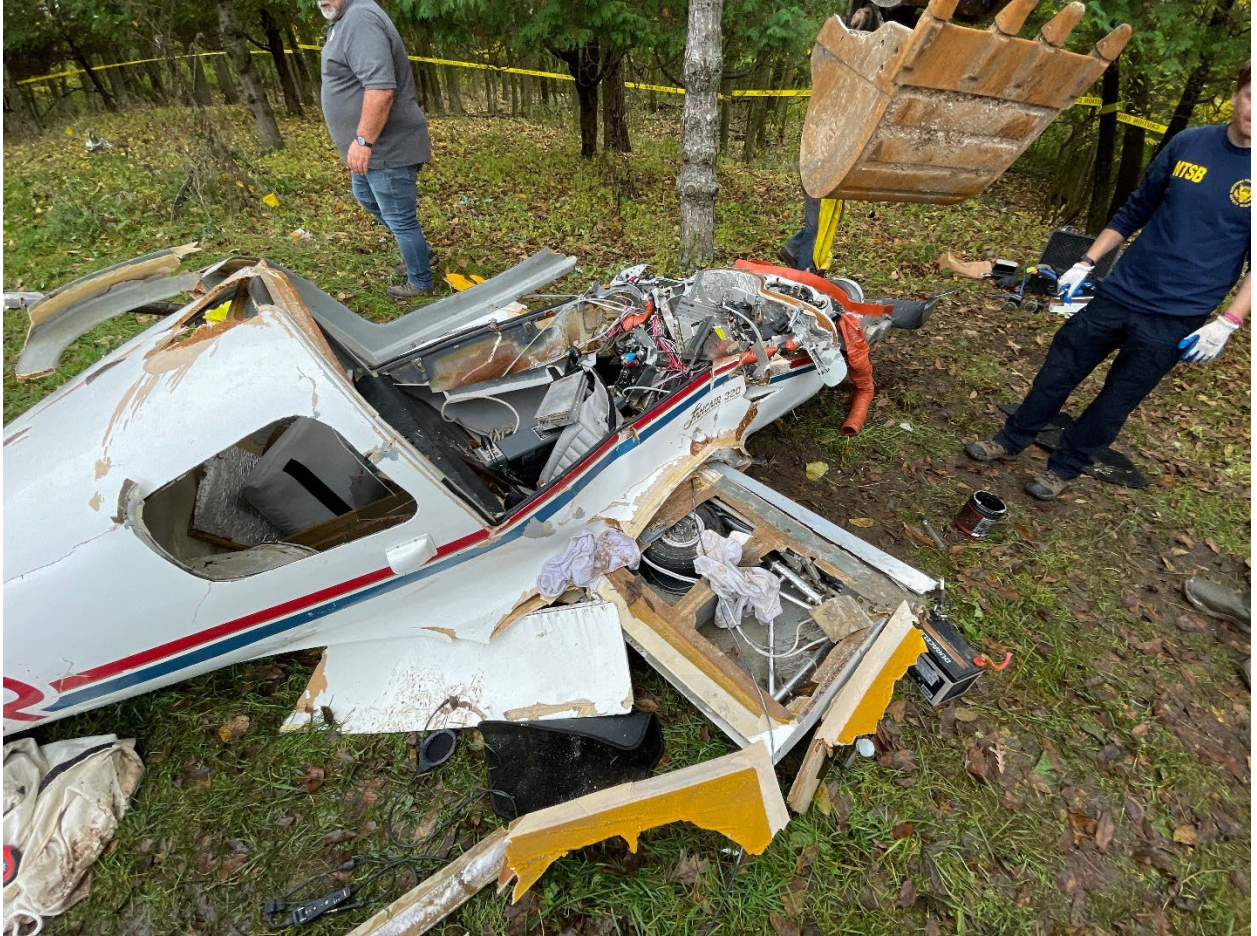
Once removed from the lake, the airframe was examined. The fuselage was broken into 2 pieces at a location just forward of the empennage. The broken tail piece remained partially attached to the forward fuselage by the rudder cables and elevator pushrod. The canopy frame was fractured but portions remained attached to the fuselage. Pieces of the canopy transparency were found in various locations around the lake shore. The forward fuselage was fractured but remained predominately intact.

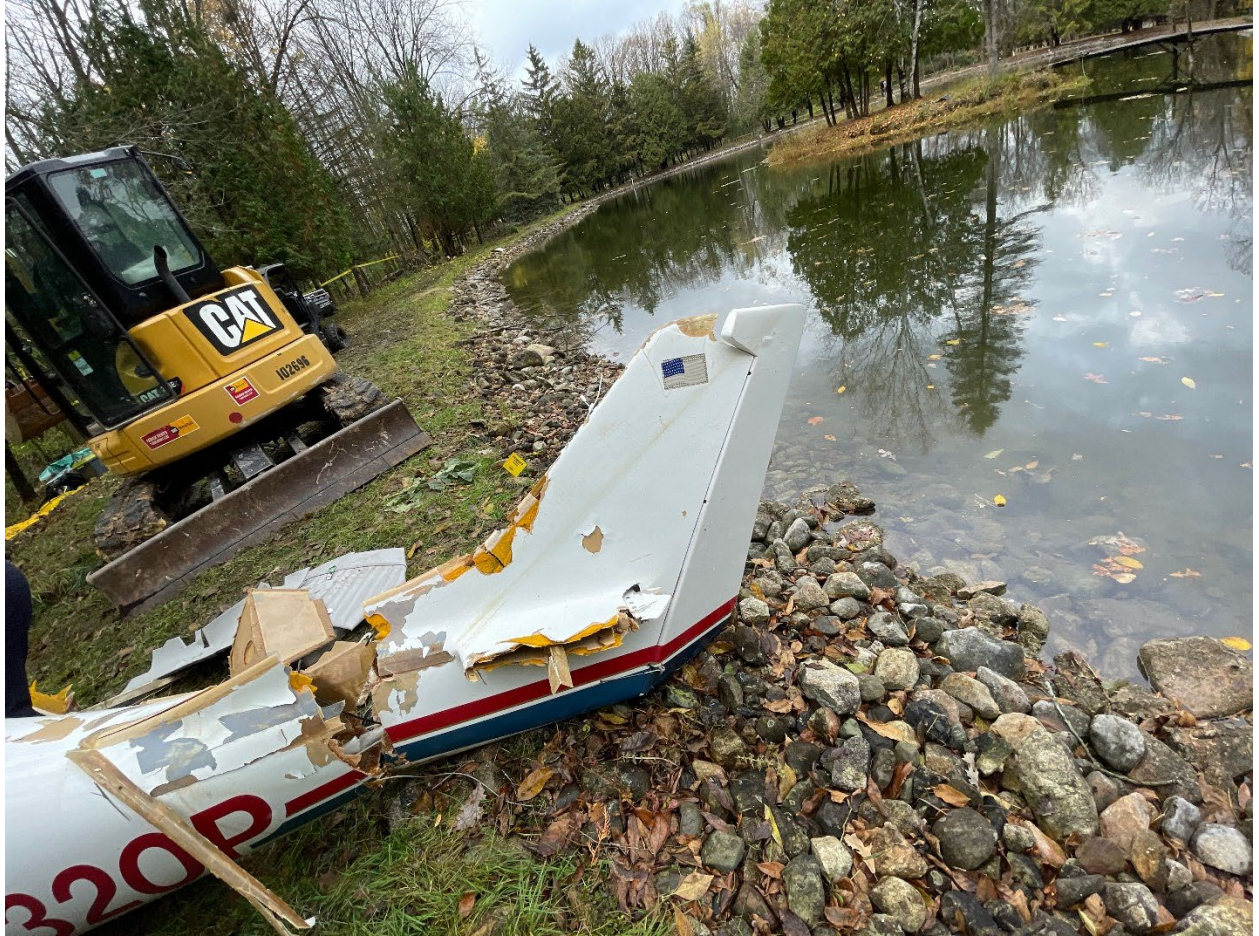
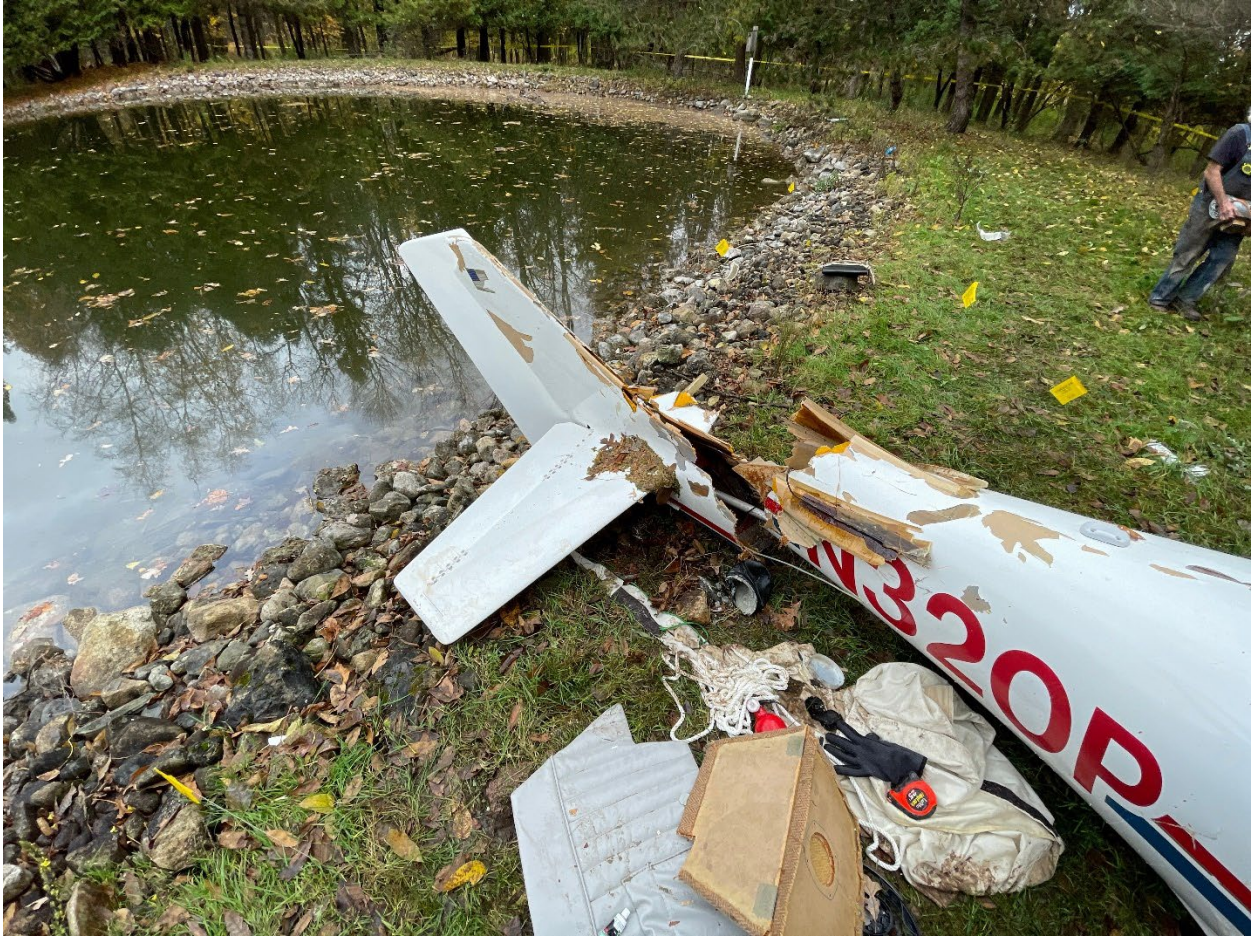
The vertical tail and rudder were intact and remained attached to the aft fuselage. All rudder hinges were intact. The right horizontal tail and elevator were intact, and all hinges were intact. The left horizontal stabilizer and elevator were separated at a point just outboard of the fuselage. Portions of the separated horizontal and elevator, including the stabilizer and elevator tips were found along the lake shore. The hinges were intact.

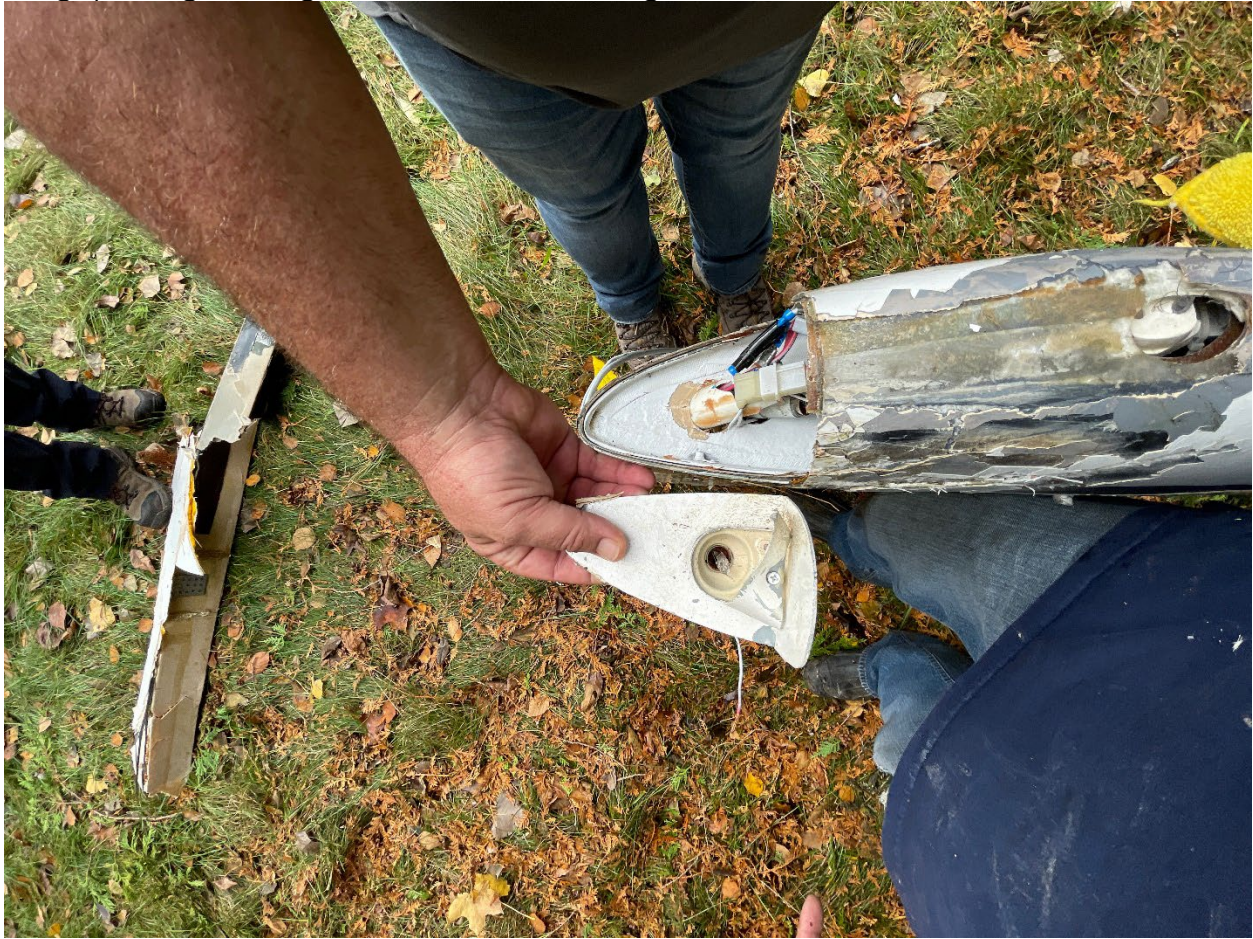
A portion of the right outboard wing main spar remained attached to the stub wing spar. The right wing outboard of the stub wing was fragmented. The right

wingtip navigation light was found at the edge of the lake.

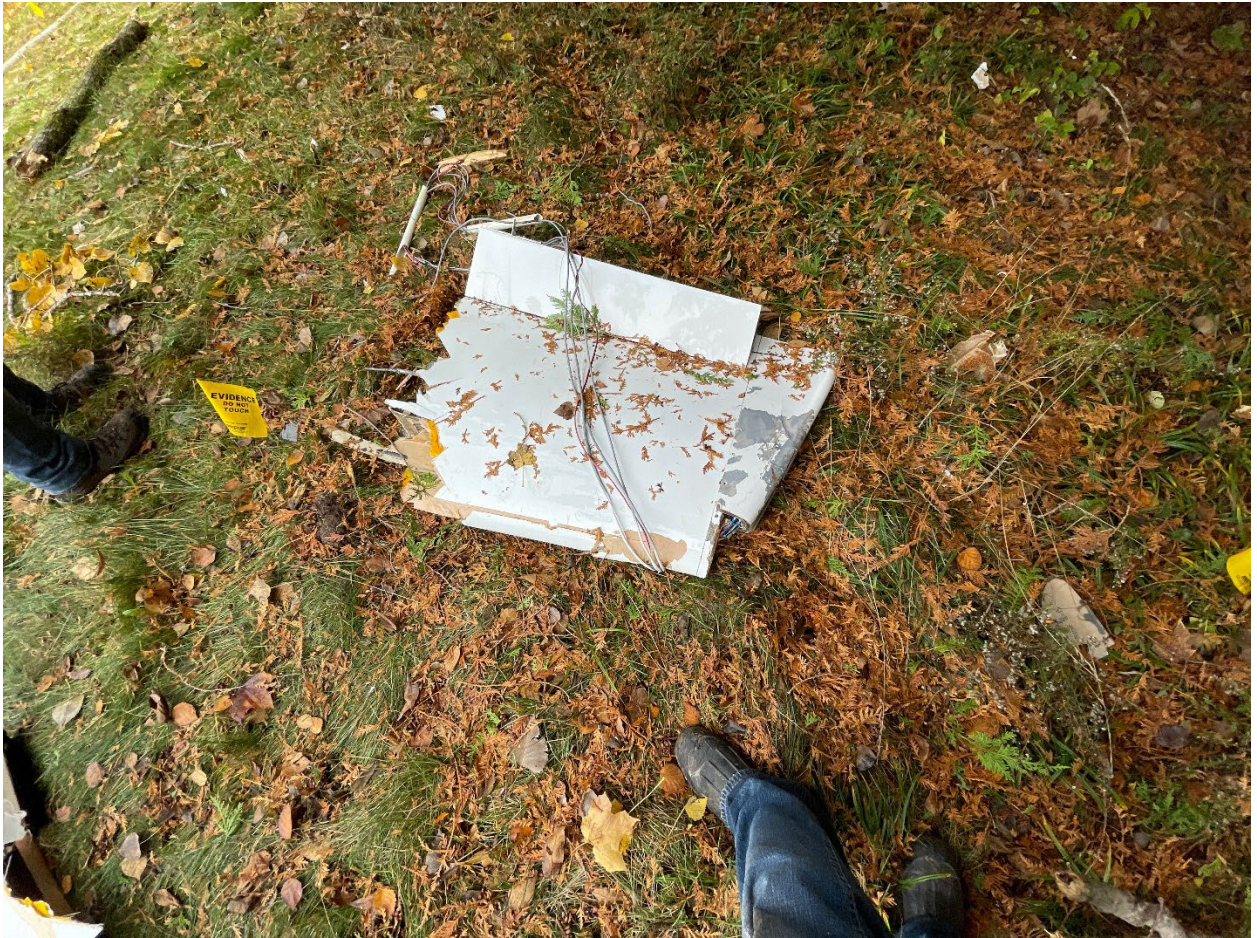
A portion of the left outboard wing main spar remained attached to the stub wing spar. The left wing outboard of the stub wing was fragmented. The left wingtip from about 2 feet inboard of the tip was found along the lake shore. The left navigation light was found in the wingtip.

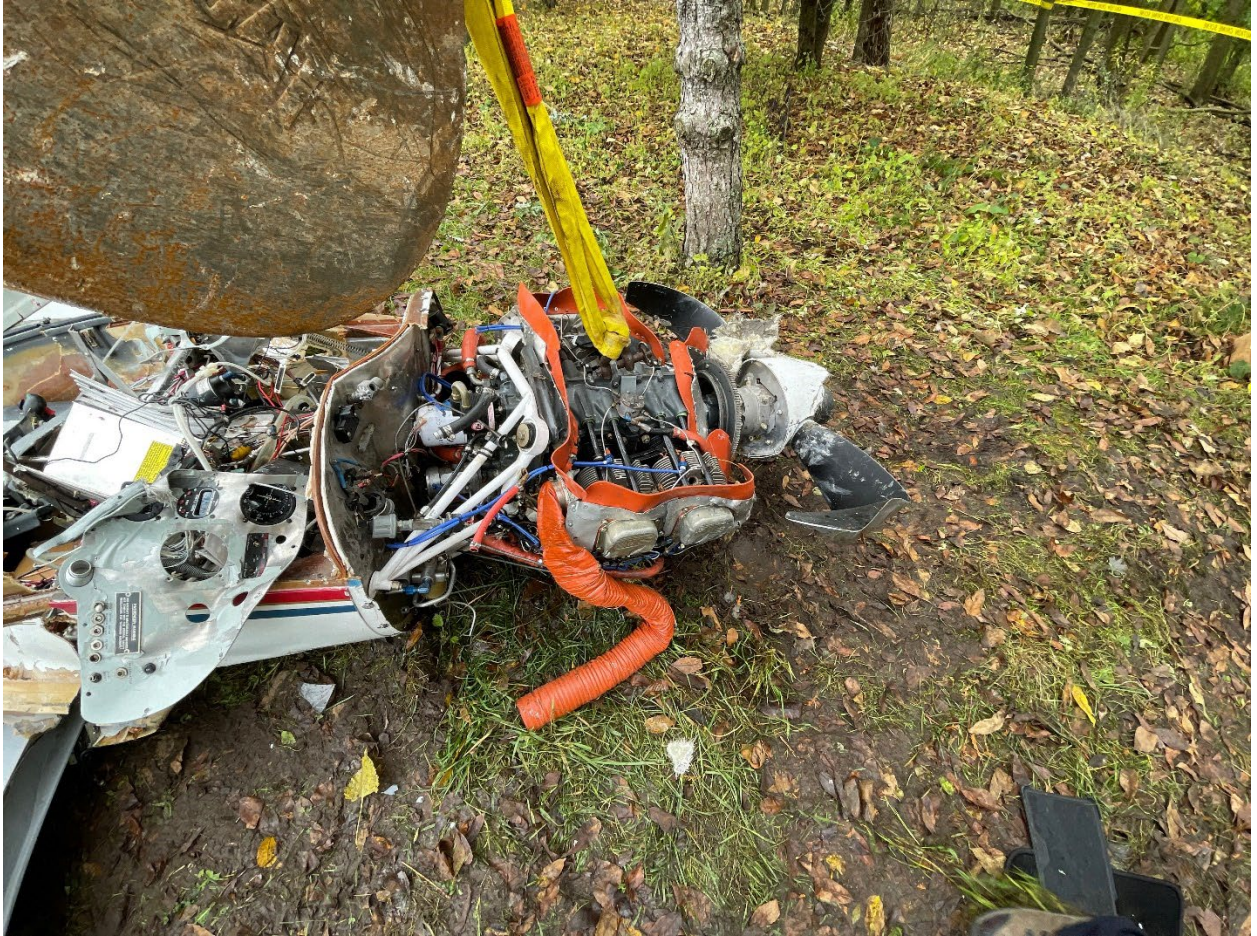
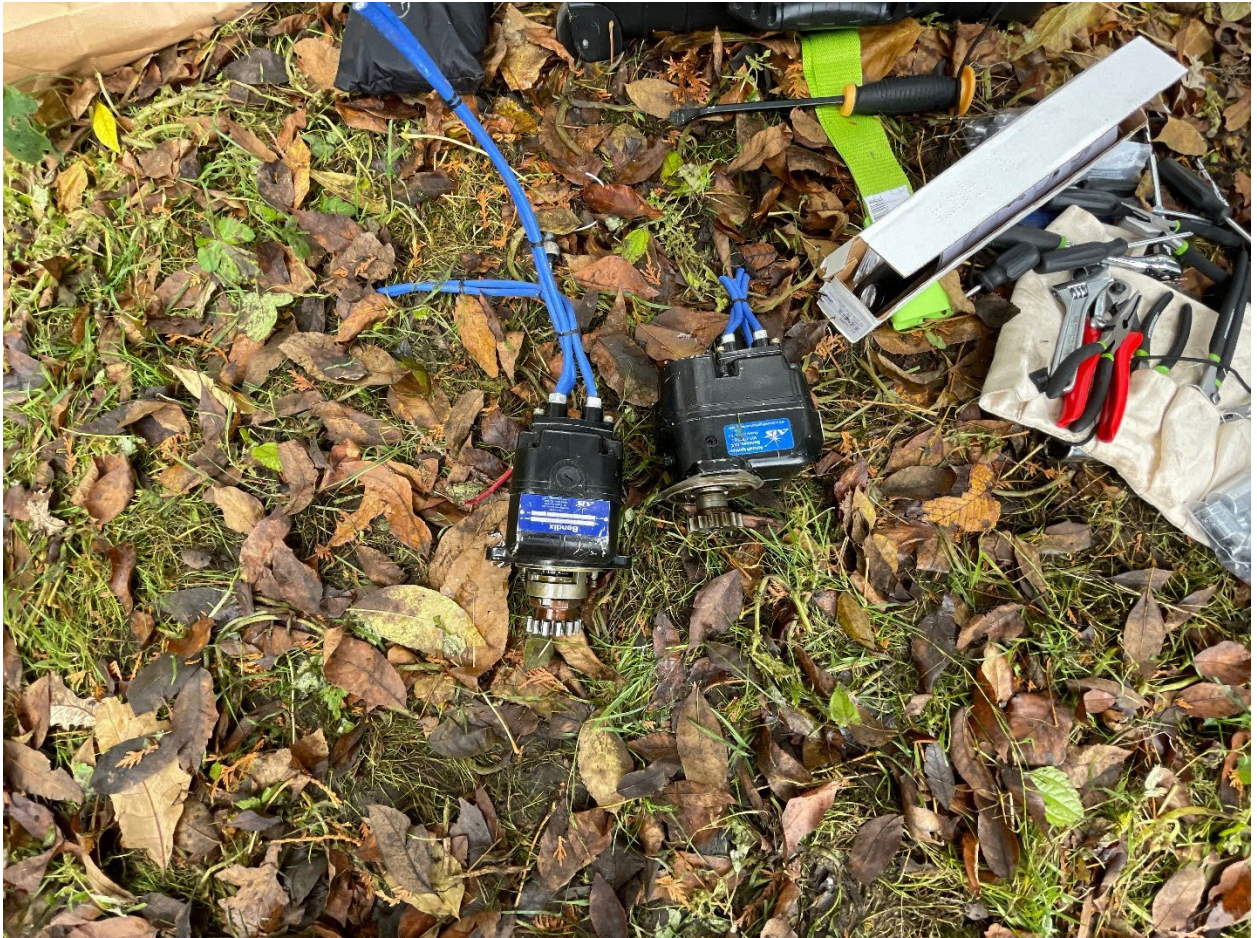
The engine was supported by its lifting eye and the upper set of spark plugs were removed. The engine was free to rotate and water was expelled from the cylinders upon initial rotation after removal from the lake. The engine rotated freely with no abnormalities in rotation detected. The No. 1 cylinder rocker cover was removed, and the engine again rotated. Movement of both No. 1 cylinder valves was noted during rotation. Thumb compression was verified on all 4 cylinders. Both magnetos were removed from the engine. The left magneto, which was equipped with an impulse coupling, produced spark on all spark plug leads with hand rotation of the input shaft. The right magneto, which was not equipped with an impulse coupling, did not produce spark with hand rotation of the input shaft. An electric drill was used to spin the input shaft at higher speed and spark was observed on all 4 spark plug leads. Engine throttle, mixture, and propeller control continuity was verified. The propeller control was connected but the mounting bracket was impact damaged. The fuel injection distribution cover was removed with no anomalies noted. Fuel was present inside the distributor.
