# National Transportation Safety Board

CEN24FA028

## **ENGINE EXAMINATION**

Location: McCook, NE  
Date: October 30, 2023  
Time: 1200 CDT  
1700 UTC  
Airplane: Piper PA46-350P

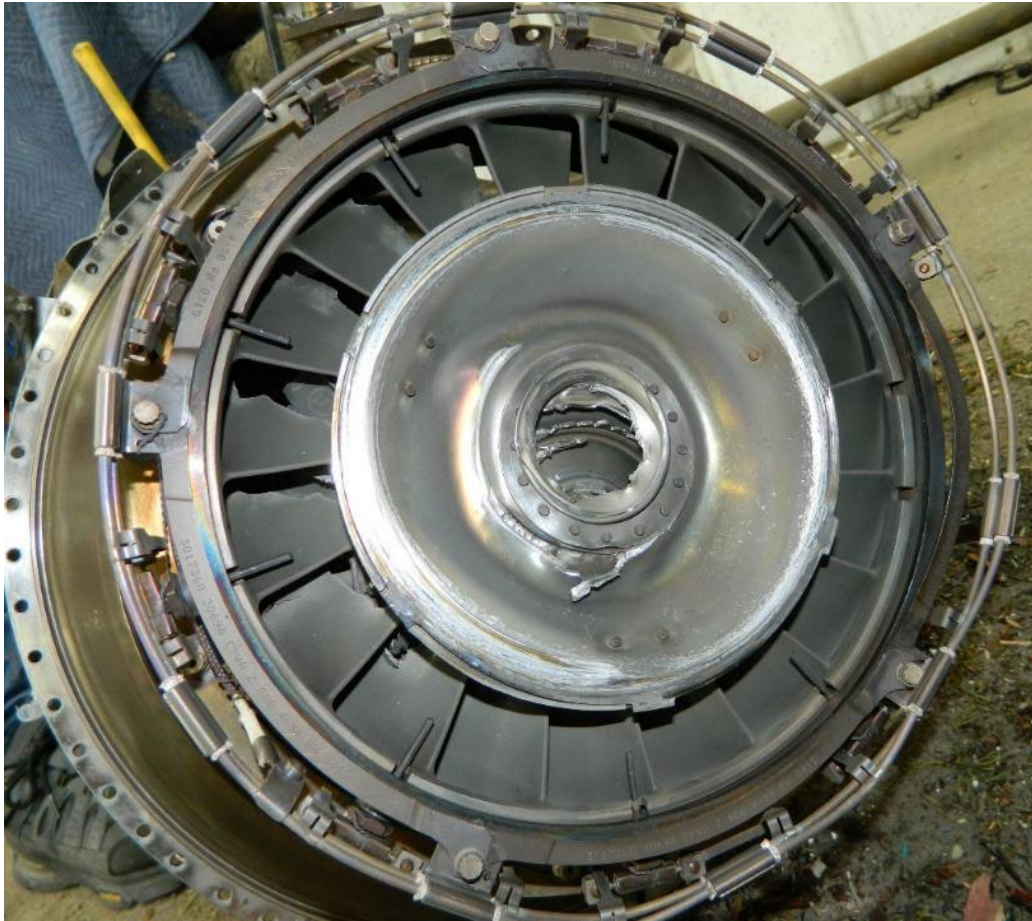
**Figure 2 Power Turbine Section**

The power section and gas generator could not be rotated by hand. Once the power section module was separated, the gas generator section would rotate normally. There was evidence that the power turbine vane ring center bore had machined to compressor turbine disk.

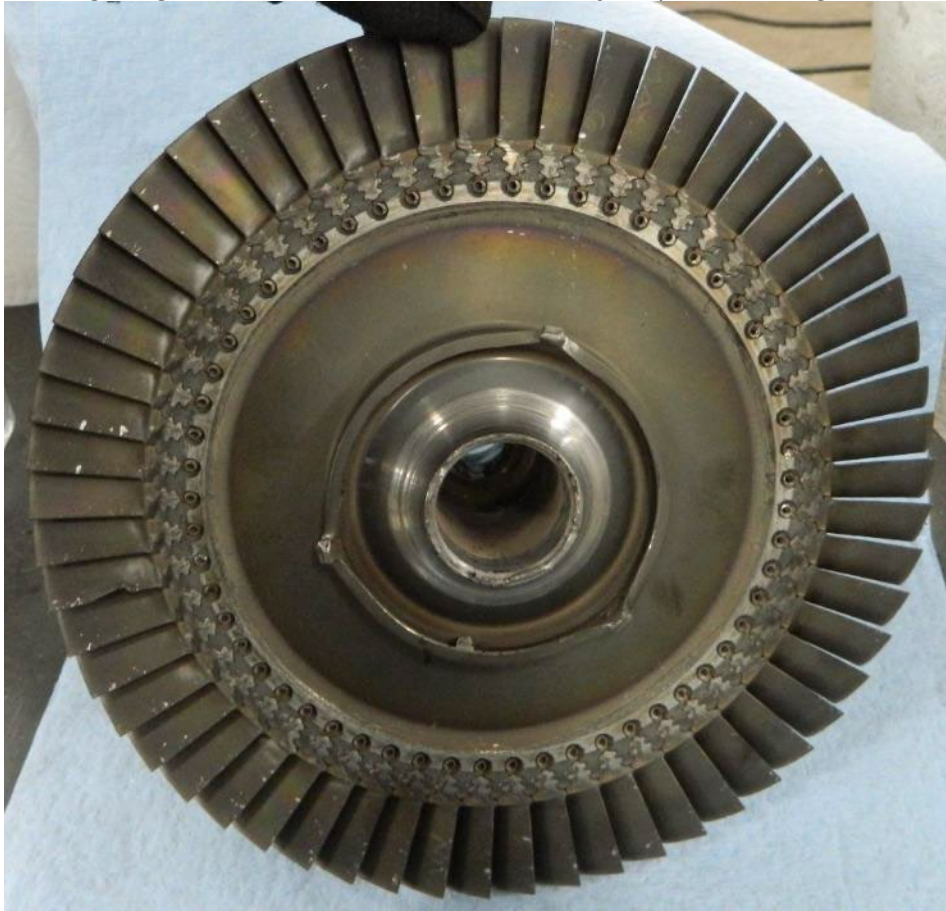
**Figure 3 Compressor Turbine Disk**

The compressor turbine section had evidence of rotational scoring on both the upstream and downstream sides of the disk. All blade remained attached and the trailing edge of the blades had secondary impact damage.

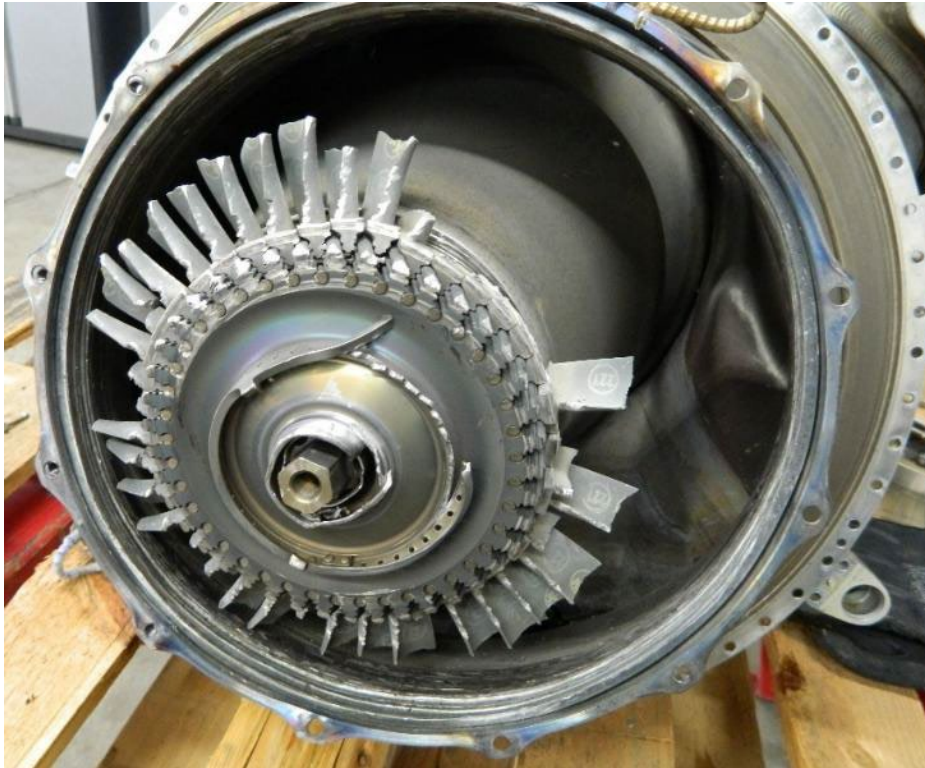
**Figure 4 Power Turbine Disk**

The power turbine disk had rotational scoring on both the upstream and downstream sides of the disk. Multiple blades were fractured with varying heights, all showing evidence of overload fractures. The blades were displaced rearward in the disk.

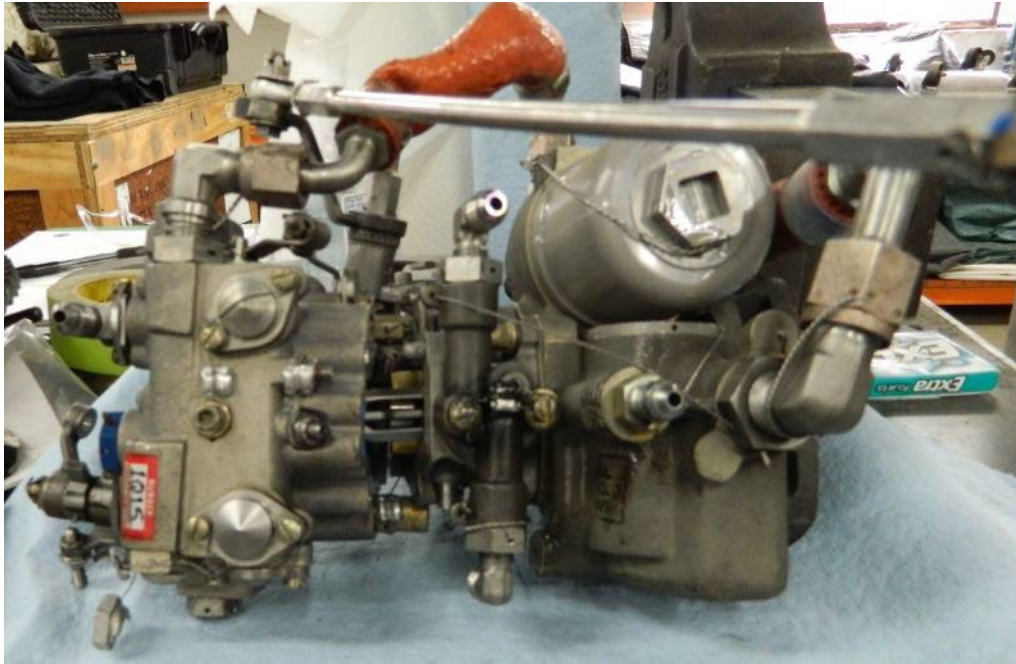
**Figure 5 Fuel Control Unit and Fuel Pump Assembly**

The fuel control unit and fuel pump were removed from the engine. The FCU was compromised and the internal components exposed, but all portion remained attached together.

No anomalies were detected with the engine during the examination. The FCU and fuel pump will be sent to P&WC for further examination. The propeller governor will be sent to Woodward for further examination.

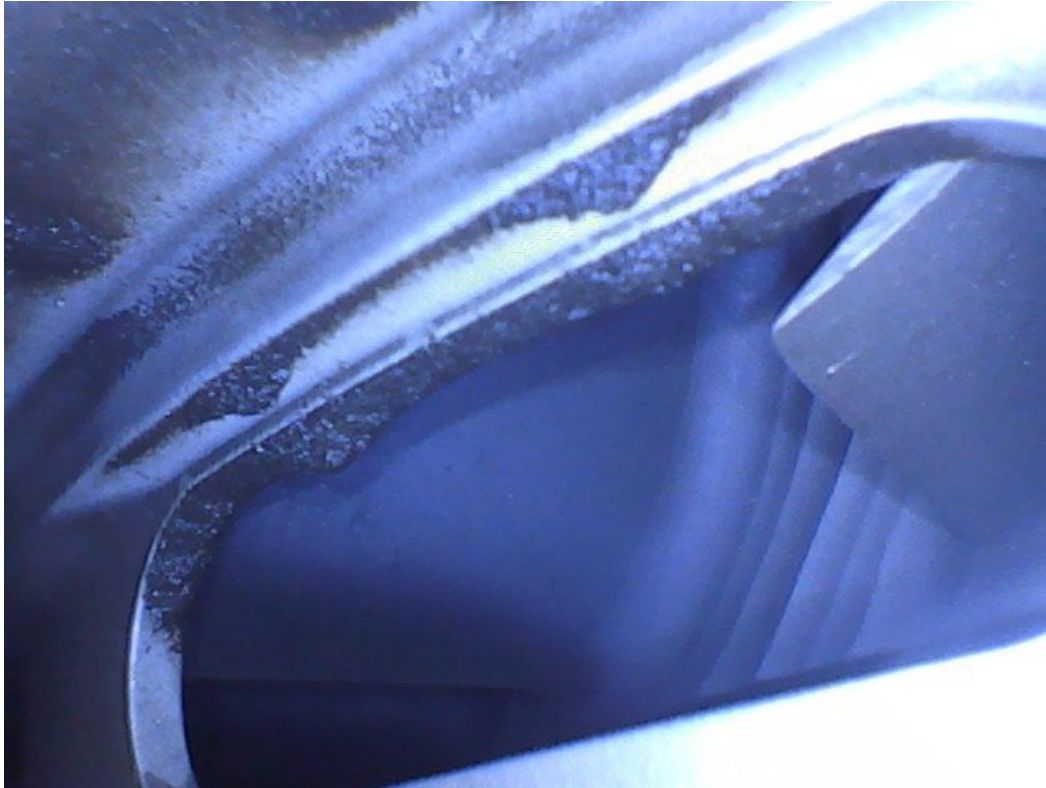
**Figure 6 Impeller Vanes**

Impeller vanes viewed through the bleed slot with a borescope showed rubbing on the blade tips and environmental debris in the area.
